21 JANUARY 2022

**Report of the Inquiry
Committee for the accident
at Stars Engrg Pte Ltd on
24 February 2021**

(PART I – MAIN REPORT)

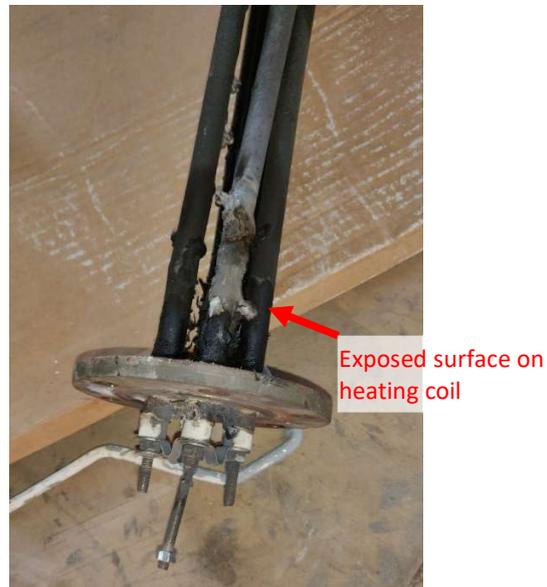
Figure 11: Heater #1 replaced on 8 August 2020

70. Imam then replaced heater #1 with a spare heater that another co-worker, Shohel, retrieved from the level 2 store within the premises. *Figure 11* above shows that the metal surface of the spoilt heater's heating element seemed melted with the interior exposed.

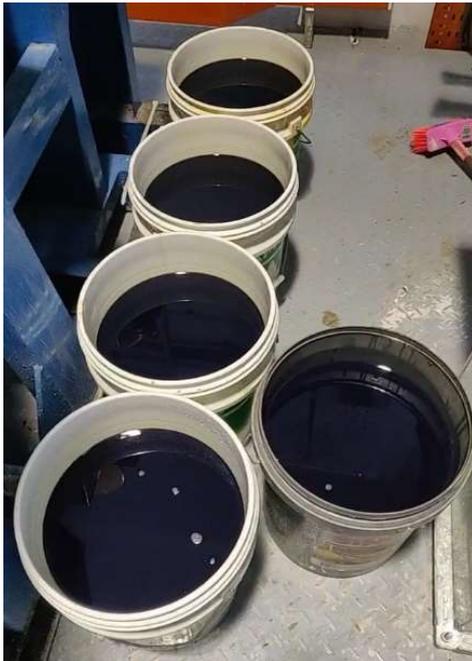
Figure 12: Screenshot from video. The 6th bucket is not shown here as it was under the drain valve

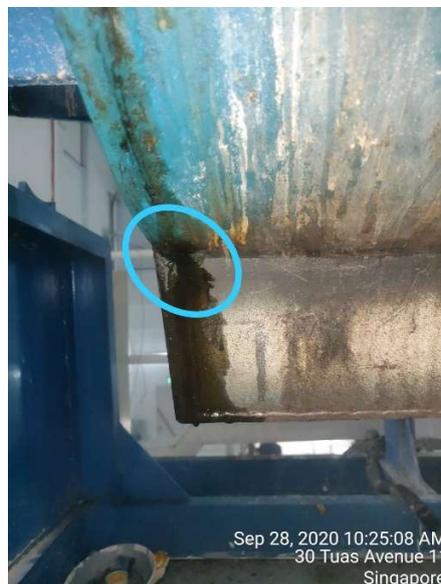
79. Imam sent a photo to Moe at 1025hrs showing oil dripping from a hole on the surface of the oil jacket at the front left bottom corner of the mixer machine with the accompanying messages “hole have small” and “need to welding bro”. Imam heard boiling sounds and saw smoke accompanying the oil leak. It was possibly the first time that an oil leak was noticed since the mixer machine was installed at the worksite. Up to that time, Stars Engrg’s workload in relation to the production of the fire wrap was not high and the mixer machine had, according to Imam, been used only about 2 to 6 times in a month.

Figure 14: First oil leak on jacket, blue circle inherent in Imam’s photograph

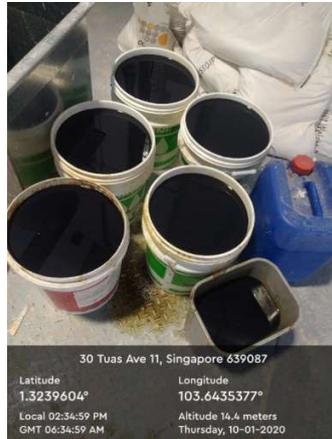
81. Oil was drained for a third time on 1 October 2020. A picture showing five buckets and a smaller container of used oil was taken by Mehedi and sent to Imam. Out of the five buckets, four were the original buckets for the thermic oil. The drained oil once again looked dark in colour.

Figure 15: A total of six containers of darkened used oil were drained from the oil jacket

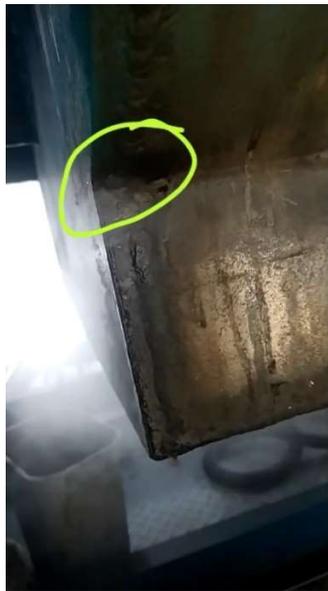
Figure 16: Screenshot from video of 12 October 2020 showing oil leak and smoke, green circle inherent in video

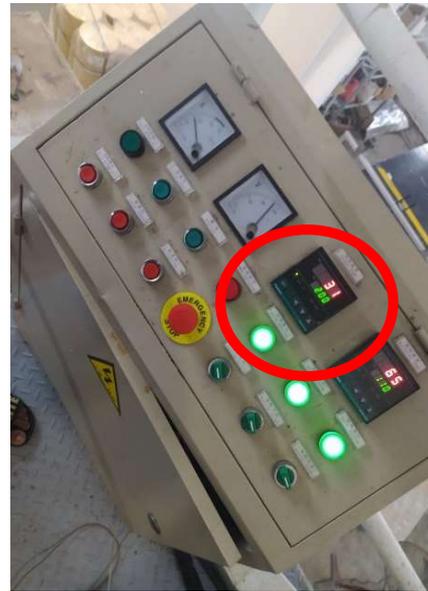
Figure 17: Safety interlock temperature setting at 200°C on 12 October 2020, green digits within red circle

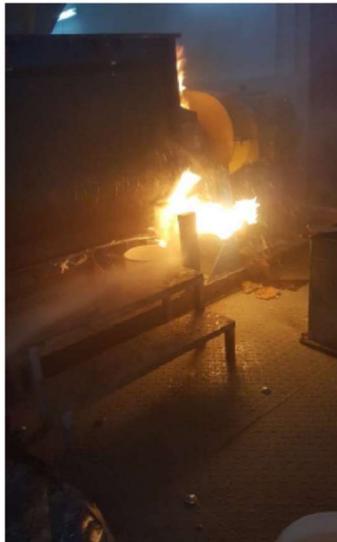
92. On 12 February 2021, which was the first day of Chinese New Year, at about 1650hrs, a fire occurred at the mixer machine near the drain valve at the bottom of the oil jacket. According to Mehedi, Marimuthu, who was operating on the platform, was the first to notice the fire, and said he observed a red-orange flame measuring about 250-300mm high, and 150-250mm wide. Mehedi and Marimuthu then put out the fire with a hose reel, before Marimuthu activated the emergency stop button to turn off the mixer machine. After the fire was extinguished, Mehedi saw beads of black oil leaking from the oil jacket and noticed a lot of smoke from the drain area, where the fire was.

Figure 19: Photograph of the fire taken by Marimuthu on 12 February 2021

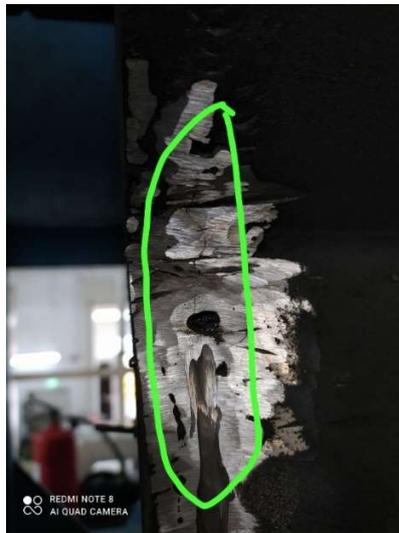
Figure 21: Grinding revealed a hairline crack on front left of machine, green circle inherent in picture

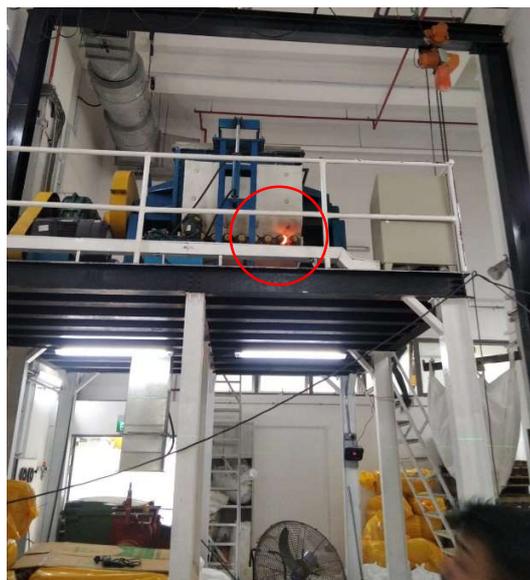
105. On 24 February 2021 at around 0839hrs, a glowing flange and a small flame was observed at heater #2. *Figure 22* below shows a picture of the incident sent by another worker, Anis, to the Shield+Daily WhatsApp chat group at 0839hrs the same day. At about 0921hrs, Moe forwarded to Chua all the photographs that Marimuthu had sent to Moe that morning and Marimuthu's earlier WhatsApp messages. After not receiving any reply from Moe, Marimuthu then forwarded this picture to Chua at 1012hrs on the same day.

Figure 22: Photo of the glowing flange taken by Anis and sent at 0839hrs on 24 February 2021.

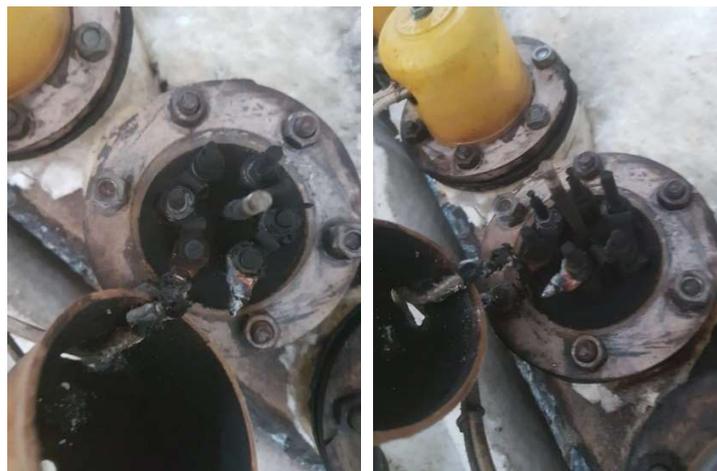
Figure 23: One of the cables on heater #2 had snapped, likely due to the earlier fire

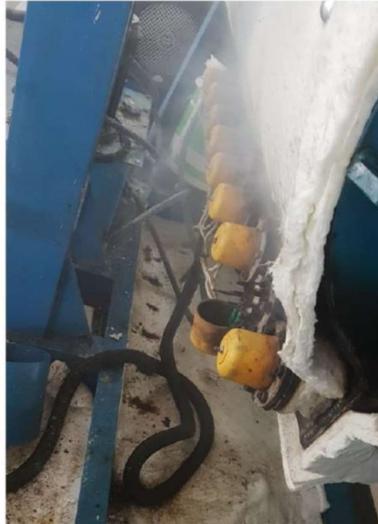
Figure 25: Photograph taken by Marimuthu on 24 February 2021 at 1113hrs showing that the wiring of the damaged heater #2 had been taped together with green tape

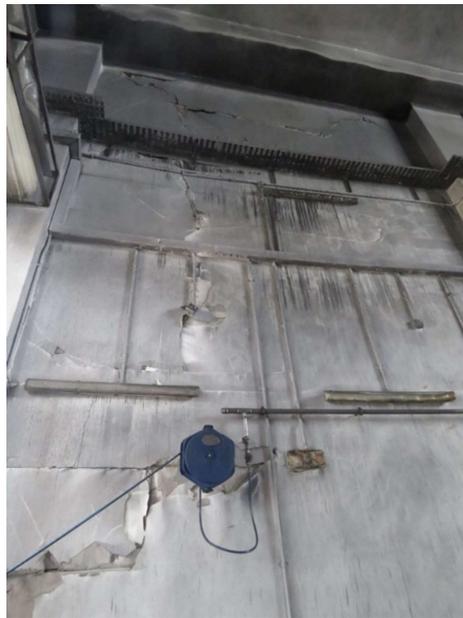
Cracks, from the bottom to the top of side wall

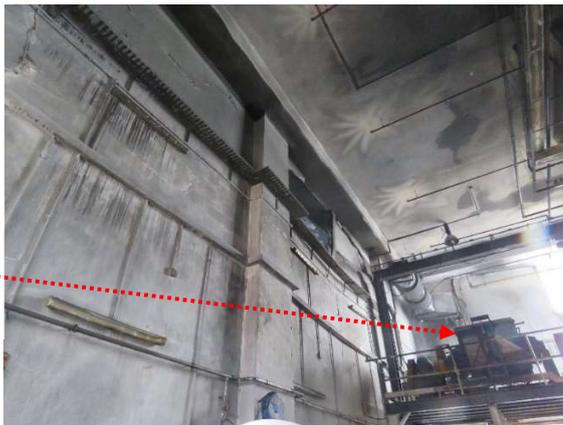
a gaping hole on the upper part of the side wall

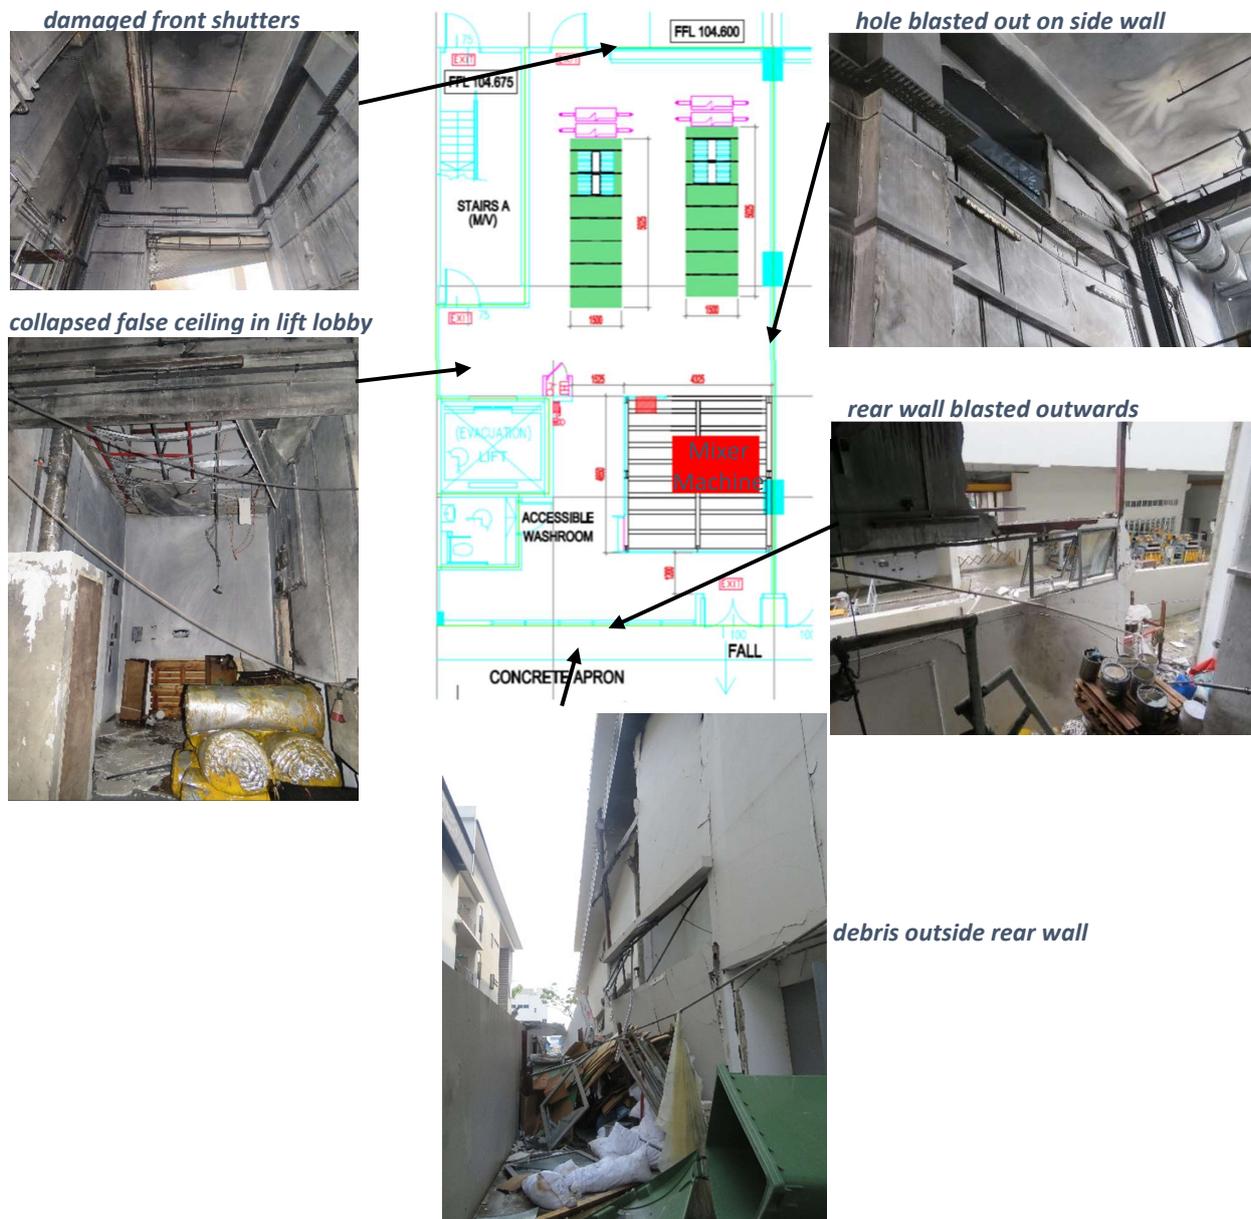
Figure 27: General damage within the worksite

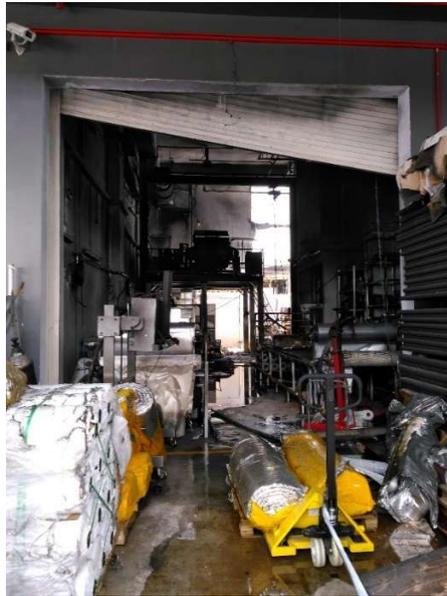
Figure 28: Damaged front shutters of the worksite

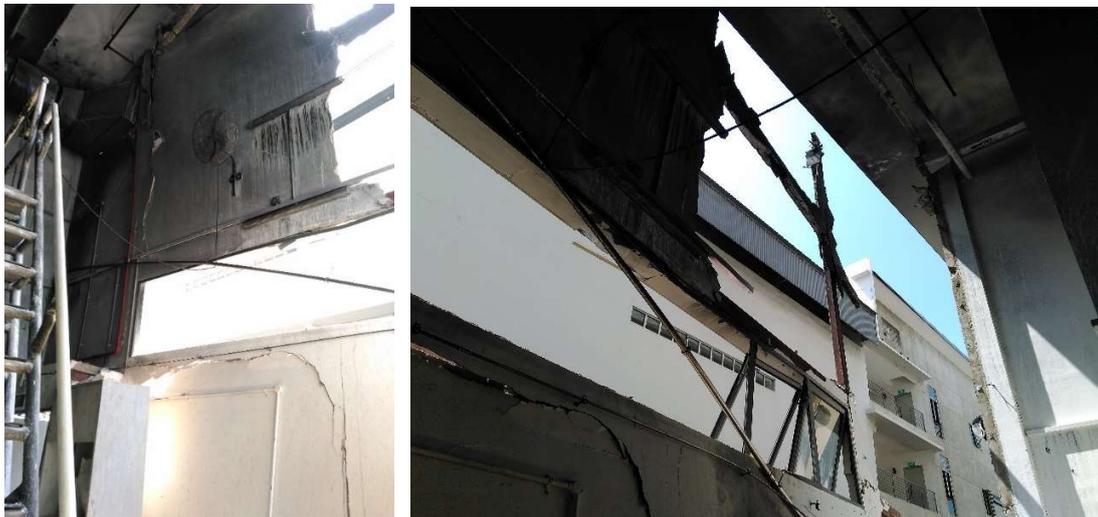
115. The back wall had partially collapsed, and debris was scattered around the back alley of the premises. The back wall also showed two different shades – the upper part had a blackish hue while the lower part largely retained its original colour.

Figure 29: Photos showing dual tones on the rear back wall of the worksite

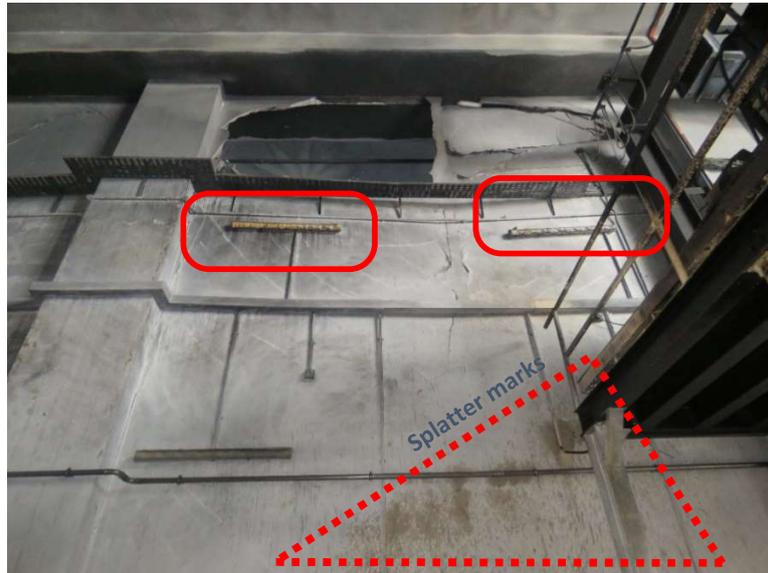
117. Splatter marks were observed on the side wall in the vicinity of the platform (Figure 30, dotted triangle in red). Based on the pattern of the splatter marks, the source appeared to be from the platform.

Figure 30: Photo showing the damaged light fixtures and splatter marks from platform

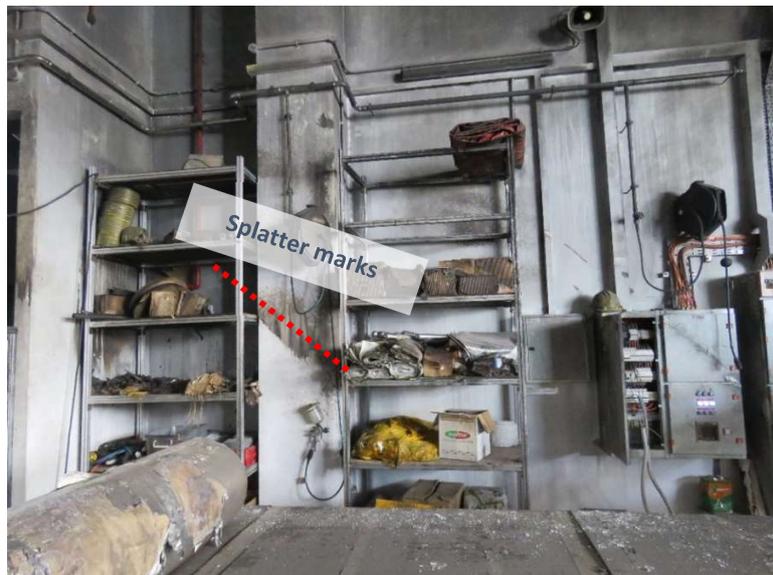
118. Splatter marks, as dotted in red in Figure 31, were also observed on the opposite side wall.

Figure 31: Photo showing splatter marks on the opposite side wall from platform

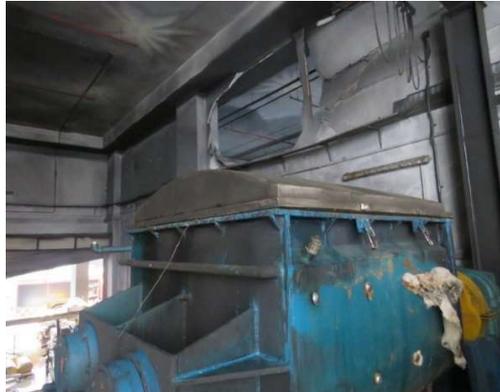
Figure 32: Hole at the top of side wall

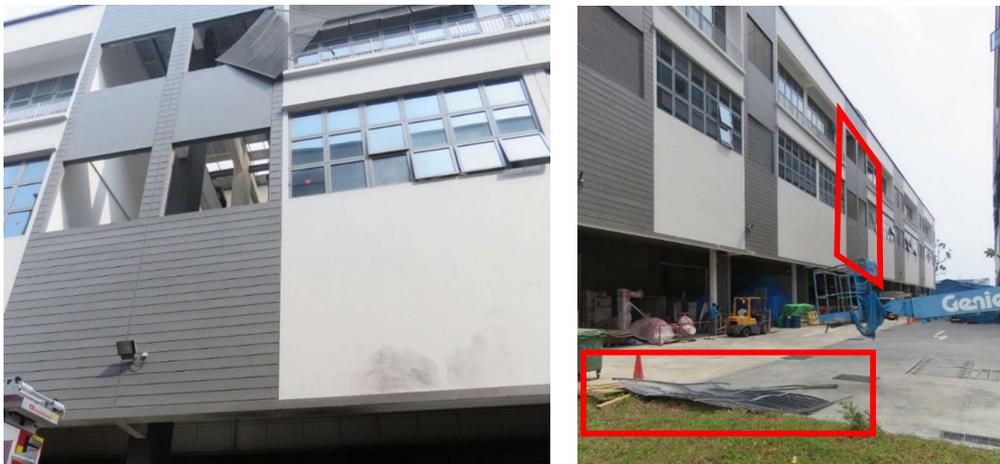
121. Four louvre panels were dislodged from the exterior façade of the building directly above the worksite. One of the dislodged panels was found dangling from its frame, and one of the panels was found some distance away close to the grass patch.

Figure 33: Photos showing the dislodged louvre panels

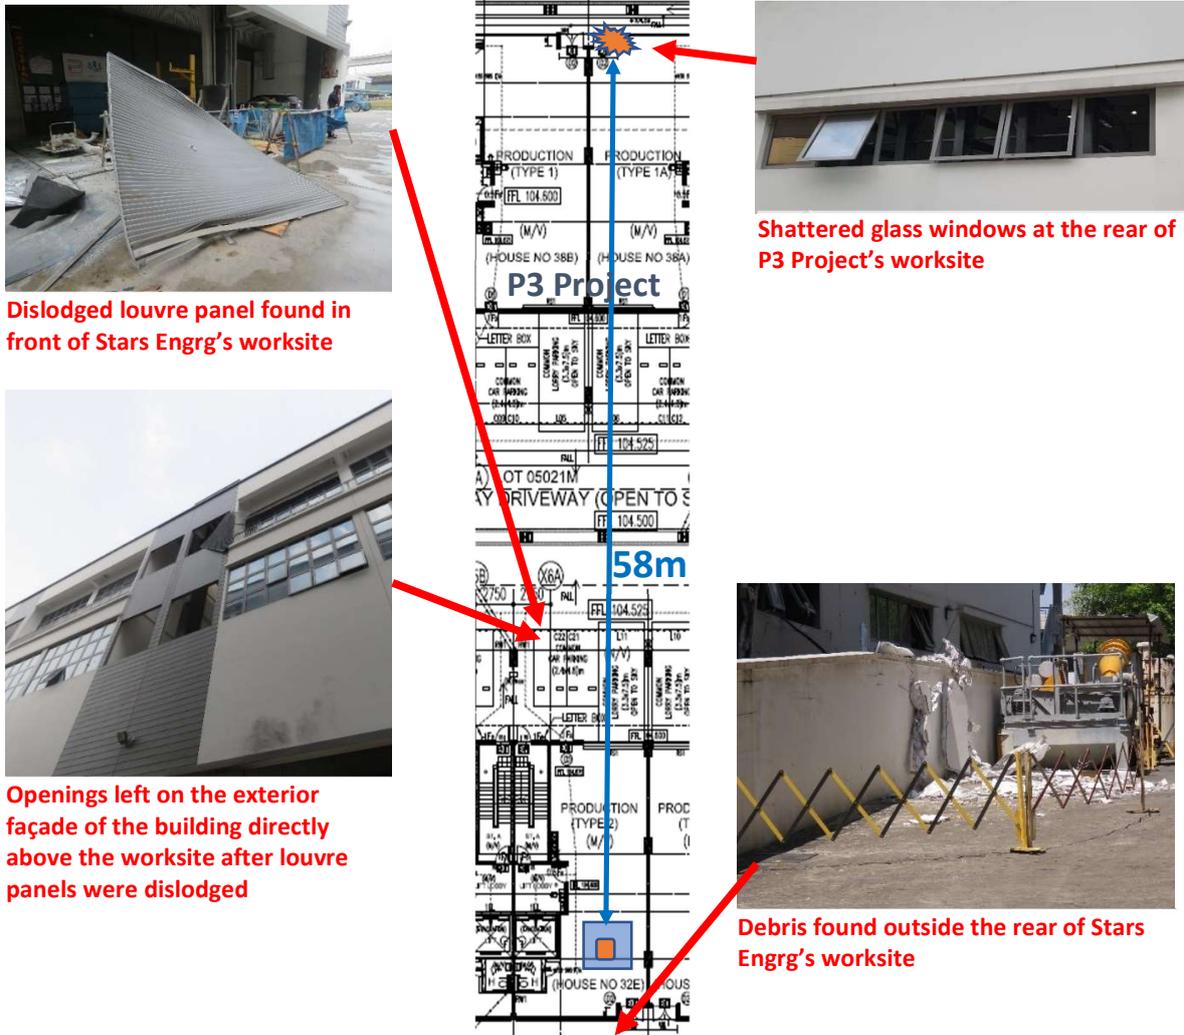
123. From the damages pieced together on the layout diagrams in Figures 34 and 35 below, the accident was likely an explosion from the mixer machine that generated blast overpressures sufficient to shatter glass at 58m away, dislodge panels, and destroyed walls.

Figure 34: Damage overlaid on layout plan, from the Tuas Site to P3 Project's rear windows

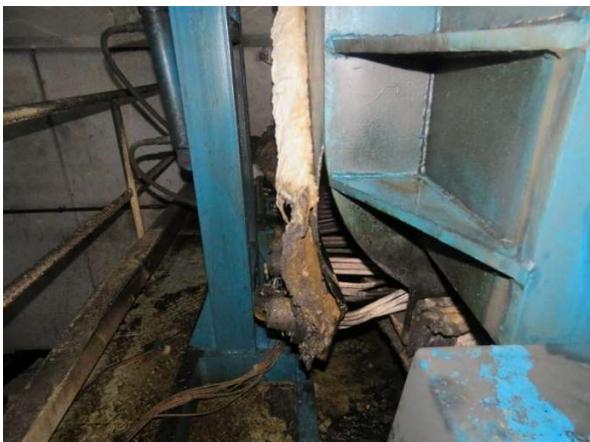
125. The oil jacket ruptured widest at the seam closest to where the replacement heater was placed. From the rupture's opening, the heating elements inside the jacket were observed to be bent and deformed as shown in *Figure 37*. The other end of the oil jacket had a darkened stain around the seam as shown in *Figure 38*. The stain was likely caused by leaked oil, so the seam at this end likely fractured as well, albeit to a smaller extent.

Figure 37: Deformed heating elements seen through the rupture on the oil jacket, rear of machine

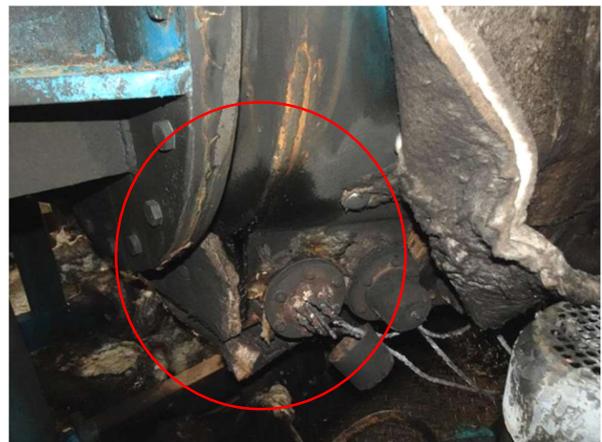
Figure 38: Dark stain on oil jacket, circled in red

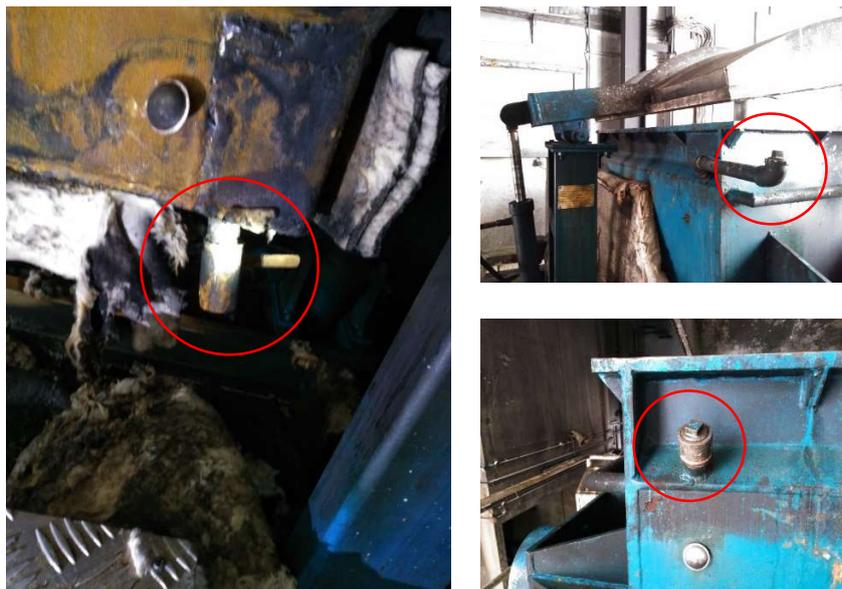
Figure 40: All three openings on the oil jacket circled in red were found closed

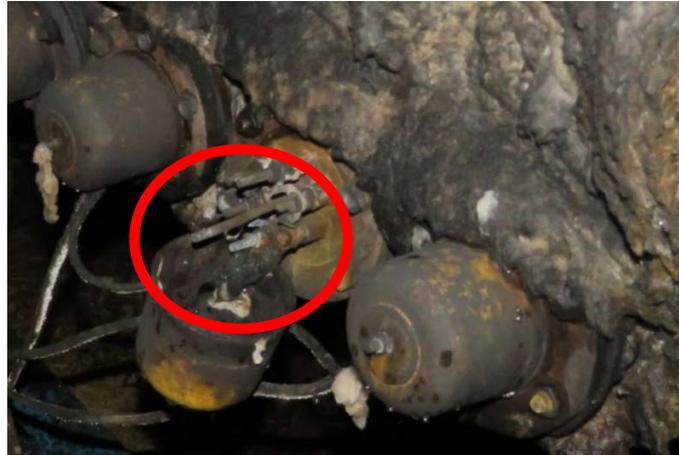
Figure 46: Green tape found on wires connected to two terminal connections of heater #2

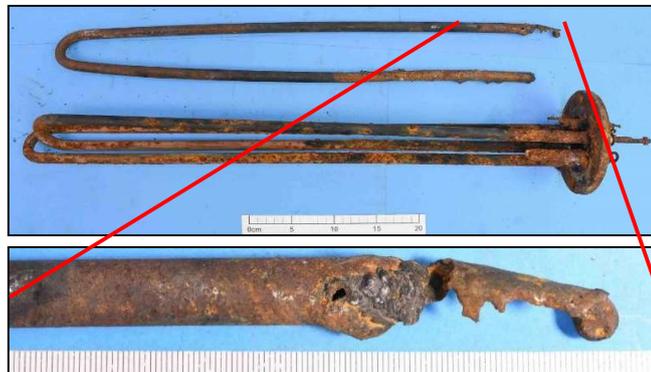
Figure 51: Post-explosion view of spoiled heater, likely to be heater #1, that was replaced on 8 August 2020

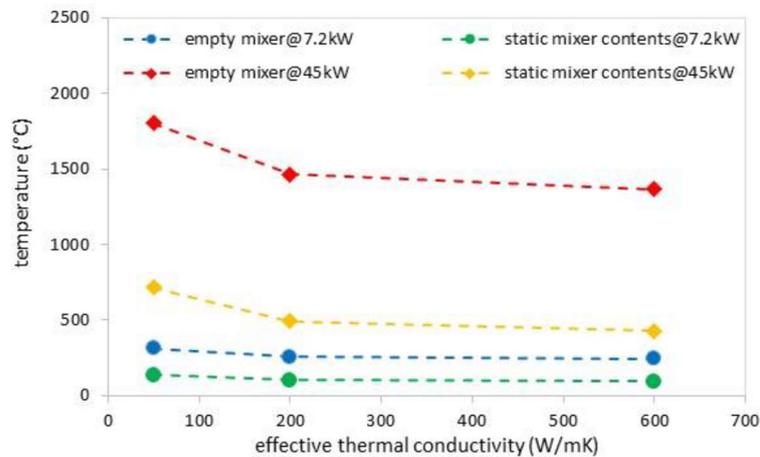
Figure 52: FEA modelling showing how low thermal conductivity of the heat transfer fluid affected jacket temperatures

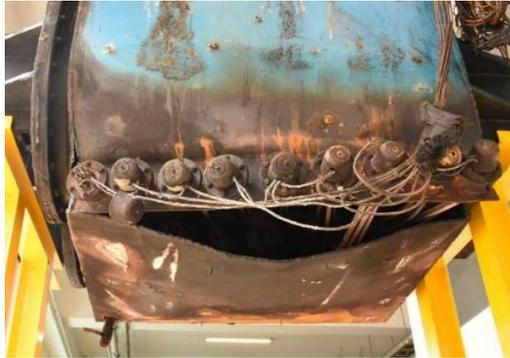
Figure 53: Bulging deformation, indicative of overpressure release from inside out

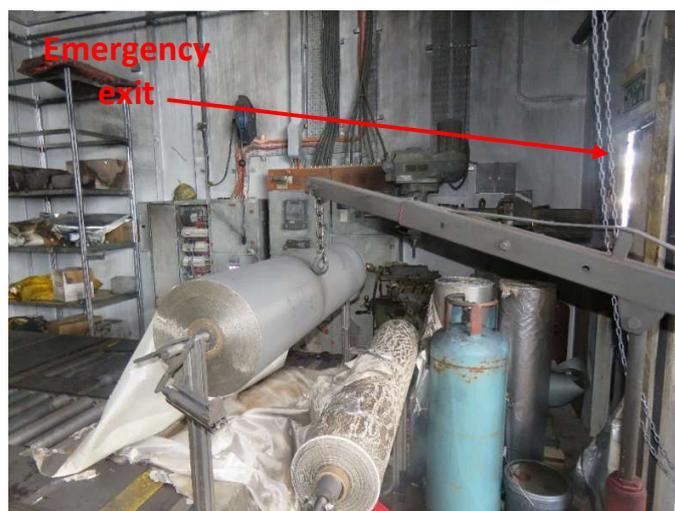
Figure 55: The assembly table that Jitu worked at, with obstructions at the emergency exit
