**Report of the Inquiry
Committee for the accident
at Stars Engrg Pte Ltd on
24 February 2021
(PART II – ANNEXES)**

TECHNICAL REPORT

| Title of Report: Failure Analysis of a Failed Mixer Machine Retrieved from Unit 32E of Platinum @ Pioneer Building involved in a Fire Explosion Incident | | Date of Last Revision/Revision No: |

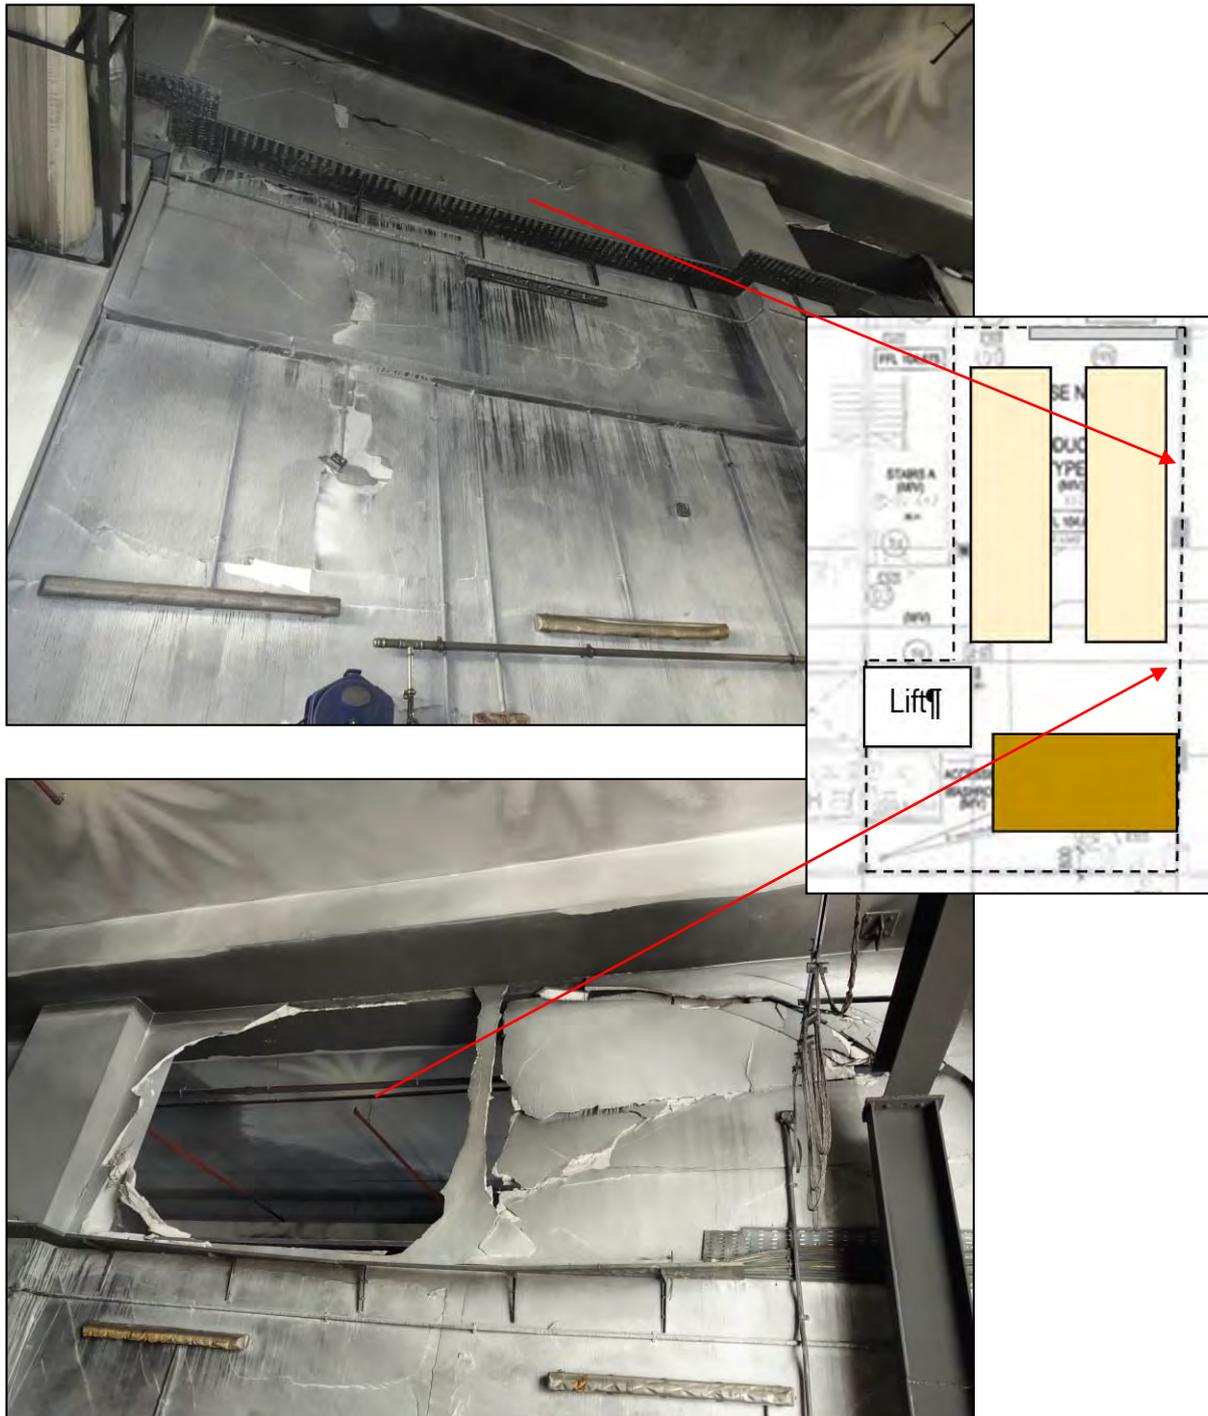
Punctured and cracked wall at localized areas on the top of the unit

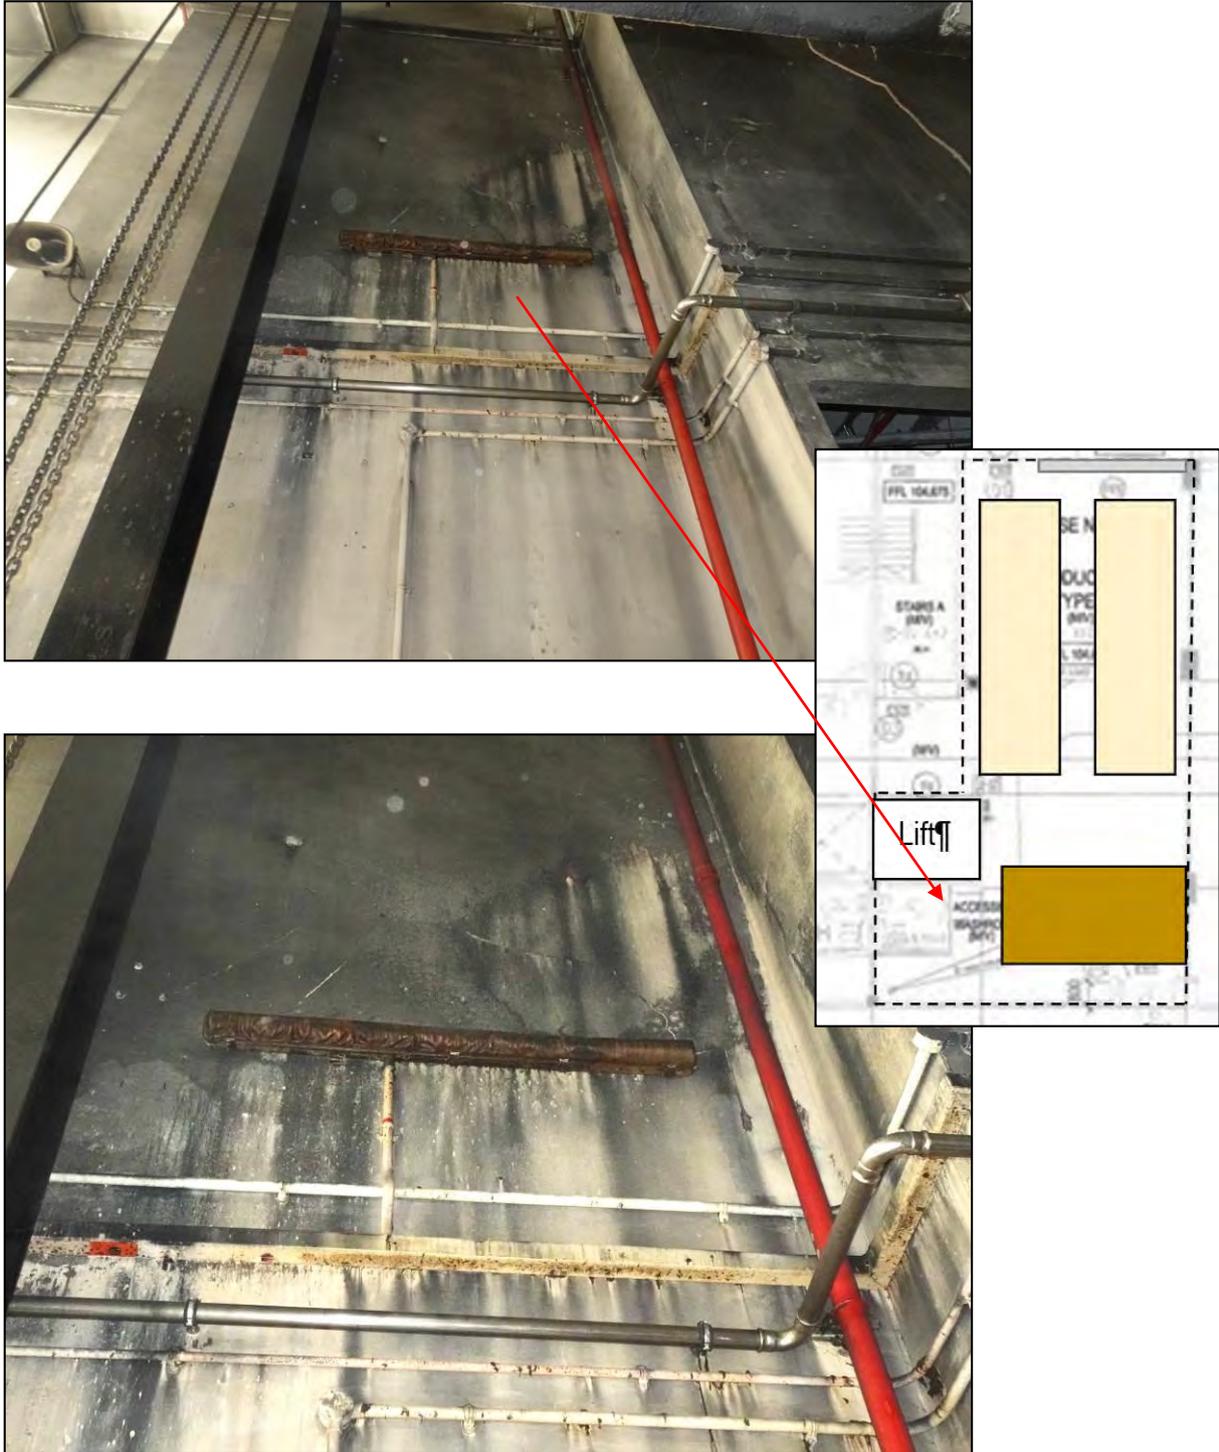
Cracked wall at localized area in the vicinity of the Platform floor

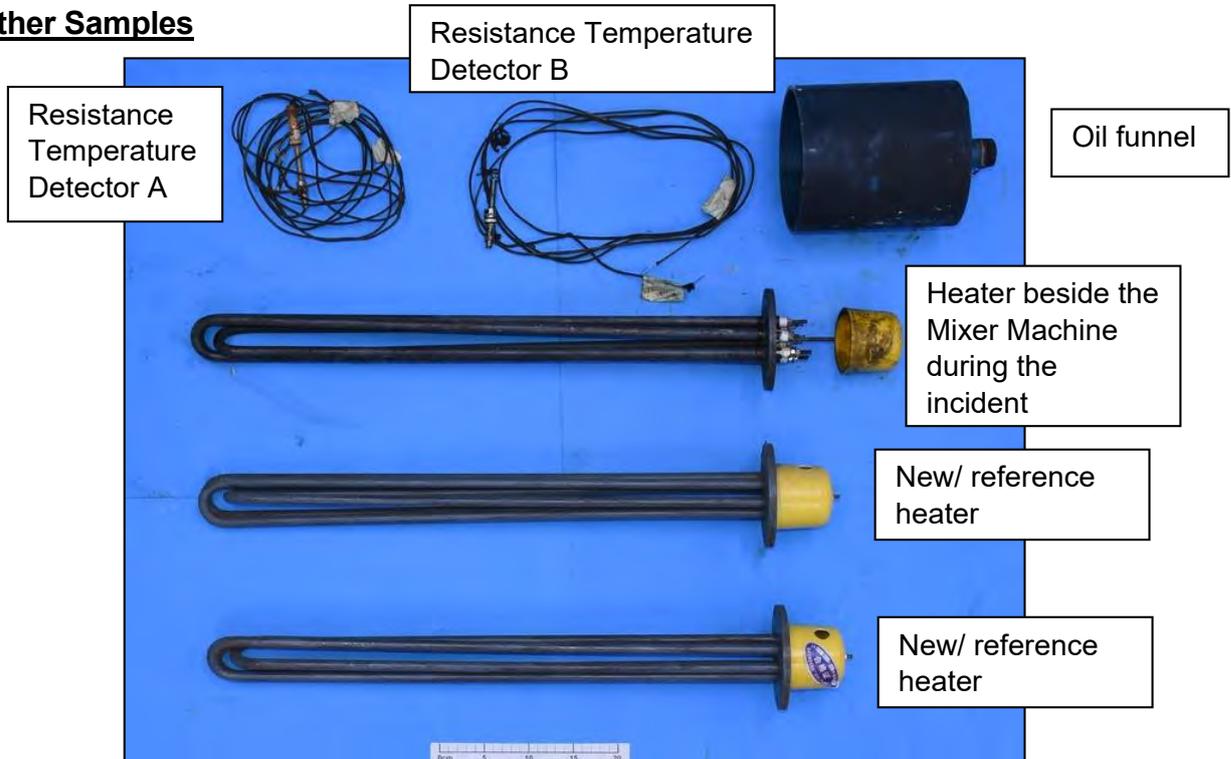
Figure 33: As-received condition of the additional samples.

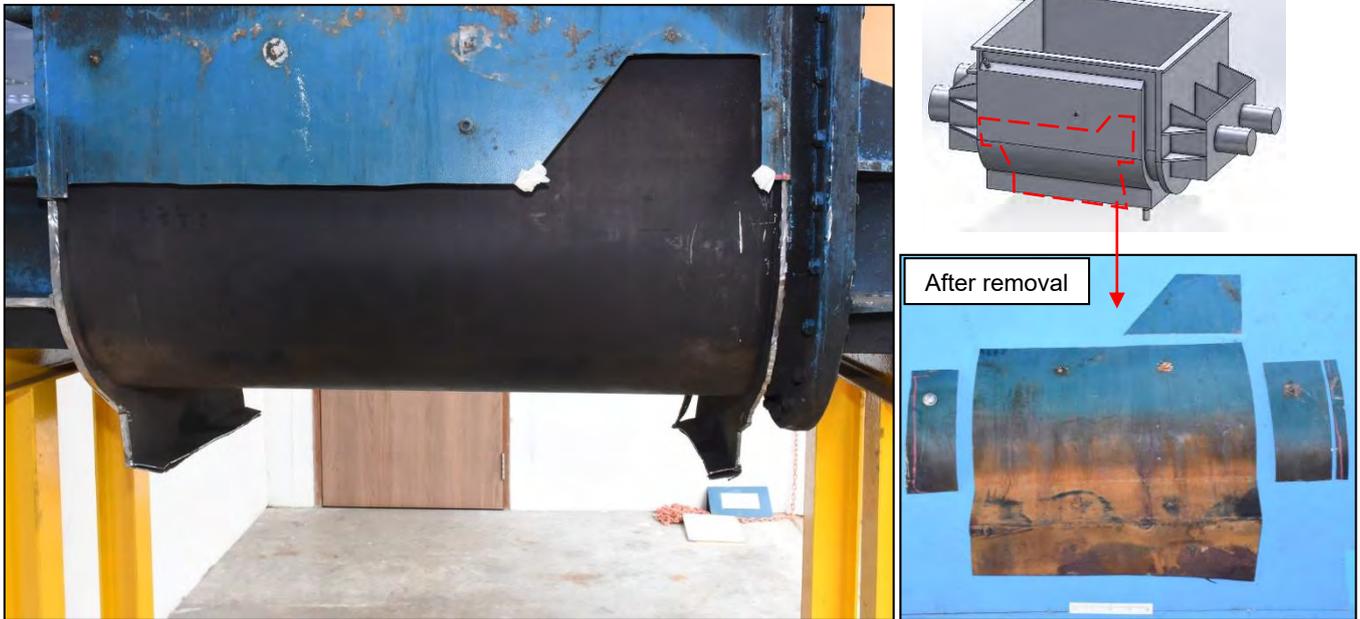
Figure 39: Internal condition of the oil jacket from the front side. The internal surface was generally covered by black soot.

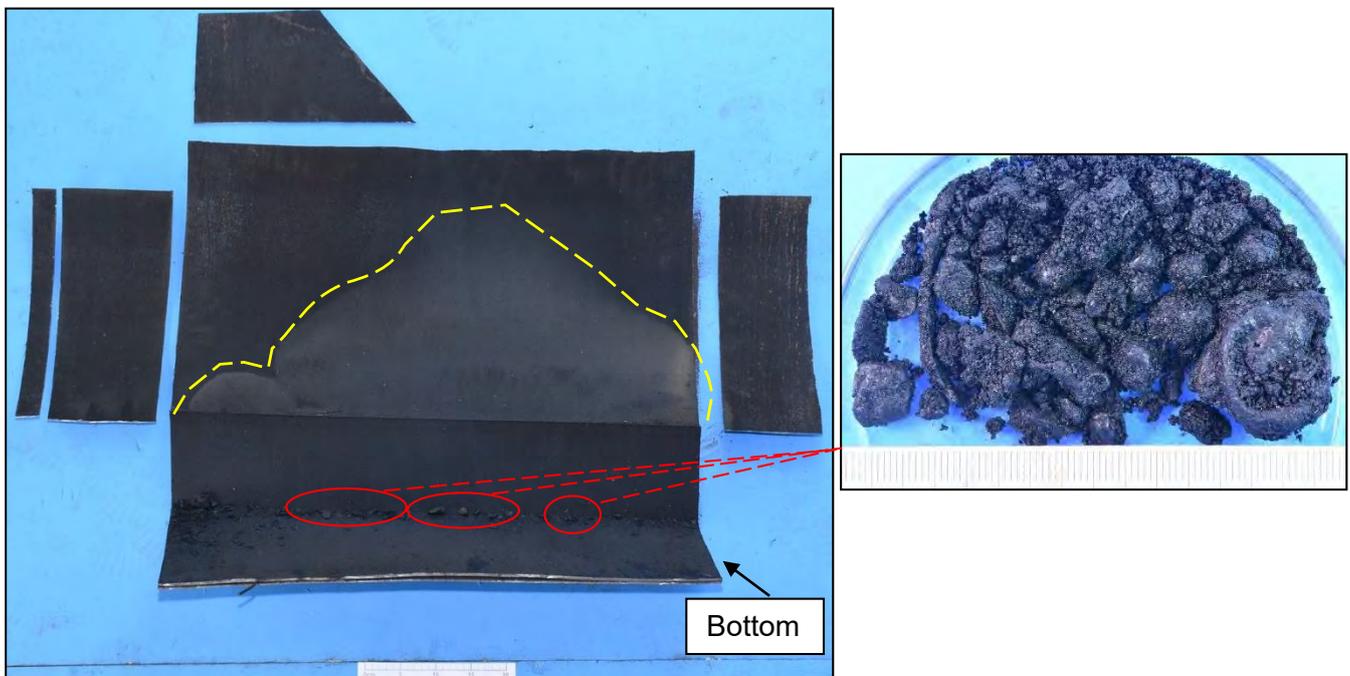
Figure 40: Cut out sections of oil jacket wall and bottom. Hard debris of various sizes (up to about 20 mm) were found at the bottom face (see red). There was also a layer of black soot/deposits masking the internal surface and the bottom face of the oil jacket (see also Figure 143). Oil stains and drips pattern were visible (see yellow line).

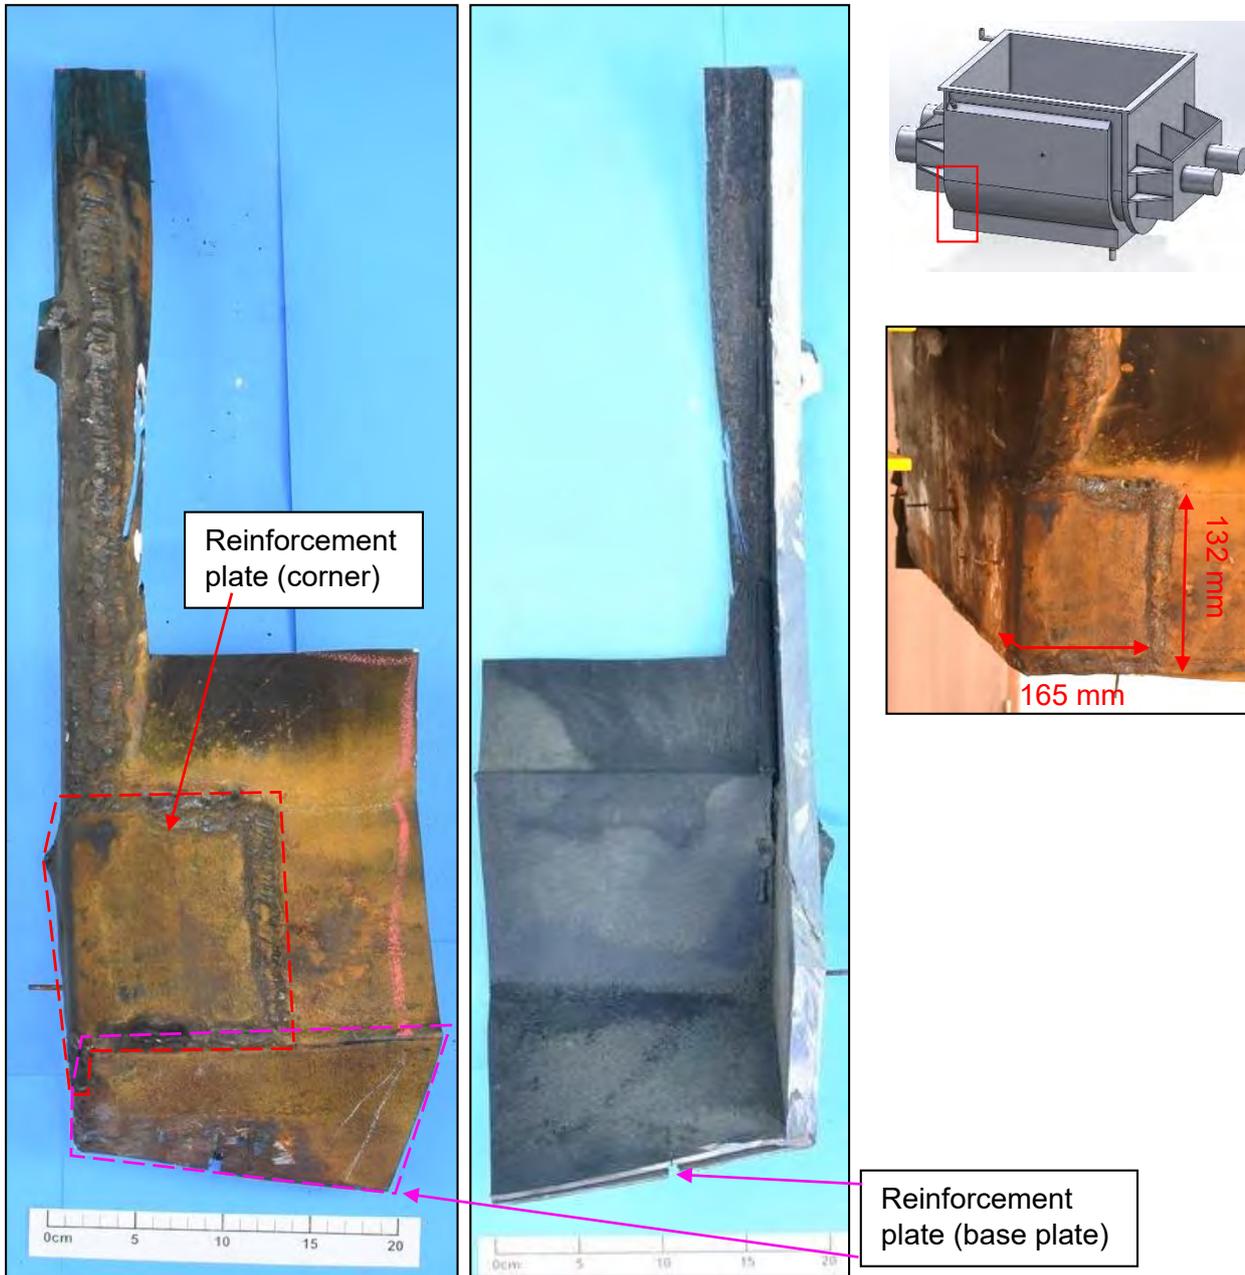
36 ➤ Both left and right edges had repair welds while the bottom corners had reinforcement plates (about 165 mm by 132 mm plates, one on each corner) welded onto the oil jacket (Figure 41 and Figure 50). A metal base plate was also added by welding ("base plate").

Figure 41: Cut out section of the front side, left edge weld. The left figure shows the external condition and the right figure shows the internal condition of this section. This cut out section included the original and repair welds. Parts of the reinforcement plates (corner and base plate identified with red and pink dotted lines) were visible here. The corner reinforcement plate had dimension of about 165 mm by 132 mm.

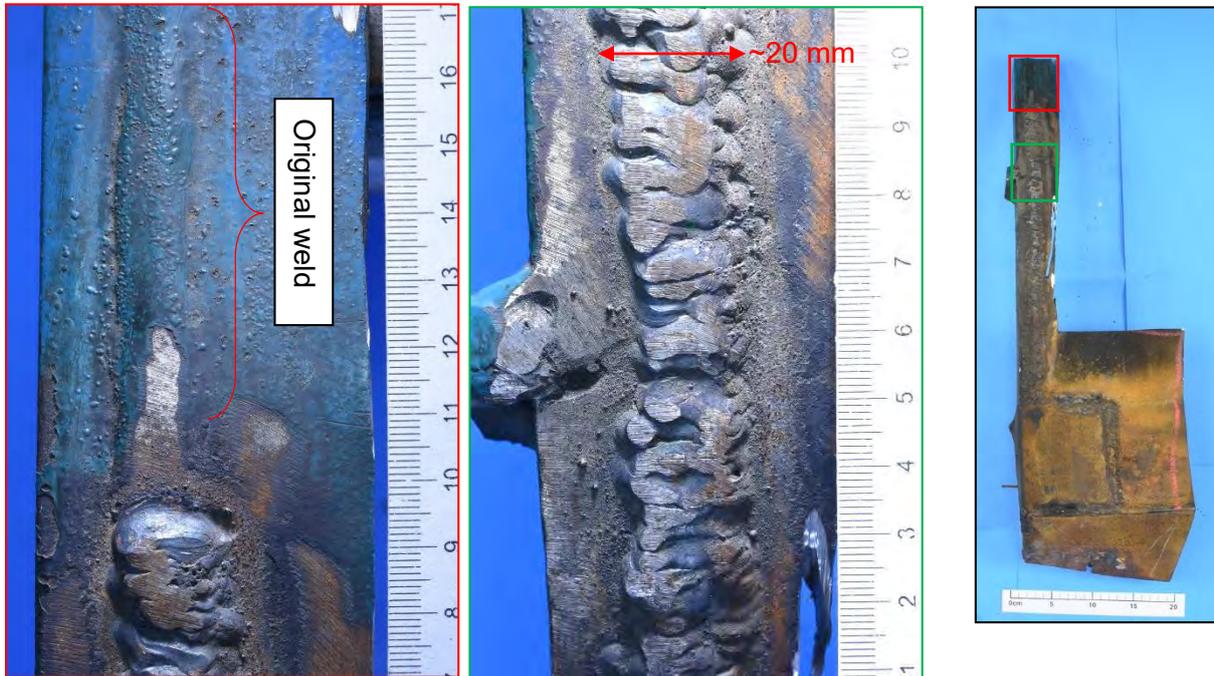
- 6 ➤ At the front side, left edge weld, the face width³ of the repair weld increased towards the bottom, measuring up to about 30 mm (Figure 42 and Figure 43).
- The weld root of the original weld had an irregular shape (Figure 46).
- 8 ➤ The root of the repair weld had a root surface width of about 4 mm and increased up to 9 mm towards the bottom. Some areas of the weld root had gaps and lack of penetration⁴ (Figure 46 and Figure 47).
- 10 ➤ A sector near the bottom end of the curved part (just above the vertical plane) an insert plate with length of 120 mm was observed at the weld root (Figure 47). See also Section 3.4 for chemical analysis and Figure 153 for cross sectional examination.
- 12
- 14

Figure 42: Close up view of side weld. Part of the original weld is indicated (in red) in the left figure. The rest of the weld towards the bottom was repaired and had a face width of about 20 mm.

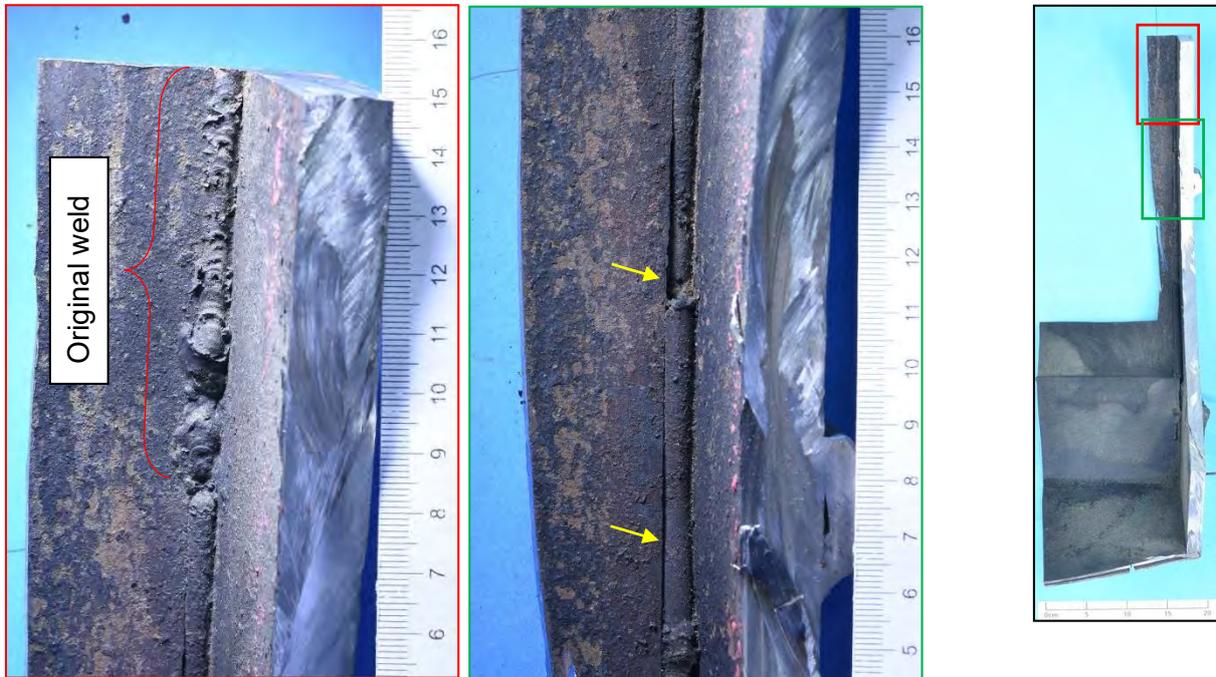
Figure 46: Condition of weld from inside the oil jacket. Part of the original weld is indicated (in red) in the left figure. The original weld root had an irregular shape. The rest of the weld was repaired, had a root surface width of about 4 mm and lack of penetration at some areas (indicated with yellow arrows).

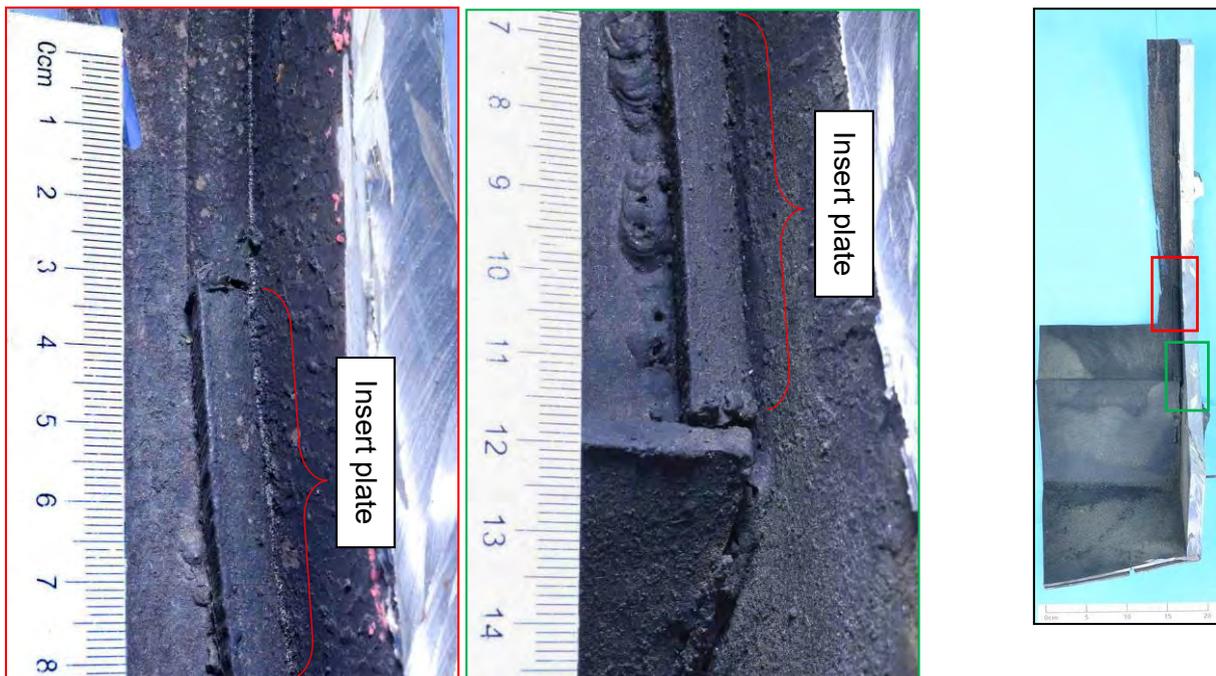
Figure 47: Condition of weld from inside the oil jacket. The width of the root surface increases towards the bottom (up to 9 mm). An insert plate with length of 120 mm was observed at a sector of the bottom end of the curved edge. (see also Section 3.4 and Figure 151)

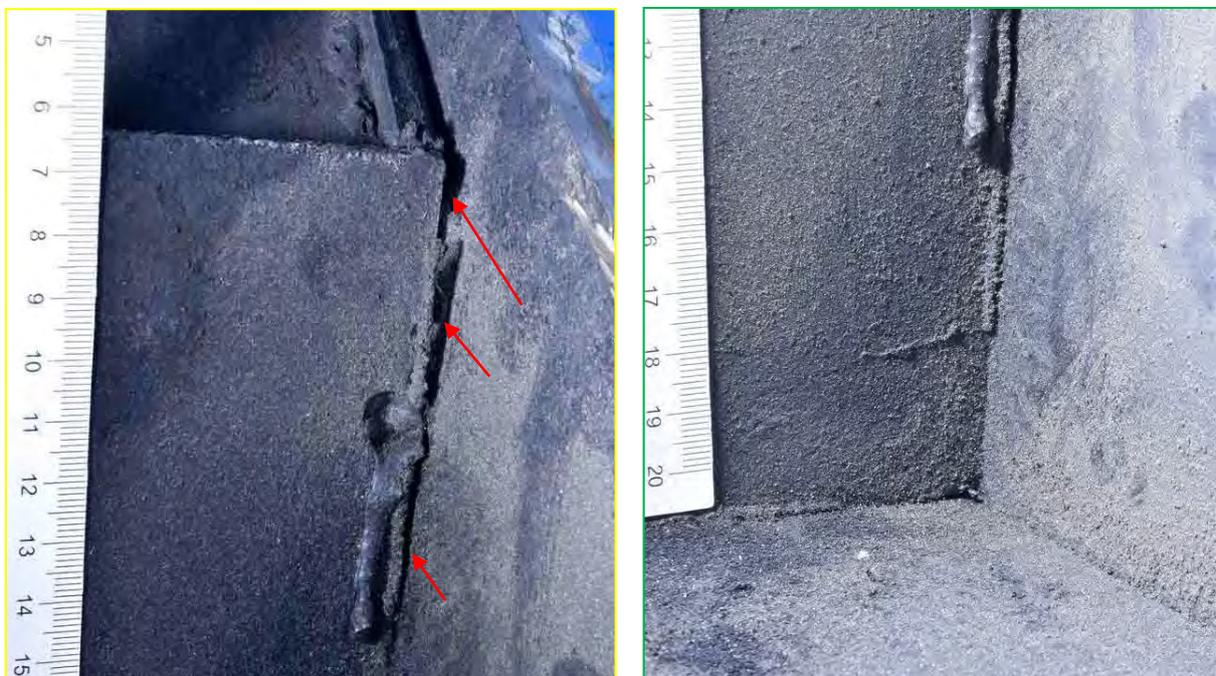
Figure 49: Close up view of the corner from inside the oil jacket. Gaps were observed between the walls (indicated with red arrows). The gap narrowed and stopped towards the bottom corner.

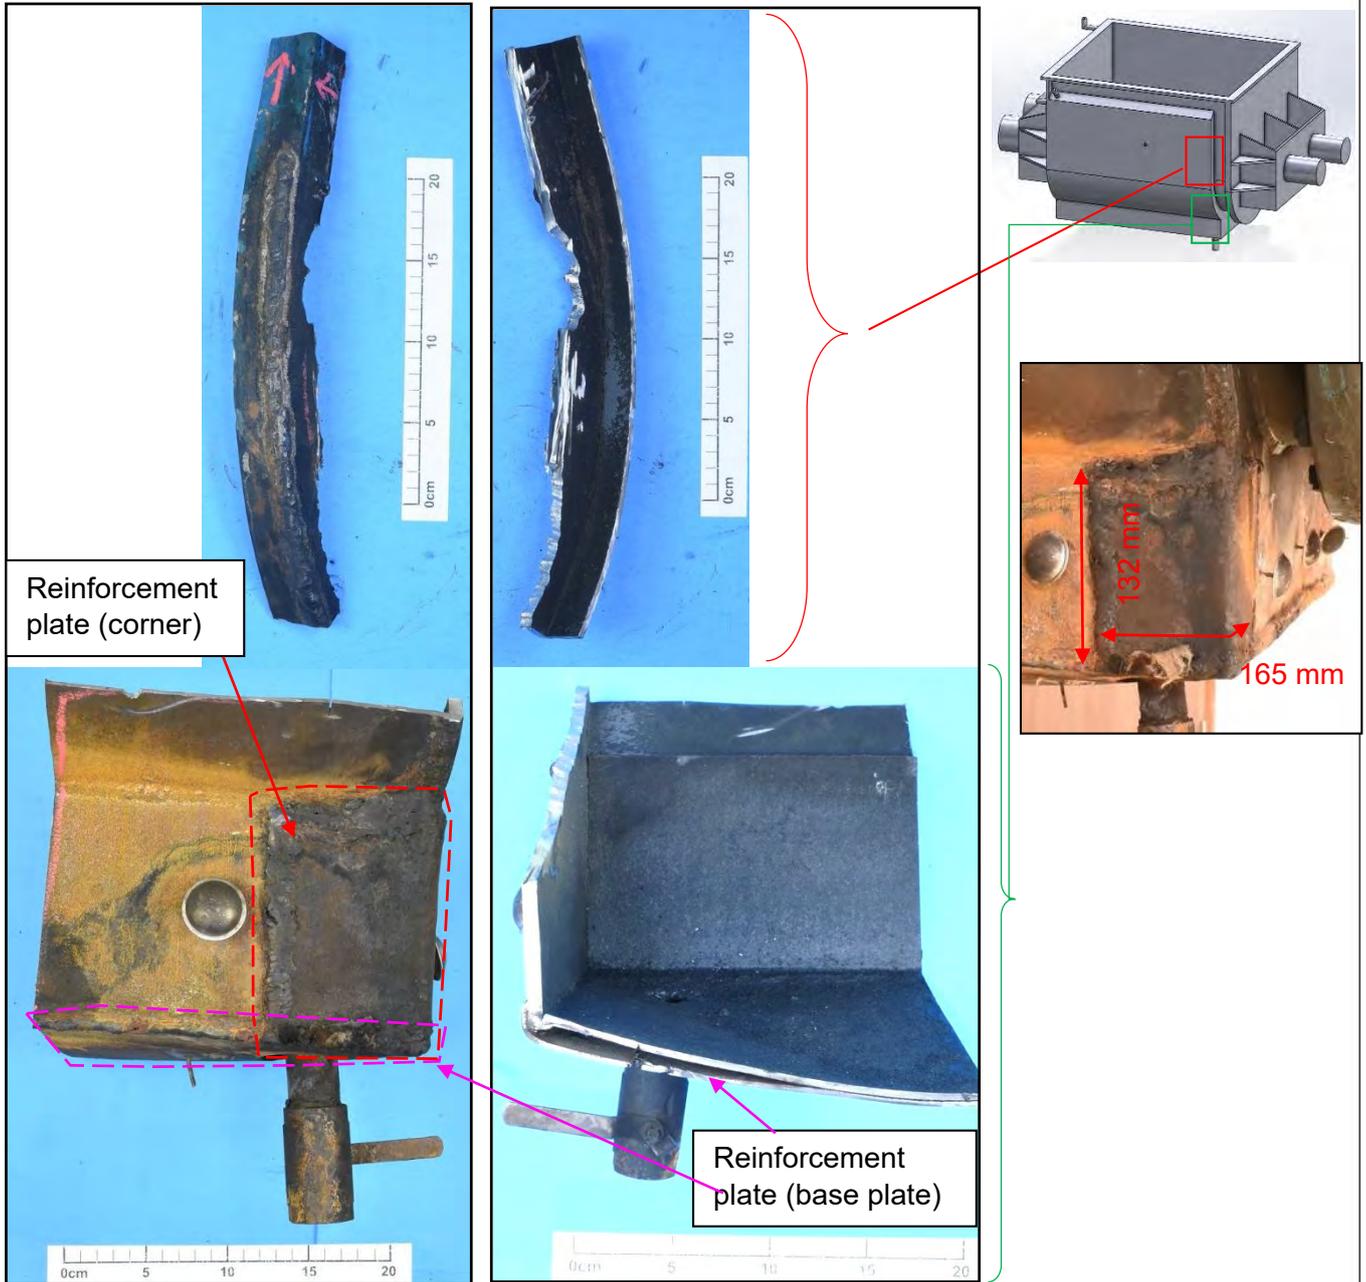
Figure 50: Cut out section of the front side, right edge weld. The left figure shows the external condition and the right figure shows the internal condition of this section. This cut out section included the original and repair welds. Parts of the reinforcement plates (corner and base plate identified with red and pink dotted lines) were visible here. The corner reinforcement plate had dimension of about 165 mm by 132 mm.

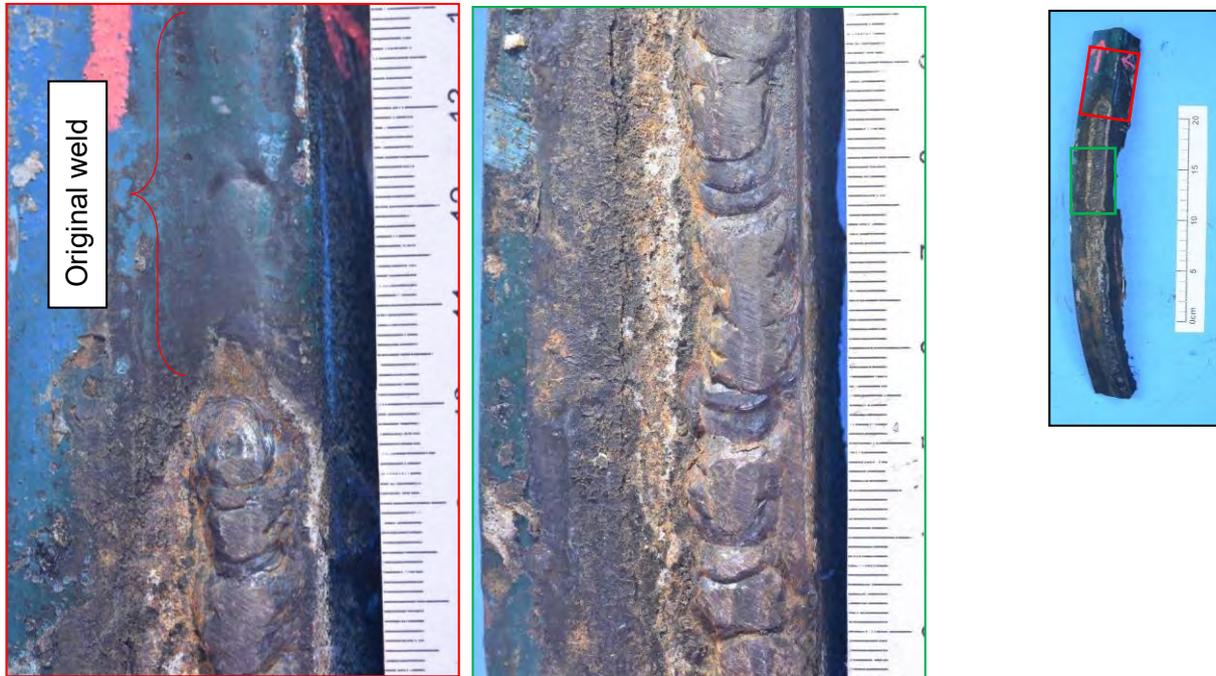
- 16 ➤ At the front side, right edge weld, the face width of the repair weld face was up to about 20 mm. The weld root was smaller and had signs of lack of root penetration at some areas (Figure 51 and Figure 52).
- 18 ➤ The bottom reinforcement plate was found to be folded over the original weld and welded to the side wall (side away from Platform stairs) (Figure 54).
- 20 ➤ Cross sections made across the corner reinforcement plate revealed voids in the weld metal of reinforcement plate (Figure 56).
- 22

Figure 51: Close up view of side weld. Part of the original weld is indicated (in red) in the left figure. The rest of the weld was repaired and had a face width of about 20 mm.

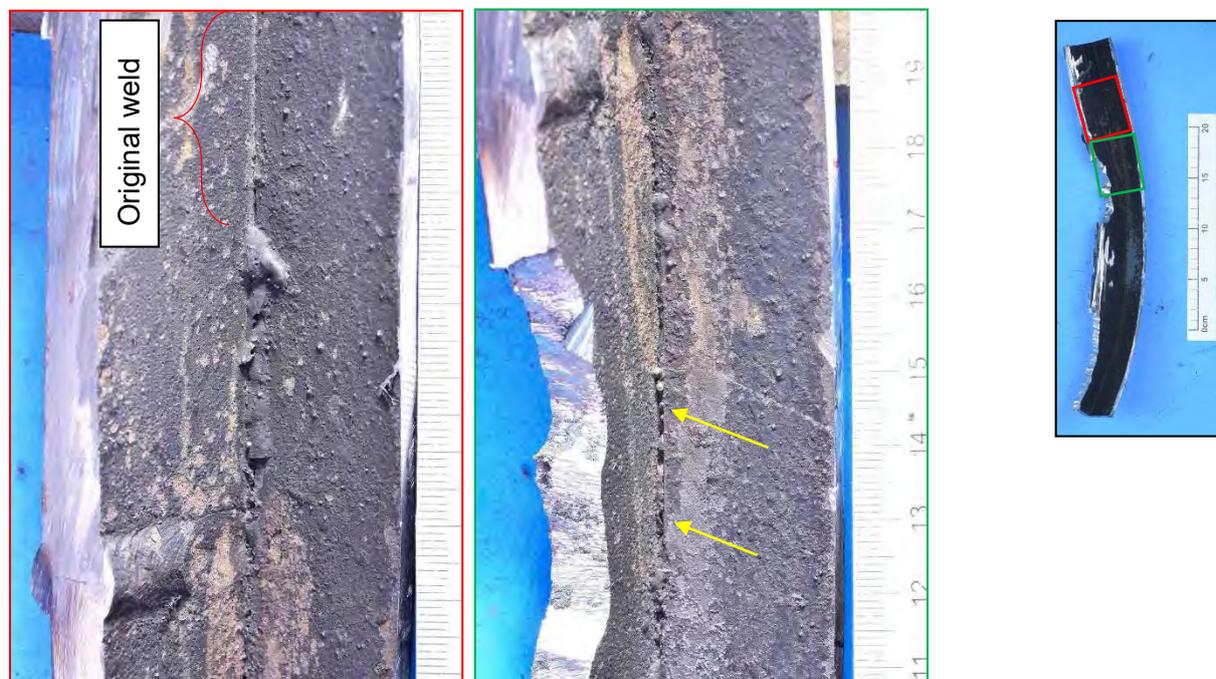
Figure 52: Condition of weld from inside the oil jacket. Part of the original weld is indicated (in red) in the left figure. The original weld root was small. The rest of the weld was repaired and had signs of lack of root penetration at some areas (indicated with yellow arrows).

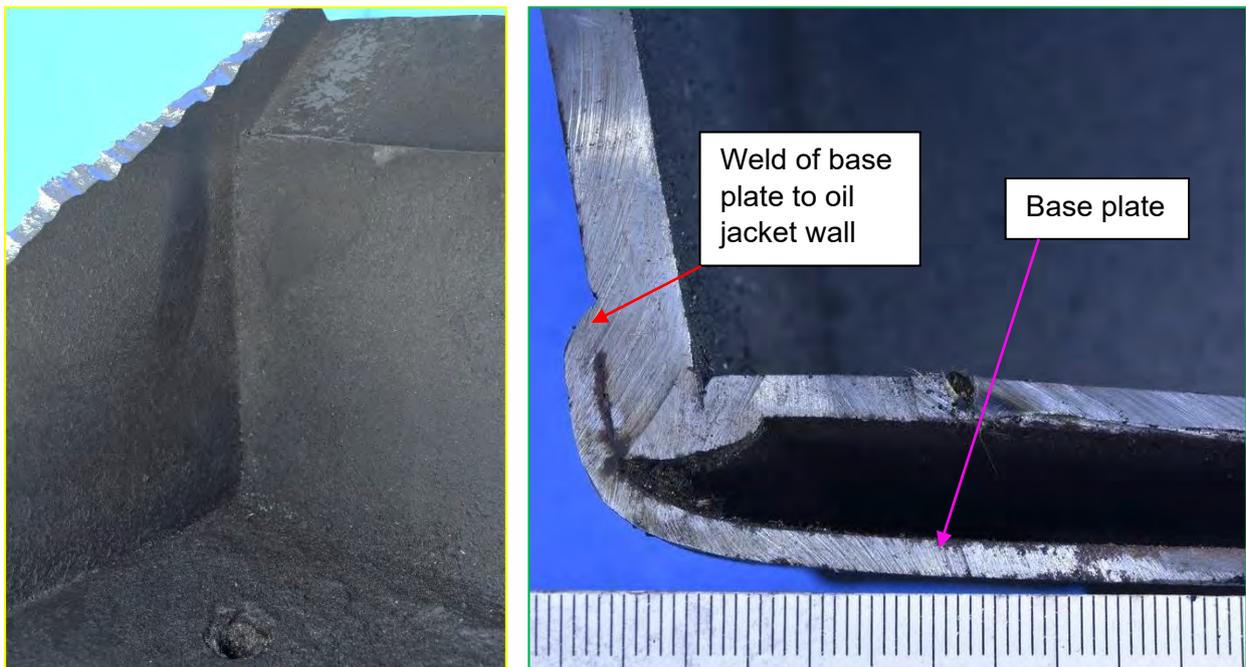
Figure 54: Close up view of the corner from inside the oil jacket (left figure). No gaps were visible at the corner joint. The base plate was folded over the original weld and welded onto the oil jacket wall (right figure).

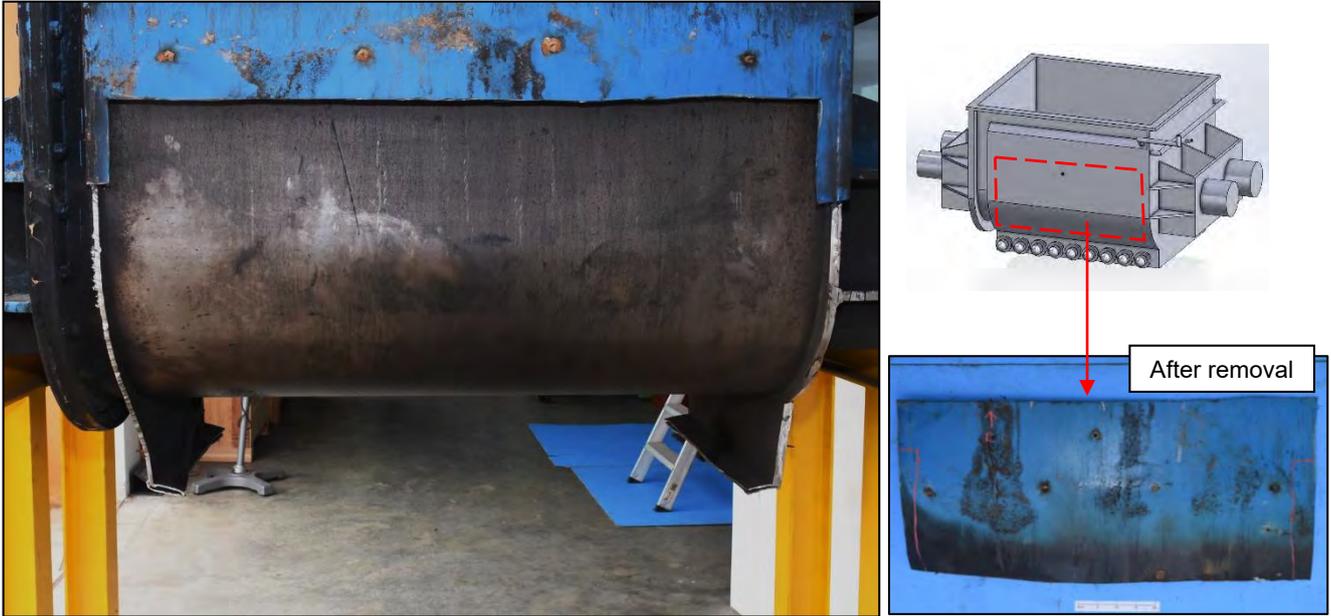
Figure 59: Internal condition of the oil jacket from the rear side. The internal surface was generally covered by black soot.

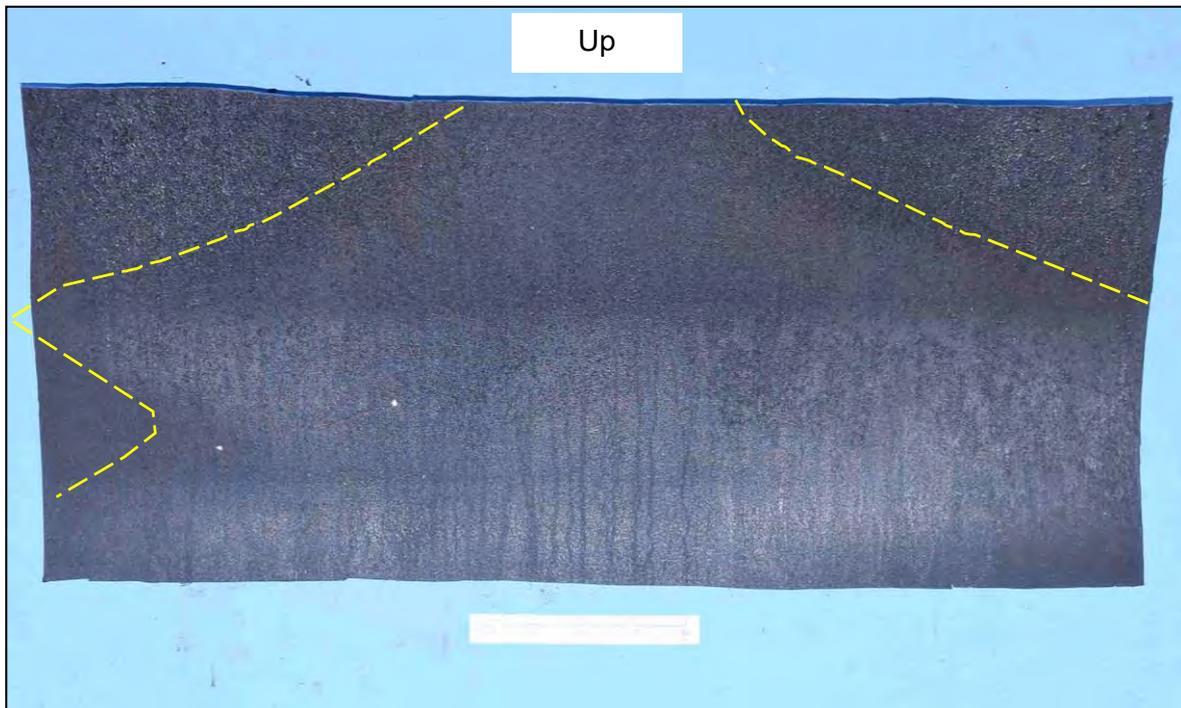
Figure 60: Cut out section of oil jacket wall, internal condition. The surface was generally covered with black soot. Oil stains and drip pattern were visible (see yellow line).

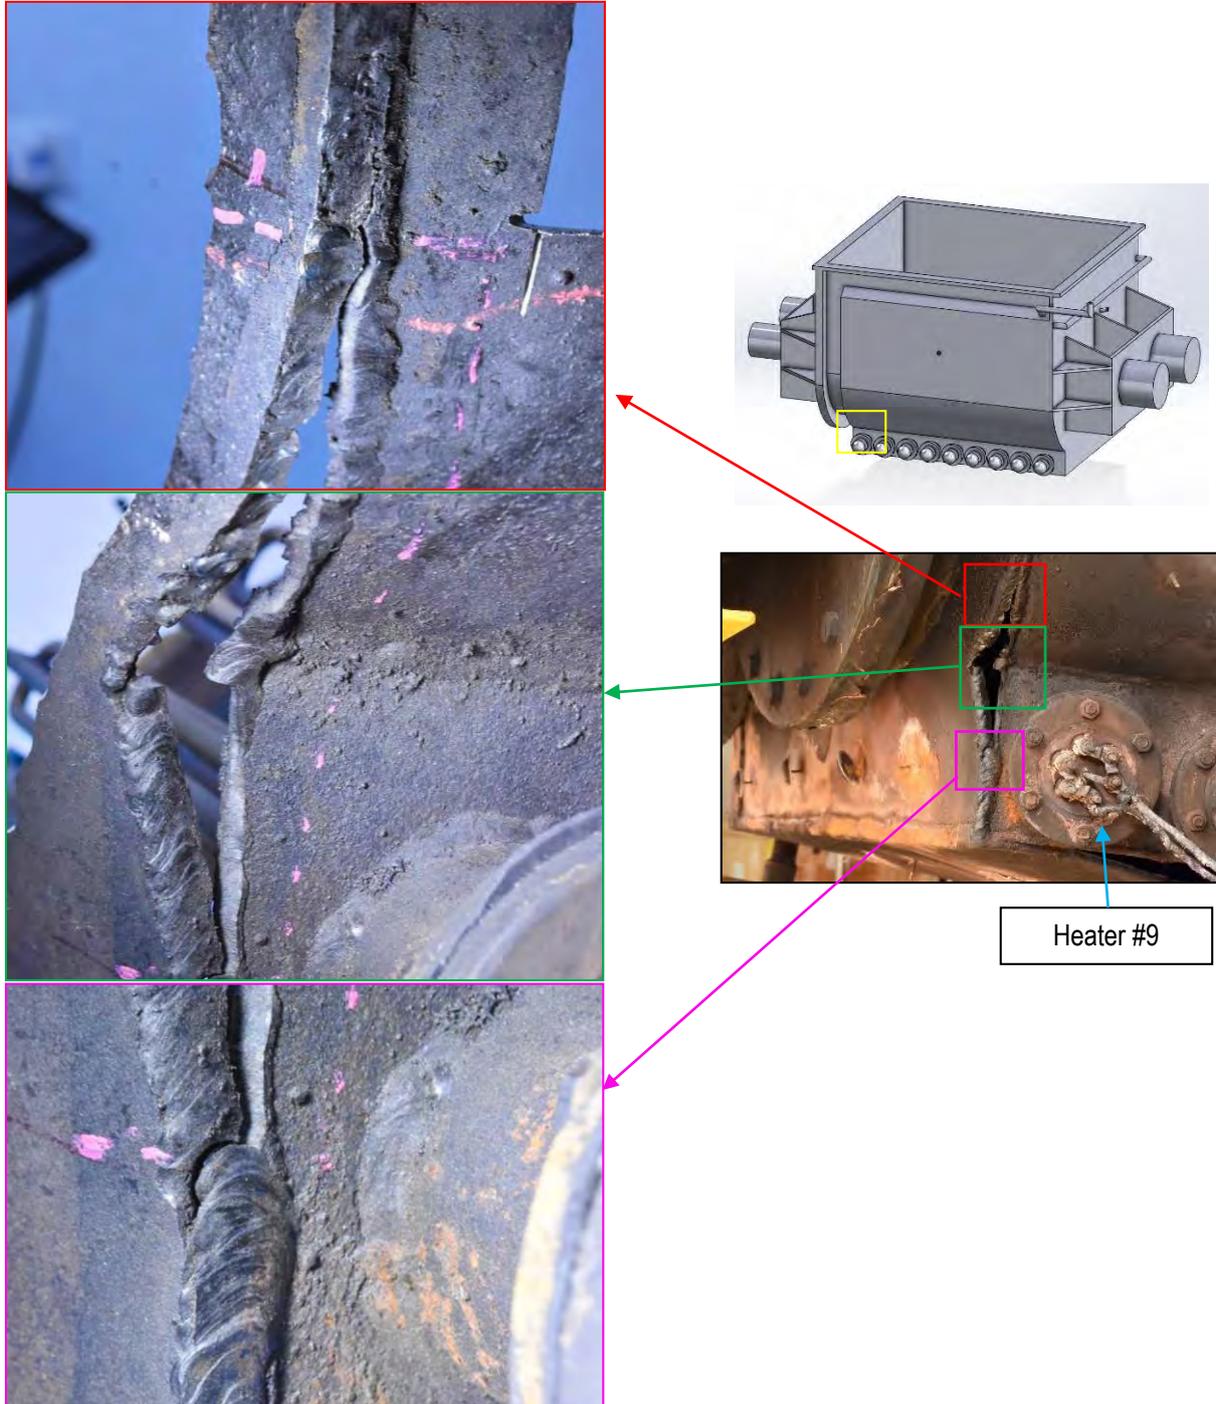
Figure 62: Close up view of rear-left side weld. The fracture path was predominantly centred along the weld face at the curved part of the oil jacket (see red and green bordered figures). The fracture path changes and propagated along the weld toe at the vertical plane of the oil jacket (see green and pink bordered figures).

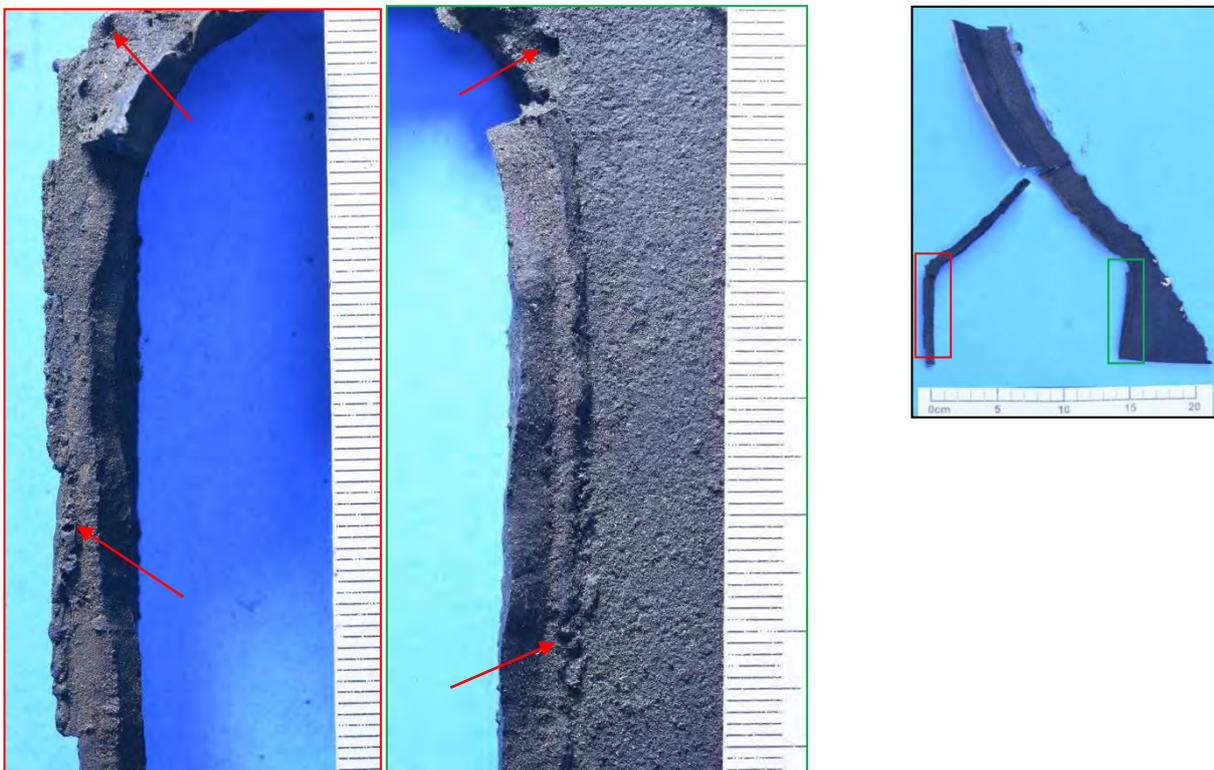
Figure 64: Close up view of side weld fracture surface at the straight and vertical plane. Some voids were observed.

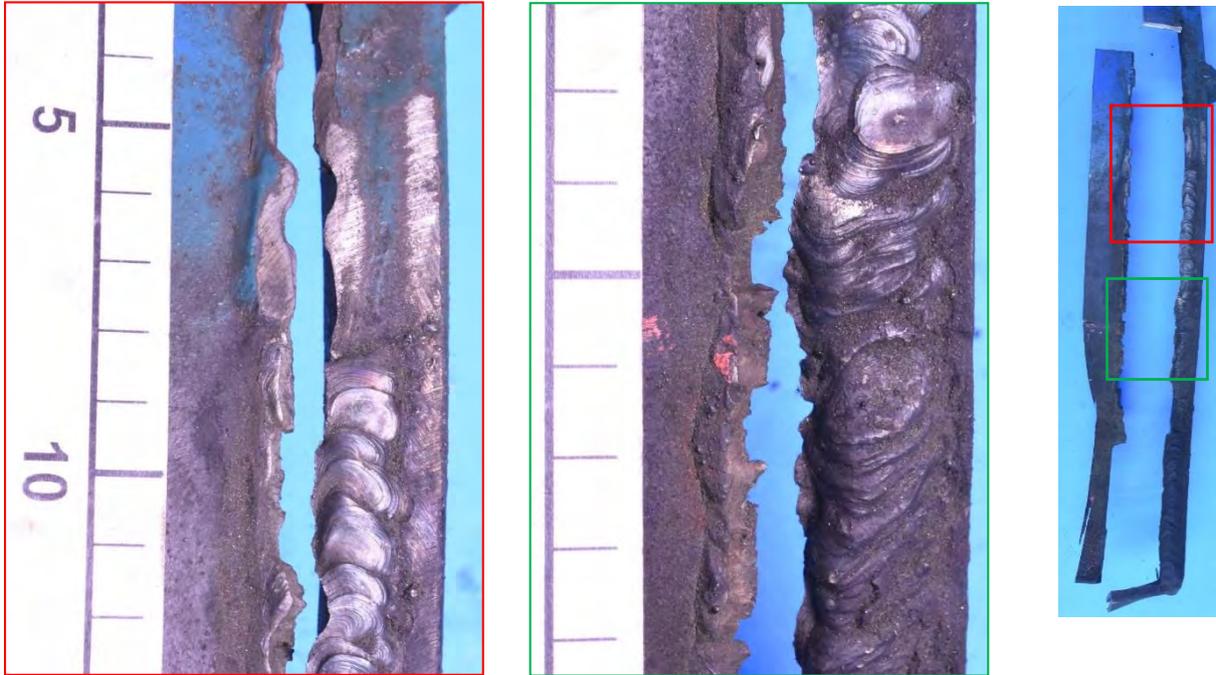
- 38 ➤ The fracture at the rear side, right edge weld had a similar fracture path at the repair weld. The fracture path was slightly off-centred along the weld face at the curved part of the oil jacket and along the weld toe at the vertical plane of the oil jacket (Figure 66 and Figure 67).
- 40

Figure 66: Close up view of side weld fracture surface at the curved part. The fracture path was slightly off-centred along the weld face at the curved part of the oil jacket.
