**Report of the Inquiry
Committee for the accident
at Stars Engrg Pte Ltd on
24 February 2021
(PART II – ANNEXES)**

TECHNICAL REPORT

| Title of Report: Failure Analysis of a Failed Mixer Machine Retrieved from Unit 32E of Platinum @ Pioneer Building involved in a Fire Explosion Incident | | Date of Last Revision/Revision No: |

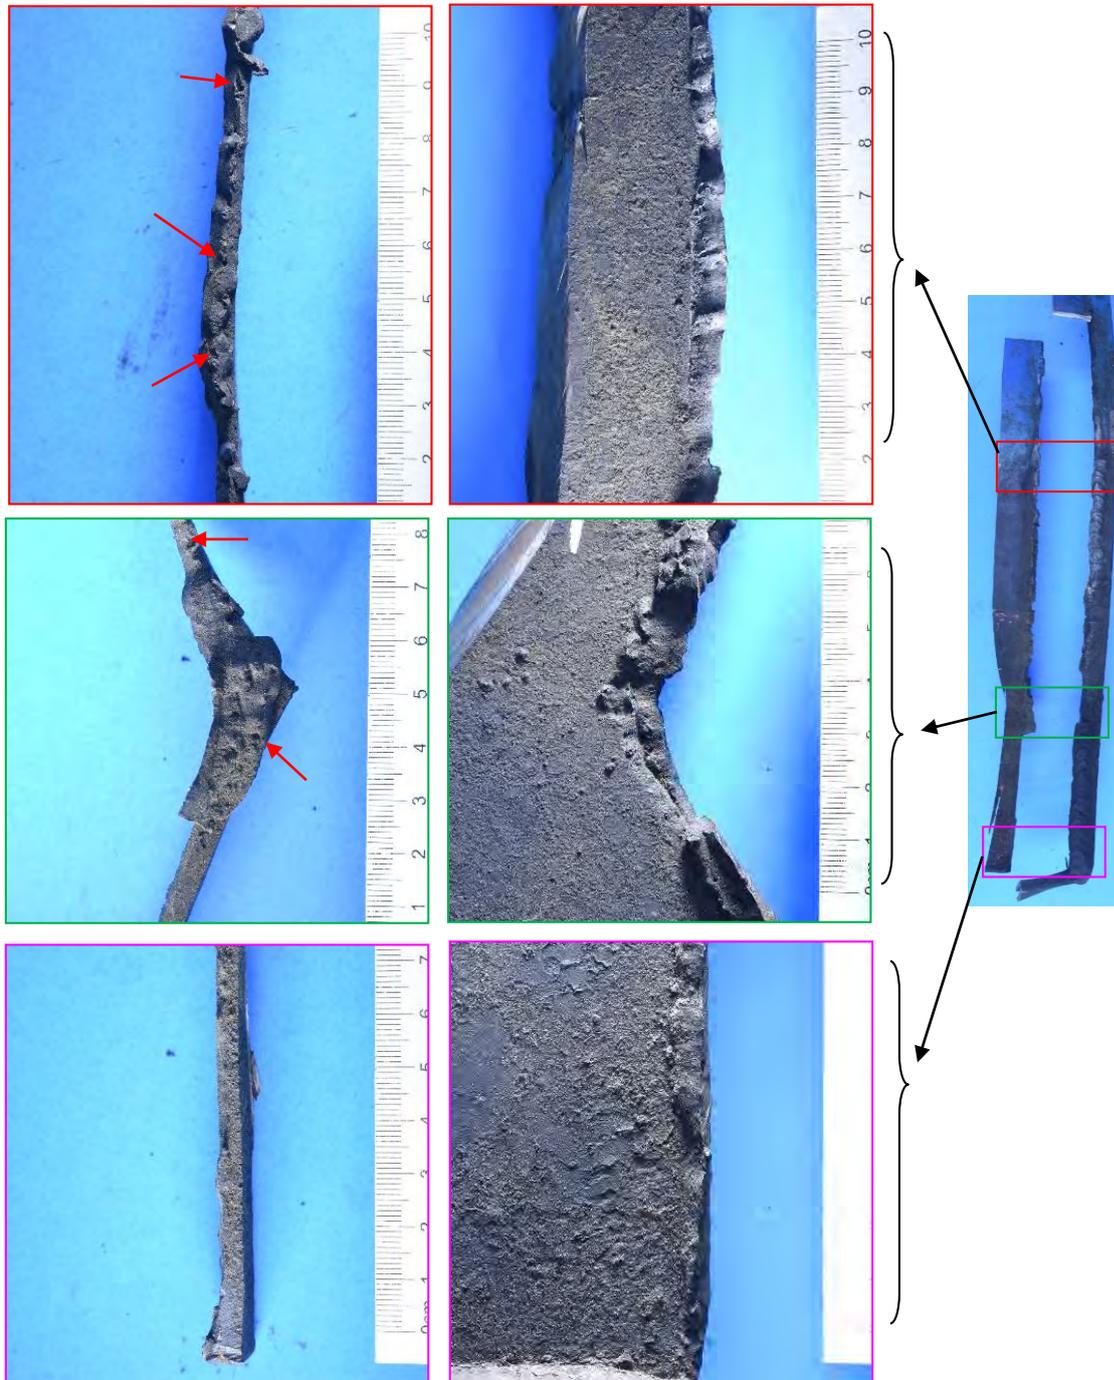
- 4 ➤ Similarly, on the fracture surface of the rear, right edge weld, voids were visible
6 along the curved part while at the vertical plane the fracture surface was flatter
 (Figure 68).

Figure 68: Close up view of the side weld fracture surface. Voids were observed along the fracture surface of the curved part where the fracture was slightly off-centred on the weld face (see red and green bordered figures). At the vertical plane of the wall, the fracture surface was relatively flat (see pink bordered figures).

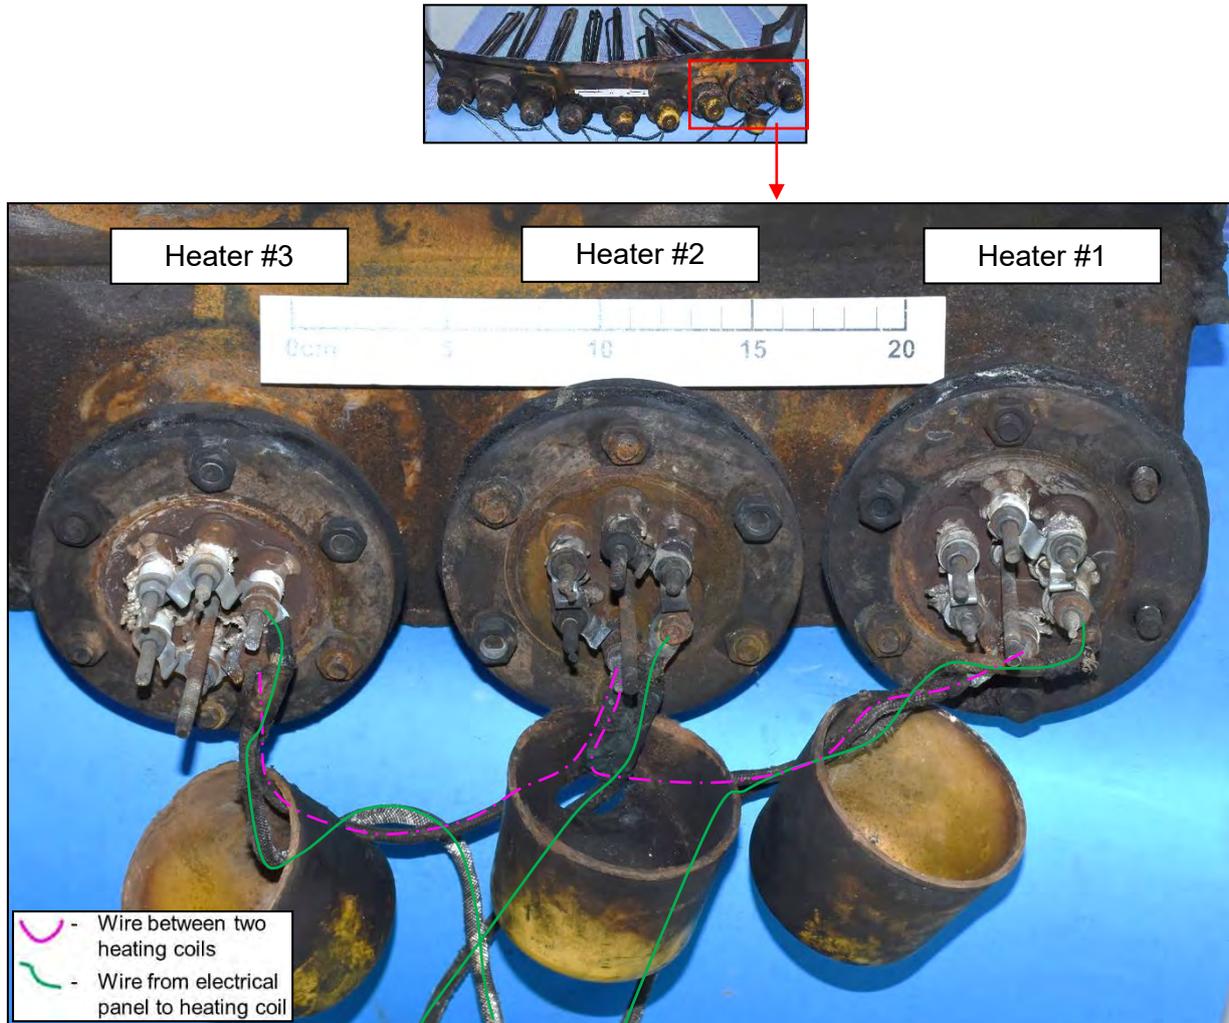
Figure 77: The as-received condition of the heaters (from right, heaters #1, #2 and #3). The flanges generally had blackish appearance. Some of the terminal covers (rounded yellow caps) were blackish on the internal surface as well. The terminals of heater #2 also had a blacker appearance compared to the terminals of the rest of the heaters

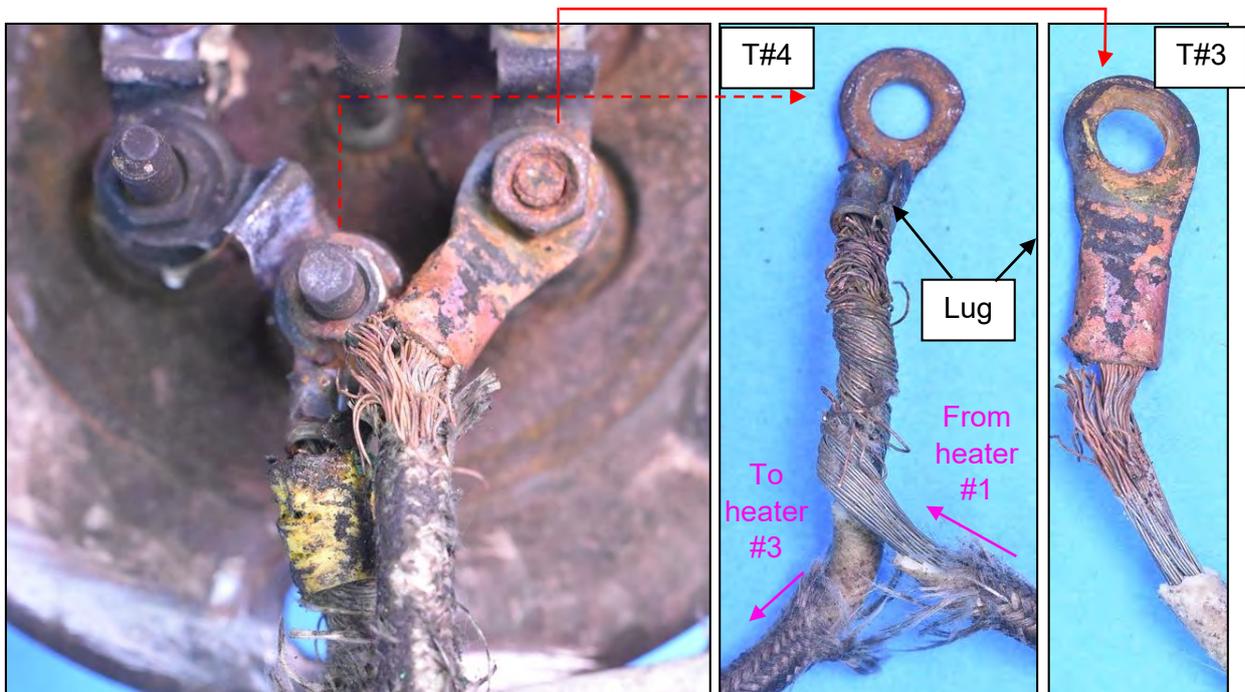
Figure 80: Beneath the green tape wrapped around the wires at terminal #4 was a yellow clip tab (left figure). The yellow clip tab and wire insulations were removed, revealing the wires shown in figures on the right. The wire from heater #1 were wound around the wire to heater #3 (see also Figure 82 to compare). Microscopic examination was conducted and presented in Figure 131.

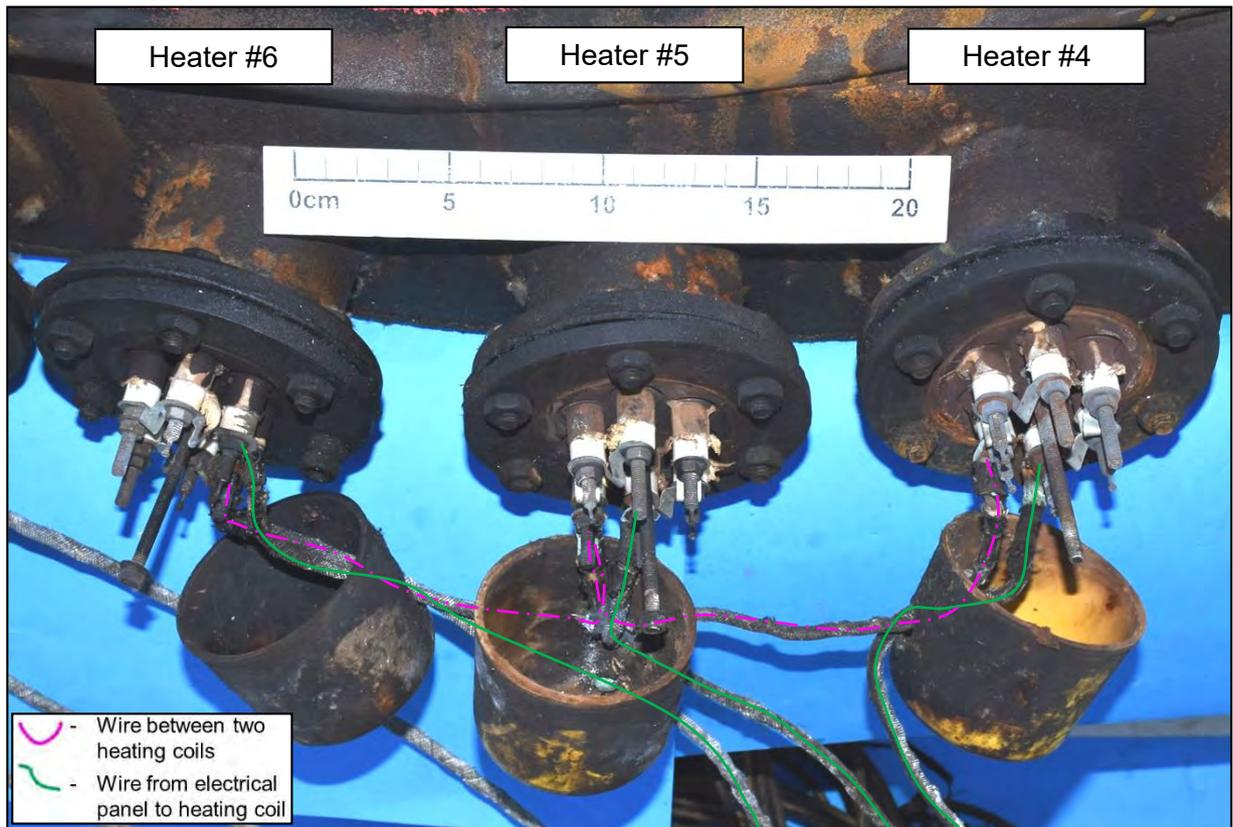
Figure 81: The as-received condition of the heaters (from right, heaters #4, #5 and #6). The flanges generally had blackish appearance. Some of the terminal covers (rounded yellow caps) were blackish on the internal surface as well.

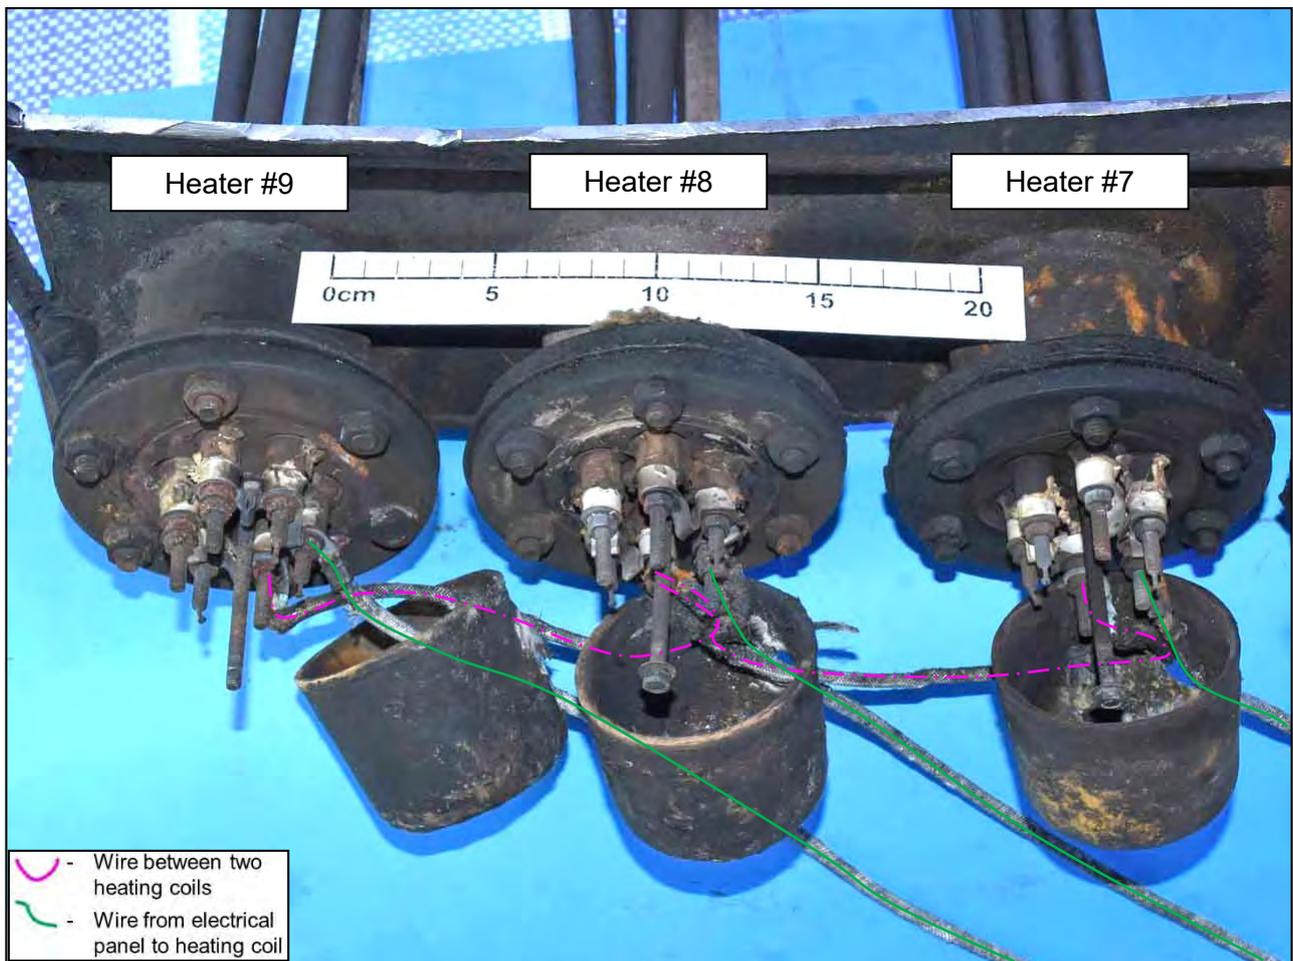
Figure 83: The as-received condition of the heaters (from right, heaters #7, #8 and #9). The flanges generally had blackish appearance. Some of the terminal covers (rounded yellow caps) were blackish on the internal surface as well.

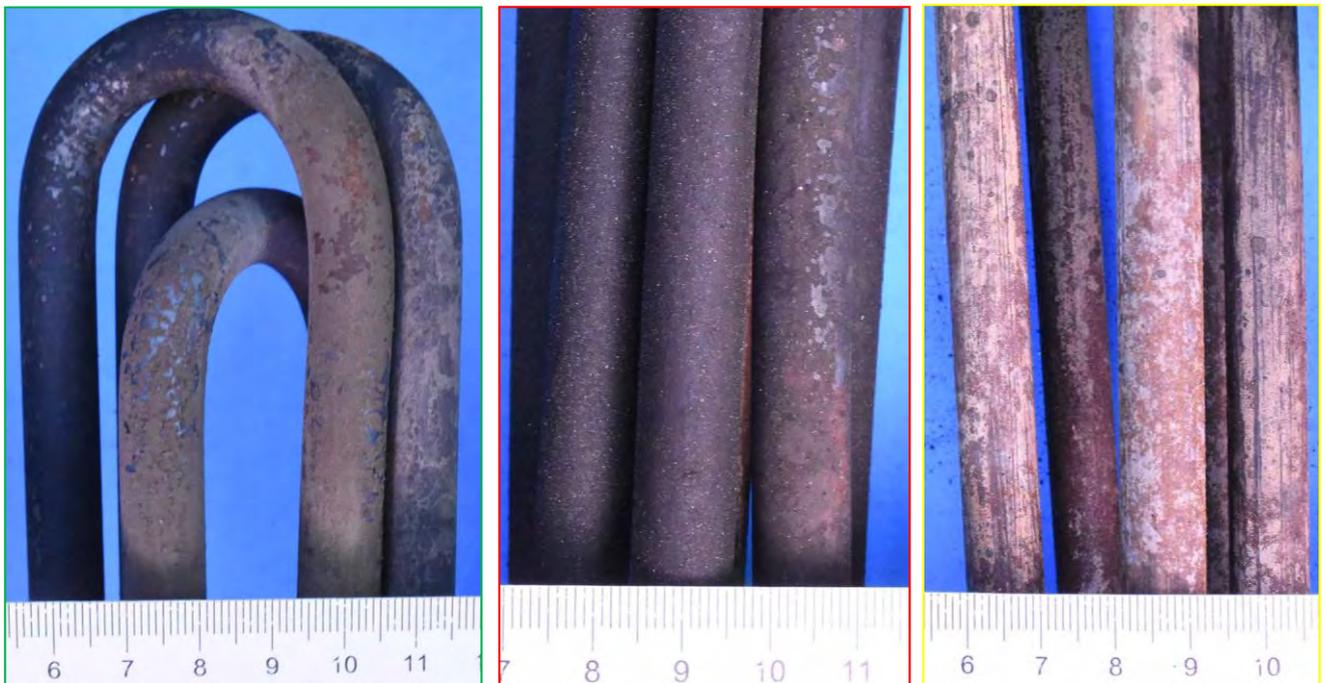
- 18
- 20 ➤ Signs of corrosion and peeling of coating were observed at various parts of the metal tubes (Figure 86).
- 22 ➤ All the gaskets had degraded and were generally brittle to the point where they broke with slight pressure (Figure 87 and Figure 90).

Figure 86: Signs of corrosion and peeling of coating were observed at various parts of the metal tubes.

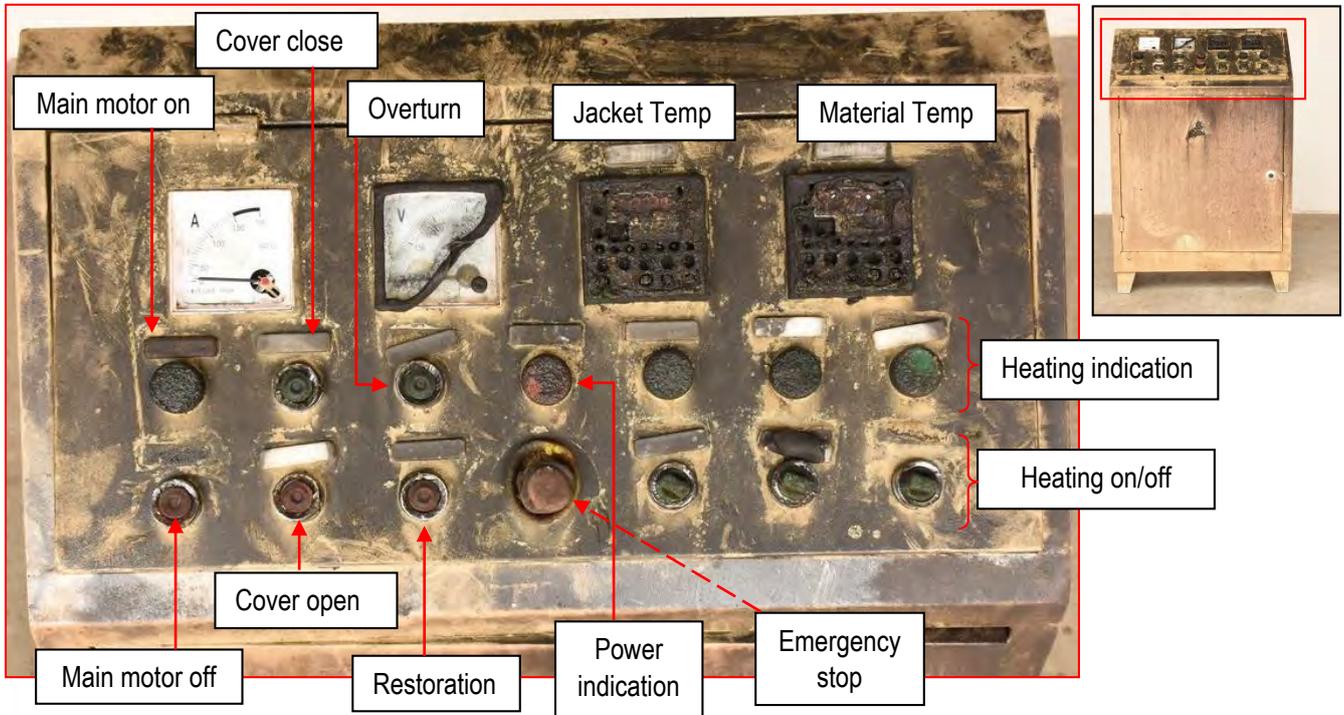
32 ➤ The electrical panel's (or local control panel) external surface was covered with
black soot and sustained fire damage, especially to the buttons and the
34 thermostats display screens (Figure 107).

Figure 107: Electric panel – top area. The labels were made based on the reference photograph provided in *Annex 4*. The thermostats labelled “Jacket Temp” and “Material Temp” were used to indicate the temperature measured by RTDs A and B respectively. The thermostats and buttons sustained fire damages during the incident.

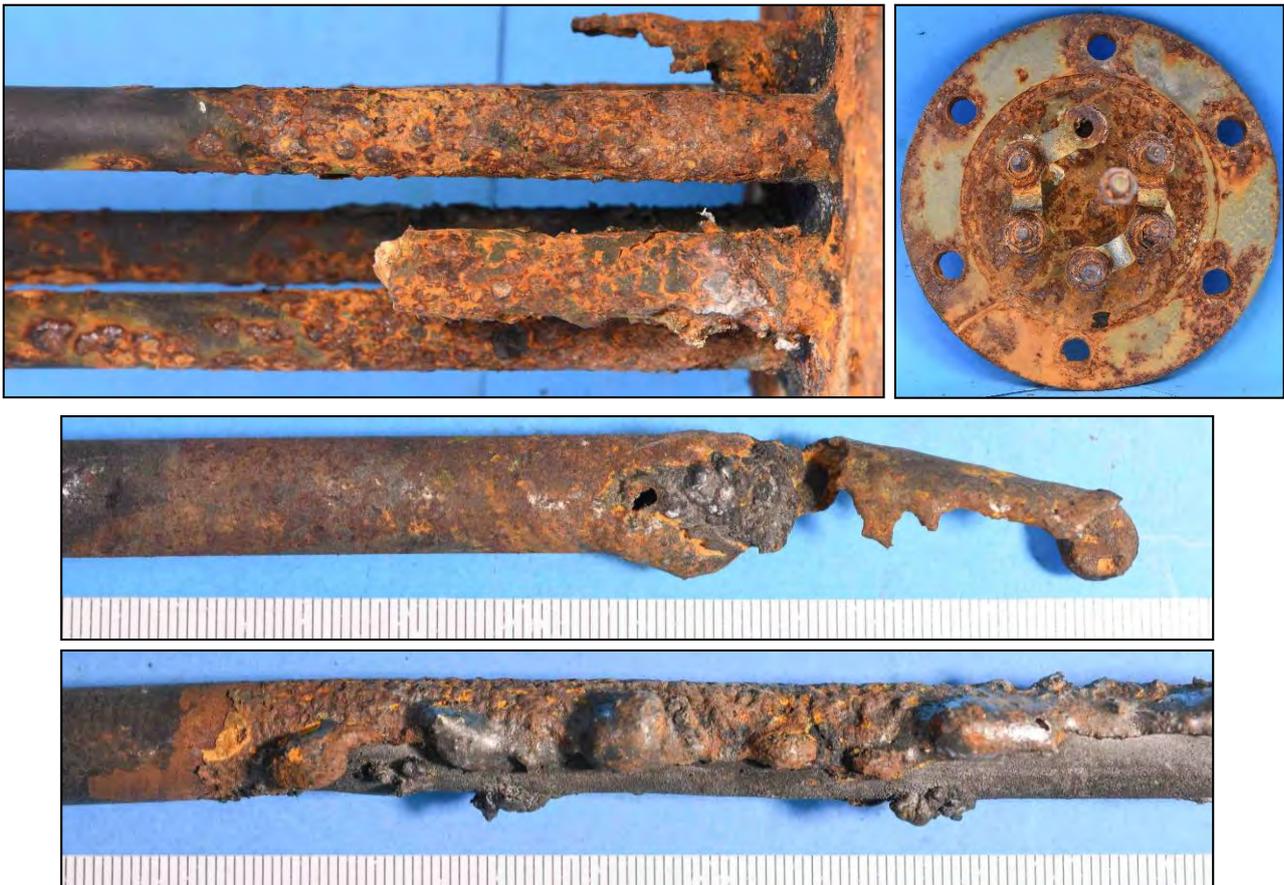
Figure 114: One of the coil had broken off from the heater. The metal tube had deformed and melted off around the breakage location as evidenced by the bulbous and droplet-like shape of the metal.

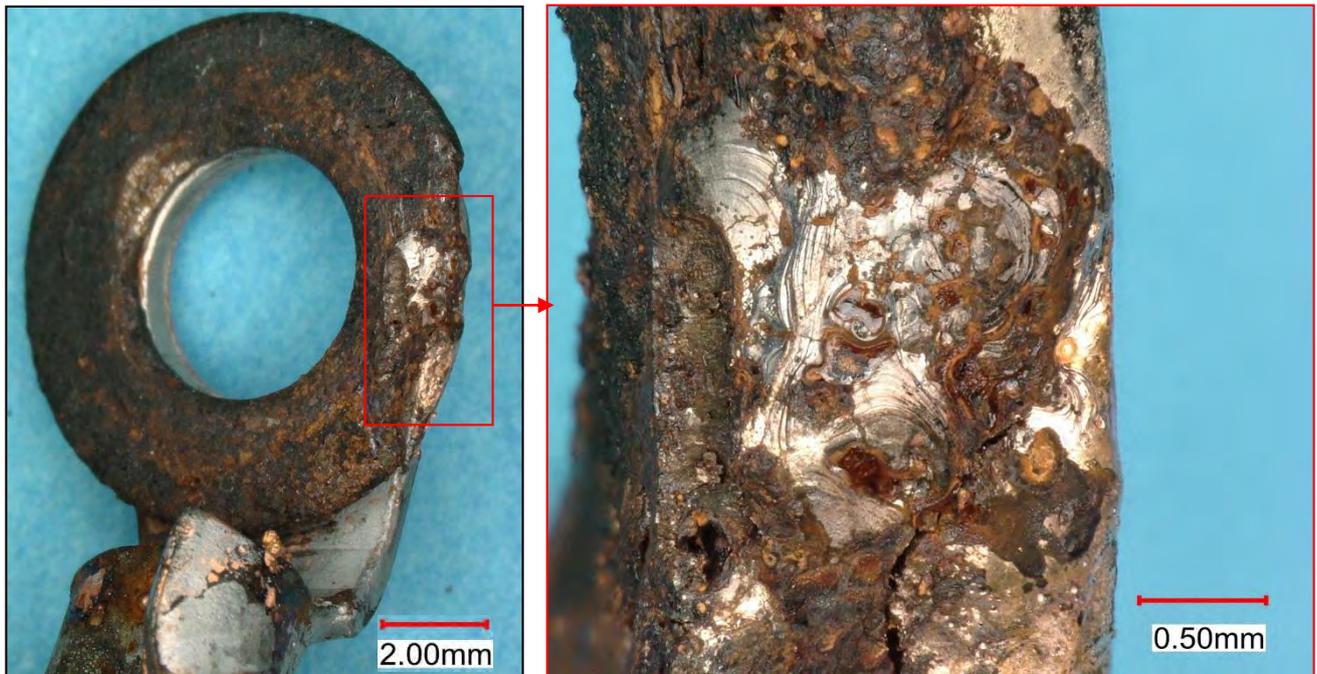
Figure 138: Condition of lug after cleaning in an ultrasonic bath of Alconox solution. Resolidification waves, a characteristic trait of arcing, observed at the lug and washer.

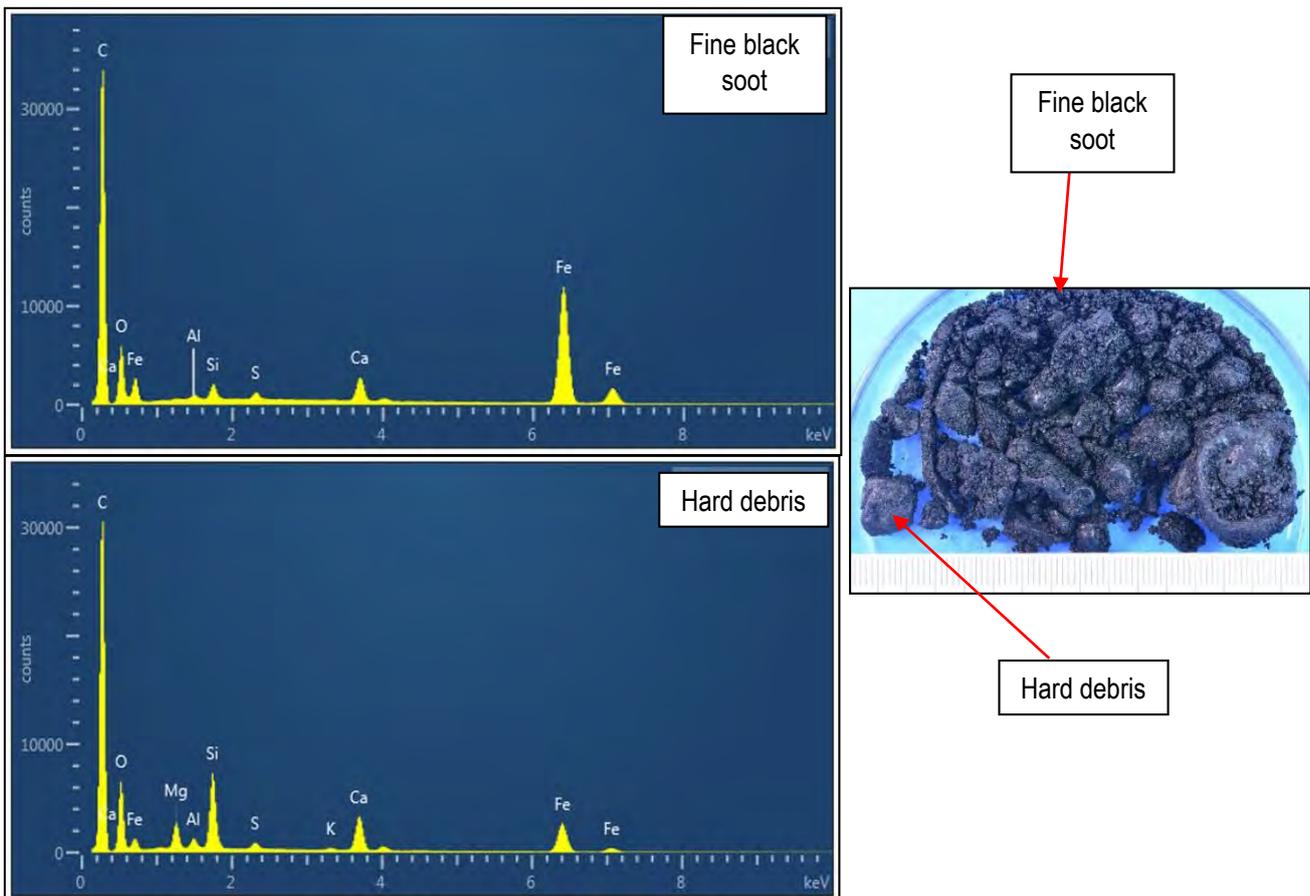
Figure 143: The major elements detected on the fine black soot were mainly associated with the thermic oil. The hard debris had high peaks of silicon and magnesium apart from elements associated with the service medium.

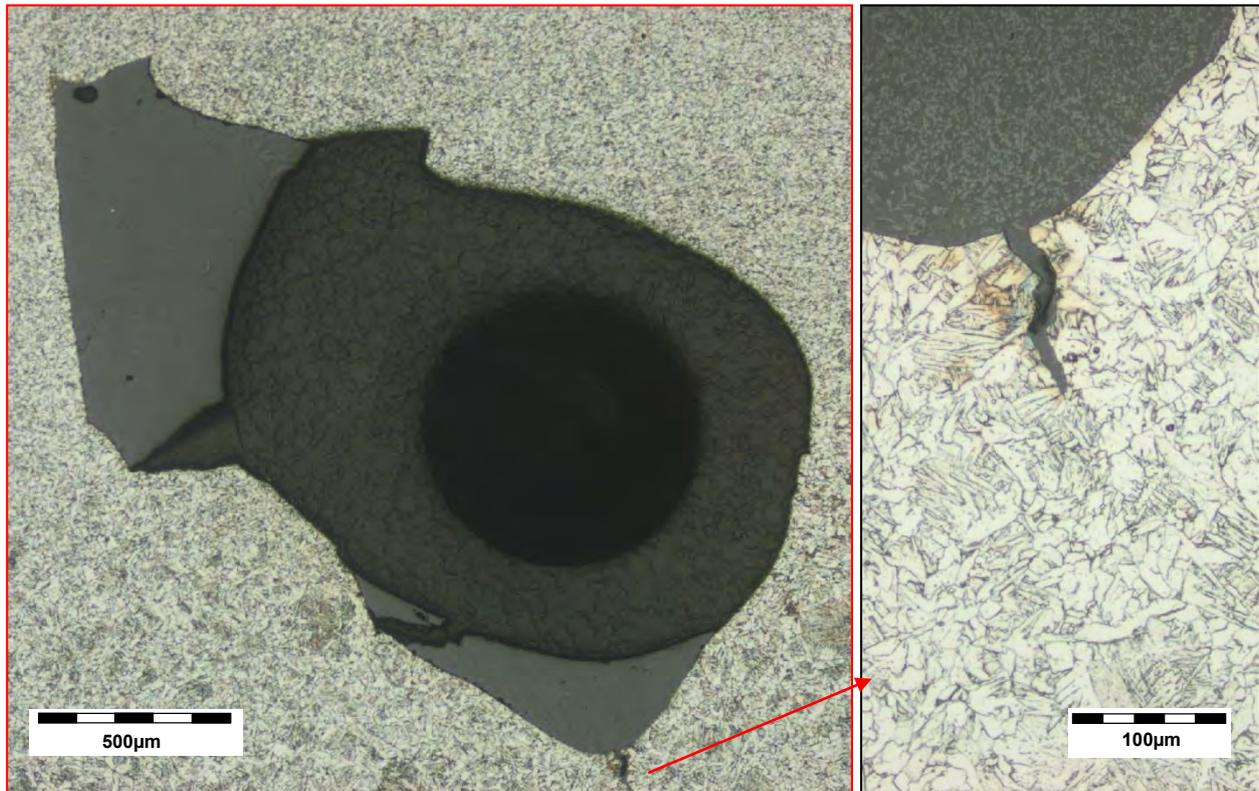
Figure 148: Micrograph of at 50x (left) and 200x (right) magnifications. A 115 µm incipient crack was at the edge of the void, propagating towards the weld face.

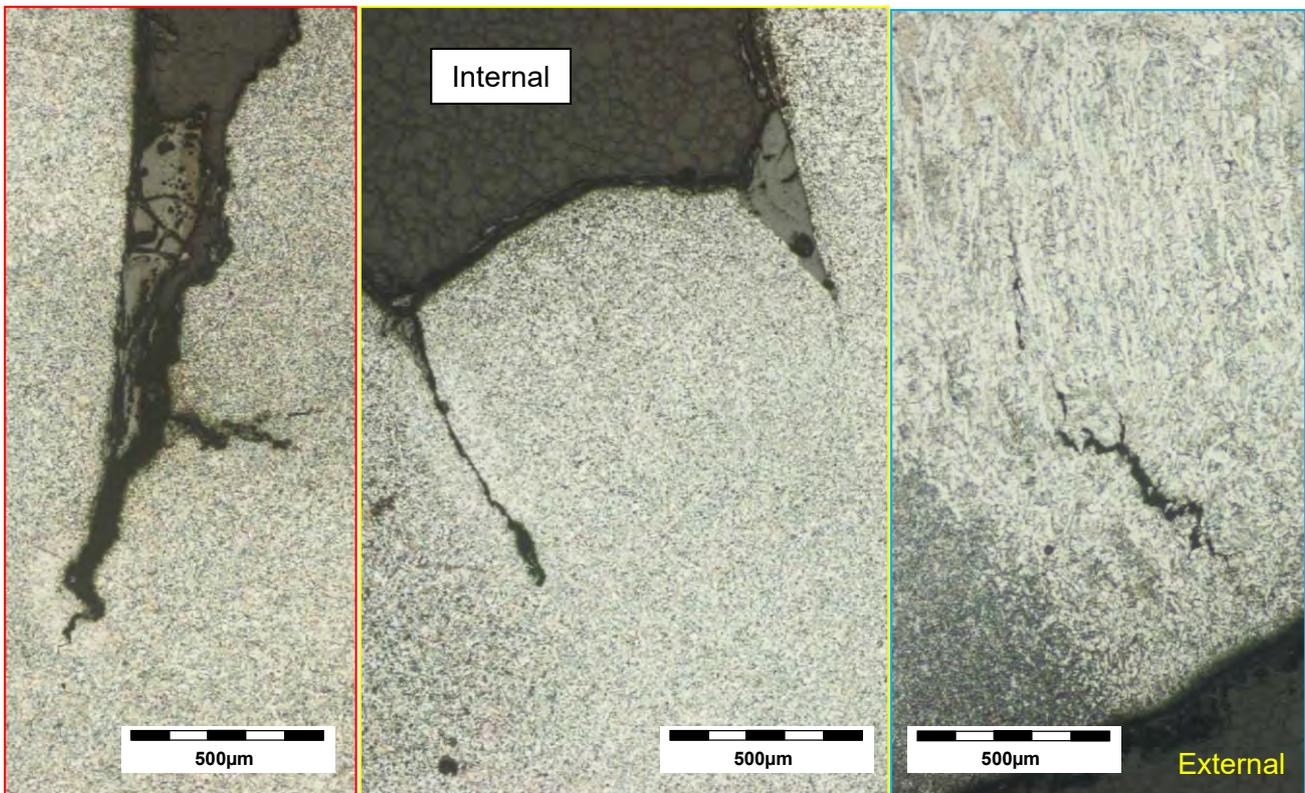
Figure 150: Micrographs at 50x magnification. Incipient cracks and discontinuities were observed at the weld root and near the weld face. The cracks were filled with oxide scales.

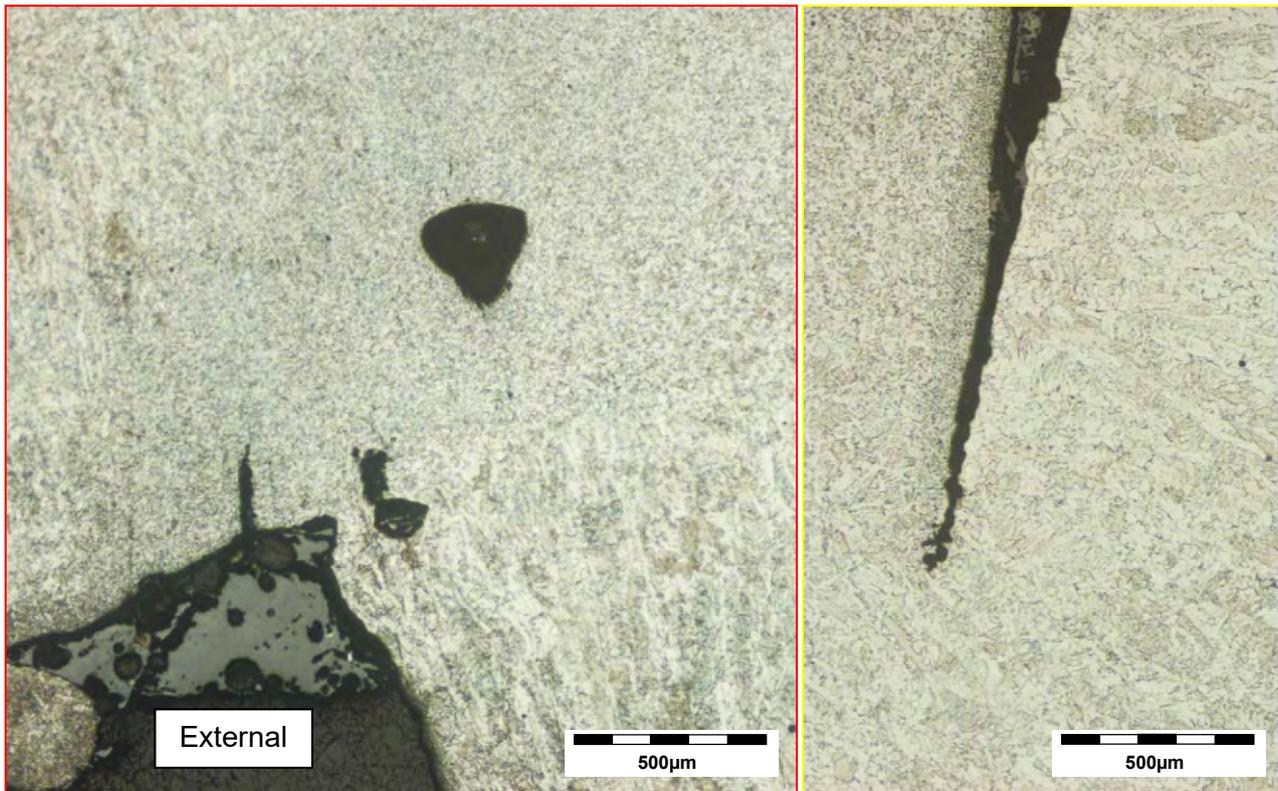
Figure 152: Micrographs at 50x magnification. Voids were observed within the weld metal (left). Oxide filled incipient crack was observed at the weld root (right).

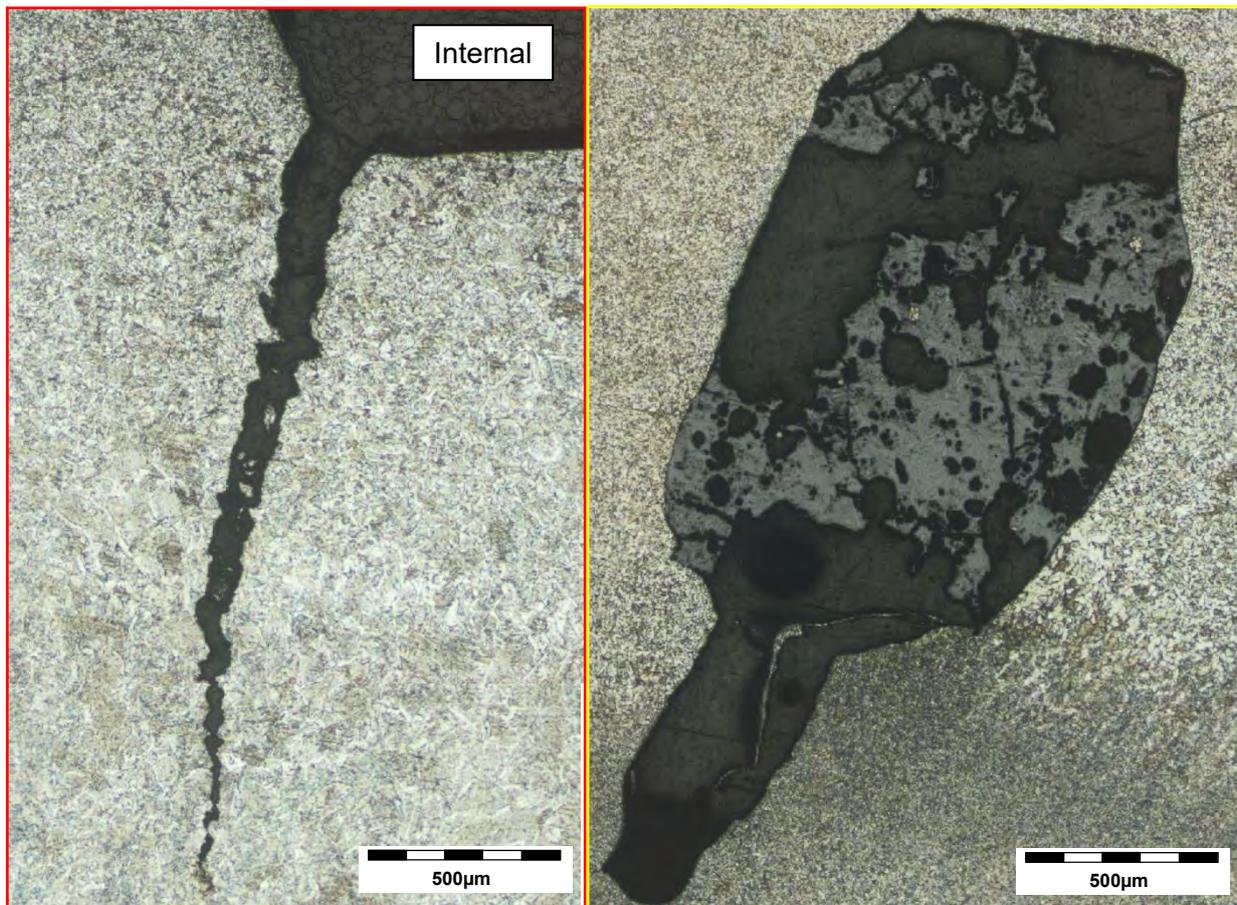
Figure 156: Micrographs at 50x magnification. Crack with a length of about 2.0 mm was observed to have initiated at the weld root and propagated towards the weld face.

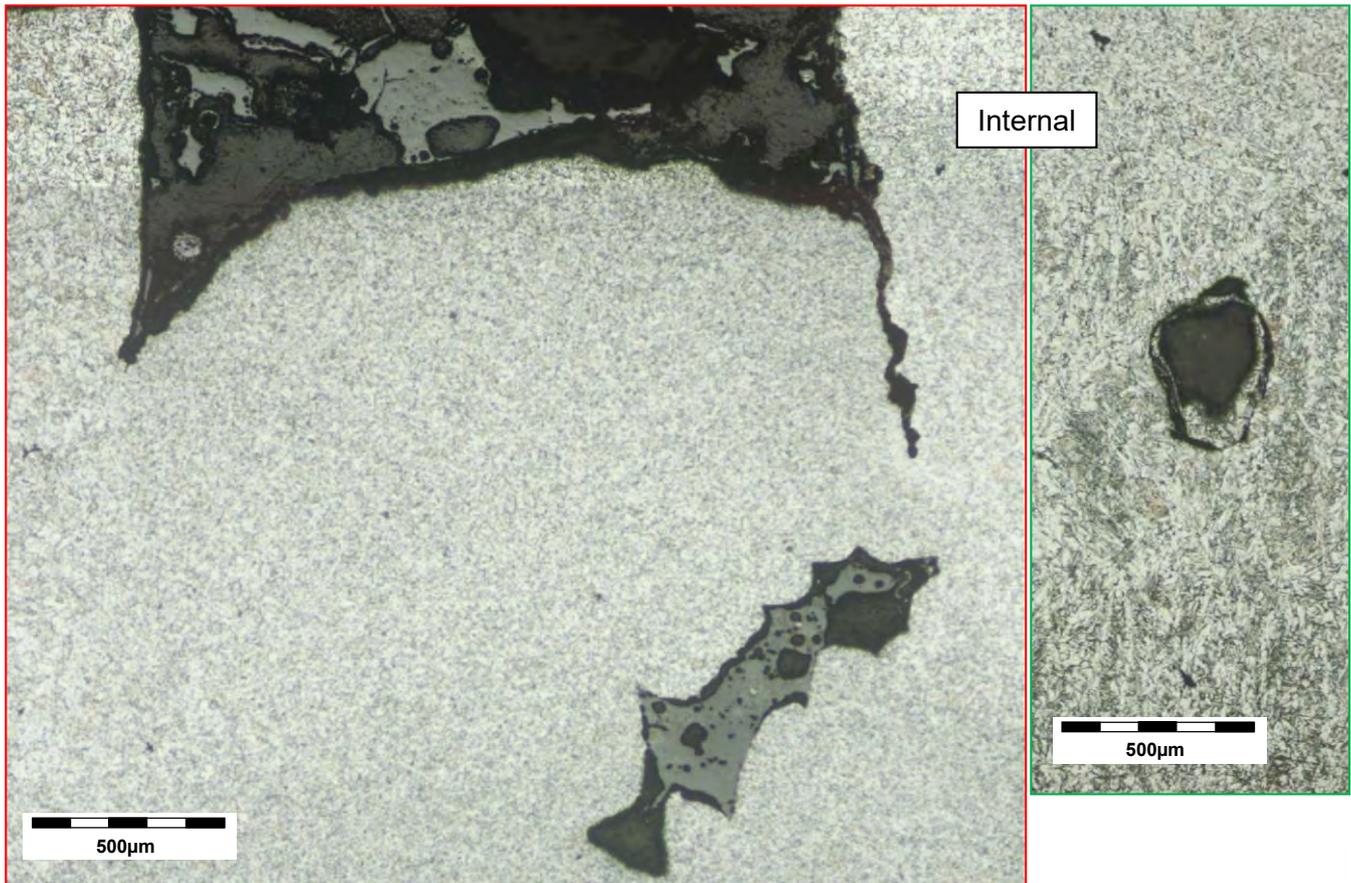
Figure 160: Micrographs at 50x magnification. Oxide filled incipient crack was observed at the weld root (left). Voids were scattered in the weld metal (right).

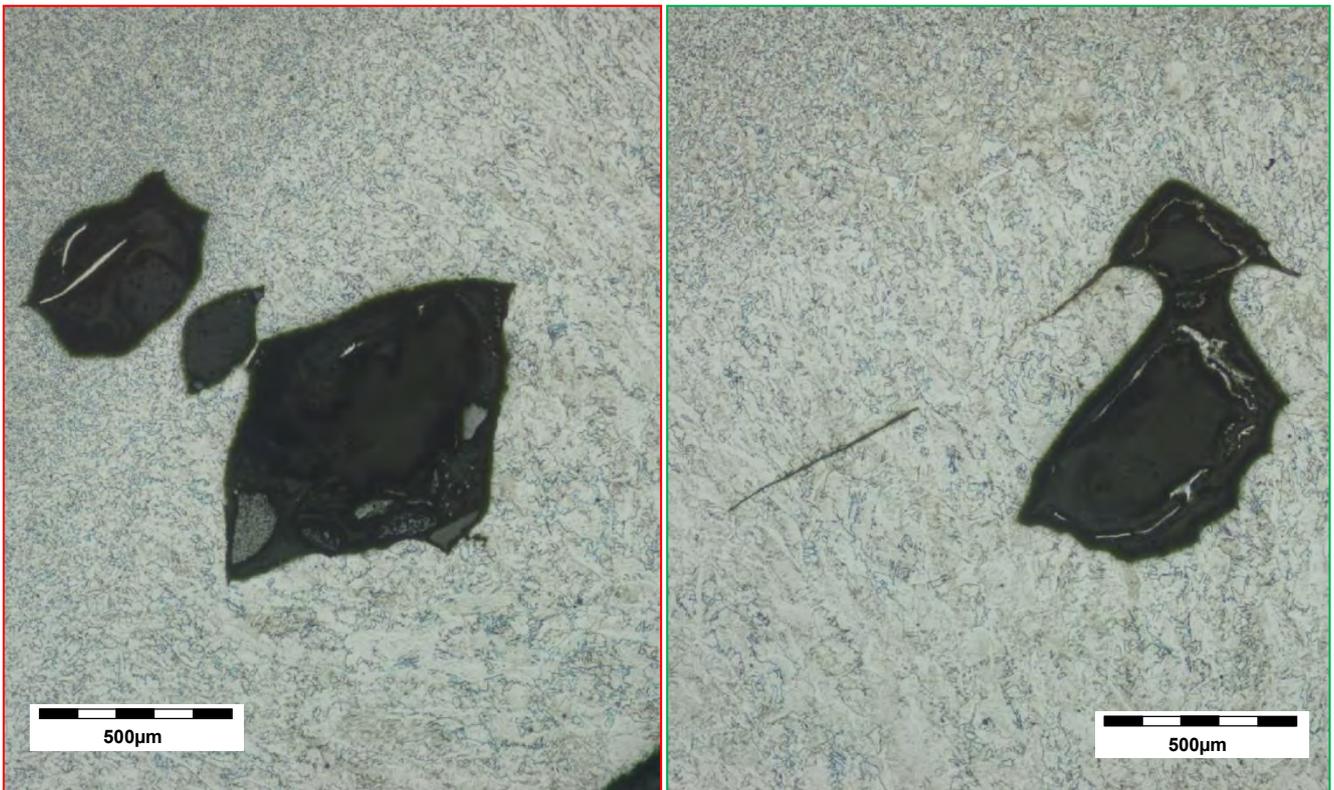
Figure 162: Micrographs at 50x magnification. Voids were scattered in the weld metal.

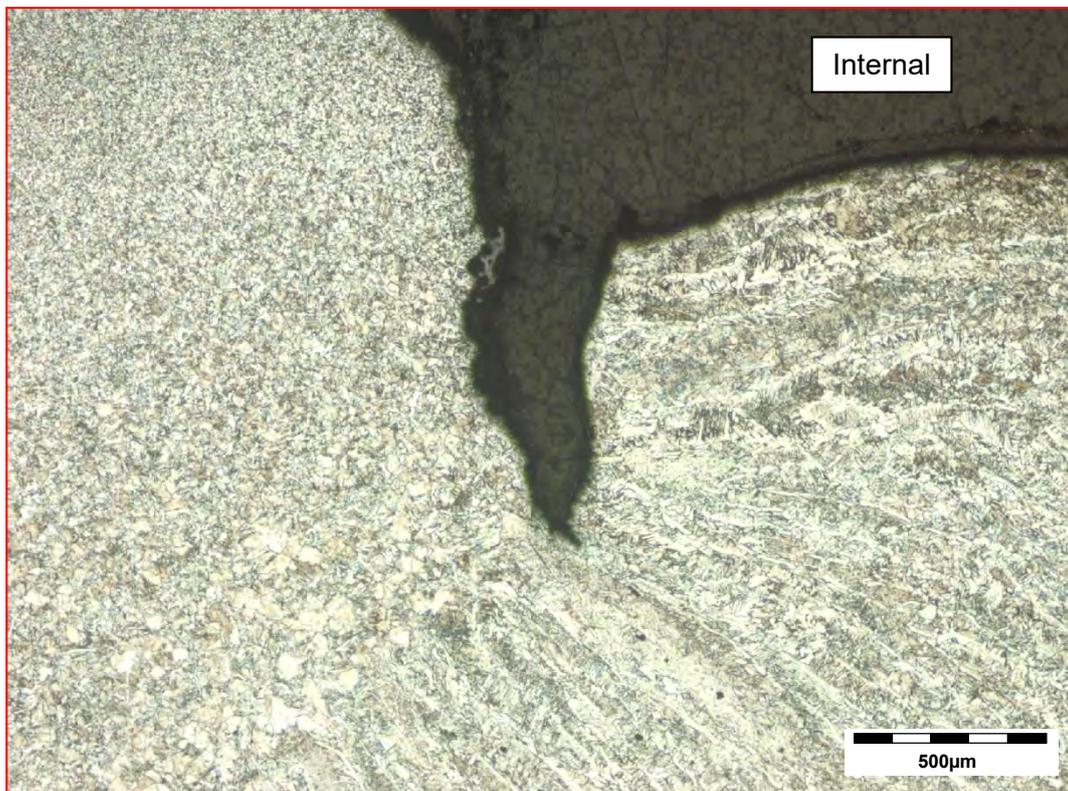
Figure 164: Micrographs at 50x magnification. Incipient crack (with some oxide scale) was observed at the weld root.

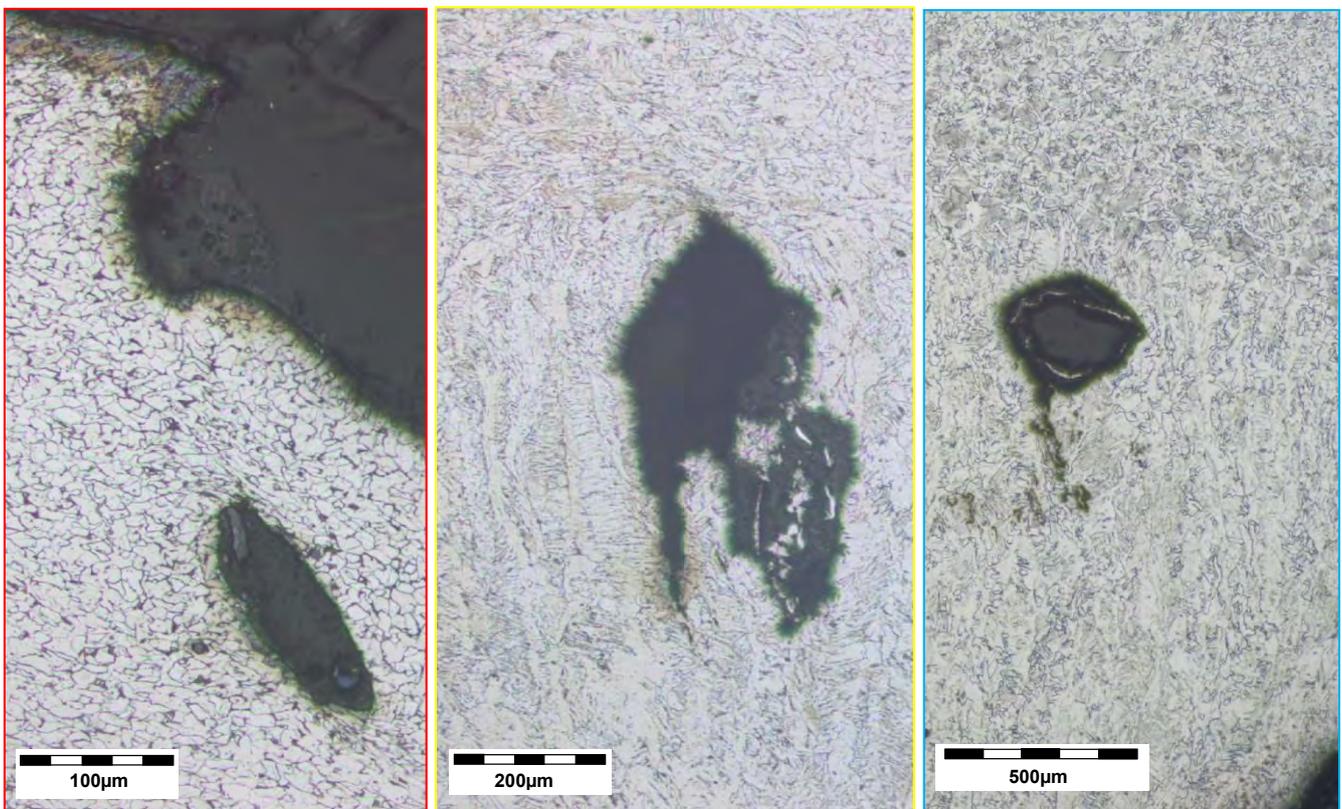
Figure 166: Micrographs at 200X (left), 100X (middle) and 50X (right) magnifications. Voids were scattered in the weld metal and along/across the crack path (left figure).

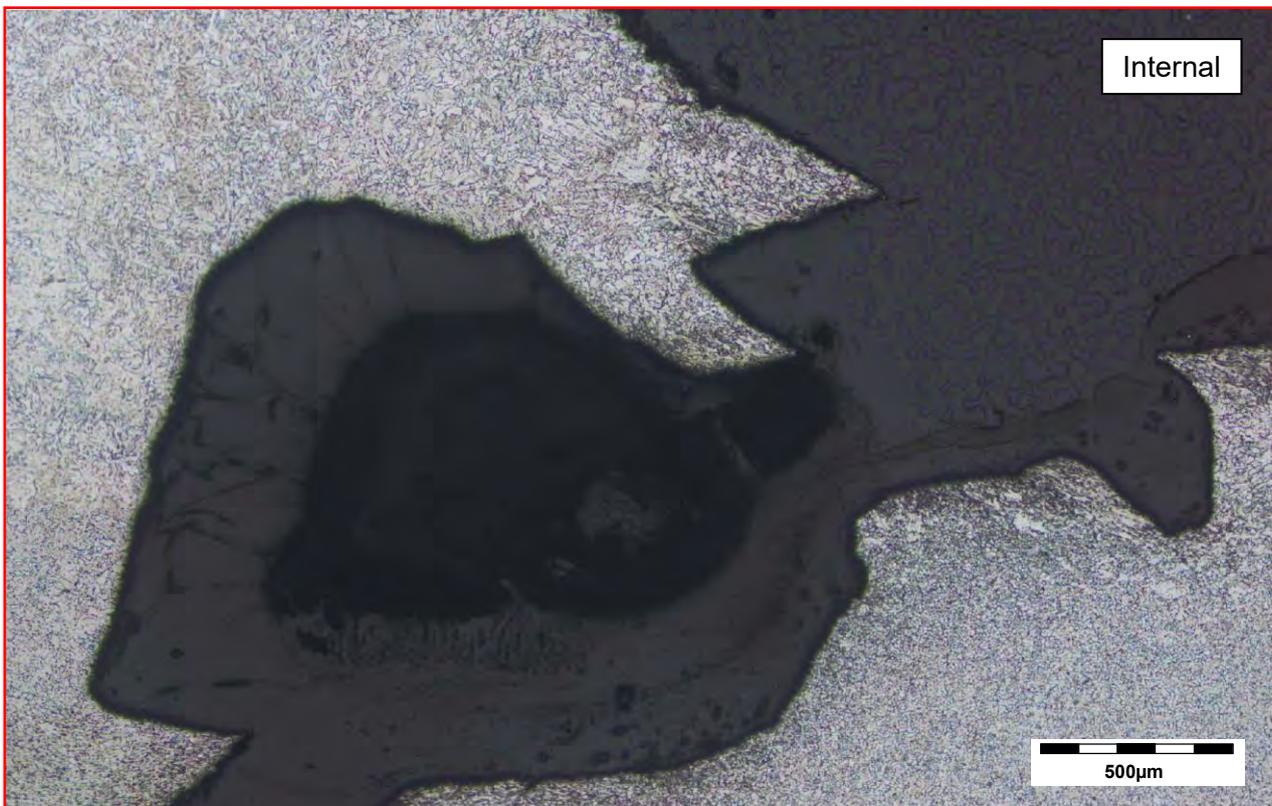
Figure 170: Micrographs at 50x magnification. The crack had propagated through the voids.

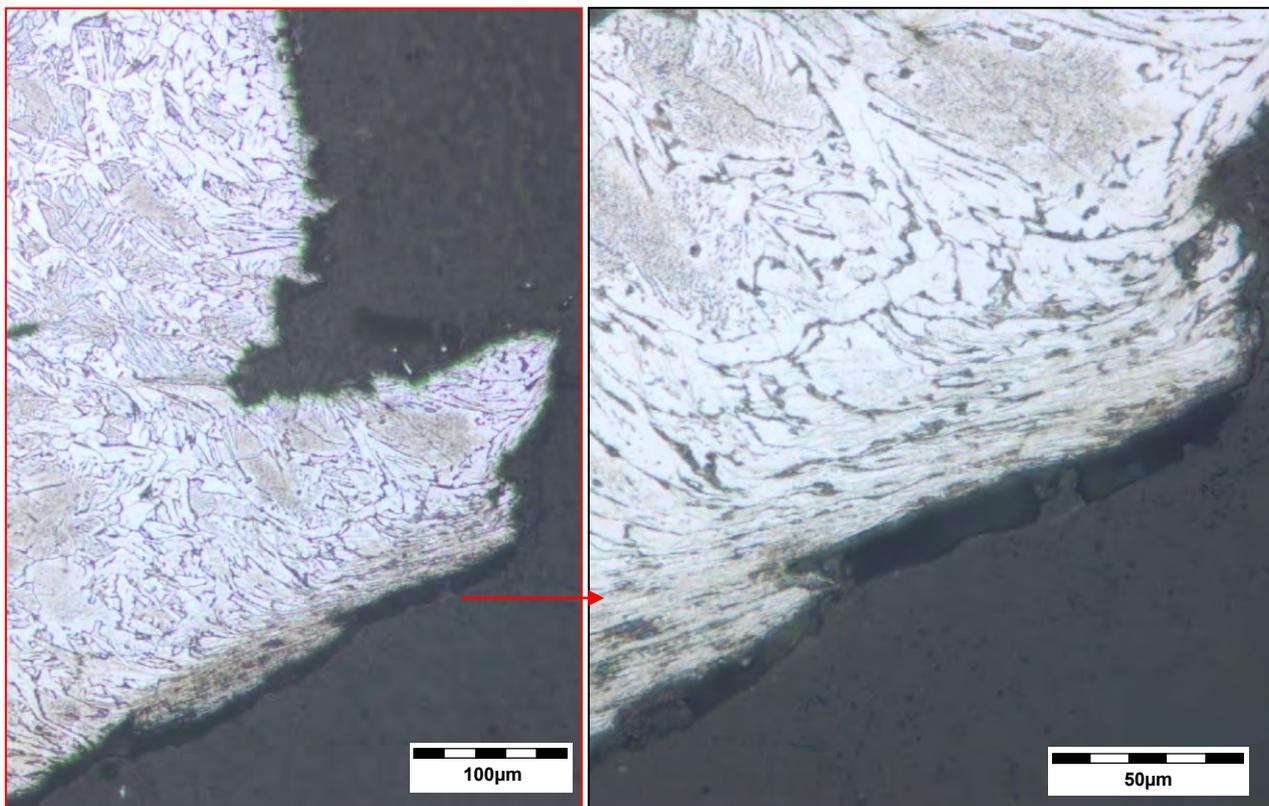
Figure 172: Micrographs at 200x (left) and 500X (right) magnifications. The structure along the crack edge had elongated grains, consistent with overload fracture.
