**Report of the Inquiry
Committee for the accident
at Stars Engrg Pte Ltd on
24 February 2021
(PART II – ANNEXES)**

TECHNICAL REPORT

| Title of Report: Failure Analysis of a Failed Mixer Machine Retrieved from Unit 32E of Platinum @ Pioneer Building involved in a Fire Explosion Incident | | Date of Last Revision/Revision No: |

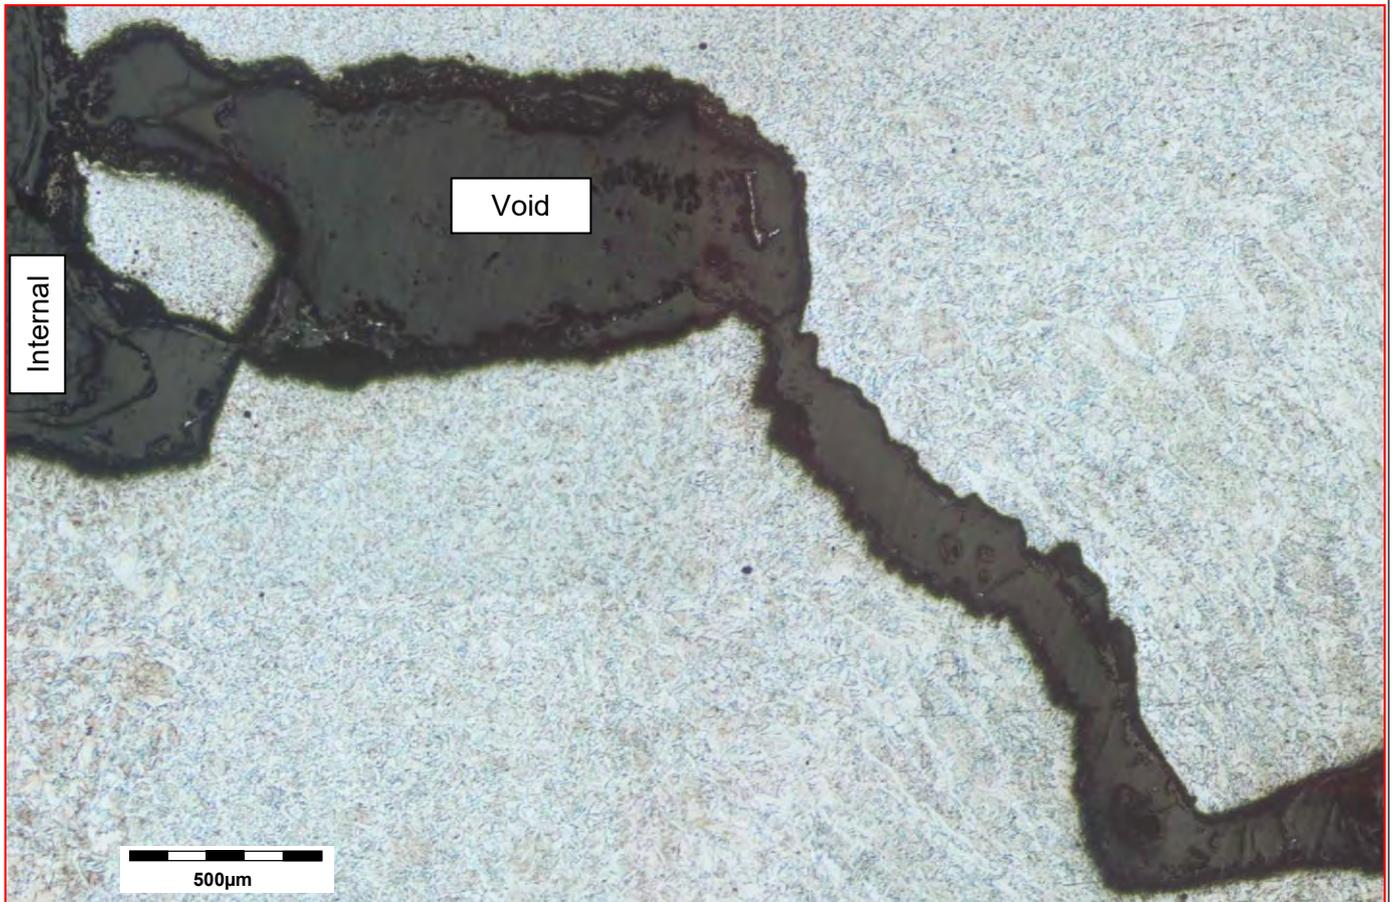
Figure 174: Micrographs at 50x magnification. The crack had propagated through a void before reaching the external side at the weld face.

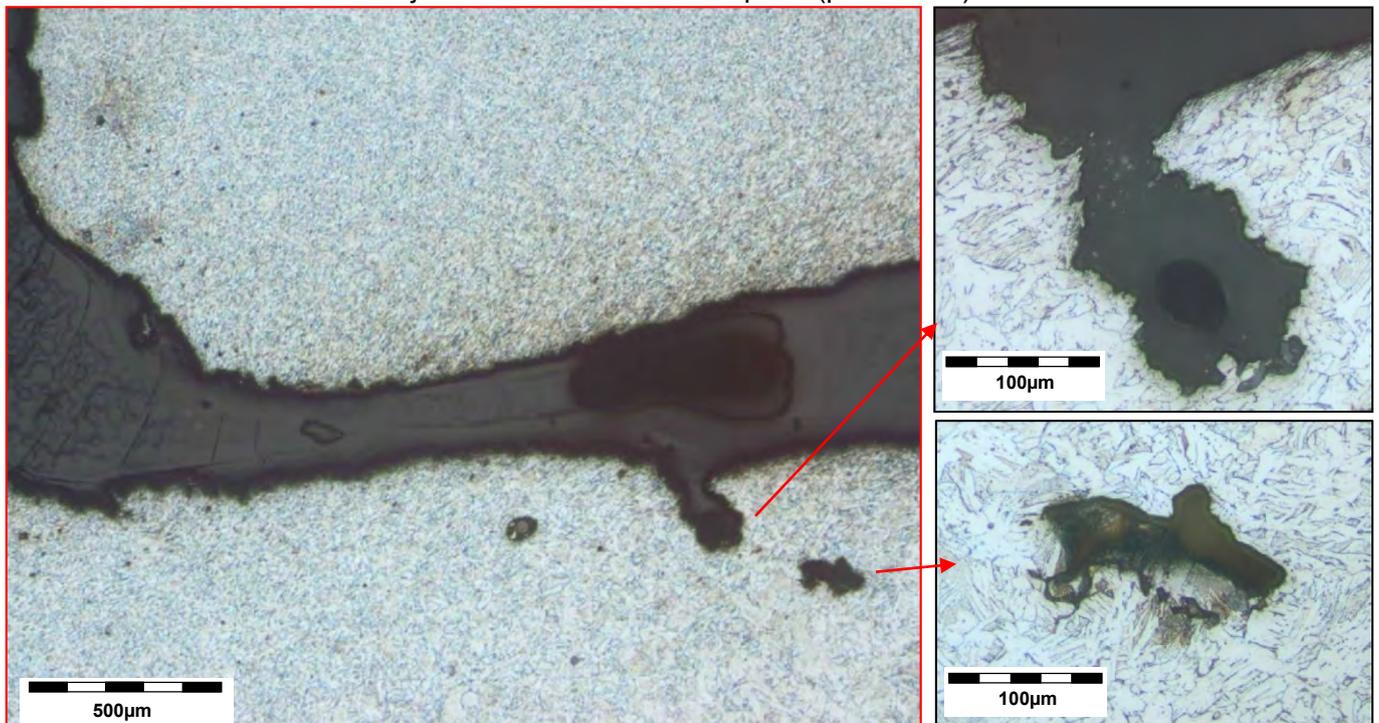
Figure 176: Micrographs at 50x (left) and 200X (right) magnifications. Closer examination along crack path at the weld joint between the oil jacket bottom plate and wall revealed voids of up to about 160 µm within the weld metal.

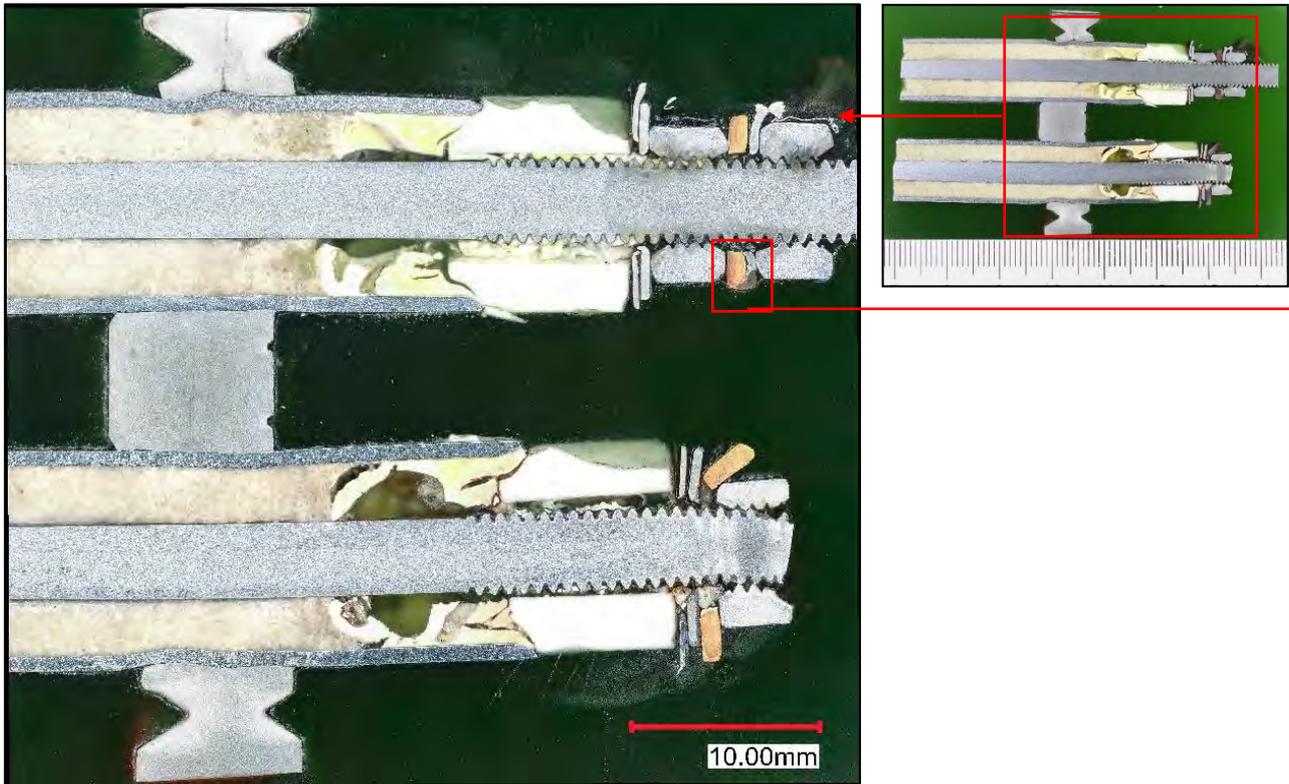
Figure 179: Sectional metallographic examination was conducted across the wired terminals (terminals #3 and #4). The arc damage is visible at the lug.

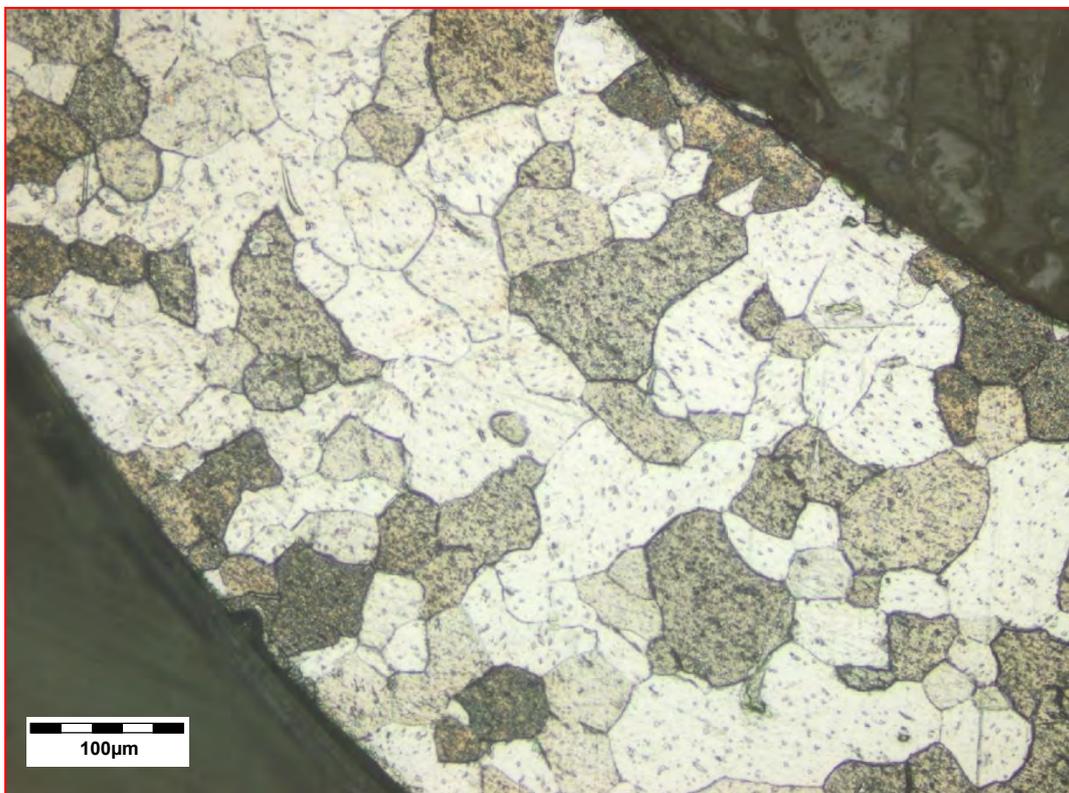
Figure 184: Micrograph of the resistance wire at 200X magnification. All the resistance wires within metal tubes were generally similar in microstructure had experienced grain growth (compared with H New, Figure 202).

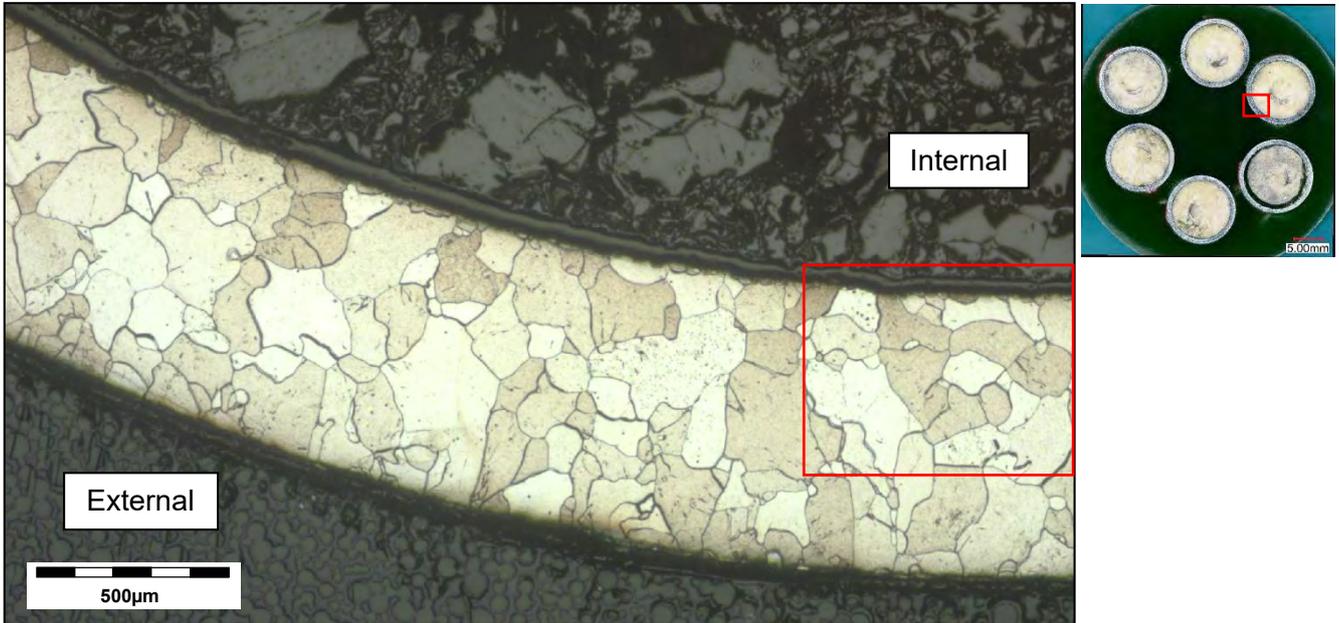
Figure 185: Micrograph of the metal tube at 50X magnification. All the metal tubes were generally similar in microstructure and had experienced grain growth (compared with H New, Figure 203).

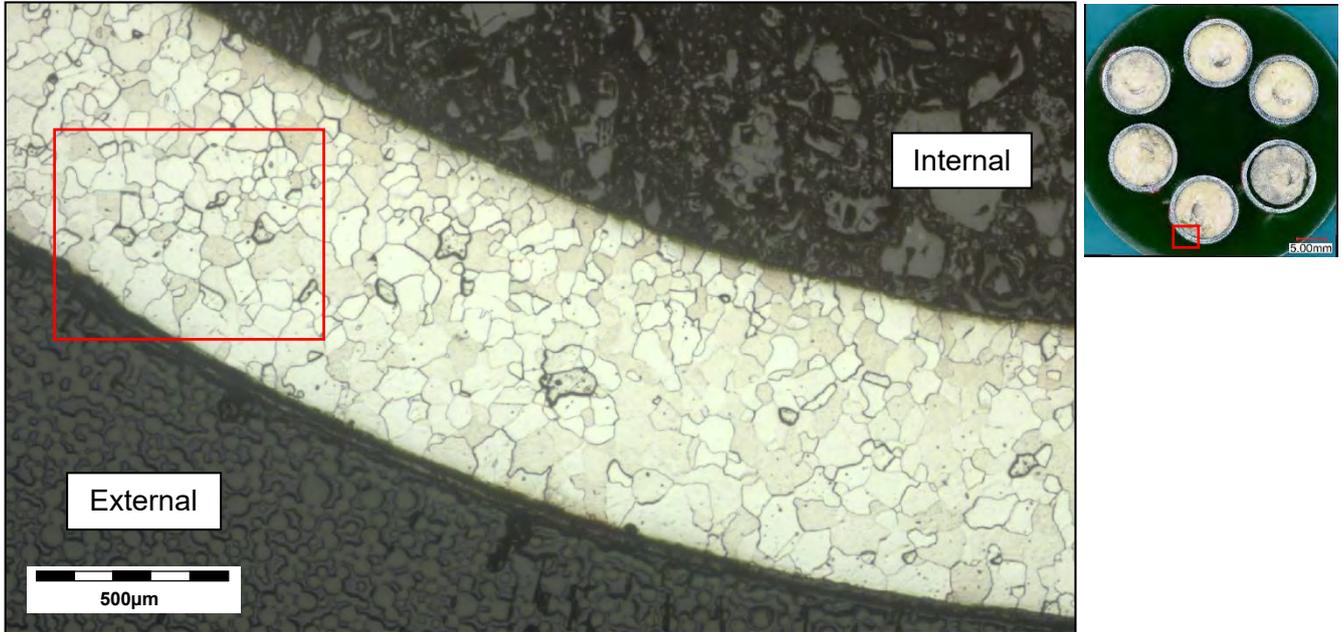
Figure 187: Micrograph of the metal tube at 50X magnification. All the metal tubes were generally similar in microstructure and had experienced grain growth (compared with H New, Figure 203).

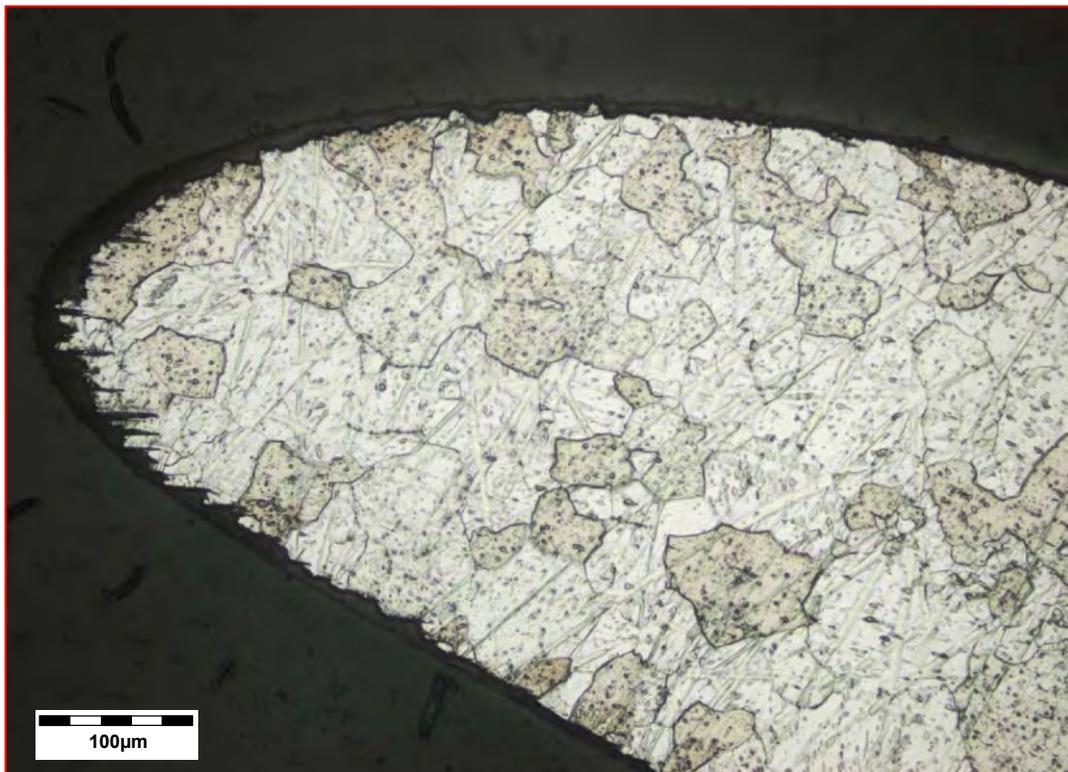
Figure 190: Micrograph of the resistance wire at 200X magnification. All the resistance wires within metal tubes were generally similar in microstructure had experienced grain growth (compared with H New, Figure 202).

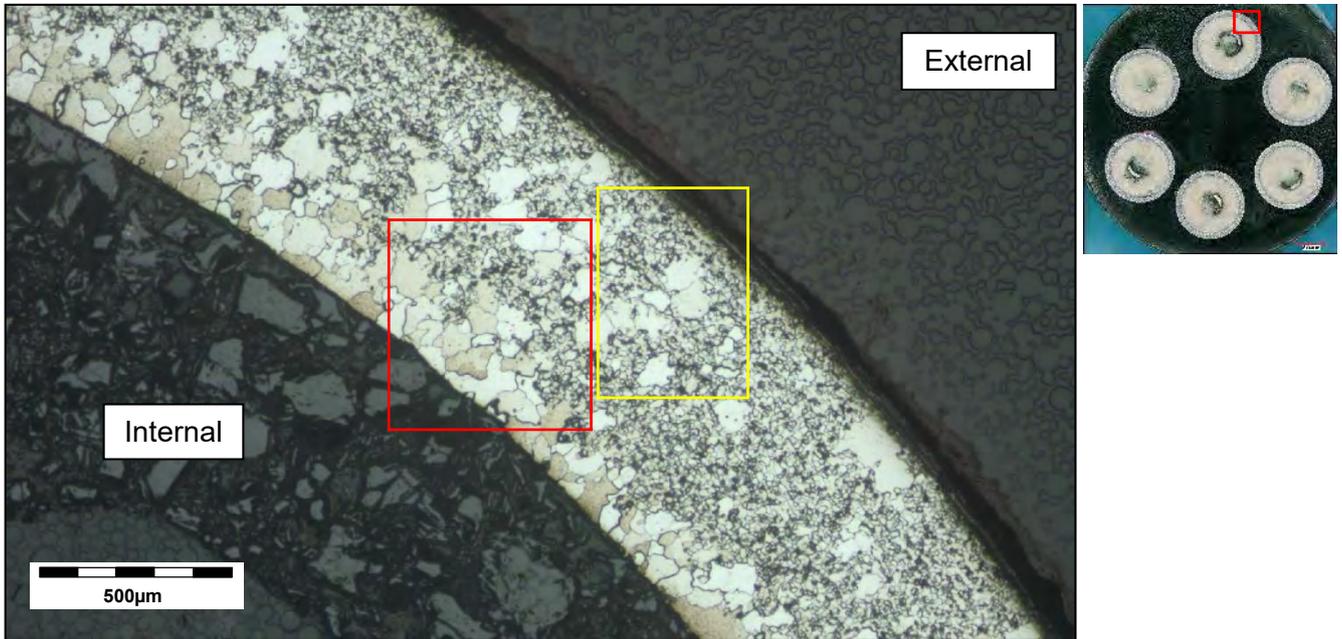
Figure 191: Micrograph of the metal tube at 50X magnification. All the metal tubes were generally similar in microstructure and had experienced grain growth starting from the internal surface up to about mid-wall thickness (compared with H New, Figure 203).

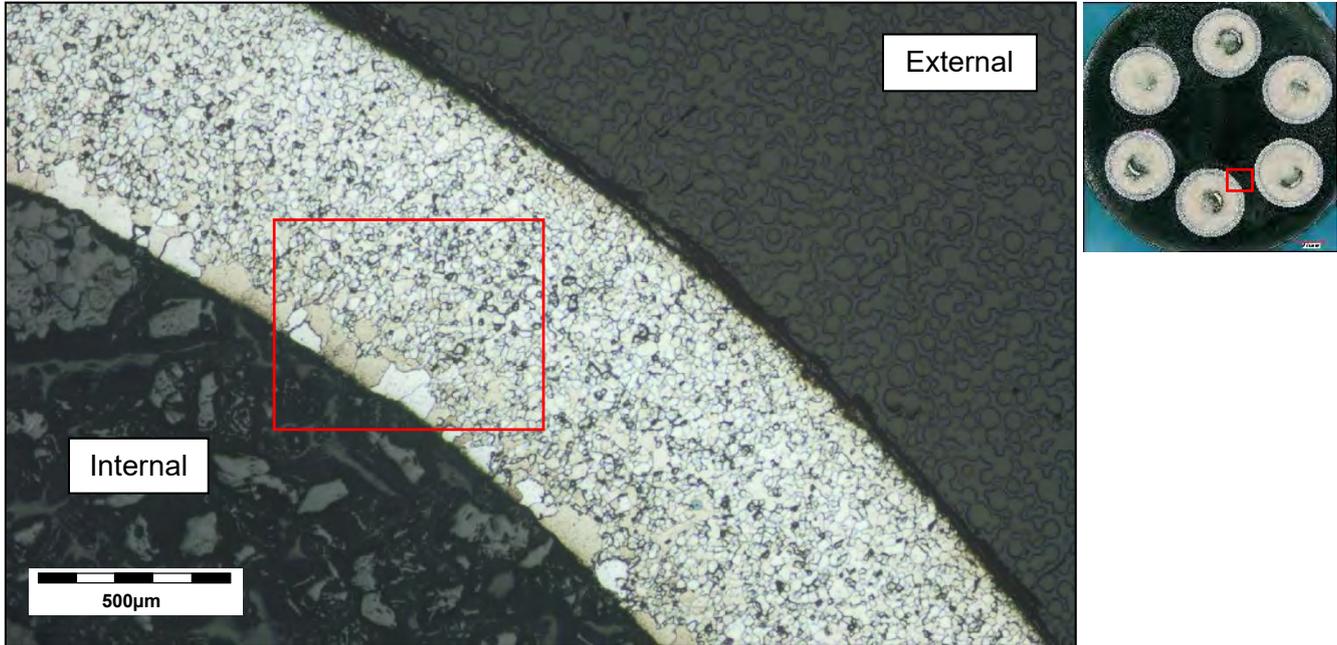
Figure 193: Micrograph of the metal tube at 50X magnification. All the metal tubes were generally similar in microstructure and had experienced grain growth starting from the internal surface (compared with H New, Figure 203).

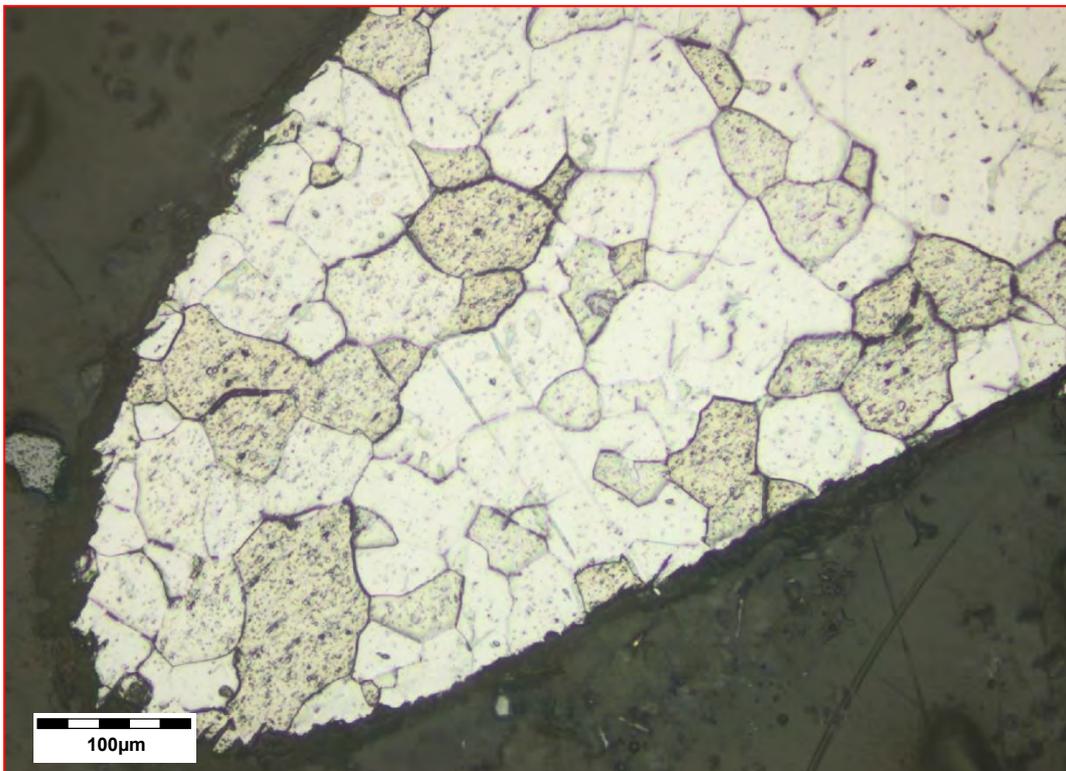
Figure 196: Micrograph of the resistance wire at 200X magnification. All the resistance wires within metal tubes were generally similar in microstructure had experienced grain growth (compared with H New, Figure 202).

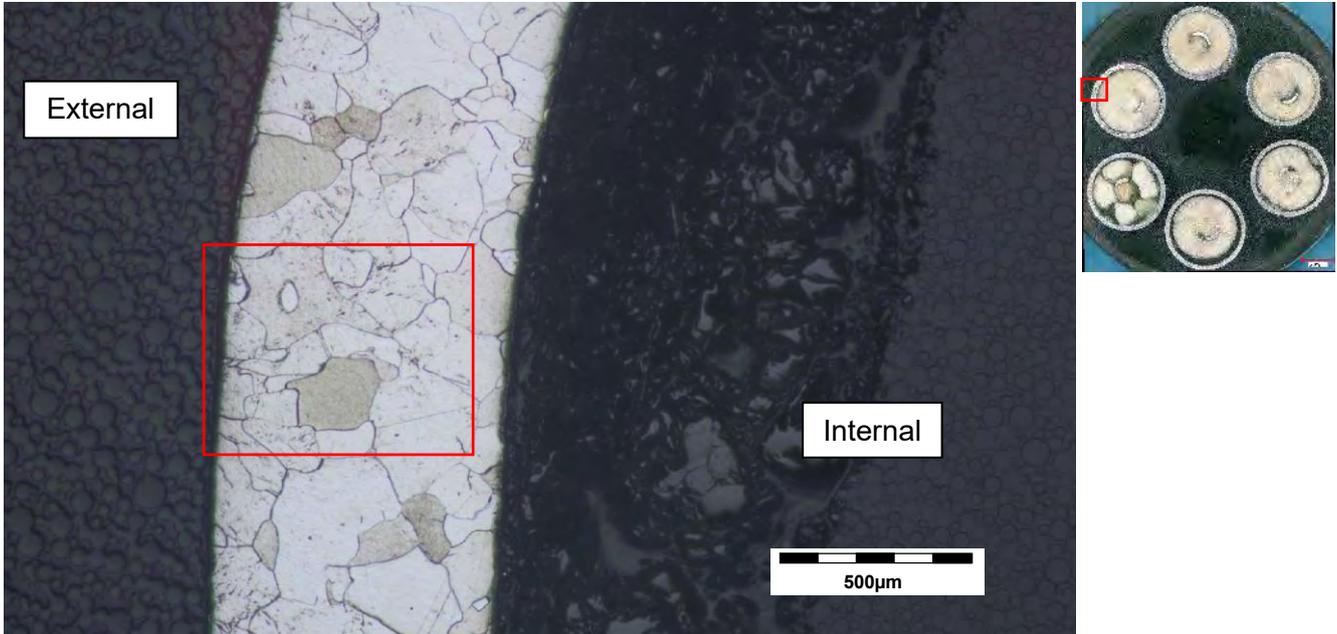
Figure 197: Micrograph of the metal tube at 50X magnification. All the metal tubes were generally similar in microstructure and had experienced grain growth (compared with H New, Figure 203).

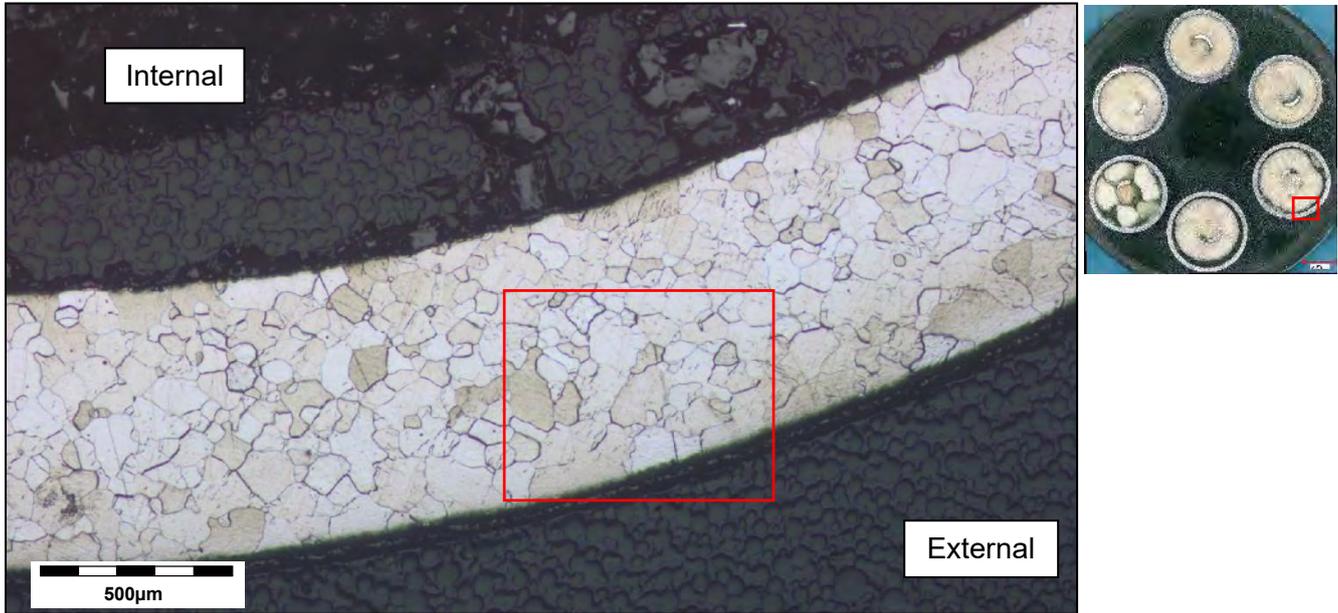
Figure 199: Micrograph of the metal tube at 50X magnification. All the metal tubes were generally similar in microstructure and had experienced grain growth (compared with H New, Figure 203).
