**Report of the Inquiry
Committee for the accident
at Stars Engrg Pte Ltd on
24 February 2021**

ACCIDENT INVESTIGATION REPORT

FIRE AND EXPLOSION AT STARS ENGRG PTE LTD (32E, TUAS AVENUE 11)

**INVESTIGATION INTO THE CAUSE OF THE EXPLOSION
THAT OCCURRED AT 32 E TUAS AVENUE 11, SINGAPORE ON
24 FEBRUARY 2021**

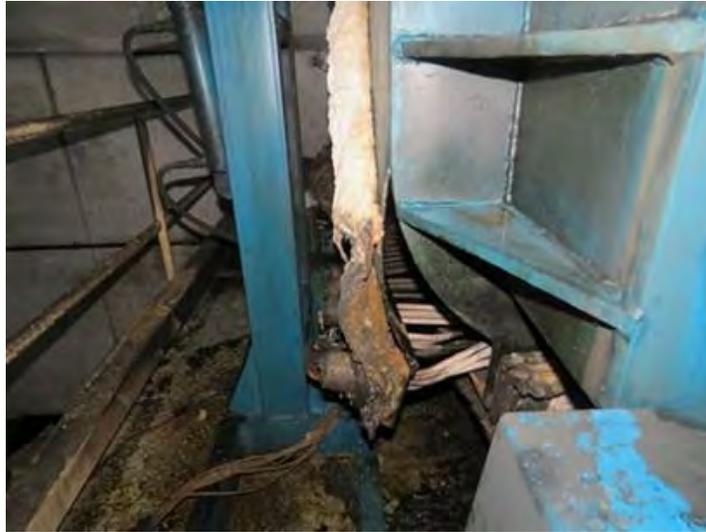
2 The two assembly tables used in the manufacture of fire insulation wrapping seemed to be intact and
had not been dislodged from their fastenings. The raised metal platform close to the rear portion of
the factory unit also seemed to be intact with no observable deformations or significant damage. A
4 mixer was located on top of this raised platform. The mixer was seen to be badly damaged with its
bottom half being split at the welding seams as shown in **Figure 1**.

8 **Figure 1.** Photograph of the rear, right edge of the mixer from the accident site taken by MOM

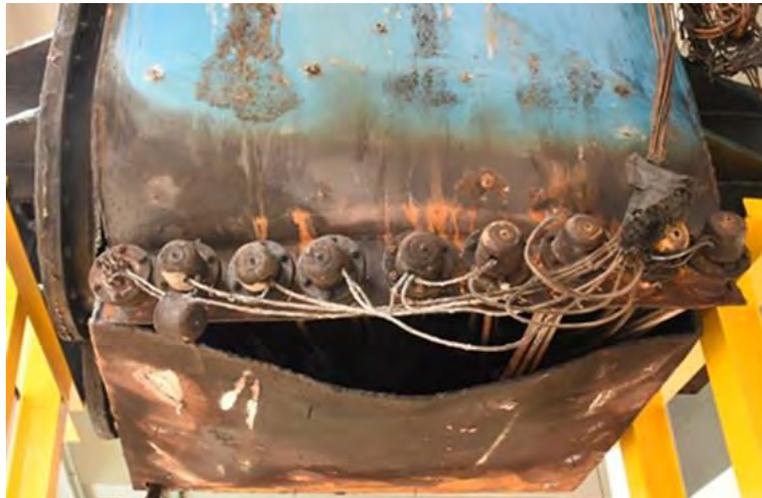
The mixer was found to have suffered catastrophic damage to its heating jacket. The bottom portion of the mixer could be seen to have been split open along its welding seams as shown in **Figure 3**.

2 **Figure 3.** Bottom view of damaged mixer taken by MOM

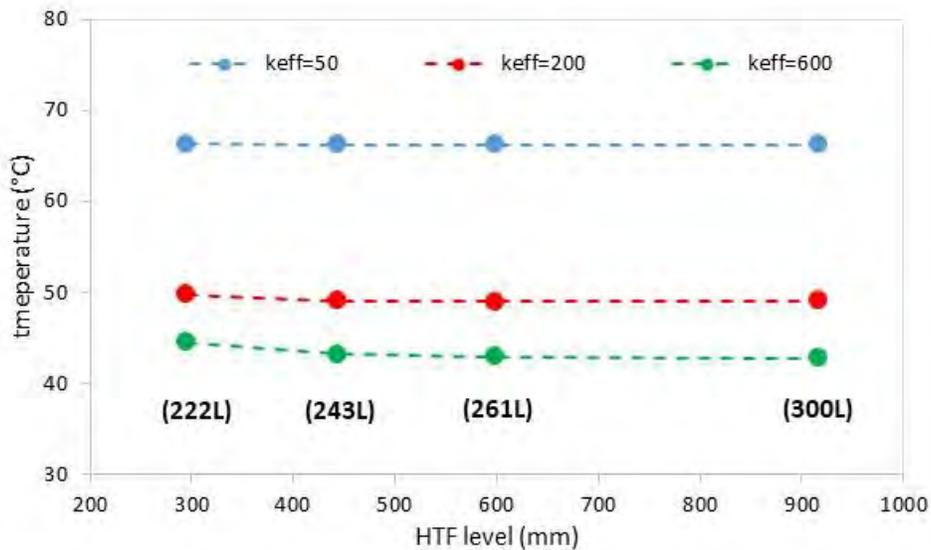
10 **Figure 6.** Maximum temperatures (average of HTF and mixer surface) obtained under high convective heat
 12 transfer conditions ($h=500 \text{ W/m}^2\text{K}$) with a 7.2 kW heating source input

14 Under high convective heat transfer conditions within the mixing chamber, it was found that the
 height of the HTF within the heating jacket did not significantly affect the HTF's temperature even at
 16 differing values of k_{eff} . The highest temperature for the HTF was approximately 80 °C while the
 highest mixer internal surface temperature was about 55 °C. The temperature difference between
 18 mixer's inner surface and HTF ranged between 2 °C to 26 °C depending on the k_{eff} for HTF. It should
 be noted that these results were based on a HTF fill volume of at least 222 litres which translates to
 a HTF level of 295 mm.

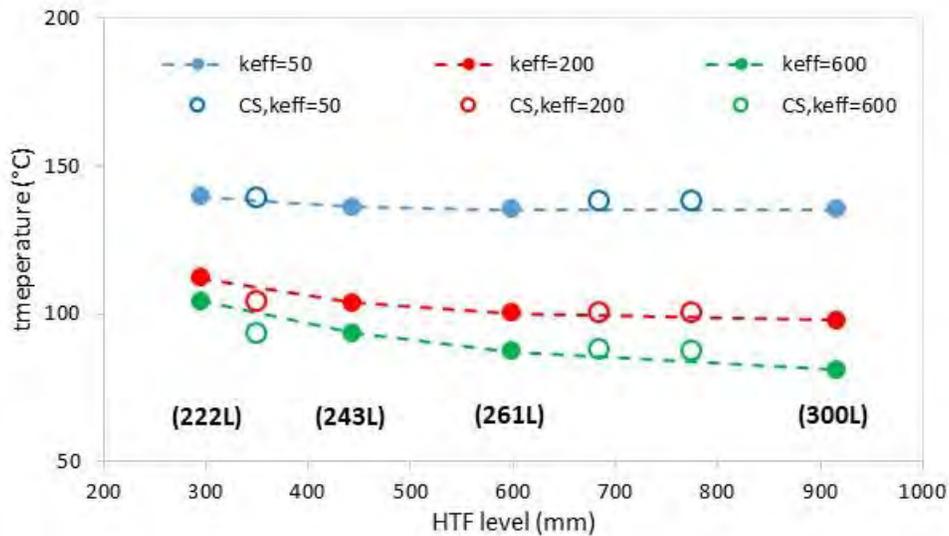
Figure 7. Maximum temperatures (average of HTF and mixer surface) obtained under moderate convective heat transfer conditions ($h=50 \text{ W/m}^2\text{K}$) with a 7.2 kW heating source input

Each plotted data point in **Figure 7** represents the averaged maximum temperatures obtained for the HTF and the inner mixer surface. Although the temperature of the HTF was found to be higher than that of the inner walls, this difference is relatively small with the difference in values ranging from 0.2% to 7.9%. In absolute terms the temperature difference between inner mixer surface and HTF ranges between 2 °C to 21 °C.

From the graph shown in **Figure 7**, it can be seen that for a given effective thermal conductivity (k_{eff}) of the HTF, variations in the HTF level within the heating jacket did not affect the fluid or the mixer's inner surface temperature much. However, it can be noted that where the HTF level drops below 450

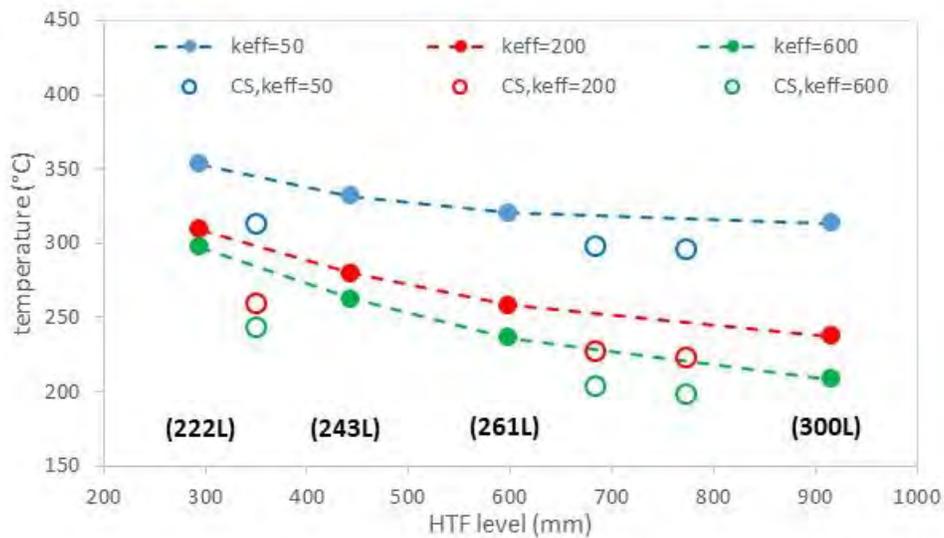
Figure 8. Maximum temperatures (average of HTF and mixer surface) obtained under low convective heat transfer conditions ($h=5 \text{ W/m}^2\text{K}$) with a 7.2 kW heating source input

Under the low convection conditions (i.e. $h=5 \text{ W/m}^2\text{K}$), we can observe that the system temperatures (HTF and mixer inner surface) increase significantly once the HTF level drops below 450 mm (ca. 243 L). A similar trend was also observed for the moderate convection scenario previously.

The temperatures attained by the HTF and the mixer's inner surface generally exceeds the mixer's design temperature of $200 \text{ }^\circ\text{C}$ with temperatures rising up to $353 \text{ }^\circ\text{C}$ when HTF levels are low (less than ca. 222L). It should also be noted that under these conditions (i.e. $h = 5 \text{ W/m}^2\text{K}$, $k_{\text{eff}} = 50 \text{ W/mK}$, heat source = 7.2 kW), the temperature of the HTF is above its flash point ($220 \text{ }^\circ\text{C}$) and maximum recommended operating temperature ($300 \text{ }^\circ\text{C}$)⁵.

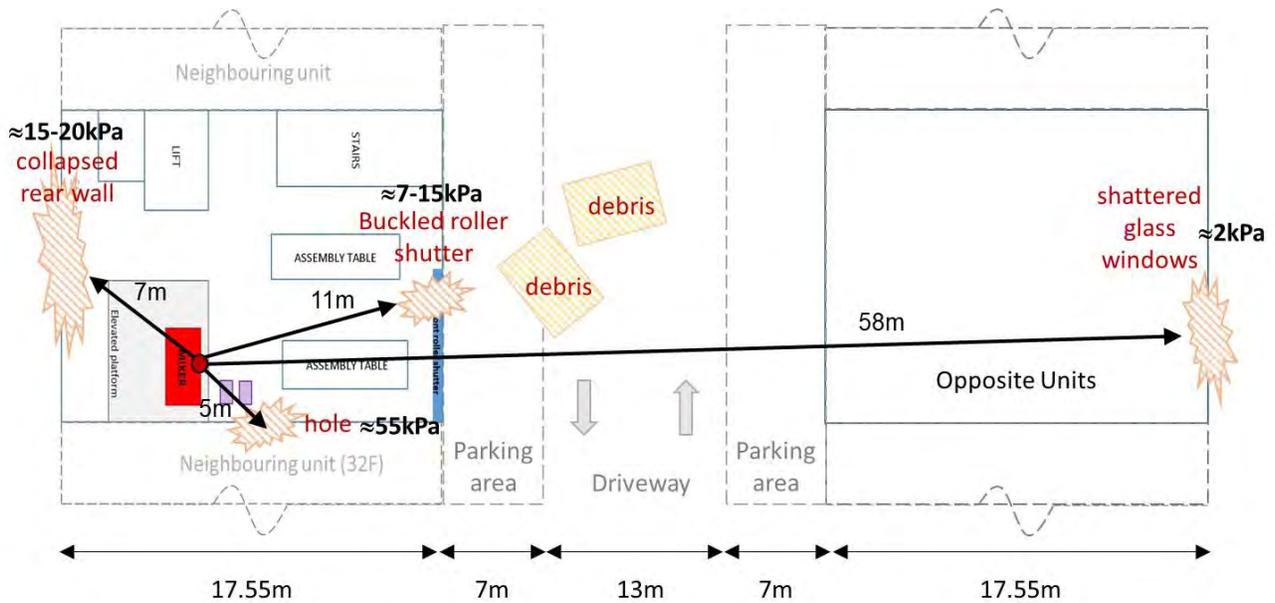
12 **Figure 15.** Schematic representation of the damage caused by the accident

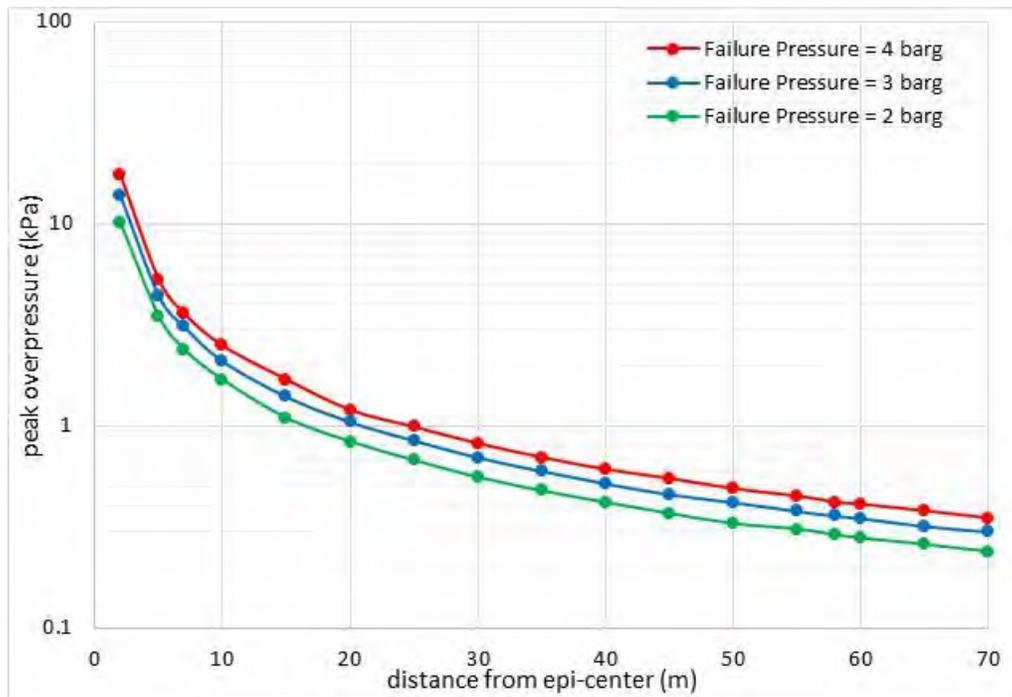
14 **Figure 16.** Graph of overpressure against distance for heating jacket failure at pressure P = 2, 3 and 4 barg

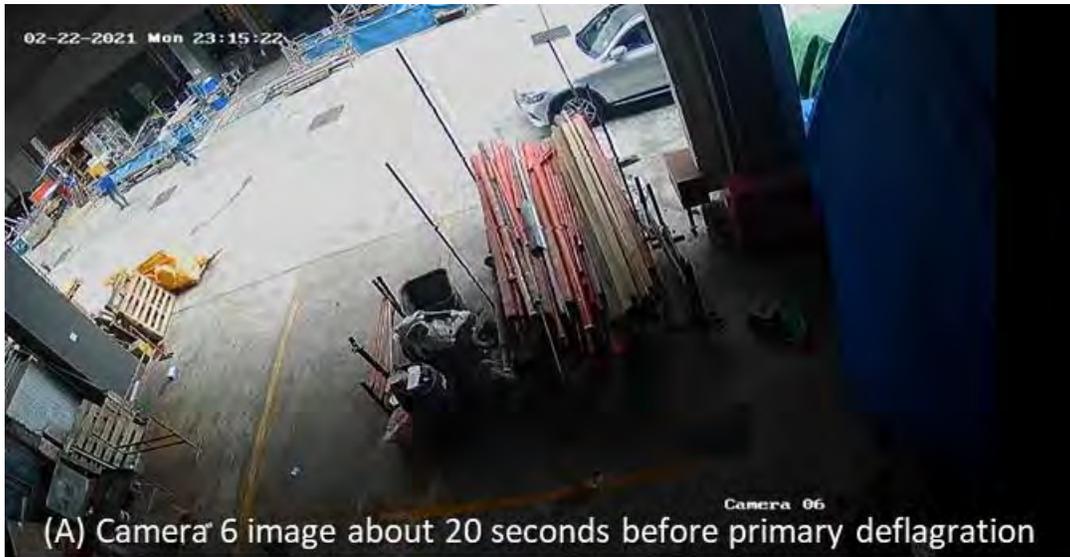
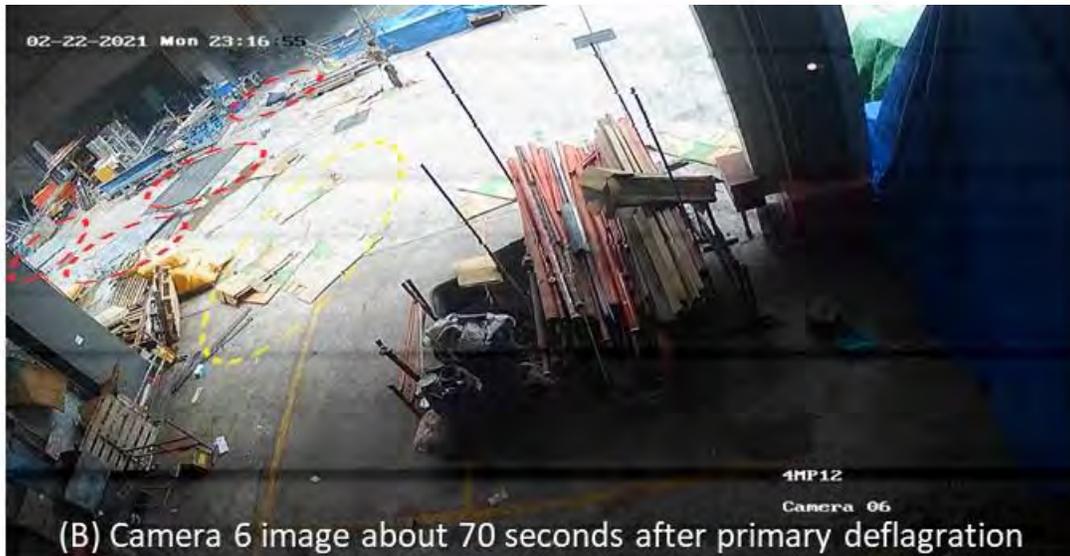
18 The CCTV video clips revealed that there was a large primary deflagration that was accompanied with significant overpressures as evidenced by vibrations and movement of objects seen in the video clips
20 as well as the extent of damage observed on site after the accident. The vibrations were evidenced by the shaking of the CCTV cameras (i.e. Cameras 3 and 4), and flying debris were recorded by
22 Cameras 5 and 6. Although Camera 6 was damaged by the accident, from the intact portions of the video clip, it was possible to observe that the overpressures of the primary deflagration were severe
24 enough to cause the dislodging and translation of large metal sheets on to the driveway of the industrial complex as shown in **Figure 25**. In addition, Camera 1 also recorded the toppling of a
26 dustbin whilst Camera 8 showed ladders being shaken during the primary deflagration event.

Figure 25. Images from CCTV Camera 6 showing the translation of large metal and cardboard sheets

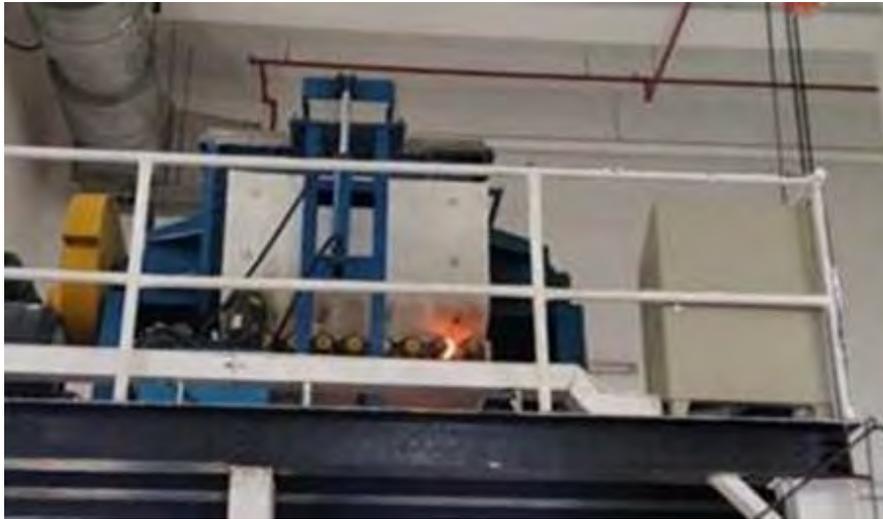
2 **Figure 26.** Image showing glowing flange connection of one of the mixer’s heating element

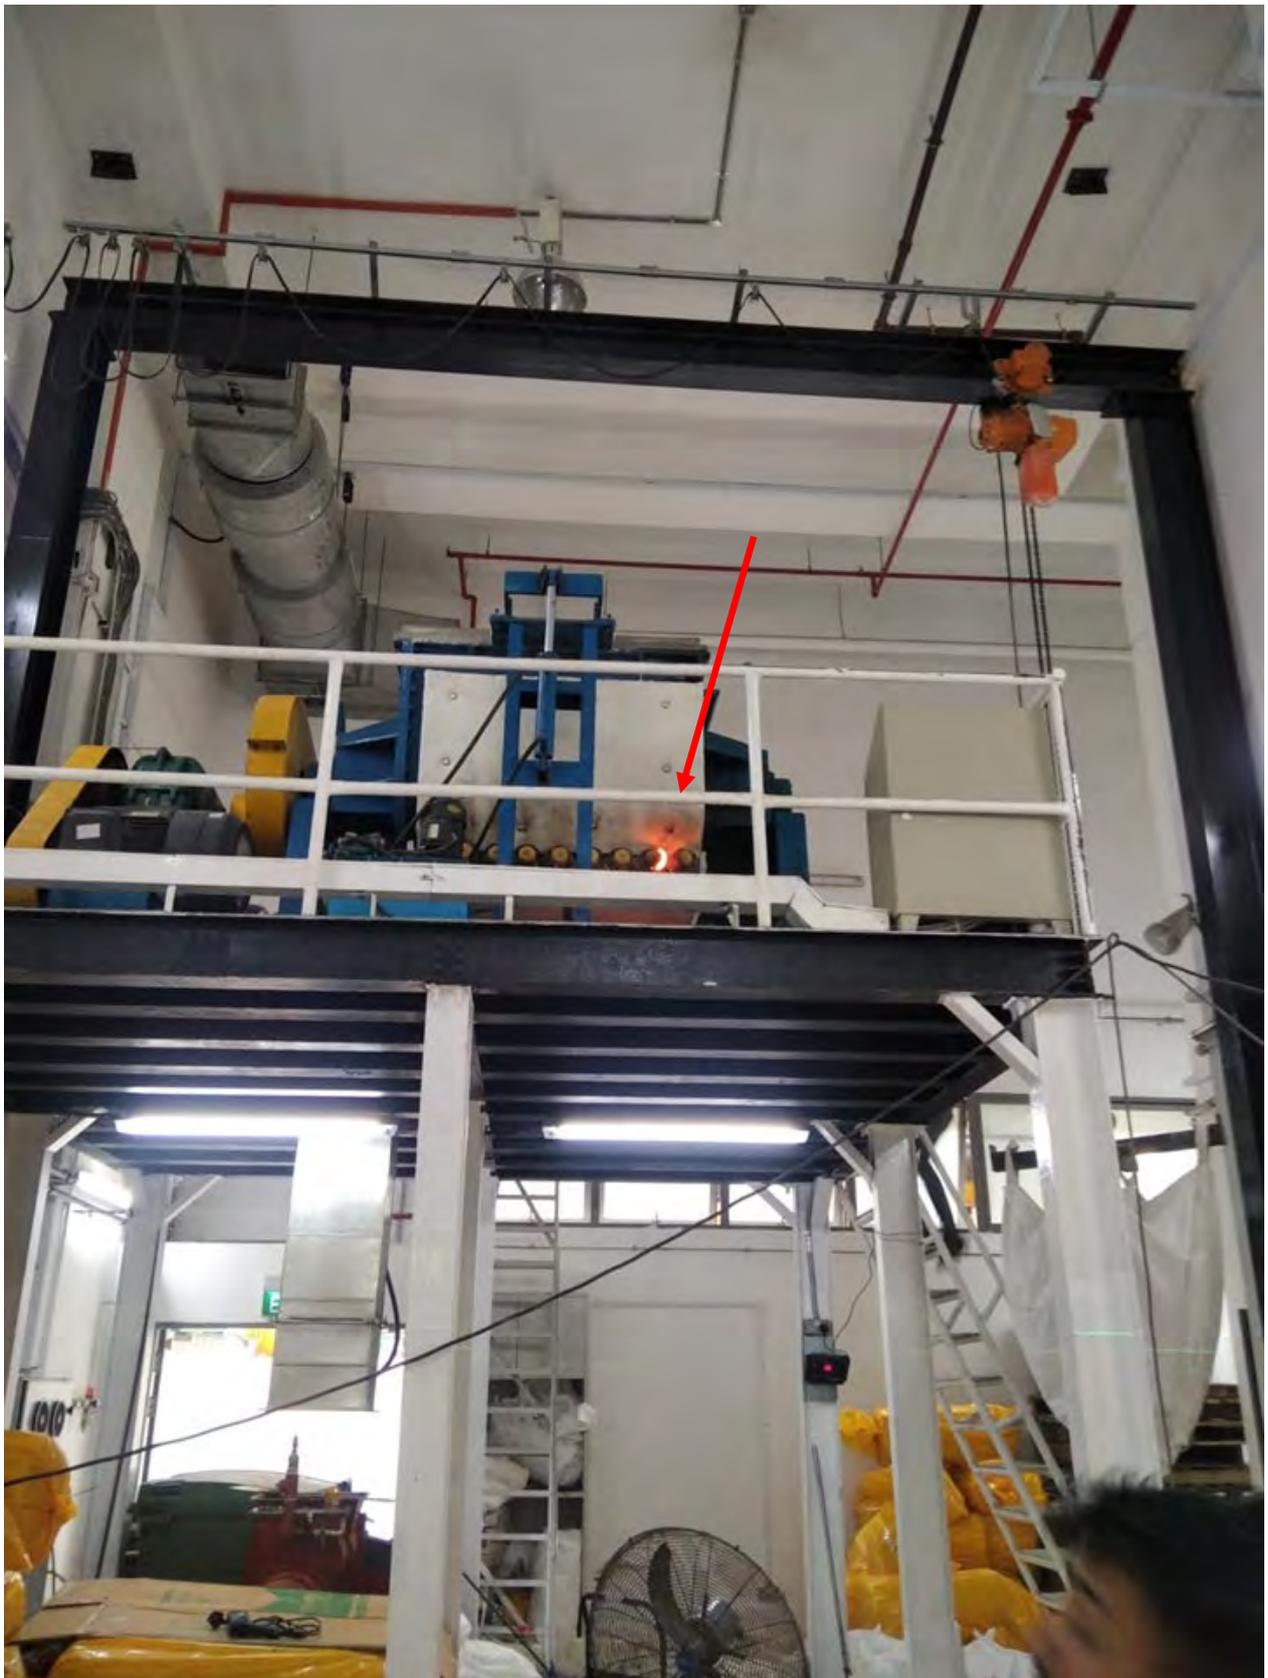
Photograph 9: Photograph sent to me by Mr Chua. The red arrow is pointing to the fire involving the machine. The fire is centred on the second heater from the right. The image shows that the thermal insulation of the machine is intact and below the mezzanine the surfaces appear free of dust.

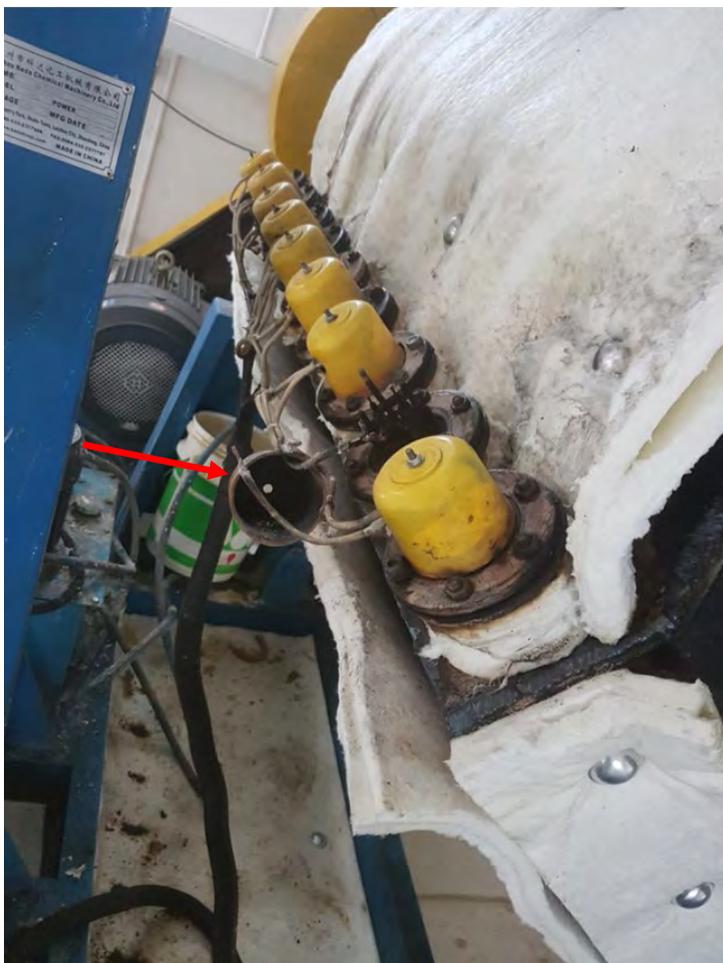
Photograph 11:

Taken after the fire. The yellow cover of the fire damaged heater has been removed. The red arrow is pointing to the heater cover and a detached heater cable. Note that the 'body' of the machine has been rotated from the normal operating orientation, shown in Photograph 10.

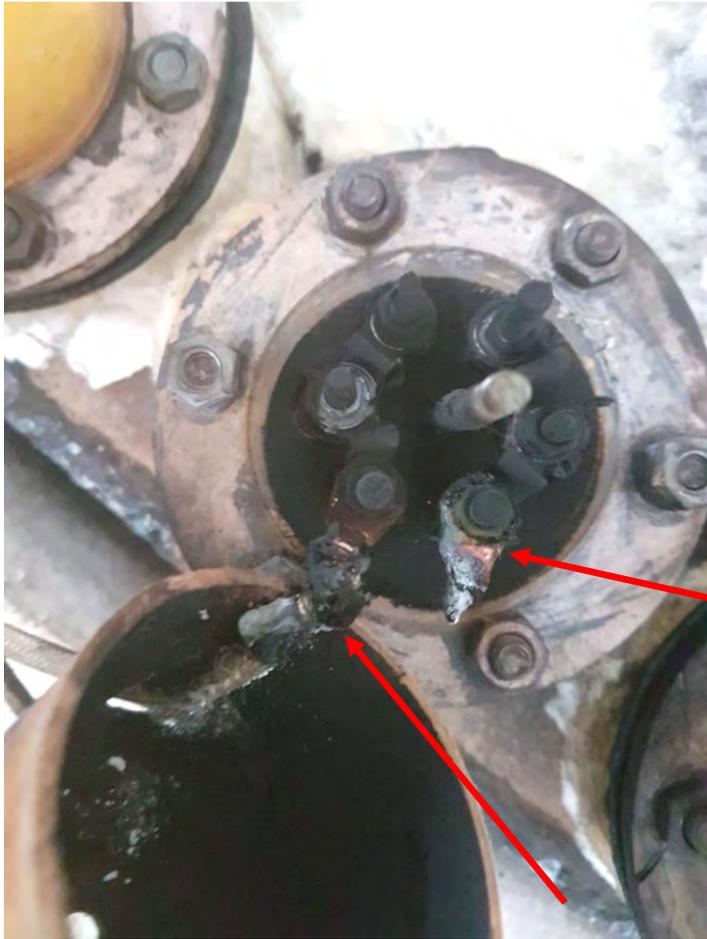
Photograph 12:
Taken after the fire. Note the fire damage to the heating element connection and cables.

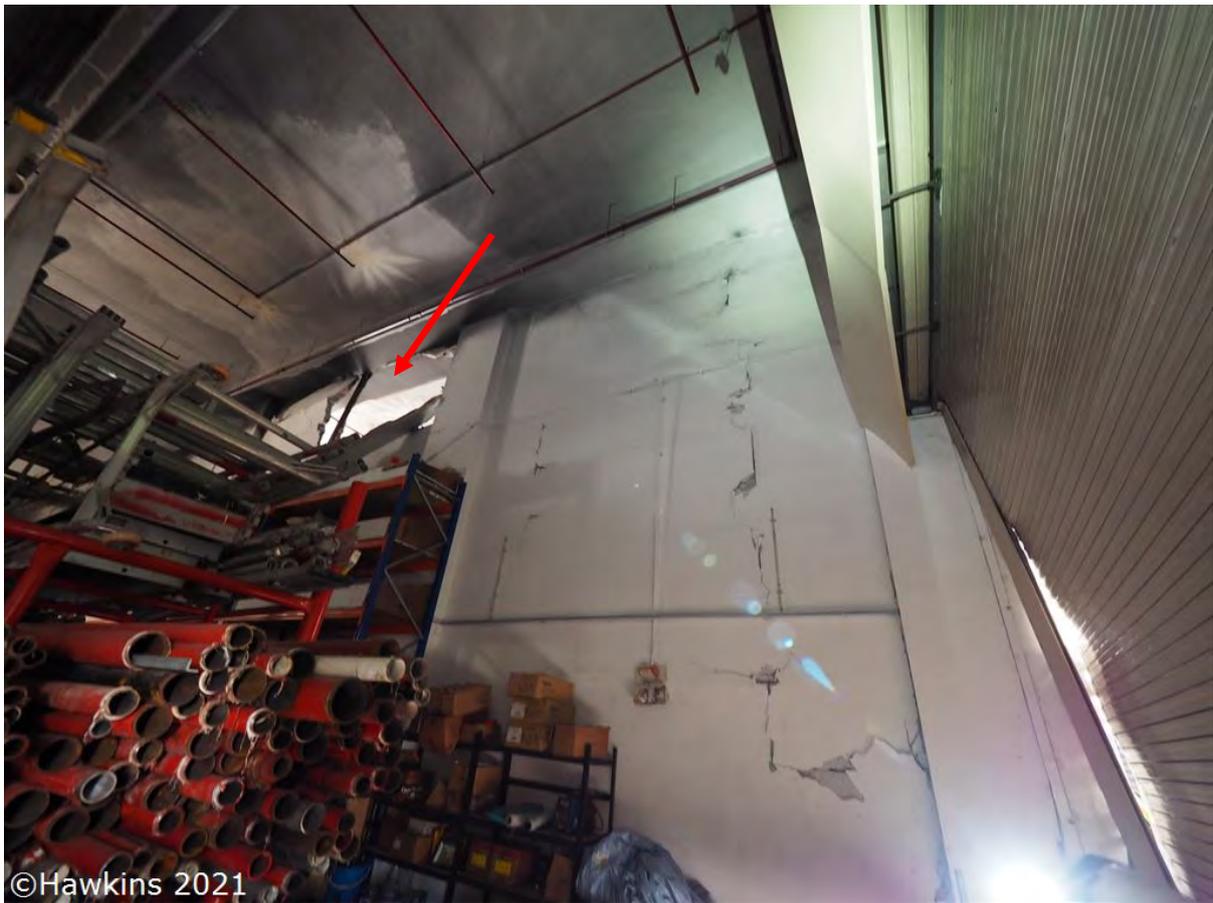
Photograph 14: Overview of the damage to Unit 32F. Note the hole and cracks in the party wall, the displaced roller shutter and the sprinkler wash on the ceiling.

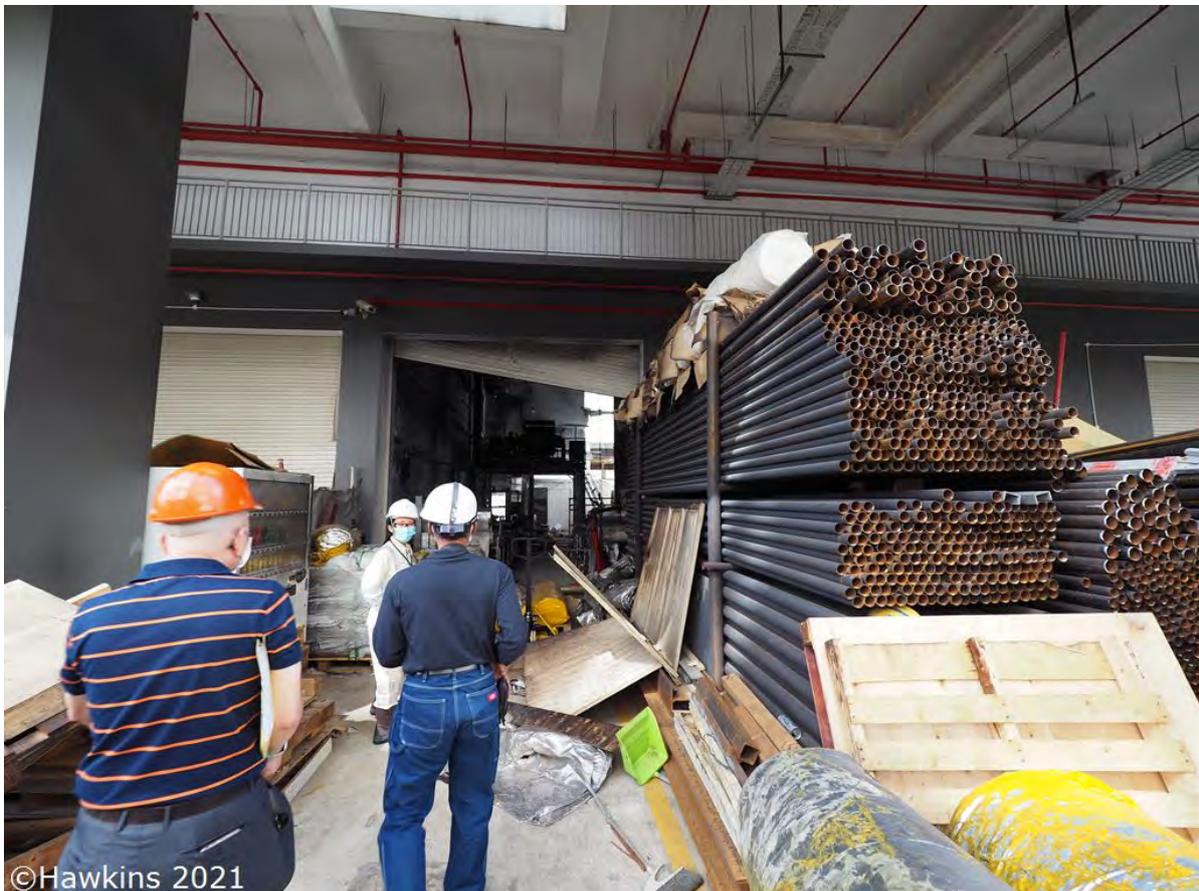
Photograph 15: Looking into Unit 32E. Note the slight fire damage to packaging materials.

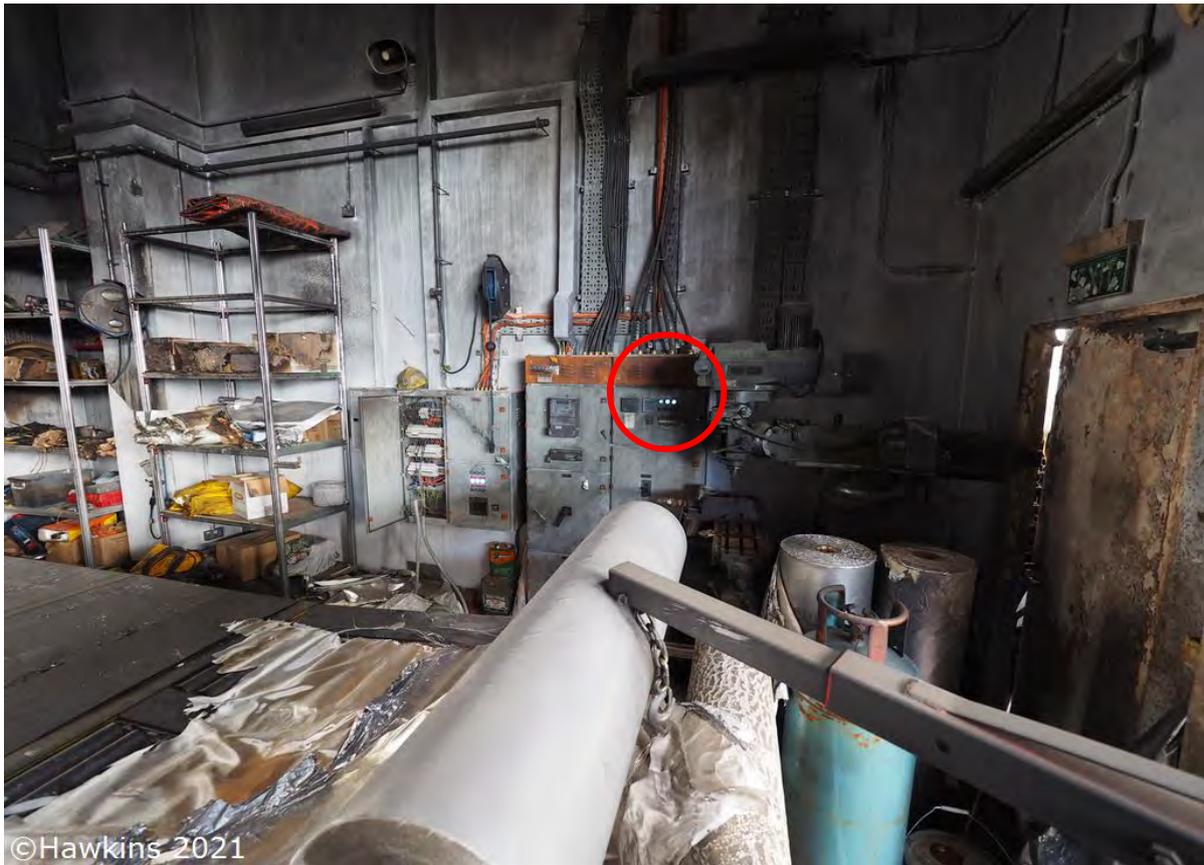
Photograph 16: Just inside the roller shutter, looking towards the electricity intake equipment. The items are heat damaged. Note the unburnt items on the shelving and the indicator lights of the electrical intake are illuminated.

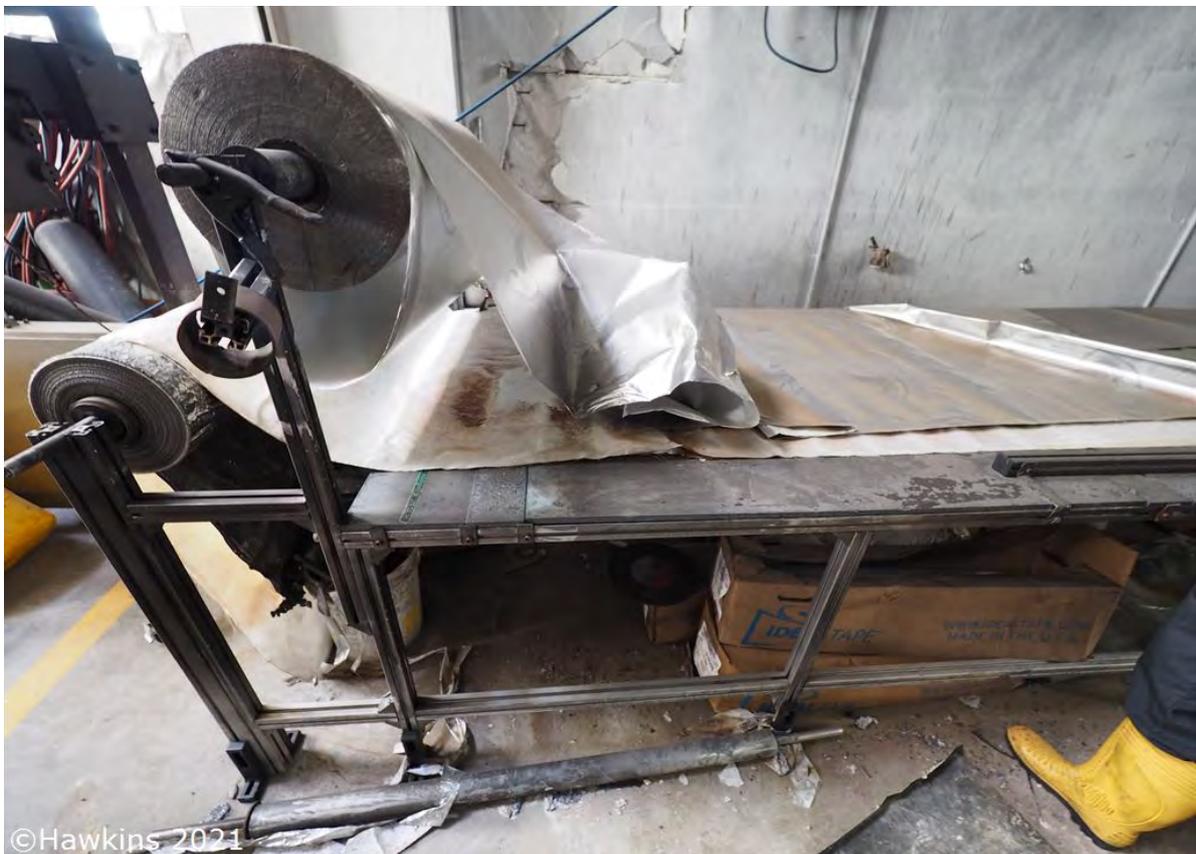
Photograph 17: Just inside the roller shutter looking away from electricity intake equipment. The items are heat damaged. Note the unburnt cardboard.

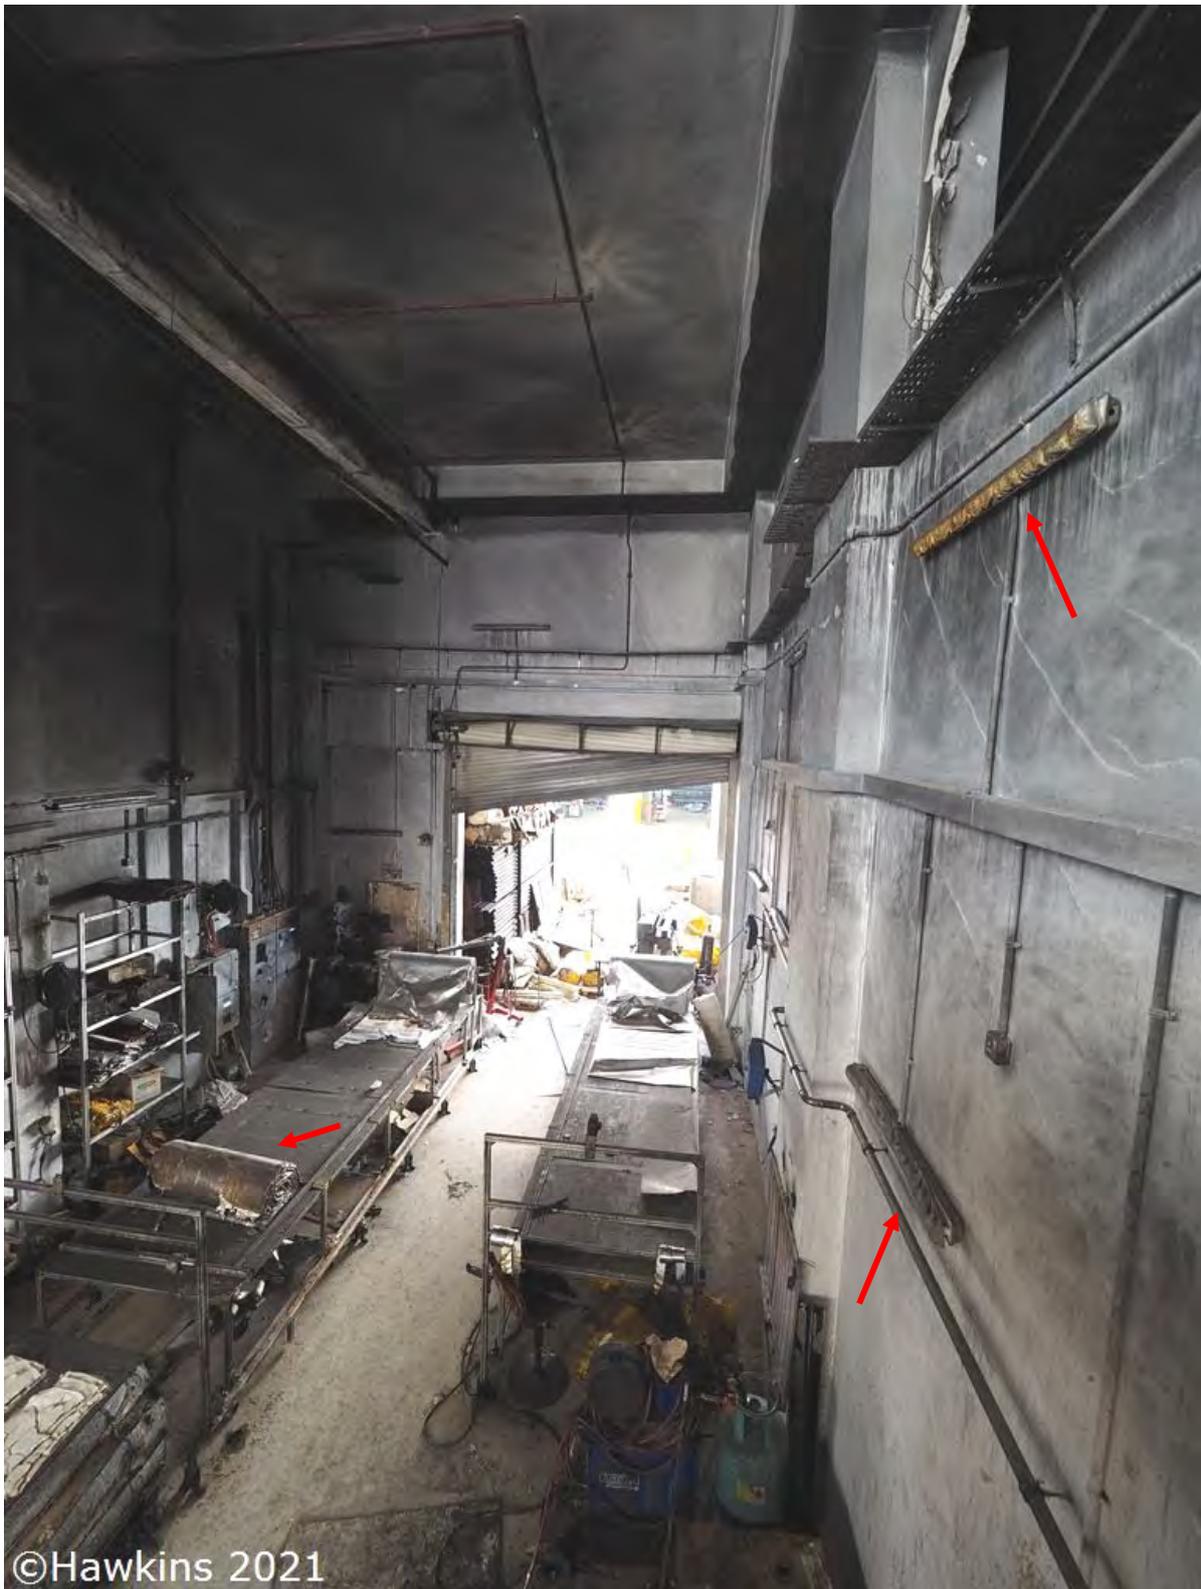
Photograph 18: Looking from the mezzanine to the roller shutter. Note there is no evidence of sustained fire damage, only scorching, blistering and superficial melting of papers, plastics etc.

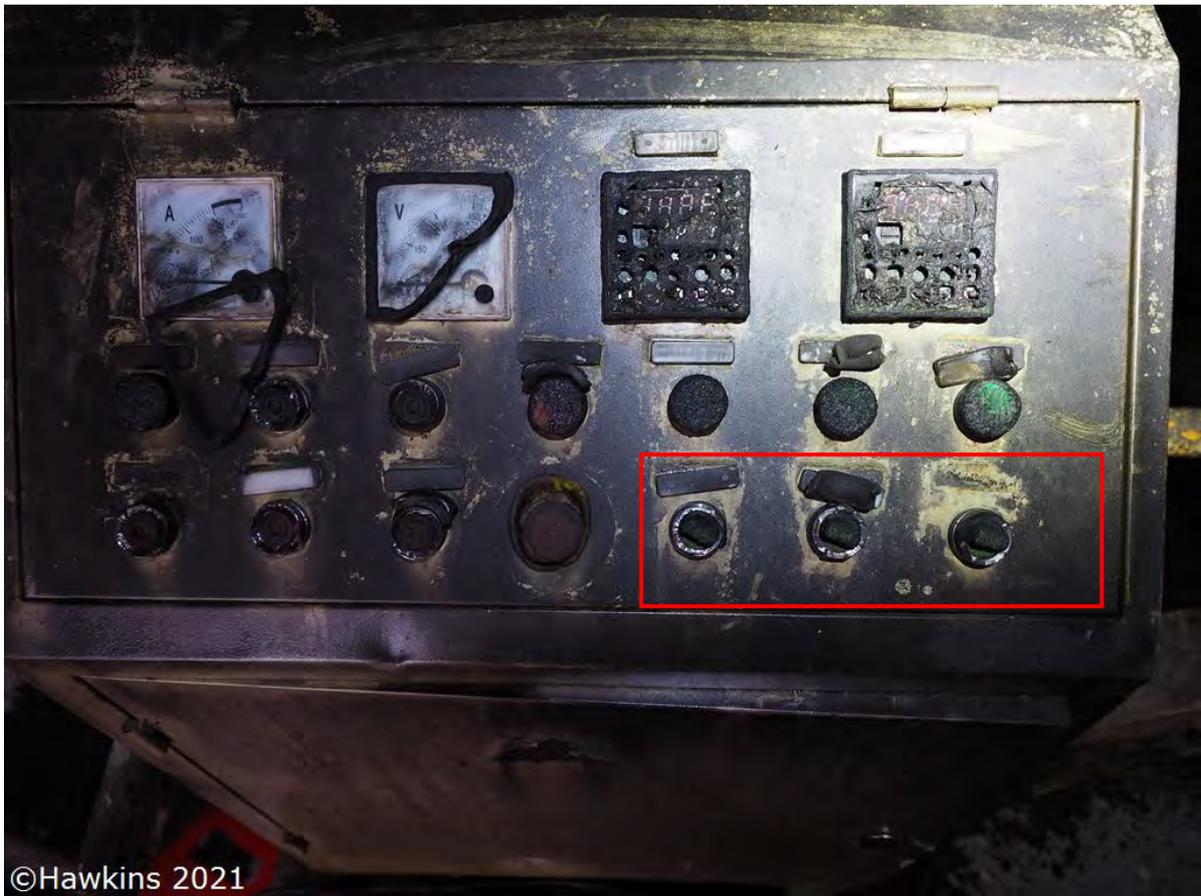
Photograph 27: The damage to the control panel. The heater switches are highlighted.

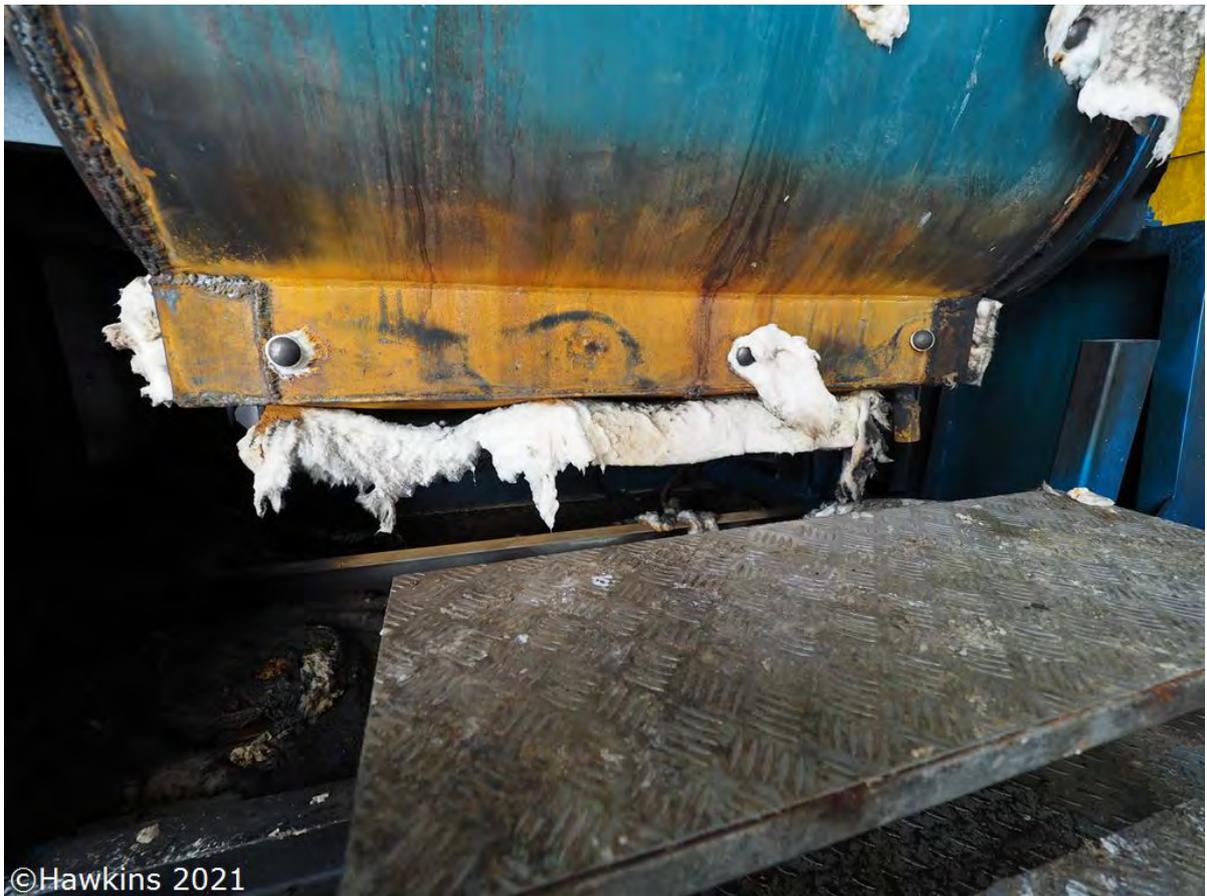
Photograph 35: The casing of the machine was rusty at low level on one side of the oil reservoir.

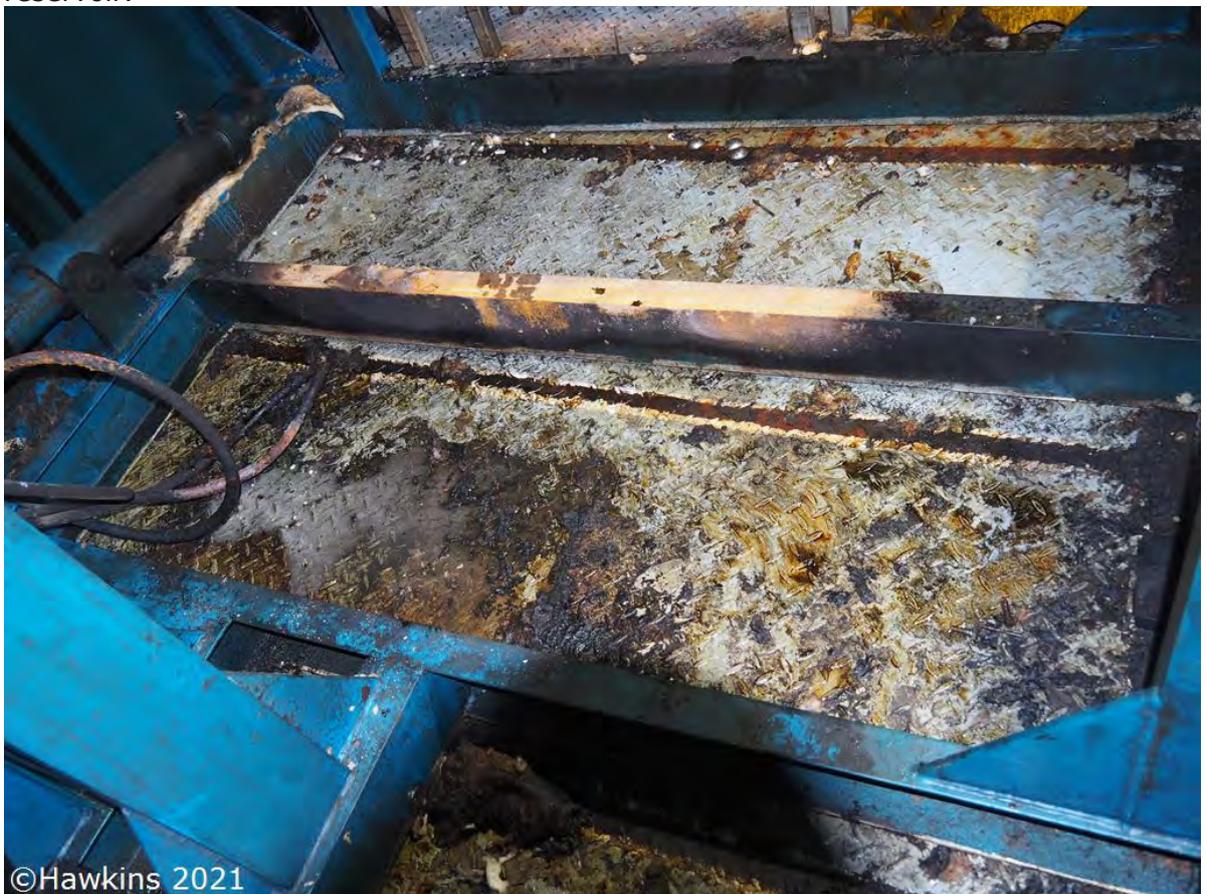
Photograph 36: The localised fire damage to the frame that supported the machine. The opposite side of the steel frame was hardly affected.

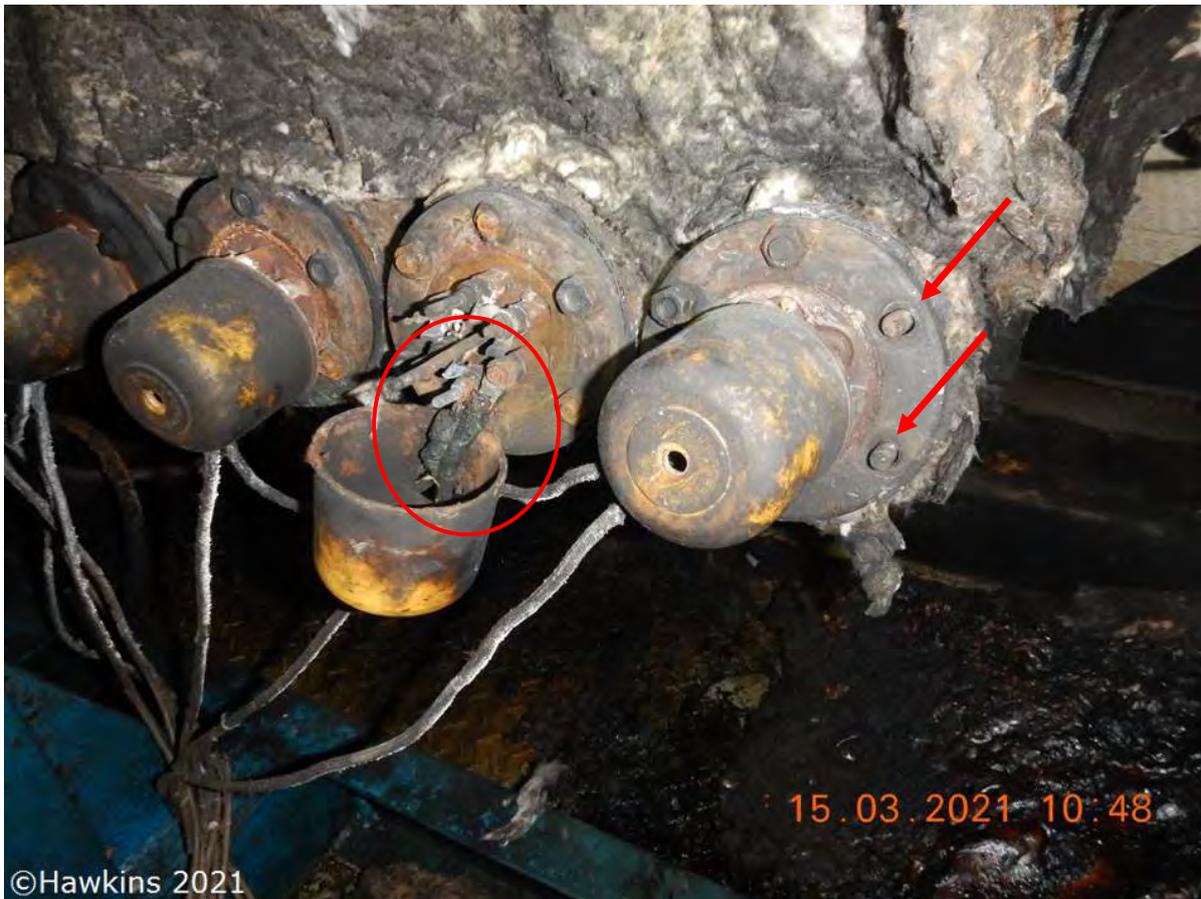
Photograph 41: The heads of the heating elements. Note the insulation tape wrapped around the cables of the element that had caught fire earlier in the day. Also note the two missing nuts (arrowed) of the heating element next to it (see Photograph 30).

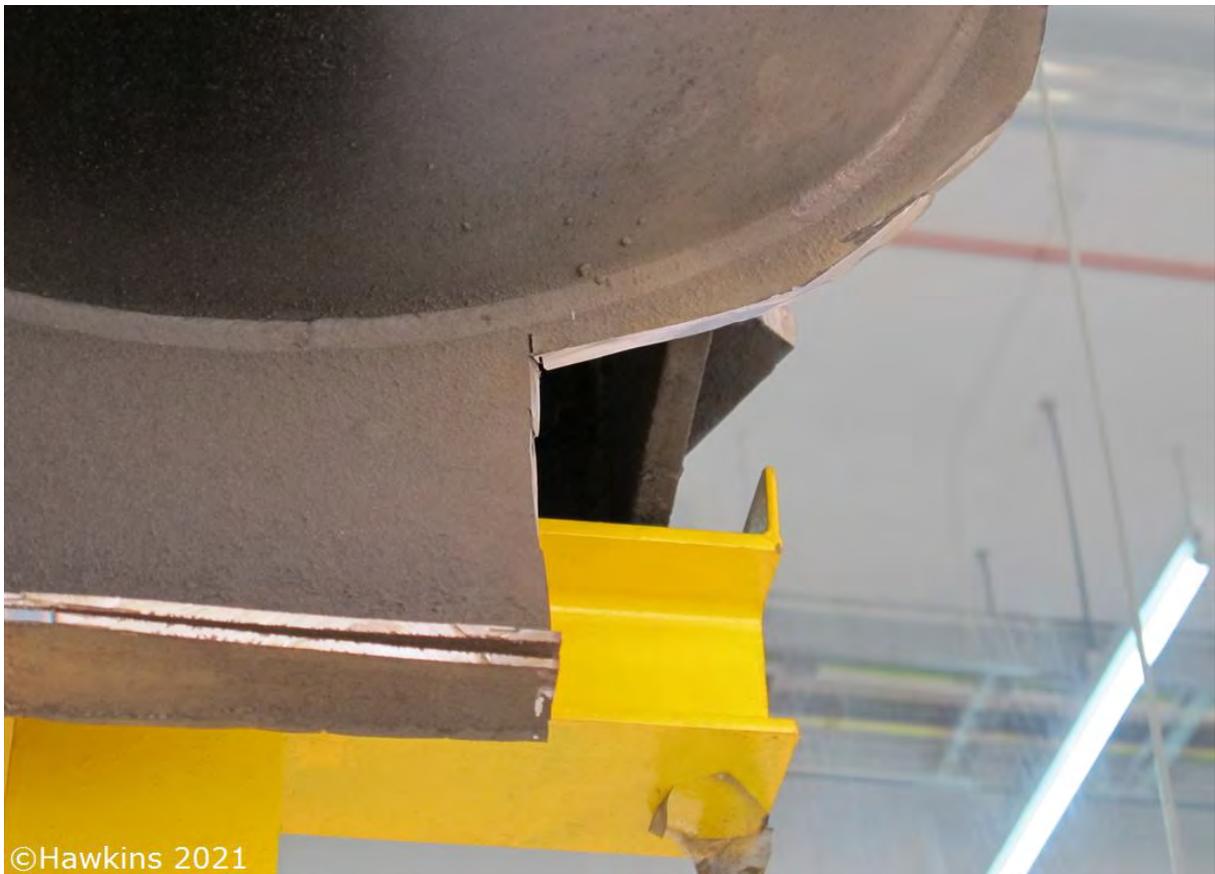
Photograph 48: The inside of the oil reservoir looking upwards to the underside of the reaction vessel at the location of the corner closest to the control panel. The soot deposits and the 'double skin' repair can be seen.
