MOM/OSHD/2020-10

RECOMMENDATION FROM LEARNING REPORT FOR FATAL ACCIDENT INVOLVING FAILURE OF A TOWER CRANE

Learning Report

**Fatal Accident Involving Failure of a Tower Crane
At Kajima Overseas Asia (Singapore) Pte Ltd's Worksite Located
At Tan Tock Seng Link**

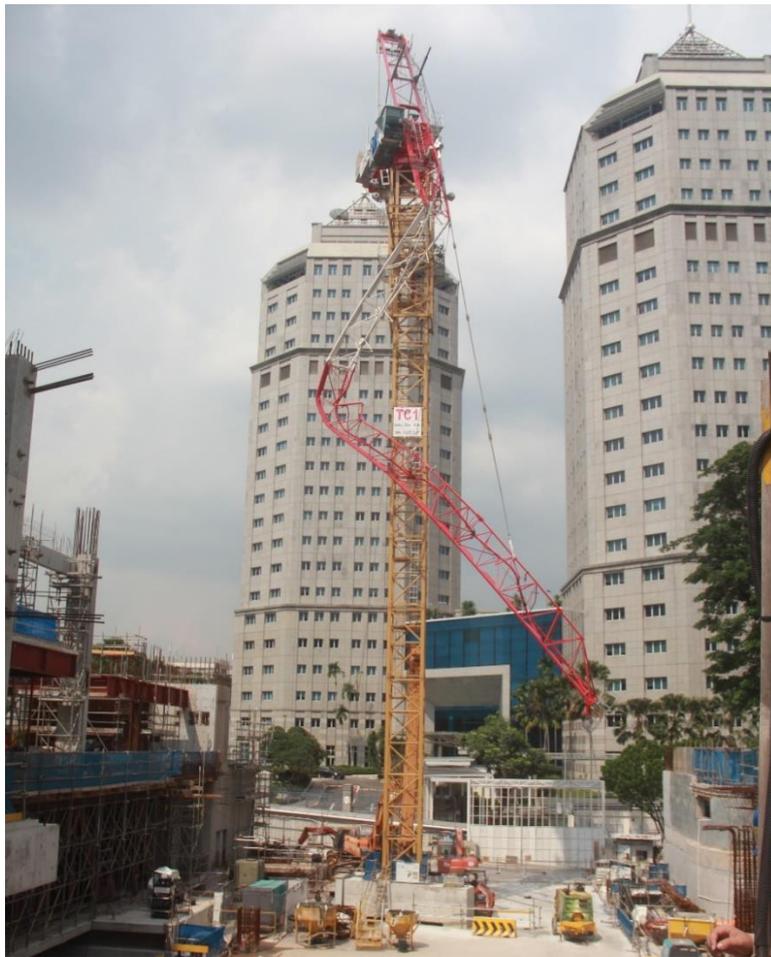
[Figure 1](#) – General view of the TC after the accident

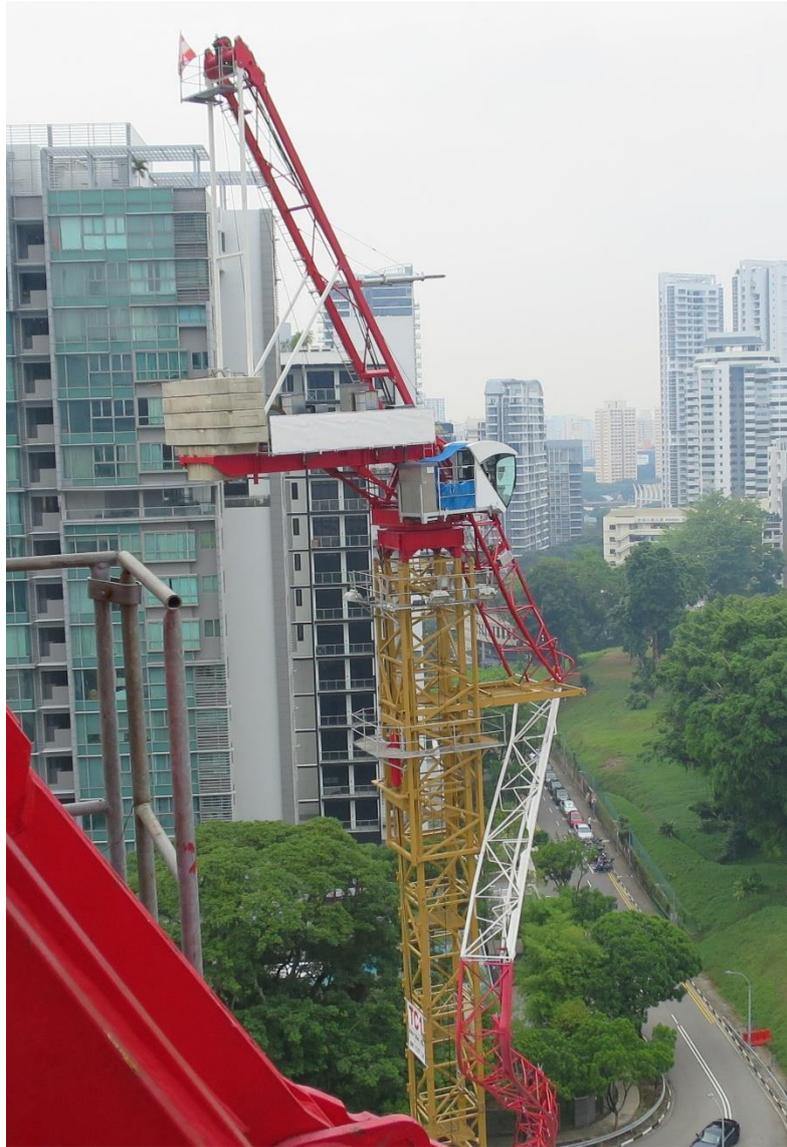
Figure 2 - Side view of the TC after the accident

- f) As the jib was held back by the luffing wire rope, it buckled at jib section #3 as it fell. The buckling of the jib occurred after the jib started to fall and was not the cause of the accident.

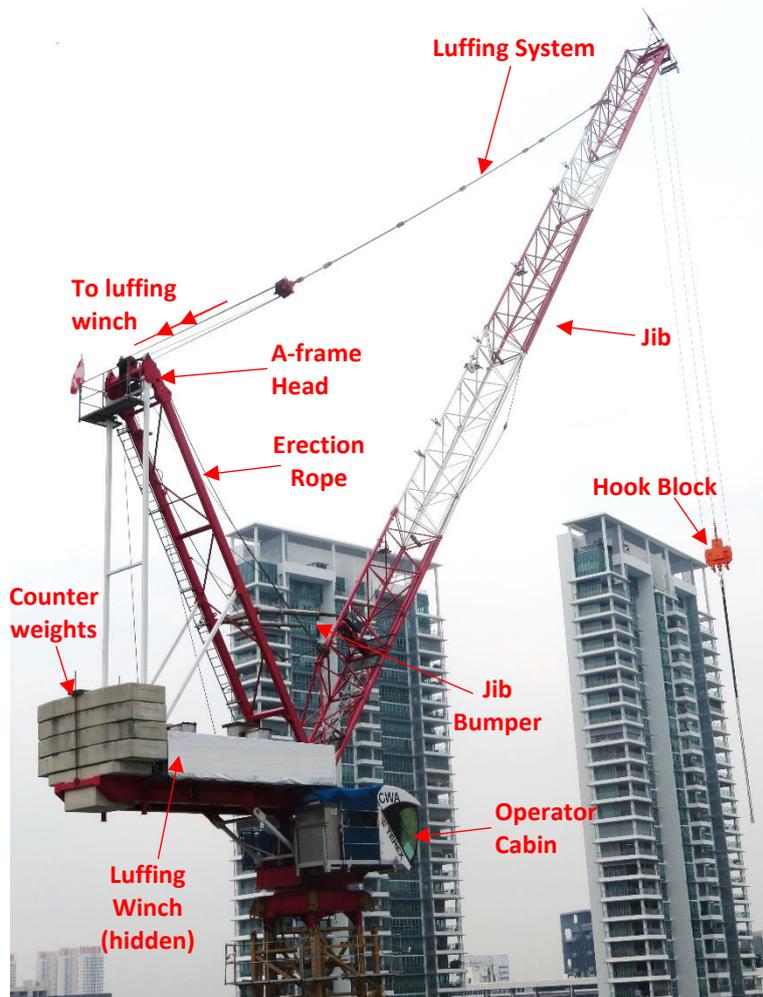
- 2.1.1 Luffing Jib Tower Cranes are a type of tower crane that vary their working radius by raising or lowering their jib through a luffing jib system. The upper portion of a Luffing Jib Tower Crane is shown in [Figure 3](#).

Figure 3 - Upper Portion of the TC

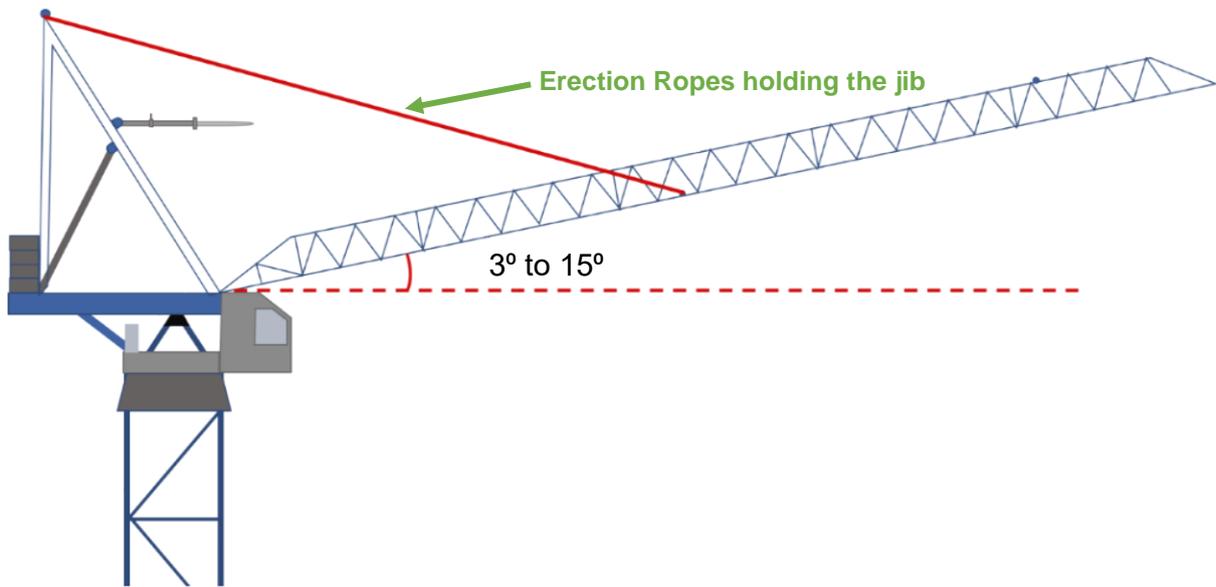
2.2.2 During the jib installation process, Erection Ropes are typically used to hold and balance the jib in position for the crane erectors to install and secure the jib onto the A-frame head (please see [Figure 4](#) and [Figure 5](#)).

Figure 4 - Function of Erection Ropes of a Luffing Jib Tower Crane

- 2.2.3 Erection Ropes usually come in a pair, with one end of each rope secured to the A-frame head and the other end secured to one of the jib sections (please see [Figure 4](#)). Erection Ropes can come in a single length or as an assembly comprising of shorter lengths of ropes. The length of the jib determines the length of the Erection Ropes used and the location on the jib they are secured to. This ensures that the Erection Ropes used are of optimal length (not excessively long or short). The specific length and position of installation of the Erection Ropes are prescribed in the tower crane manual.
- 2.2.4 After the luffing system of the jib has been installed, the Erection Ropes play no further role in the function and operation of the tower crane.

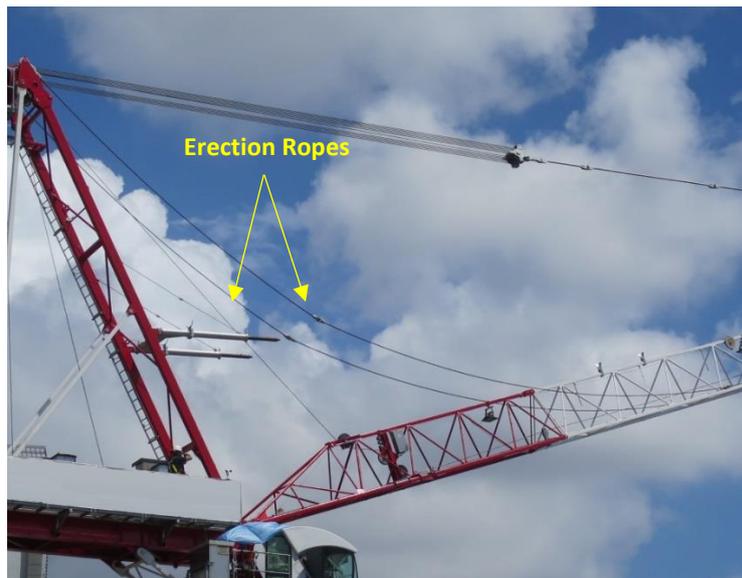
Figure 5 - Erection Ropes of luffing jib when the jib is lowered

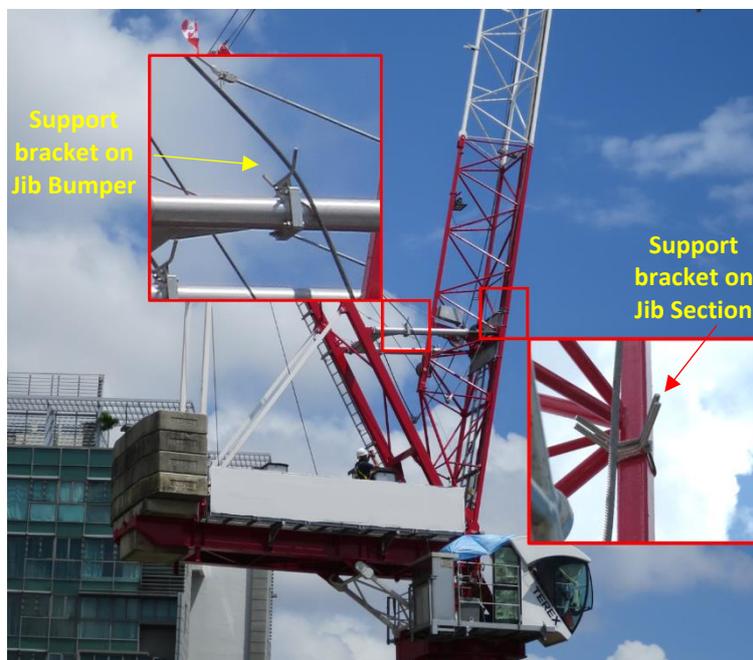
- 2.2.7 For Erection Ropes that are left on the tower cranes after the jib installation, the amount of slack in the Erection Ropes will vary during operation - they will have more slack when the jib is raised and less slack when the jib is lowered. As such, support brackets are often provided on the tower crane to contain and guide the Erection Ropes into its proper resting position and prevent excessive dangling of the Erection Ropes when the jib is raised (please see Figure 6).

Figure 6 - Erection Ropes rest in the support bracket when the jib is raised

3.2.1 The design of the support brackets (to contain and guide the Erection Ropes) was open and shallow – in a widened “U” shape (please see [Figure 6](#)). This was deliberate so that the Erection Ropes could move freely as it slackened or tightened depending on whether the jib was raised or lowered. The support brackets were not meant to be load bearing.

4.2.1 Erection Ropes are secured at their ends. Hence, their lengths are free to progressively slacken to correspond to the movement (raising or lowering) of the jib. For cases where the Erection Ropes are not removed or disconnected, any support brackets to contain and guide the Erection Ropes in position, should be adequately designed to prevent unintended slippage during the repeated raising and lowering of the jib. To ensure that the Erection Ropes will return to their resting position within the support brackets, regular testing (without load) by repeated raising and lowering of the jib should be carried out to check if there is any unintended or excessive slippage of the Erection Ropes.

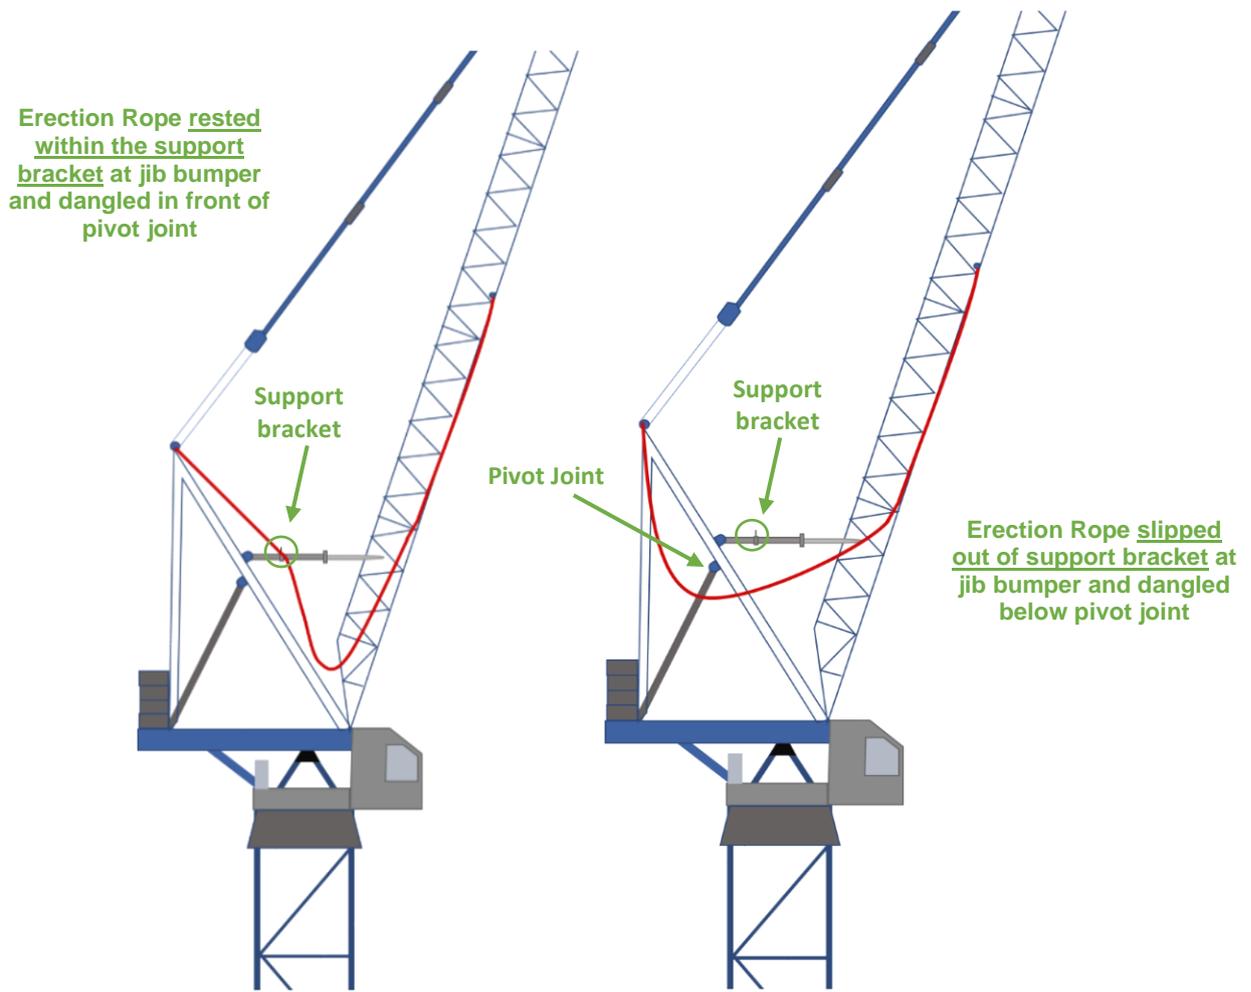
- a) The TC was operated to lift a load at the time of the accident.
- b) The TC's jib was raised to reach the load which was positioned near to the TC's mast. During the process, the Erection Ropes slackened and the right Erection Rope likely slipped out of its support bracket instead of resting within it, as shown in [Figure 7](#).

Figure 7 - Schematic views of Erection Rope in and out of the support bracket

3.2.2 When the Erection Ropes were not positioned within the support brackets, they would dangle below the A-frame (please see [Figure 7](#)), resulting in the possibility of them being entangled with other parts of the crane. As the jib was subsequently lowered, any entanglement would cause mechanical restriction to the luffing of the jib of the tower crane and could impact the operation of the crane.

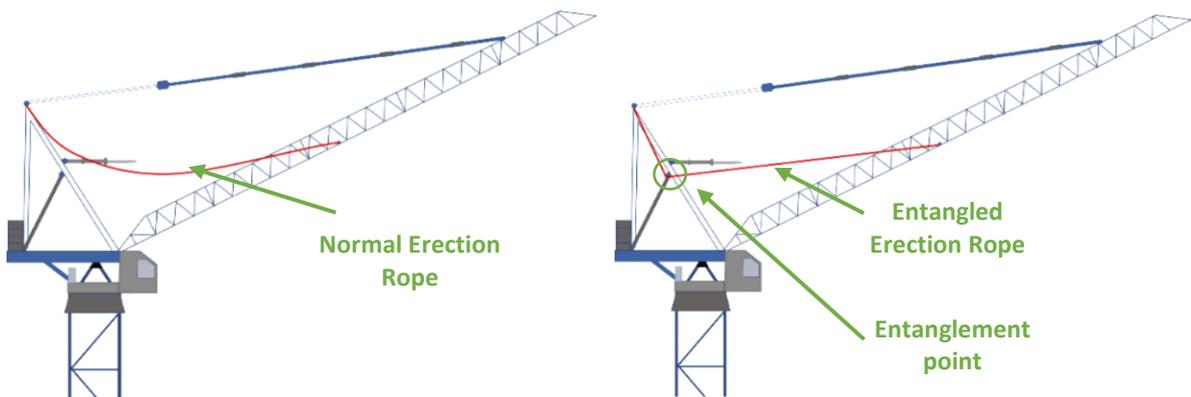
- c) After the load was picked up, the TC's jib was lowered to reach the intended unloading position. During the process, as the Erection Ropes straightened, **the right Erection Rope became entangled with the outer pivot joint on the right side of the A-frame**, (please see [Figure 8](#)).

- d) The entanglement of the right Erection Rope caused a mechanical restriction to the luffing function of the jib of the TC i.e. the jib was prevented from being lowered further.

Figure 8 - Schematic views of the TC showing conditions with normal and entangled Erection Rope

4.1.1 Whenever the jib is being raised or lowered, the Erection Ropes will progressively shift from a more slackened to a less slackened configuration, and the lengths of the Erection Ropes will glide past fixed structures of the upper body of the tower crane. While some manufacturers recommend that it is acceptable for the Erection Ropes to be left on the tower cranes during the operation phase, **MOM has consulted industry stakeholders and recommend that, notwithstanding manufacturers' recommendation, Erection Ropes should be removed or disconnected and stowed securely on the crane after the jib installation.** This is to eliminate any risk of accidental entanglement of the Erection Ropes with any fixed structure of the tower crane as the Erection Ropes will not be in tension even when the jib is being lowered.

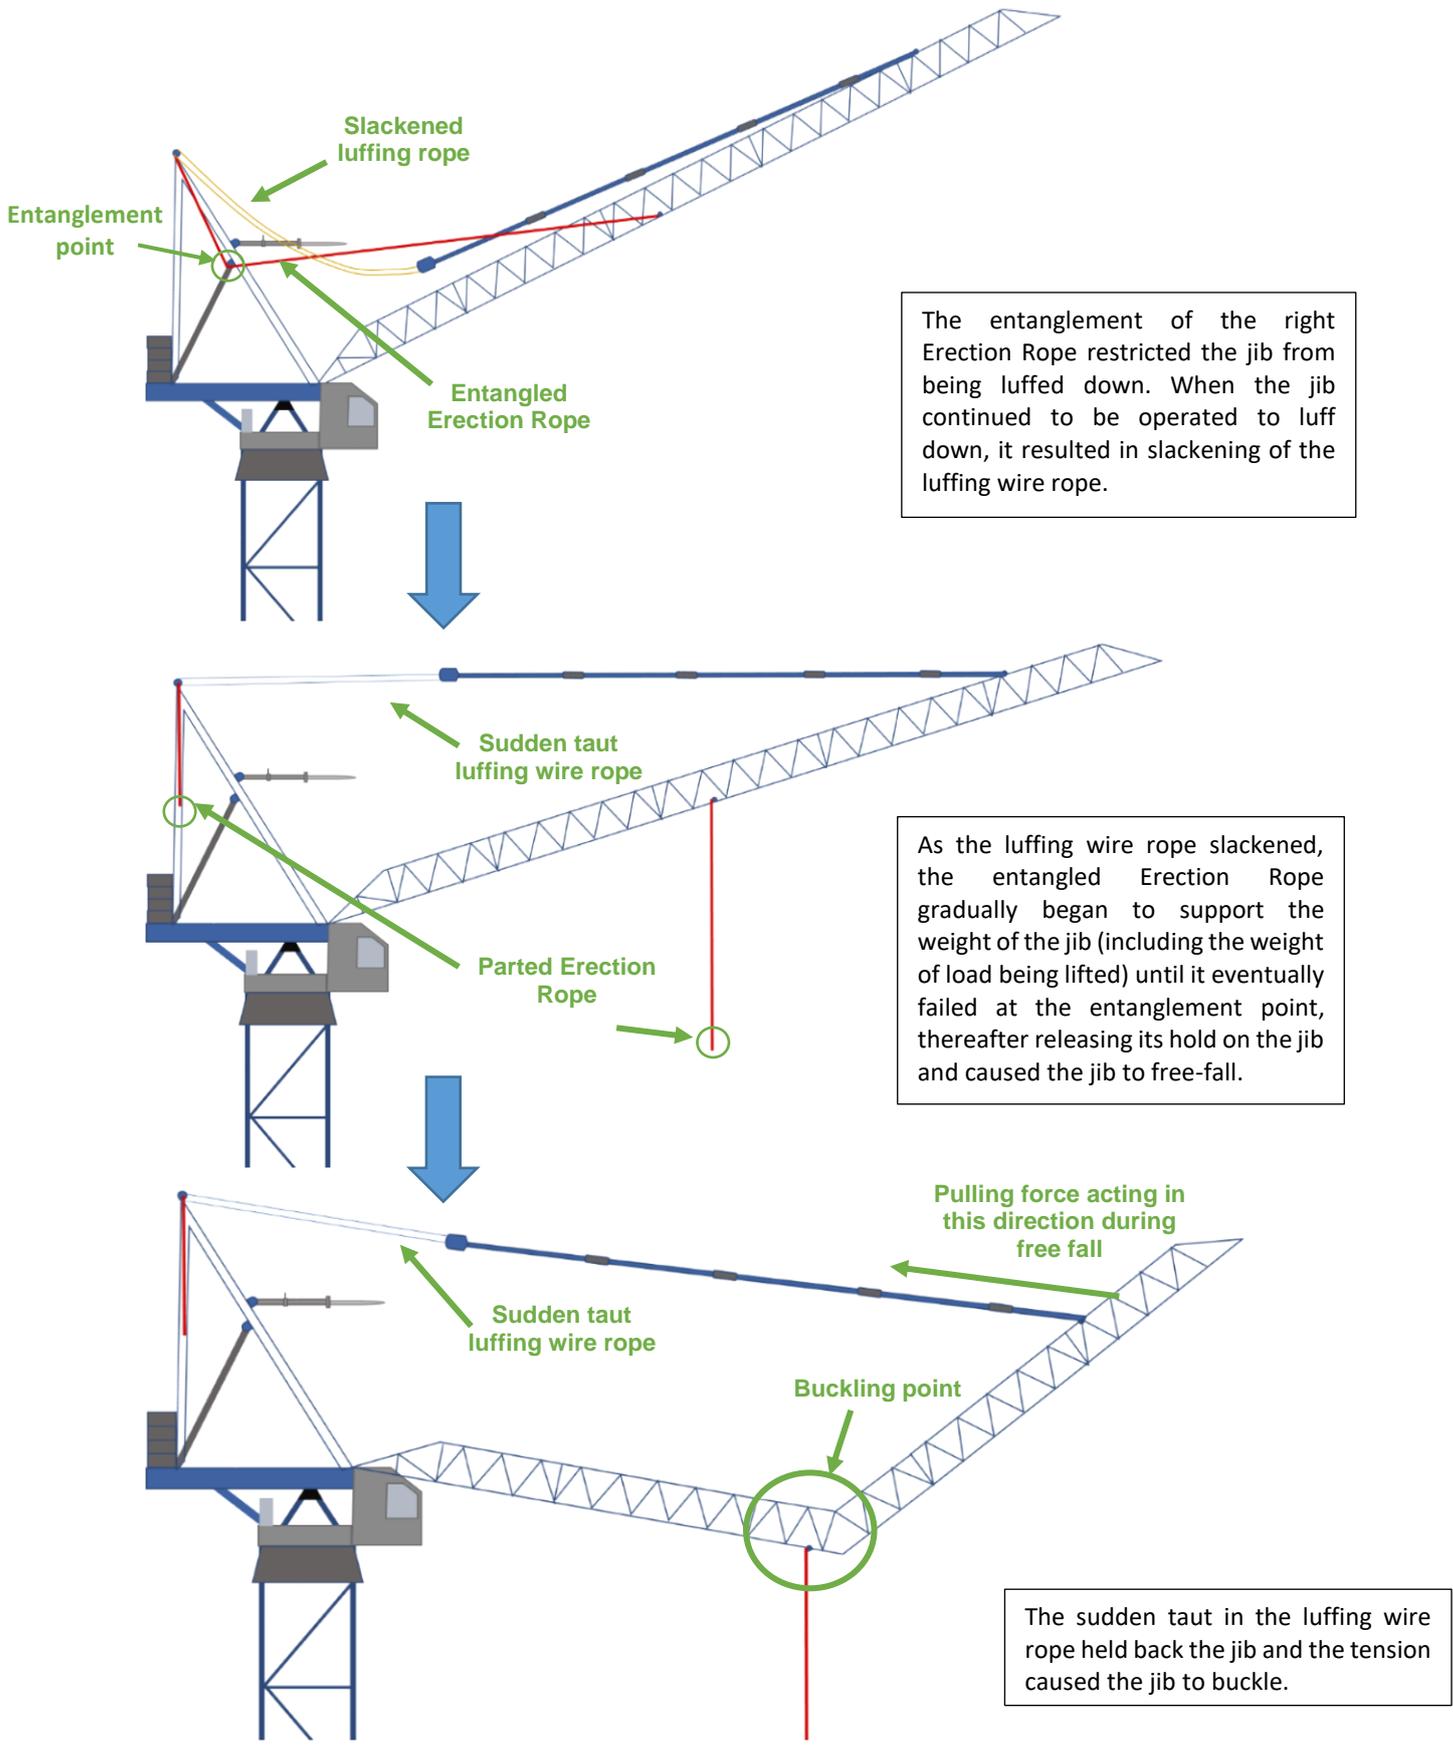
- e) The attempt to continue luffing down the TC's jib resulted in the luffing winch continuing to unspool and thereby releasing the luffing wire rope from the drum. As the luffing wire rope became slackened, the entangled right Erection Rope began to take on the weight of the jib and the suspended load. Under continual stress, the right Erection Rope eventually failed at the entanglement point, and the jib jerked downwards in free-fall.

- g) Consequently, the hook block and load also plummeted down to the ground, hitting the deceased and another worker who were working in the vicinity.

Figure 9 – Sequence of events on the buckling of luffing jib of the TC

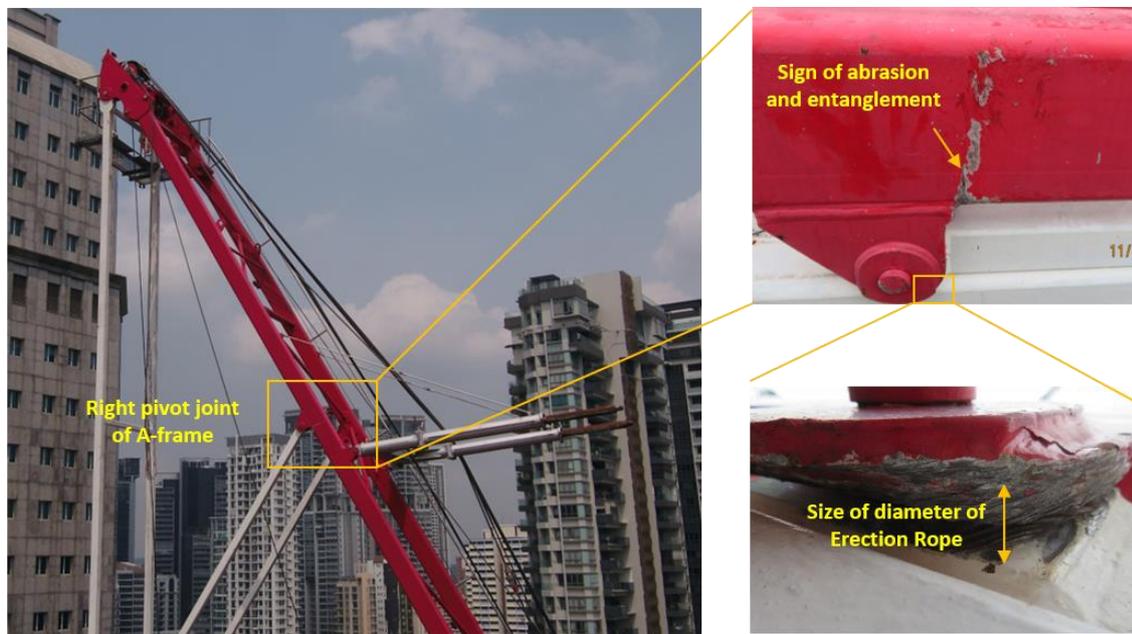
3.2.3 There was a groove/gap at the connection between the main and supporting frame of the A-frame at the pivot joint (please see [Figure 10](#)). The size of the gap was about the size of the diameter of the Erection Rope. This created an entanglement risk when the Erection Rope glided past the pivot joint while the jib was being lowered.

Figure 10 - Close-up view of the right pivot joint of the A-frame

4.1.2 If the removal or disconnection of the Erection Ropes is not practicable or it introduces additional risks, crane manufacturers and suppliers will need to review and identify any potential entanglement points and mitigate the risks of accidental entanglement of the Erection Ropes at these points. For the TC involved in the accident, this could be done by way of reviewing the design of the pivot joint to eliminate the presence of the groove/gap or installing a purpose-built protective guard to cover the entanglement points, to reduce the risk of entanglement.
