**Report of the Inquiry
Committee for the accident
at Stars Engrg Pte Ltd on
24 February 2021**

(PART II – ANNEXES)

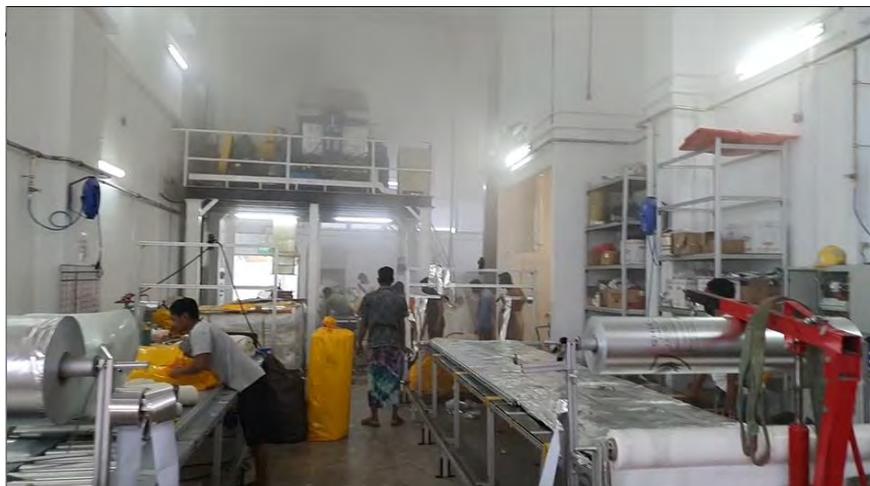
11. Stars' Unit 32E has 3 floors. Level 3 is a dormitory housing some of Stars' workers. Level 2 was used to store the materials for making fire clay and fire wrap.
12. Level 1 was the workshop where fire clay and fire wrap were made:
- (1) View of the workshop, from front shutters facing in **[S-162]**:

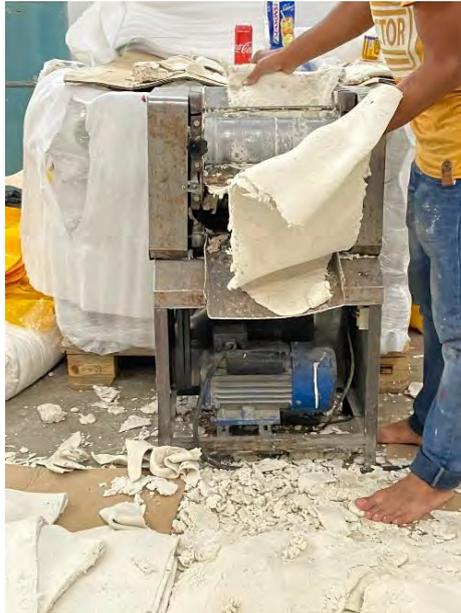
(2) Roller machine flattening fire clay [S-27]:

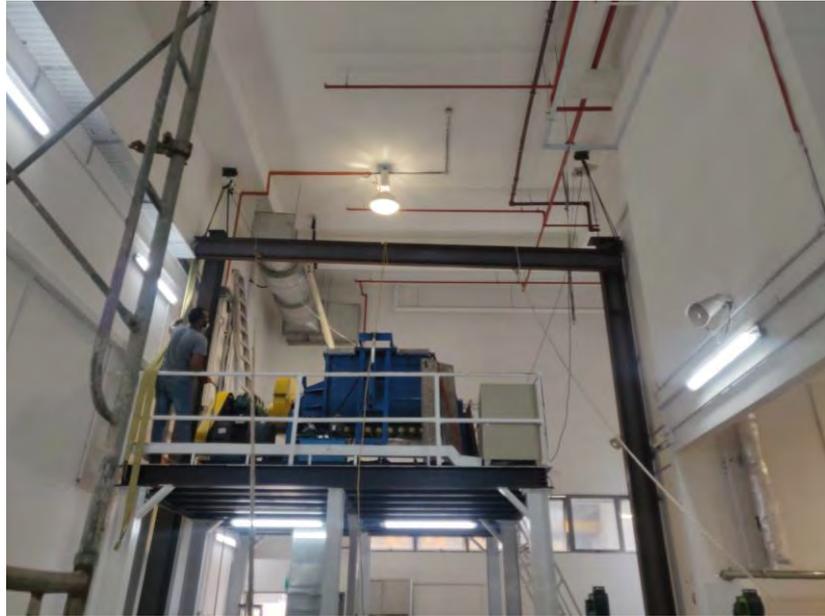
13. The Mixer Machine was purchased by Mr Chua in August 2019, from Laizhou Keda Chemical Machinery Co., Ltd (“**Laizhou Keda**”) in China, via the ‘Alibaba’ online platform. It was delivered to Stars in October / November 2019. It was installed on the Platform on 12 June 2020 **[S-50]**:

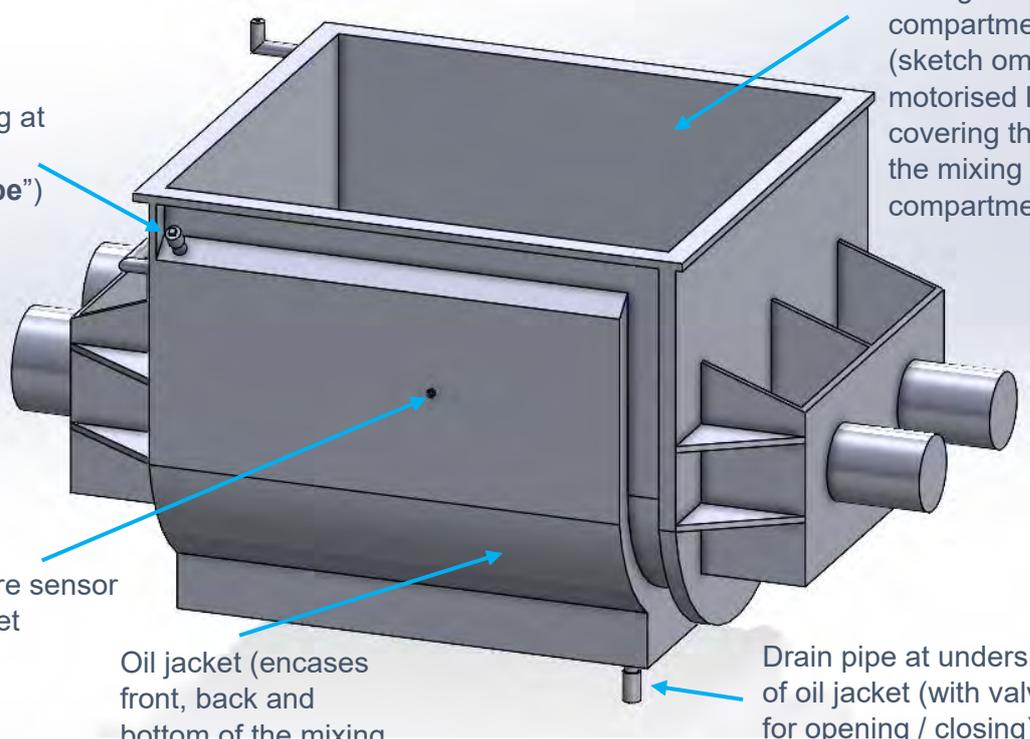
Front view

14. The front of the Mixer Machine faces the rear of the workshop, while the back of the Mixer Machine faces the front shutters.
15. 3D sketch of the front and back of the Mixer Machine with some of its main components labelled:

Mixing compartment (sketch omits the motorised lid covering the top of the mixing compartment)

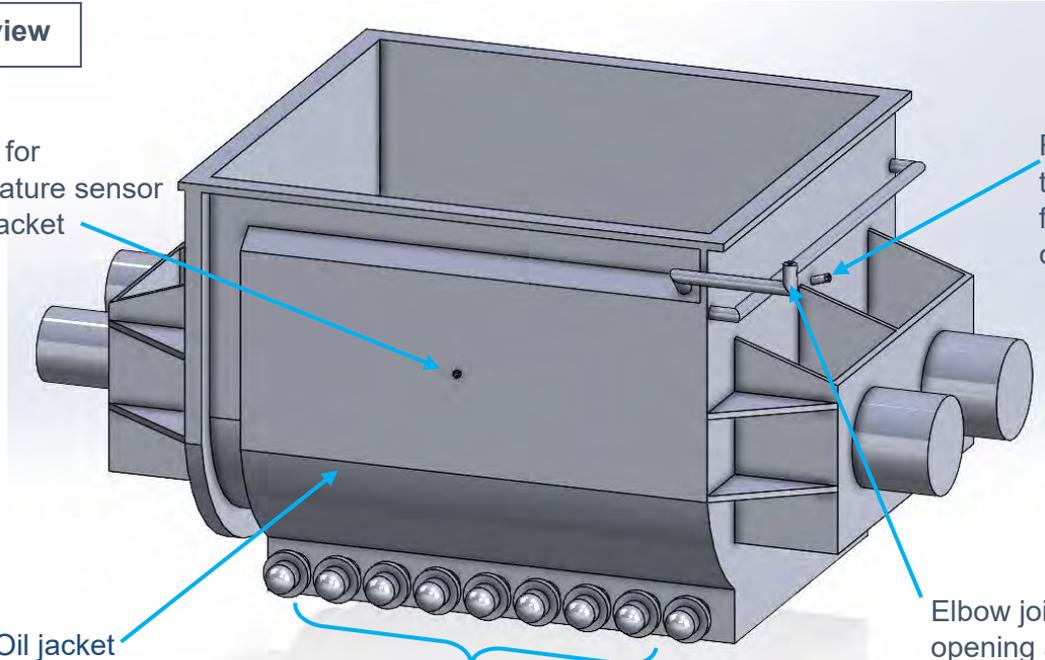
Back view

Fixture for temperature sensor for oil jacket

Elbow joint/pipe opening at the back of the oil jacket ("**Back Pipe**")

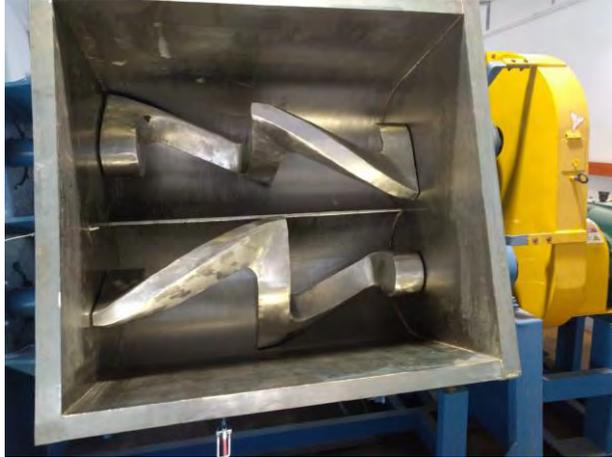
16. Mixing compartment: There are sigma-shaped blades within, which rotate to mix the water, **potato starch**, boric acid, silicon oil, aluminium trihydrate and bentonite clay used to make fire clay. When mixing is completed, the mixing compartment can be tilted forward for removal of the contents [**S-106**].

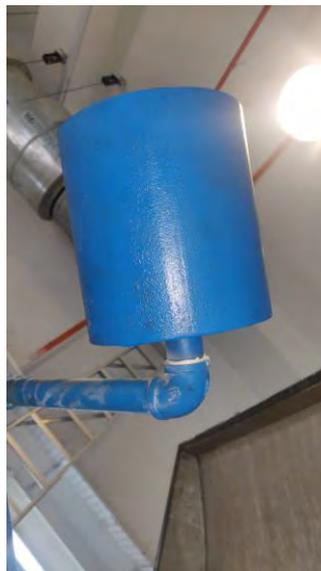
17. When tilted, the Front Pipe would have to be closed to prevent oil in the oil jacket flowing out. The Mixer Machine was delivered with 1 end cap placed on the Front Pipe.
18. Oil jacket: The oil jacket had to be filled with thermic oil, which would be heated by the heaters. The heated oil would in turn heat the contents in the mixing compartment.
19. Oil was added to the oil jacket through a blue funnel. The Mixer Machine was delivered with the blue funnel attached to the Back Pipe [**S-46**].

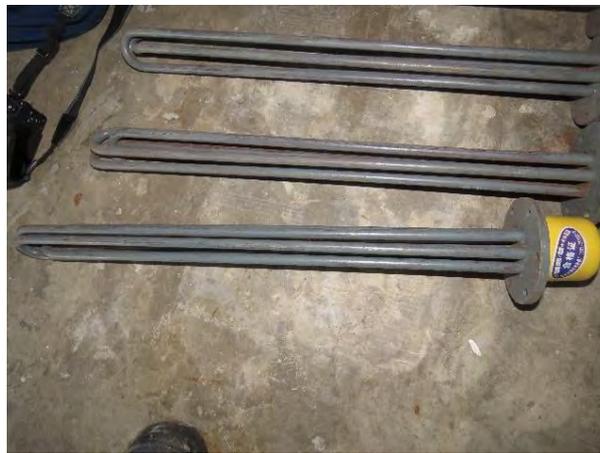
20. The User Guide provided by Laizhou Keda stated the following in respect of the design of the oil jacket **[S-271]**:
- (1) Design temperature: 200°C.
 - (2) Operating temperature: 70-160°C.
 - (3) Working pressure: $\leq 0.2\text{Mpa}$.
21. Heaters: Each heater comprised 3 U-shaped metal tubes / coils, the ends of which connected to 6 terminals on the heater flange **[S-127]**.

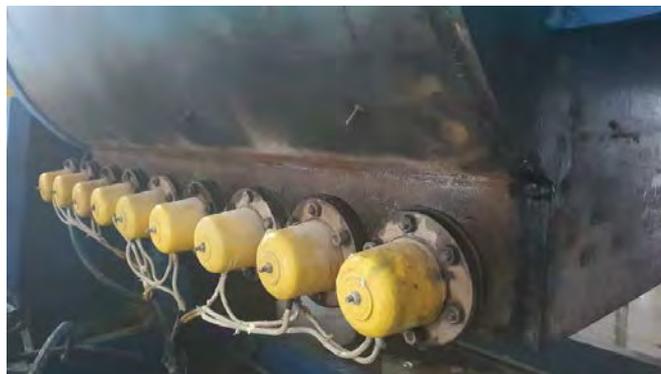
22. The metal tubes portion of the heaters would be inserted into the bottom of the oil jacket through openings for the heaters. There were gaskets placed between the openings and the heater flanges. From the outside, the flanges would be bolted to the openings, to keep the heaters in place. Yellow hub caps covered the heater terminals **[S-59]**.

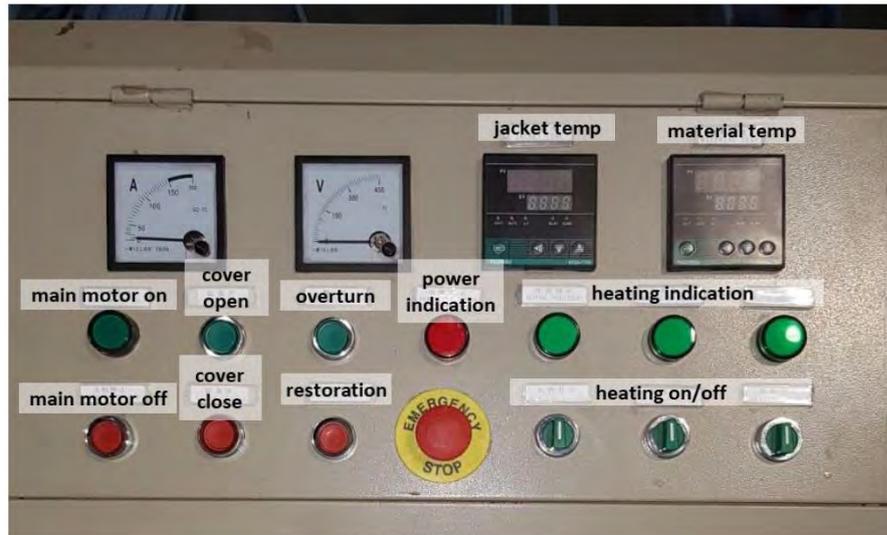
27. Control panel: The control panel / console was placed on the Platform next to the back of the Mixer Machine. See labelled control panel:

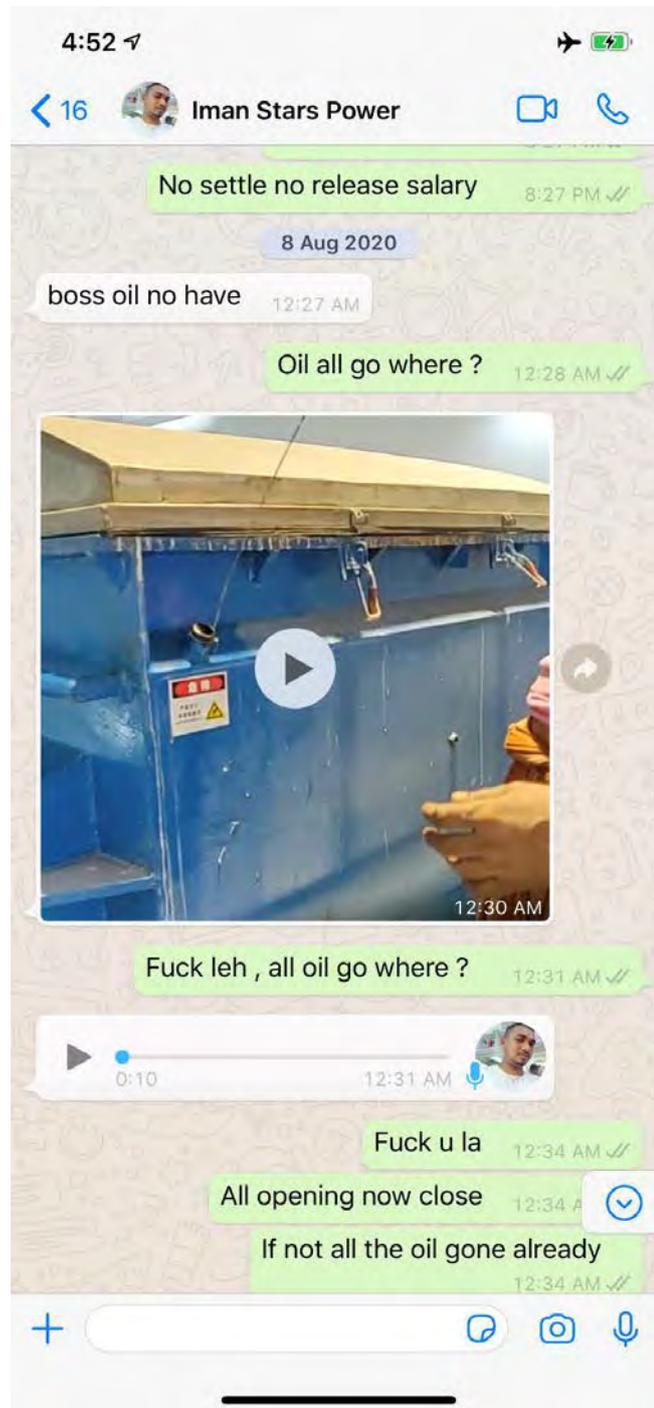
34. On 7 August 2020 night, Moe instructed Imam to make a batch of fire clay. While operating the Mixer Machine, Imam suspected that the oil in the oil jacket was running out.
35. Slightly past midnight on 8 August 2020, Imam informed Mr Chua about the situation:

- (1) WhatsApp messages between Imam and Mr Chua on 8 August 2020, from 12:27am to 12:34am **[S-6]**:

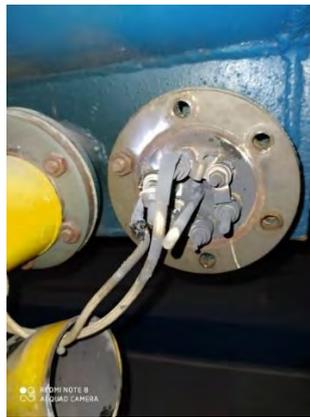
36. The IC will hear the following from Imam. In the morning of 8 August 2020, Imam started making a batch of fire clay. While the Mixer Machine was in operation, a spark and smoke came out from Heater No. 1.
37. Imam turned off the Mixer Machine. He then drained out the oil in the oil jacket, which came to about 1.5 x 20L buckets.
38. Imam removed Heater No. 1 – one of its heating rods was found to be deformed from burning:
- (1) Photo of damaged Heater No. 1, sent by Imam to Mr Chua on 8 August 2020, 9:30am **[S-6]**:

39. The damaged heater was replaced with a new spare heater that morning. Later that afternoon, the Mixer Machine was operated again to make fire clay.

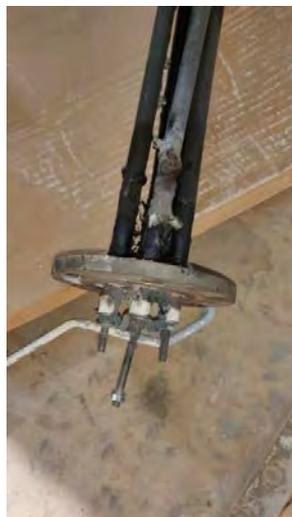
- (2) Photo of damaged Heater No. 1, sent by Imam to Mr Chua on 8 August 2020, 9:40am **[S-6]**:

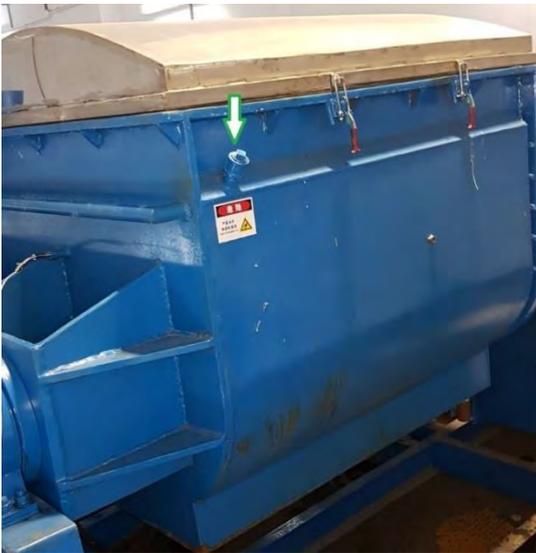
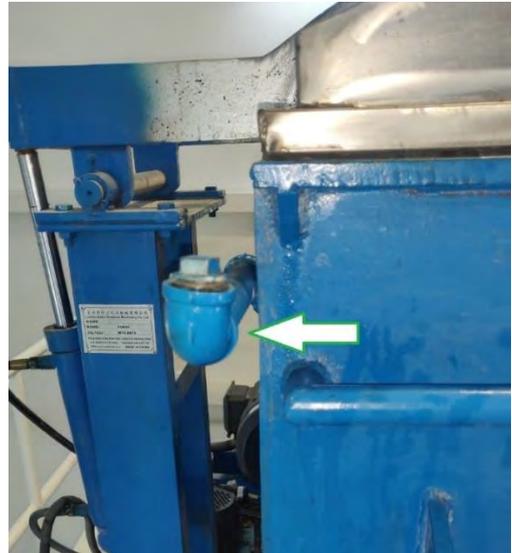
40. Further to instructions given by Mr Chua on 8 August 2020, Imam also closed each of the Front Pipe and Back Pipe openings with an end cap. Except for a few and brief occasions (e.g. when oil was added to the oil jacket through the Back Pipe), the openings remained closed thenceforth, including when the heaters were turned on during the Mixer Machine's operation.
41. See photos of the closed Front Pipe and Back Pipe:

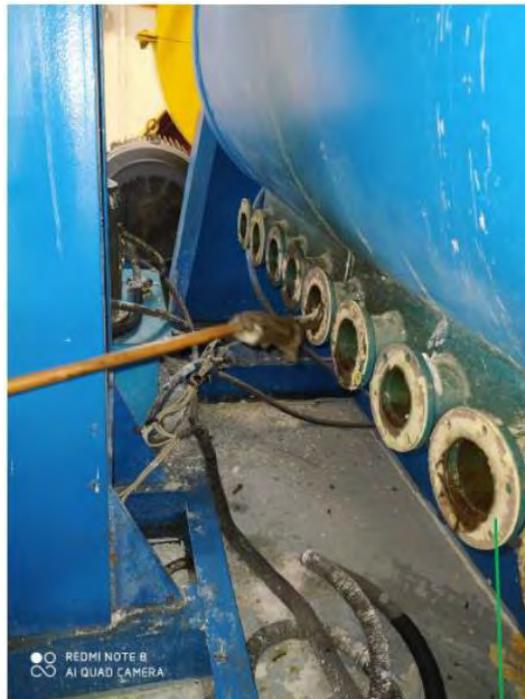
48. When the heaters were removed, it was observed that the gaskets on the heater openings of the oil jacket had deteriorated. See photo **[S-113]** (green 'X' marks the deteriorated white-coloured gasket):

49. The old worn-out gaskets were replaced by new gaskets.

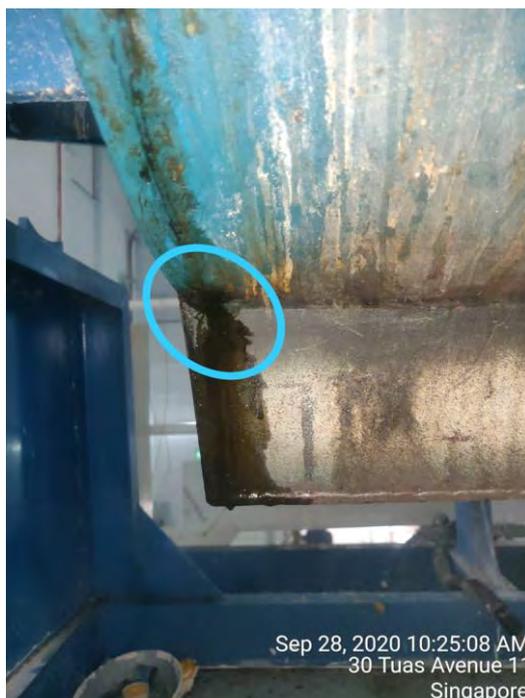
52. On 28 September 2020, Imam and Mehedi noticed a leak in the front bottom left corner of the oil jacket when the Mixer Machine was operated. Imam notified Moe:

- (1) Photo sent by Imam to Moe on 28 September 2020, 10:25am (blue circle drawn by Imam) **[S-52]**:

54. Imam expressed at that time that the leak should be closed by welding:

55. Nasim was the only certified welder at Stars at the time. In any event, no welding of the leak in the oil jacket was done, until after the events of 12 October 2020 (see [58]-[61] below).

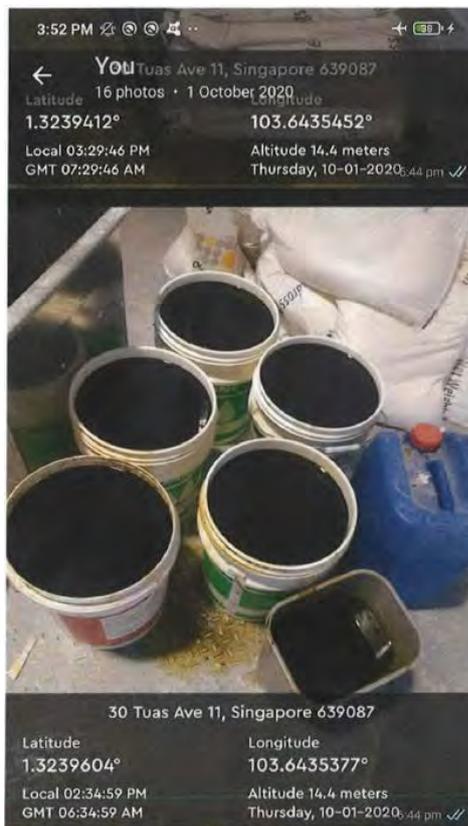
56. On 1 October 2019, the oil in the oil jacket was drained out. See photo sent by Mehedi to the “SHIELD+ Daily” WhatsApp group chat on 1 October 2019 at 6:44pm [S-53]:

57. It was observed that there were black sediments in the drained oil. The drained oil, less the black sediments which settled at the bottom of the containers, was poured back into the oil jacket later that day.

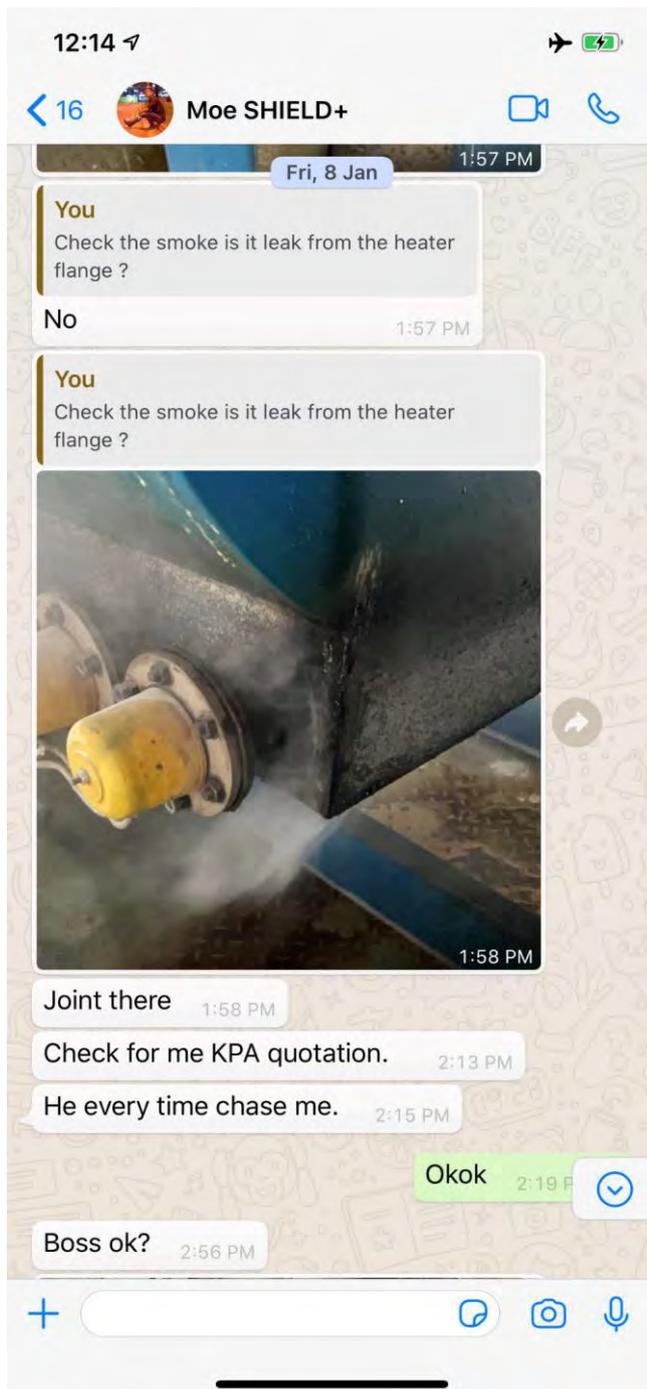
(2) Messages from Moe to Mr Chua on 8 January 2021, 1:58pm [S-14]:

63. The IC will hear from Moe that, from that time until the next incident on 12 February 2021 (see [65] below), white smoke came out from the bottom corners of the oil jacket in the last 10 minutes of the operation of the heaters whenever the Mixer Machine was used to make fire clay.

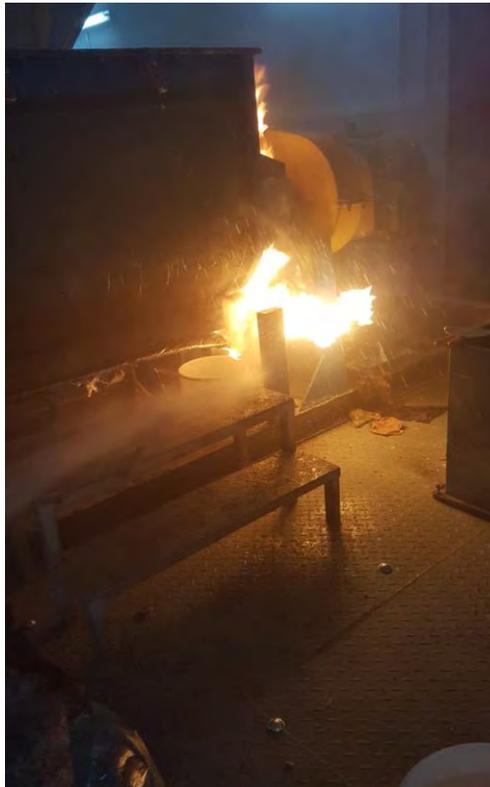
65. The IC will hear from Mehedi that at around 4:50pm on 12 February 2021, a fire broke out at the front bottom right corner of the Mixer Machine / oil jacket, which the workers managed to put out. See:

- (1) Photo sent by Mr Subbaiyan Marimuthu (“**Marimuthu**”) to Mr Chua on 12 February 2021, 6:17pm **[S-63]**:

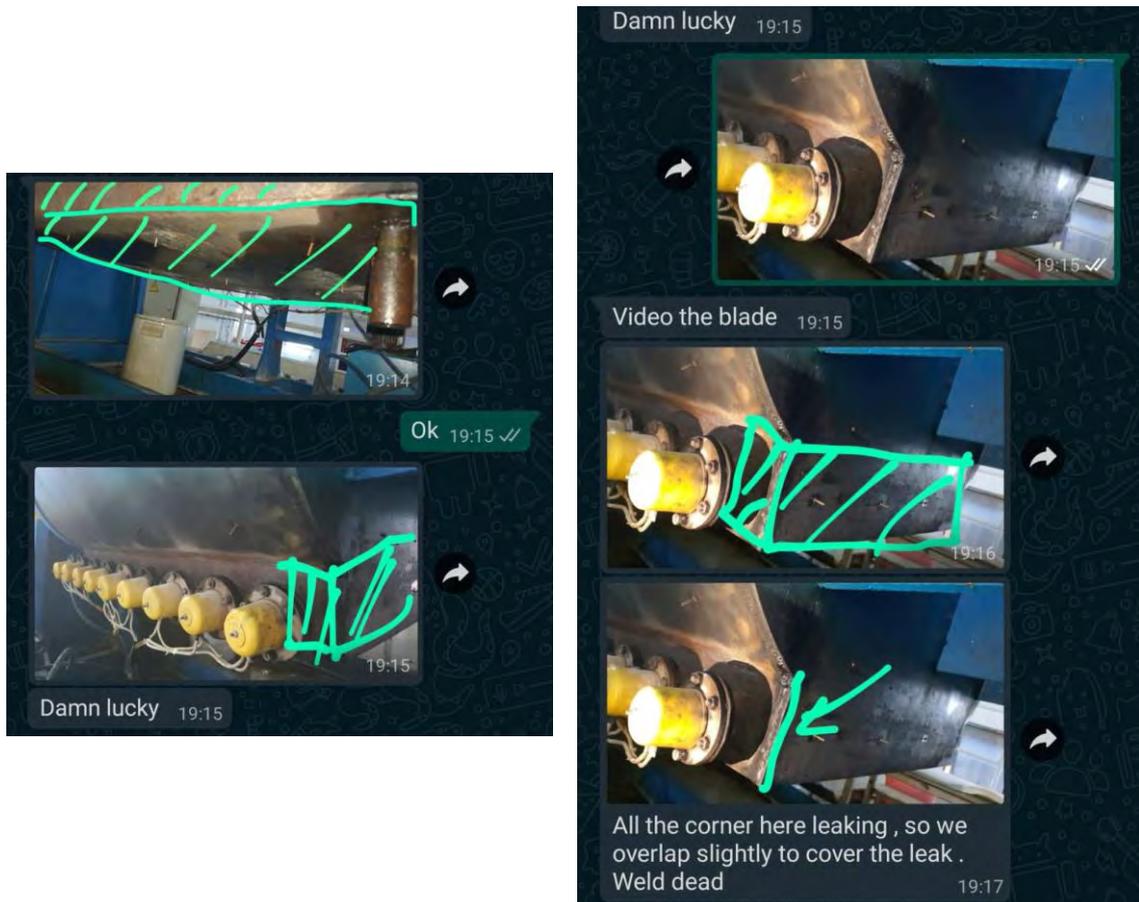
67. At the close of that day’s activity, Mr Chua gave instructions for Nasim to weld the four bottom corners of the oil jacket, and to weld an additional base plate to the underside of the oil jacket / Mixer Machine – see messages from Mr Chua to Murugan on 12 February 2021, 19:14hrs to 19:17hrs (green markings in photos made by Mr Chua) **[S-20]**:

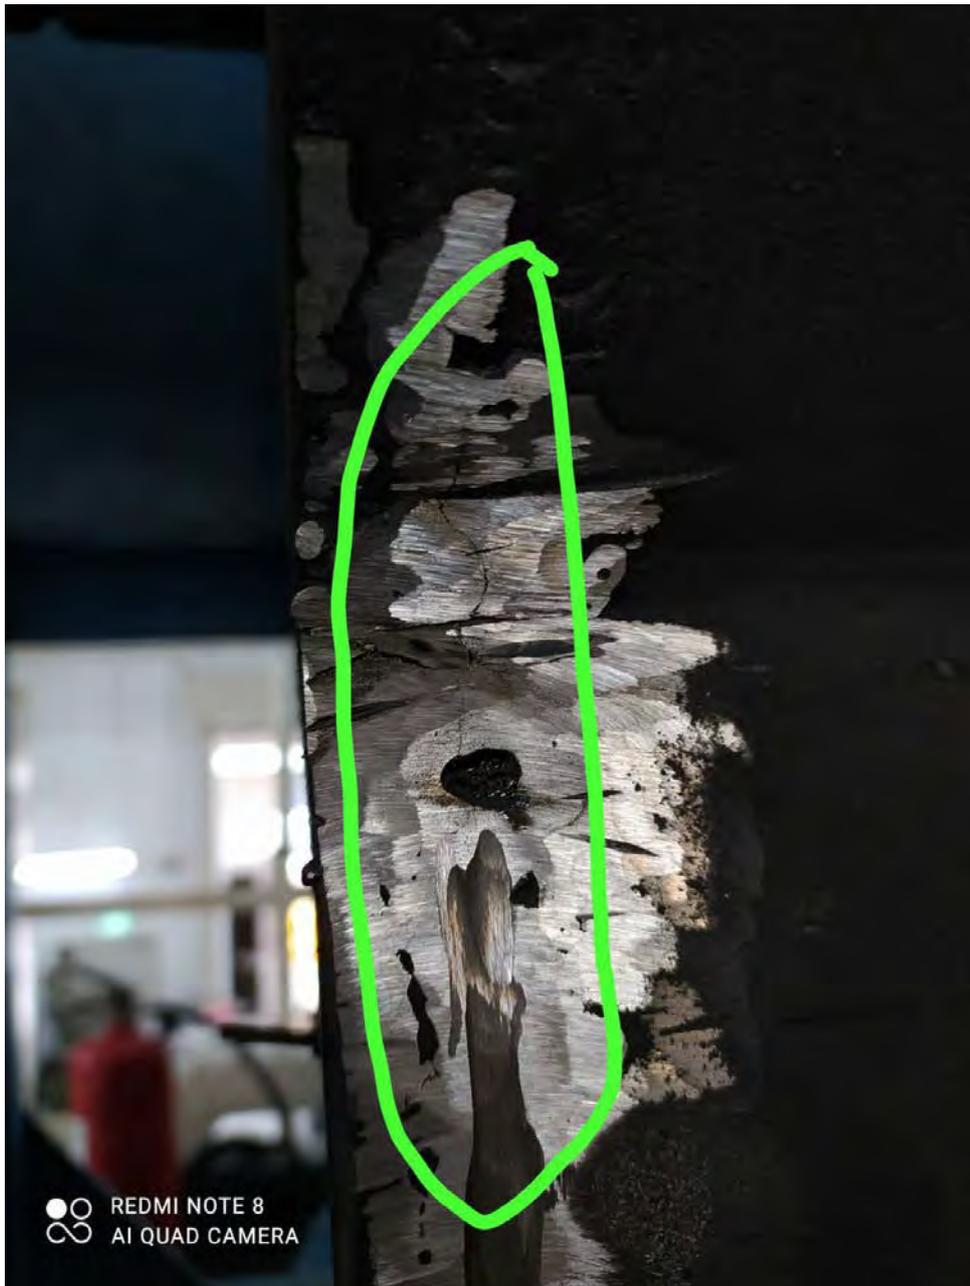
68. Nasim commenced welding operations on 13 February 2021 by grinding the four corners of the Mixer Machine / oil jacket. Mehedi was present. Nasim and Mehedi observed a hairline crack on each of the two front bottom corners of the oil jacket.
69. Mehedi sent Mr Chua a photo and message in respect of the crack at the front bottom left corner:
- (1) Messages from Mehedi to Mr Chua on 13 February 2021, 1:49pm to 1:50pm [S-21]:

- (2) Photo sent by Mehedi to Mr Chua on 13 February 2021, 1:49pm [S-65]:

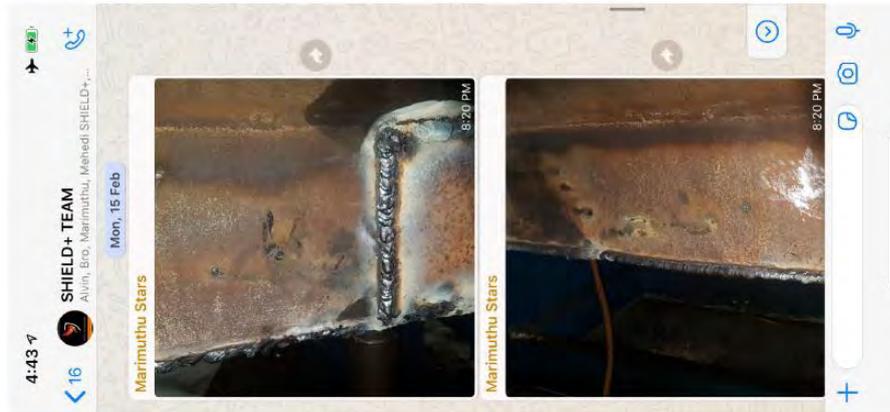
- (2) Welded an L-shaped plate onto each of the front bottom right and left corners of the oil jacket. See first photo from Marimuthu to the “SHIELD+ Team” group chat on 15 February 2021, 8:20pm **[S-25]**:

- (3) Welded a base plate (with a hole cut out for the drain pipe) to cover the underside of the Mixer Machine. See second photo from Marimuthu to the “SHIELD+ Team” group chat on 15 February 2021, 8:20pm **[S-25]** (immediately above).

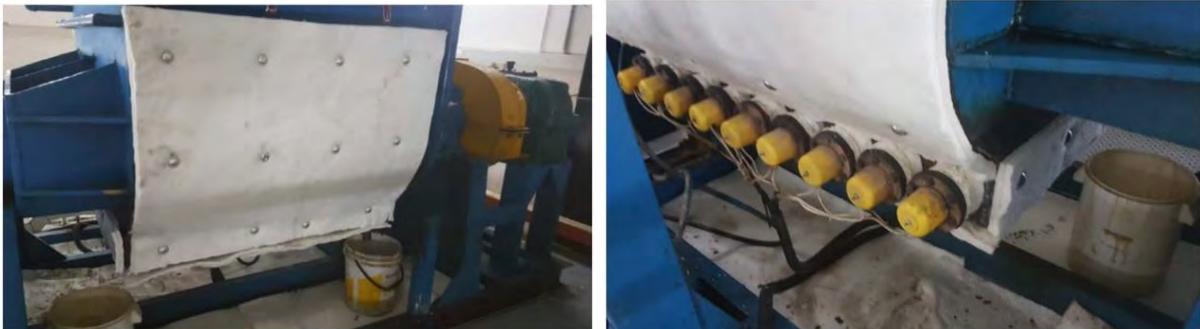
71. On 17 February 2021, new insulation, comprising fibre only, was installed on the oil jacket’s exterior surfaces – see photos sent by Marimuthu to the “SHIELD+ Team” group chat on 17 February 2021, 8:52pm **[S-70; S-72]**:

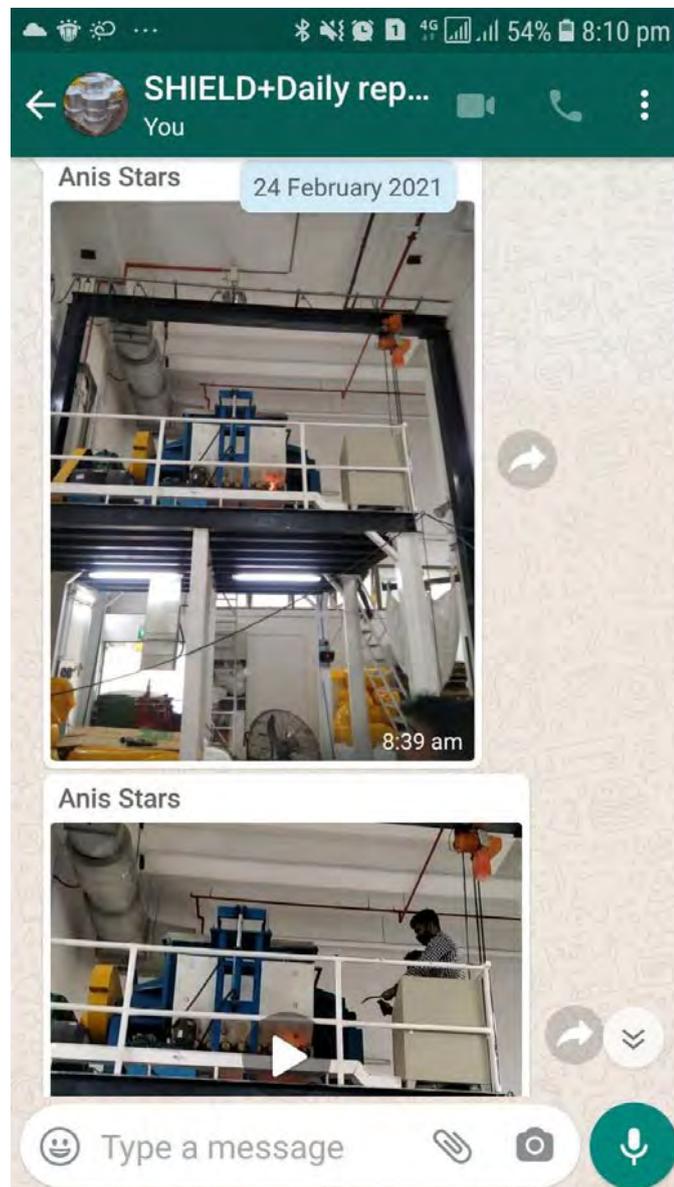
(1) Photo sent by Anis to the “SHIELD+ Daily” WhatsApp group chat on 24 February 2021, 8:39am [S-29]:

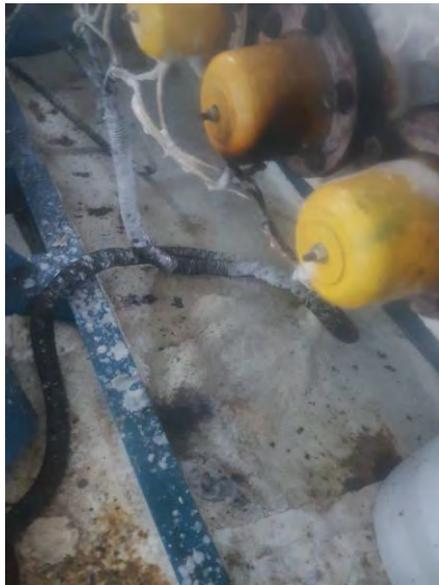
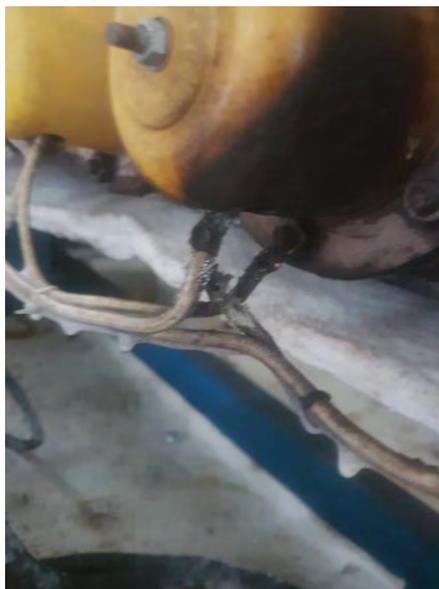
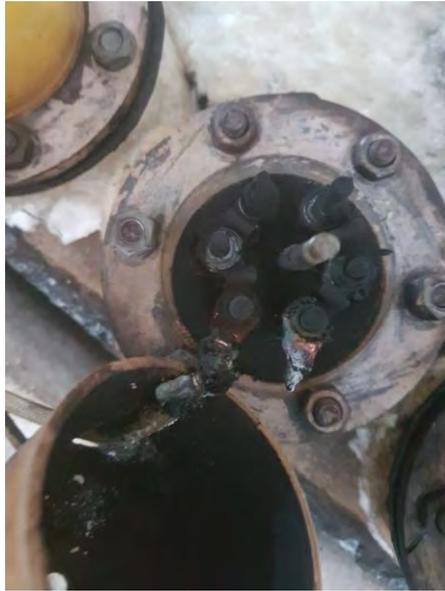
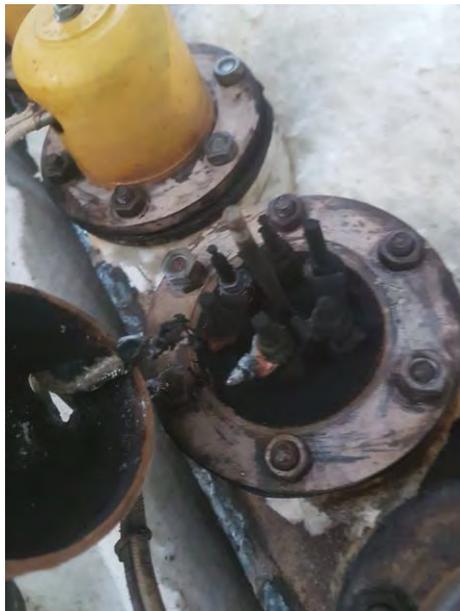
74. Marimuthu sent the photo of the small fire (see [73(1)] above), and photos of the damaged Heater No. 2, to Moe:

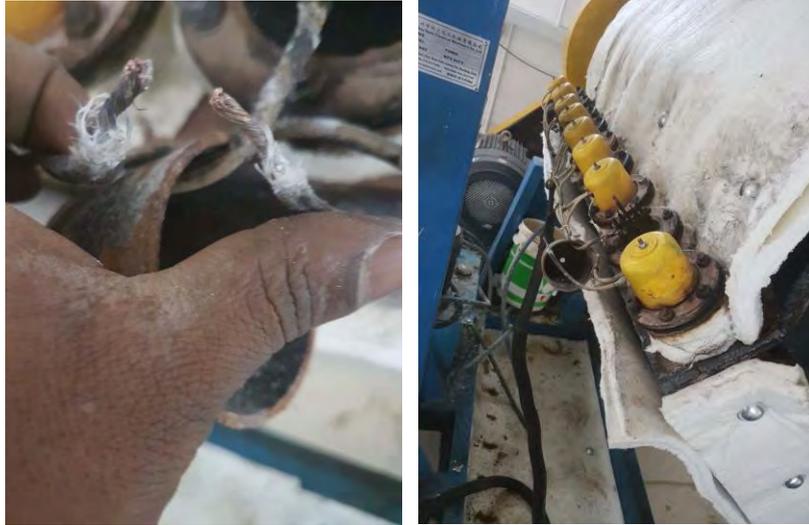
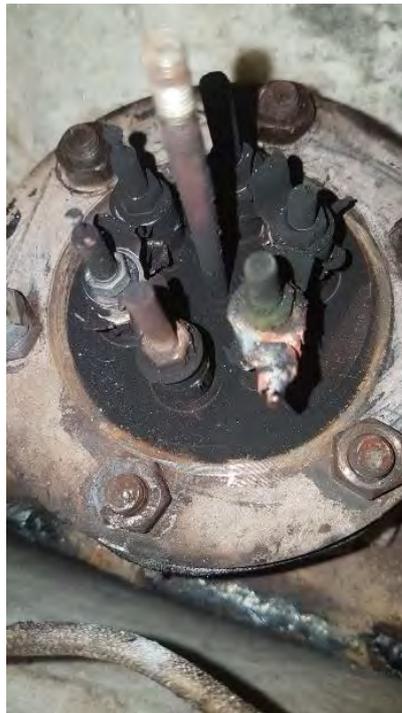
75. Moe forwarded the photos to Mr Chua at 9:21am **[S-32]**. Further photos of the damaged / burned Heater No. 2 were also sent by Marimuthu to Chua:

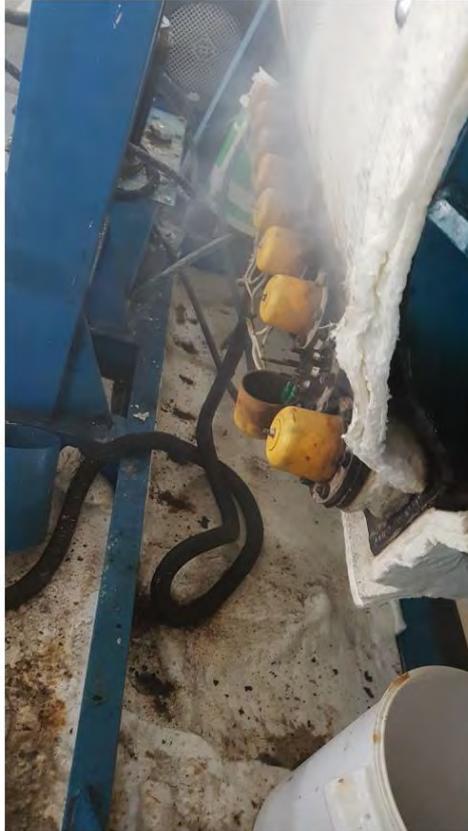
78. At 11:13am, Marimuthu took a photo showing the damaged Heater No. 2 bolted into the oil jacket, with green tape around its wiring [S-83]:

79. The IC will hear from Moe that a similar photo to that at [78] above was sent by Marimuthu to him at 11:13am; but Moe deleted this photo from his and Marimuthu's phones after the Accident. Moe had replied to Marimuthu at 11:32 am saying "Ok let me know ASAP" [S-30, IM#257]; but Moe also deleted this message from his and Marimuthu's phones after the Accident. The damaged Heater No. 2 with the green taped-wiring was found still in the oil jacket, after the Accident.

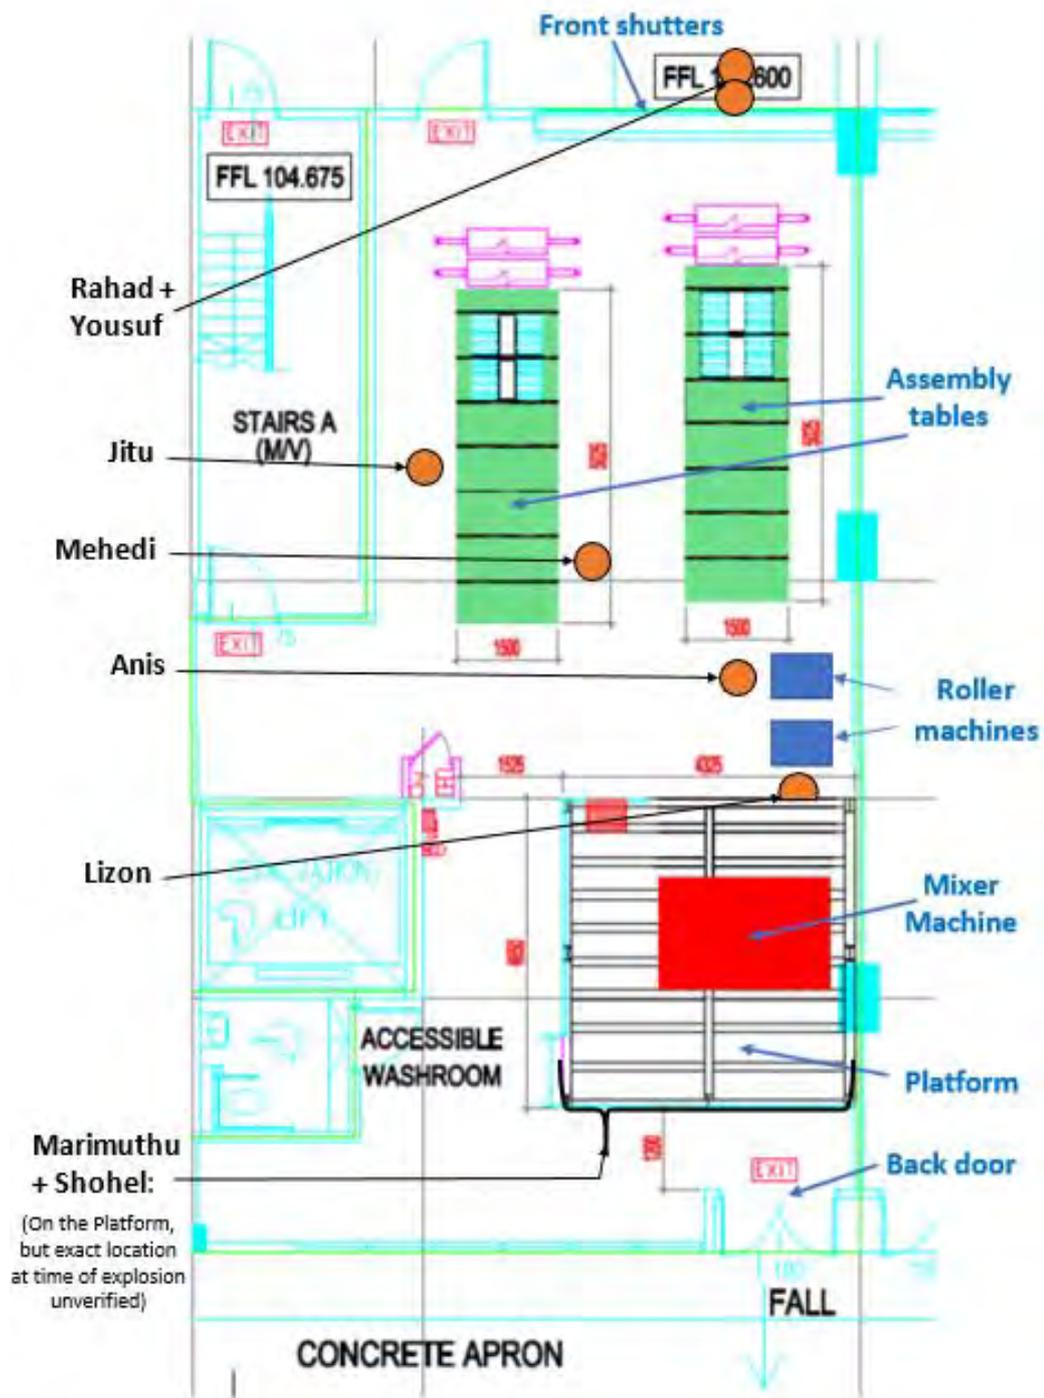
83. When the explosion occurred, the workers were in various locations at the workshop:

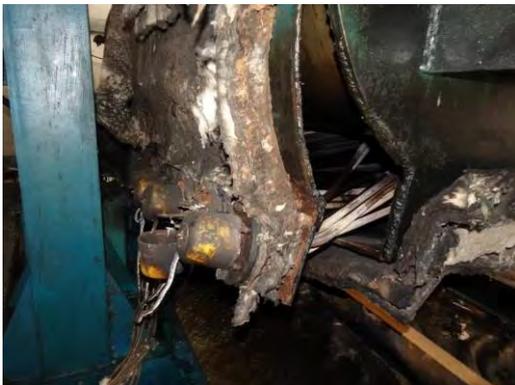
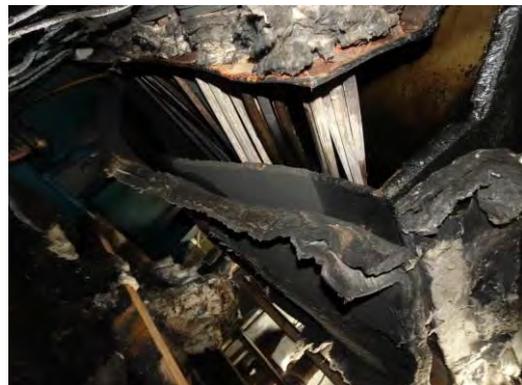
86. Damage to the Mixer Machine: multiple damage, but primarily, the lower portion of the back of the oil jacket had ruptured open along its welding seams:
- (1) Figure 10 from Matcor's Report:

90. Based on their respective reports, the chemical engineering experts appear to agree that, based on the type and extent of damage found, the explosion was a chemical explosion involving the ignition of thermic oil aerosols. Where their views presently differ is regarding the mechanics of how such chemical explosion occurred – whether it occurred from inside the oil jacket; or occurred following a physical rupture of the oil jacket due to internal overpressure.

- (4) What effect would the build-up of high internal pressure inside the oil jacket have, in particular at the weld seams?
 - (5) What was the quality of the affected welding, what accounted for such quality, and what effect (if any) did that have on the rupture of the welds?

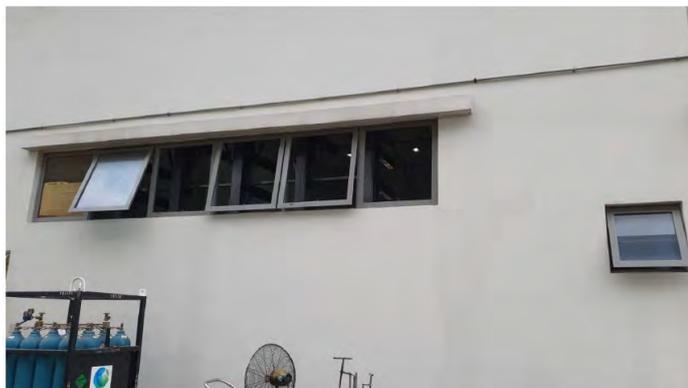
- (1) See walk-through of scan of premises done by Envista Forensics on 23 March 2021.
- (2) P3's Unit 38A – glass window panels on the rear wall were blasted out of their metal frames **[S-136]**:
