21 JANUARY 2022

**Report of the Inquiry
Committee for the accident
at Stars Engrg Pte Ltd on
24 February 2021**

(PART I – MAIN REPORT)

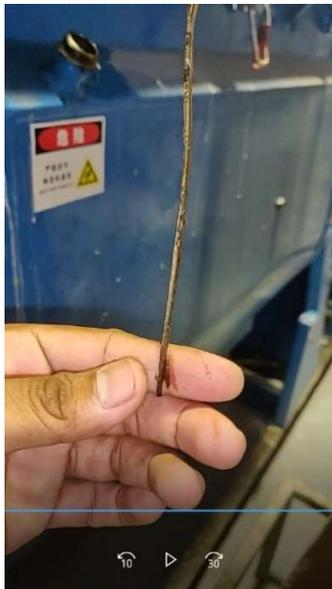
Figure 10: Screenshot from video sent by Imam to Chua on 7 August 2020

there were no boiling sounds, and suspected that the oil in the oil jacket was running out.

66. As a co-worker, Nasim, was in the vicinity, Imam approached Nasim to help figure out if anything was amiss with the mixer machine. Nasim used an improvised dip stick to determine the amount of oil in the oil jacket. The dip stick showed that the level of oil barely covered the tip of the dip stick, although the depth that the dip stick had reached into the jacket was unclear. After receiving a video of Nasim's dipstick check from Imam at 0030hrs on 8 August 2021, Chua issued instructions to seal all openings on the oil jacket, explaining "*if not all the oil gone already*". This was not done immediately. Shortly after, at 0037hrs on 8 August 2021, Chua made an order for 4 buckets of thermic oil via WhatsApp.

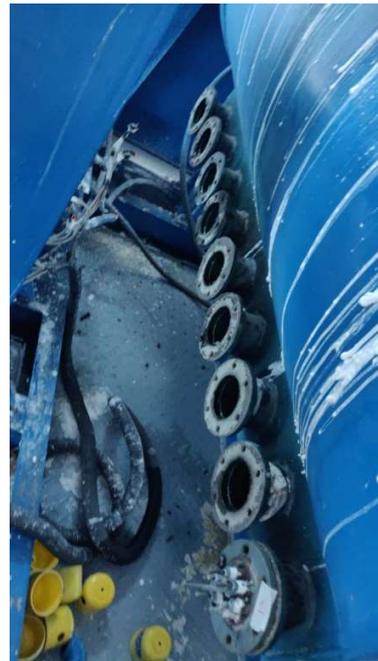
Figure 13: Photo taken on 28 August 2020 after checks and cleaning were carried out

28 Aug 2020*	<ul style="list-style-type: none"> Smoke observed around the heaters. Oil drained was of a darkened hue (about 6 buckets or 120 litres) Heaters were checked and gaskets replaced
21 Sep 2020*	<ul style="list-style-type: none"> Smoke seen around heaters
28 Sep 2020*	<ul style="list-style-type: none"> Boiling sounds from inside the oil jacket and oil leaking from a small hole on the surface of the oil jacket
1 Oct 2020*	<ul style="list-style-type: none"> Oil drained was darkened in hue (about 5.5 buckets or 110 litres) Drained oil left to stand so that heavier soot particles settled at the bottom, and oil on top was returned to the jacket Imam stopped working at the worksite sometime in October 2020 and returned sometime in late December 2020.
2 Oct 2020*	<ul style="list-style-type: none"> Chua carried out his monthly maintenance check on the mixer machine

77. Imam called Chua again and managed to update him on the issues involving the mixer machine. Chua told Imam to replace all the worn-out gaskets and instructed Imam to ask Nasim to make new gaskets. Mehedi and Shohel replaced the old gaskets with the new ones made by Nasim and Imam re-installed the heaters. The drained thermic oil, less the black sediments, was then returned to the jacket through the top opening with an elbow via the funnel, and the opening was thereafter resealed with the end cap. Operations of the mixer machine resumed and there were no problems with the heating when he used the machine the next day.

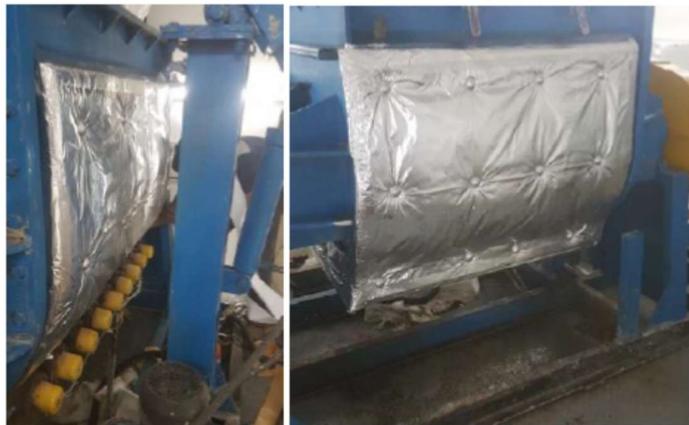
Figure 18: Photographs of the insulation on the oil jacket taken by Marimuthu on 6 February 2021

91. On 6 February 2021, on Chua's instructions, new insulation of ceramic fibre covered with aluminium sheet was installed around the shell of the mixer machine to prevent workers coming into contact with the hot oil jacket surface. The insulation was affixed onto welding pins which were tag-welded to the oil jacket without penetrating the surface.

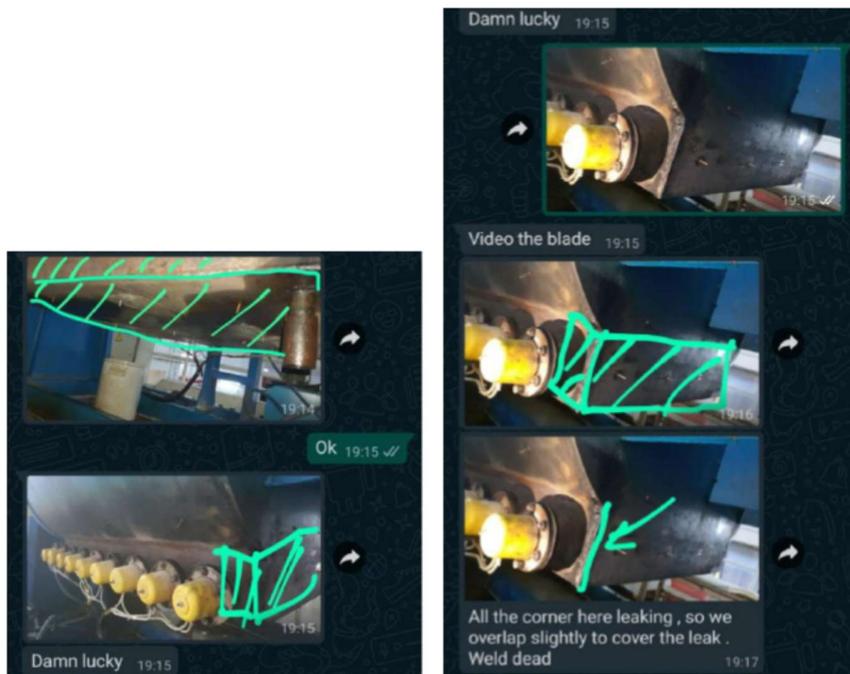
Figure 20: Screenshots from Murugan’s mobile phone of his WhatsApp messages with Chua on 12 February 2021

95. Chua also instructed Murugan to check on the condition of the mixer machine. Murugan took a photo of the front right bottom corner of the mixer machine where the fire originated. Murugan observed that there were oil stains around the corner and observed that the mixer machine and oil inside the jacket were very hot, because he could feel the heat and hear oil boiling sounds from inside the jacket. Murugan sent a video with “boiling” sounds to Chua. Chua replied that boiling sounds were common as the oil was heated up, similar to heating water over a stove. Chua then sent instructions to Murugan via WhatsApp to check the mixer, and to weld an additional layer of metal plate overlapping the bottom corners of the oil jacket “as they were leaking”. Murugan then conveyed Chua’s instructions to Nasim and said that Marimuthu would show him the leak areas. Chua conveyed the welding instructions to Murugan via the following marked photographs and accompanying instructions “All the corner here leaking, so we overlap slightly to cover the leak. Weld dead”.

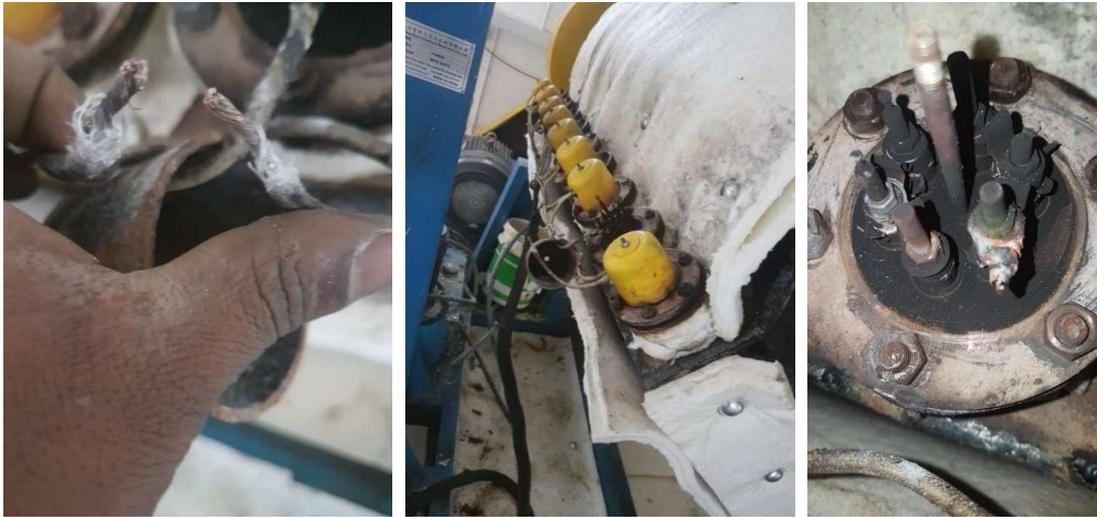
Figure 24: Pictures sent by Marimuthu to Chua between 1006hrs and 1012hrs

108. Chua gave Marimuthu a missed call at 0958 hrs. At 0959hrs, Marimuthu returned the call and told Chua that there was a fire and one of the heaters was faulty. Between 1006hrs and 1012hrs, Marimuthu sent the following pictures to Chua, including the earlier picture taken by Anis of the glowing flange on heater #2 in *Figure 22*.

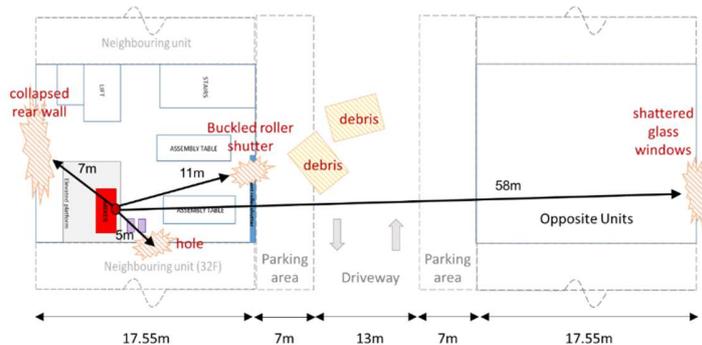
Figure 35: Schematic diagram with measured distances from the mixer machine

123. From the damages pieced together on the layout diagrams in Figures 34 and 35 below, the accident was likely an explosion from the mixer machine that generated blast overpressures sufficient to shatter glass at 58m away, dislodge panels, and destroyed walls.

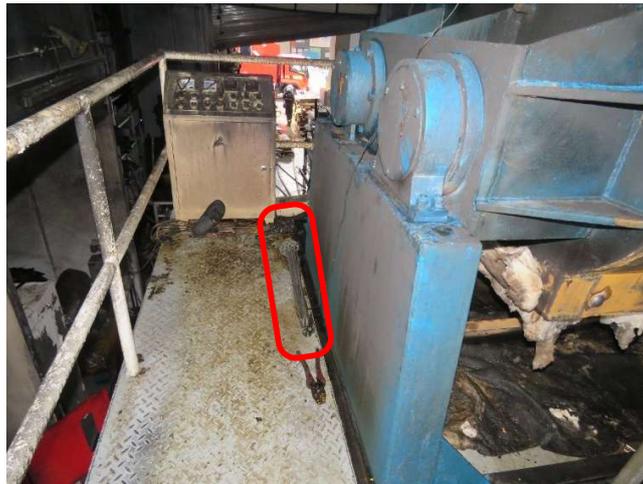
Figure 36: Heater found next to Mixer Machine, encircled in red

124. Some remains of the insulation that was originally placed around the oil jacket were found below the mixer machine. The control panel that was located close to the machine reeked a strong smell of remnant oil when opened. A replacement heater was found next to the mixer machine along with some tools (encircled in *Figure 36* below).

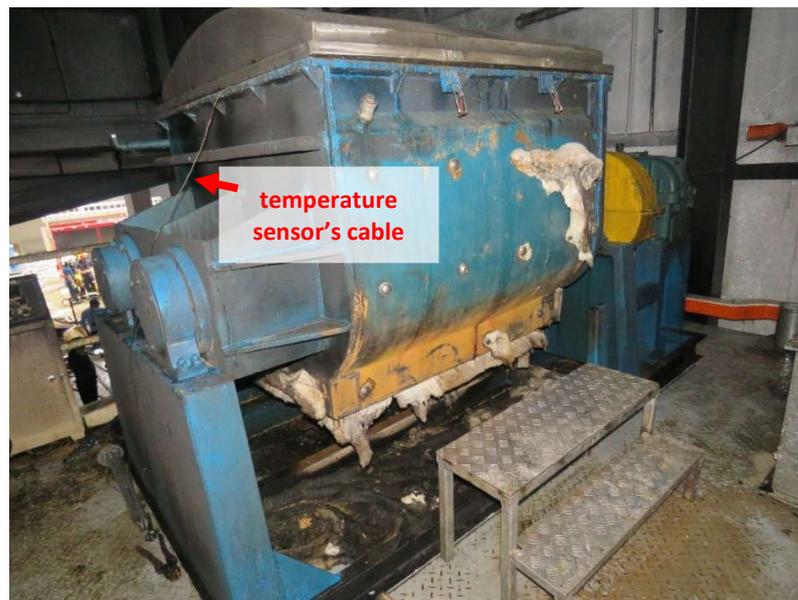
Figure 39: Temperature sensor in mixing chamber

126.A cable from the control panel was found connected to a RTD which was placed inside the mixing chamber of the mixer machine (*Figure 39*). Remnants of the insulation on the mixer machine were found with some soot on the exterior. All three openings on the oil jacket were found closed post-accident. Both openings at the top of the jacket had end caps that rendered them sealed, while the drain valve was found in a closed position (*Figure 40*).

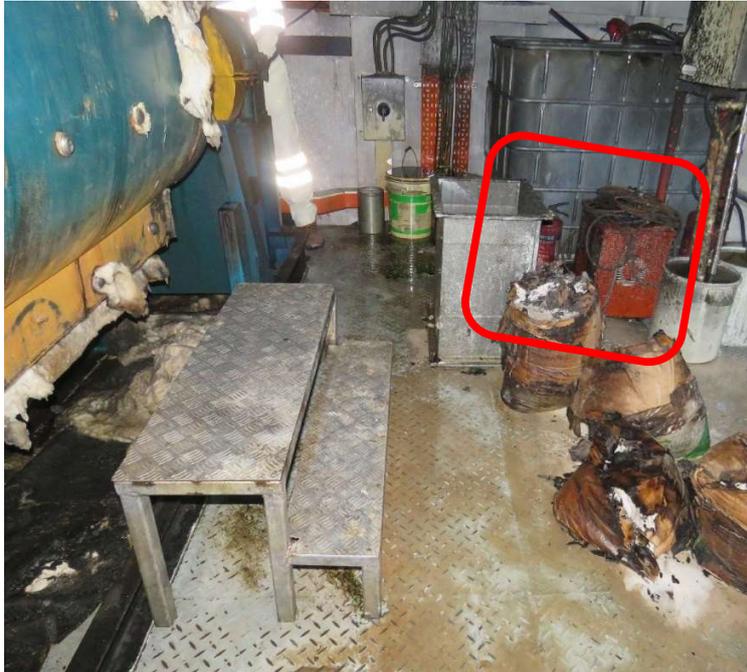
Figure 41: Welding set on platform, encircled in red

127. A welding set was found on the platform as shown below in *Figure 41*, along with an Intermediate Bulk Container, some bags of powder, buckets, and tools.

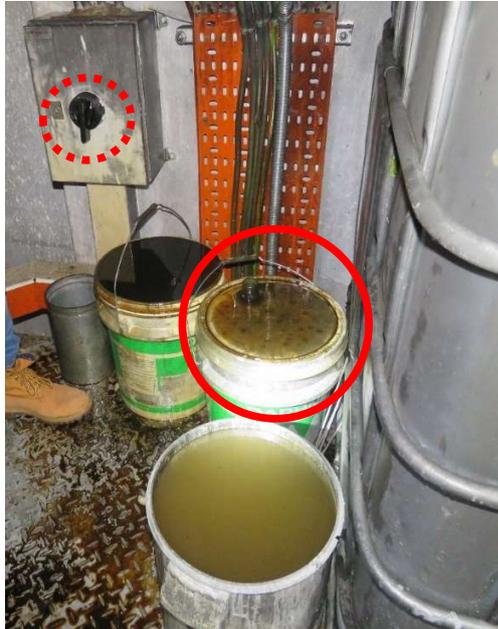
Figure 42: Covered bucket (circled in red) and mixer machine's isolator in the "ON" position (dotted circle in red)

128. Three buckets were found on the platform, one of which was covered (*Figure 42*, circled in red). The isolator located nearby which powered the mixer machine was found in the “ON” position (*Figure 42*, dotted circle in red).

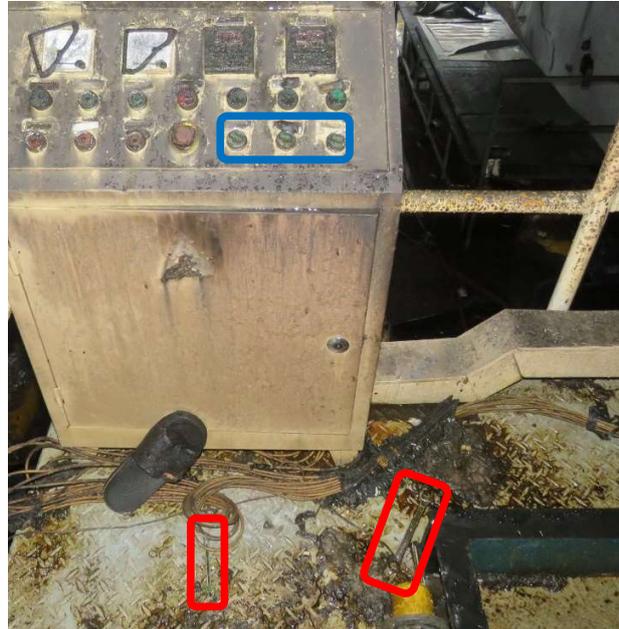
Figure 43: Spanners found close to the additional replacement heater (with yellow cap), encircled in red; heater switches on the control panel found in the "ON" position, encircled in blue

129. Two spanners and a black slipper, likely belonging to one of the workers working on the platform at the time of the accident, were found close to the replacement heater. The spanners are circled in red in *Figure 43* below⁶. The three heater switches on the control panel were found in the “ON” position, boxed up in blue in *Figure 43* below.

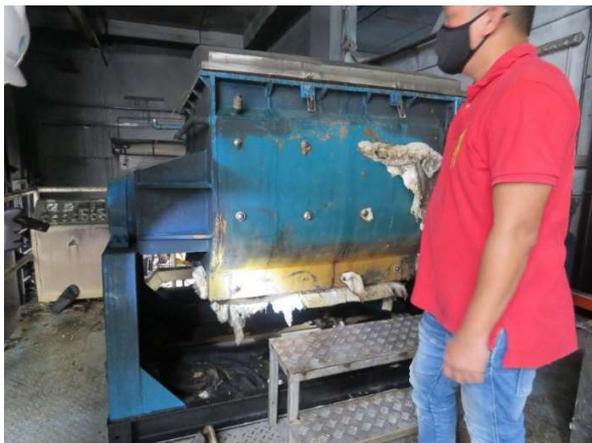
Figure 44: Upright mixing chamber with lid closed

130. The mixer machine's mixing chamber was found upright (i.e. not tilted) with the lid closed, as shown in *Figure 44* below. The inside of the mixer machine's mixing chamber was observed to be filled with water at the bottom as shown in *Figure 45* below.

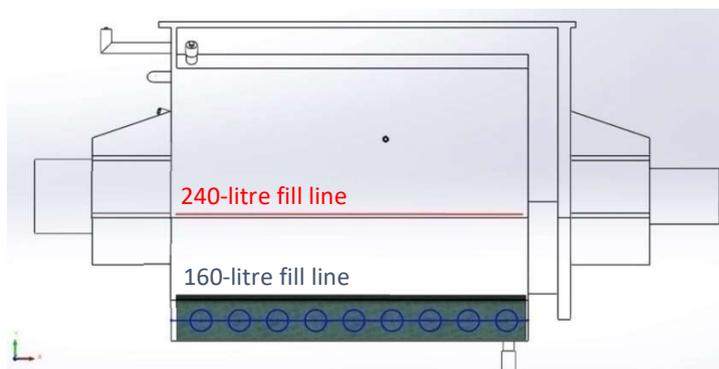
Figure 47: Matcor's 3D rendering showing the fill level corresponding to 160/240 litres in the oil jacket

139. From Matcor's 3D renderings in *Figures 47 and 48* below, a 160-litre oil level would only be just enough to immerse the heating coils, but would not be in contact with the lowest internal surface of the mixing chamber, compared to a much higher oil level if the jacket was filled with 240 litres of thermic oil.

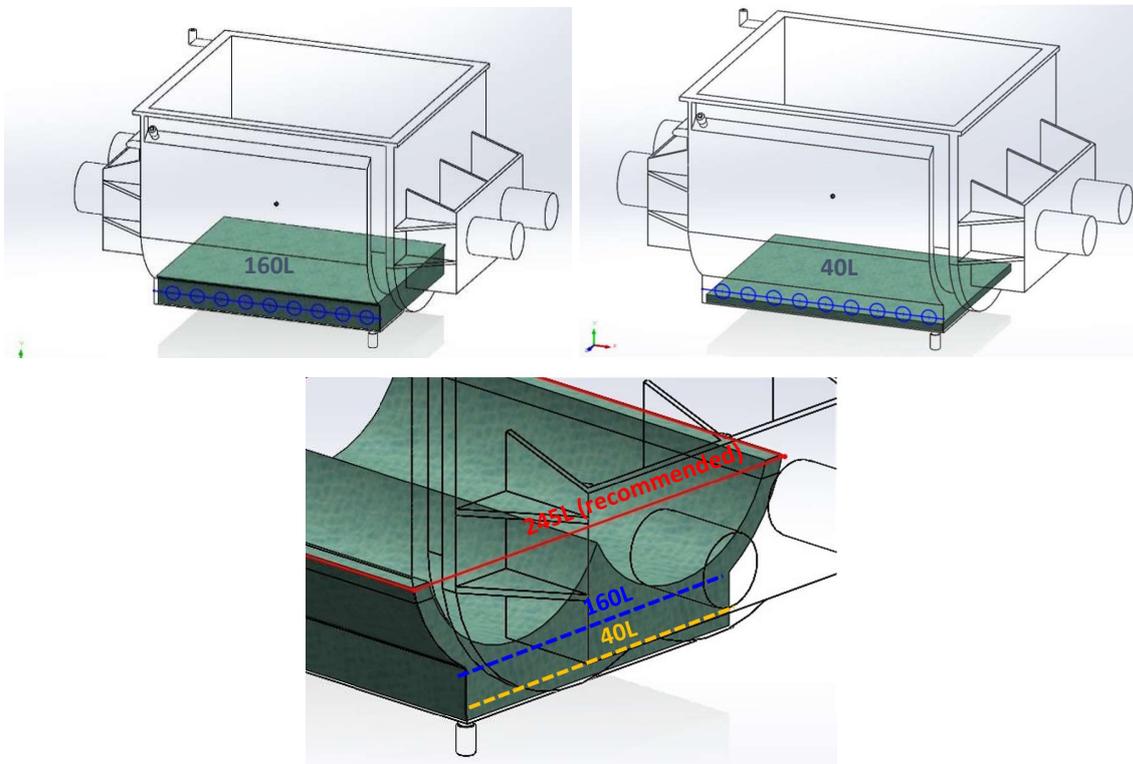
Figure 49: Fill levels corresponding to 40 litres, 160 litres and 245 litres in the oil jacket

140. *Figure 49* below shows the fill levels for 245, 160 and 40 litres of oil in the oil jacket.

141. When Stars Engrg started operating the mixer machine with thermic oil, only two buckets, or 40 litres, of oil were added to the oil jacket. As shown in *Figure 49* above, the heaters were not immersed in the thermic oil and there was a gap between the top of the 40 litres oil level (yellow dotted line) and the lowest point of the mixing chamber. The heaters were immersion type heaters which were meant to be completely immersed in the service medium. This gap created a layer of air insulation between the oil and the mixing chamber, causing inefficient heat transfers between the heated oil in the oil jacket and the water in the mixing chamber. Hence, more heat would need to be supplied by the heaters to the oil, to overcome the air insulation and attain the desired water temperature of 80°C to 90°C in the mixing chamber.

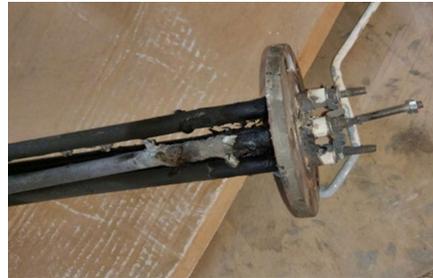
148. One of the spoilt heaters examined by Matcor showed melted carbon steel sheath, as shown in *Figure 50* below. This heater was retrieved by MOM post-accident during its investigation on 27 May 2021, and was likely heater #1 that was replaced on 8 August 2020 (see *Figure 51*). For the carbon steel sheath to have melted, the temperature was likely to have been at the melting point

of around 1400°C, indicating that excessive heating had already occurred by 8 August 2020.

Figure 50: Photo showing replaced heater #1 (taken from Chua's phone pre-explosion)

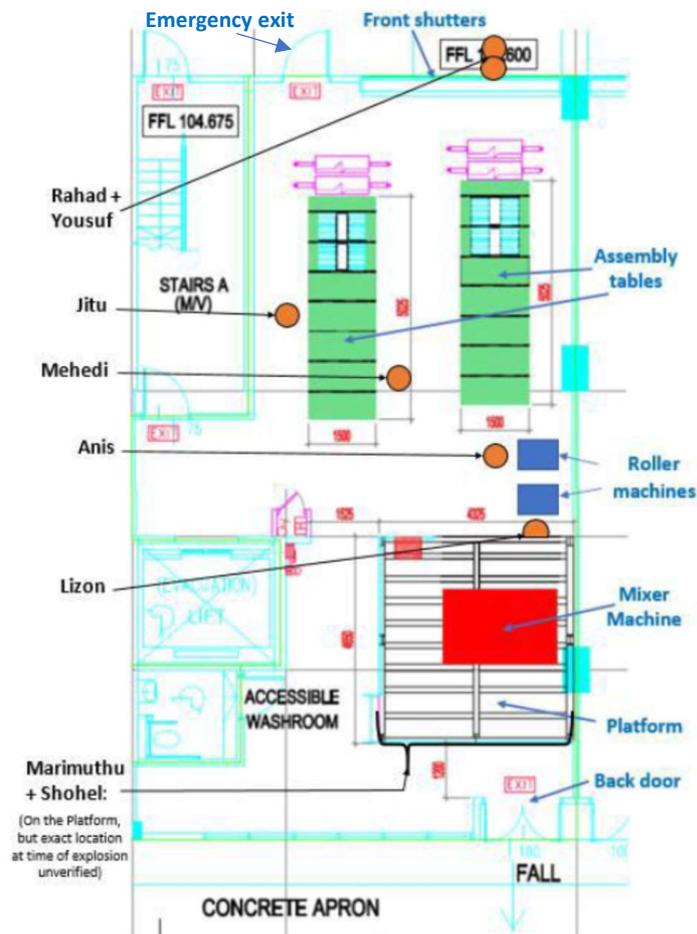
191. Jitu was working at one of the assembly tables which was near an emergency exit just before the explosion. However, access to the emergency exit was obstructed with a drilling machine, aluminium rolls, and a gas cylinder etc, as depicted in *Figures 54 and 55* below. Jitu thus had to jump over the table to escape.

Figure 54: Layout showing where the workers were positioned before the accident
