**Report of the Inquiry
Committee for the accident
at Stars Engrg Pte Ltd on
24 February 2021
(PART II – ANNEXES)**

TECHNICAL REPORT

| Title of Report: Failure Analysis of a Failed Mixer Machine Retrieved from Unit 32E of Platinum @ Pioneer Building involved in a Fire Explosion Incident | | Date of Last Revision/Revision No: |

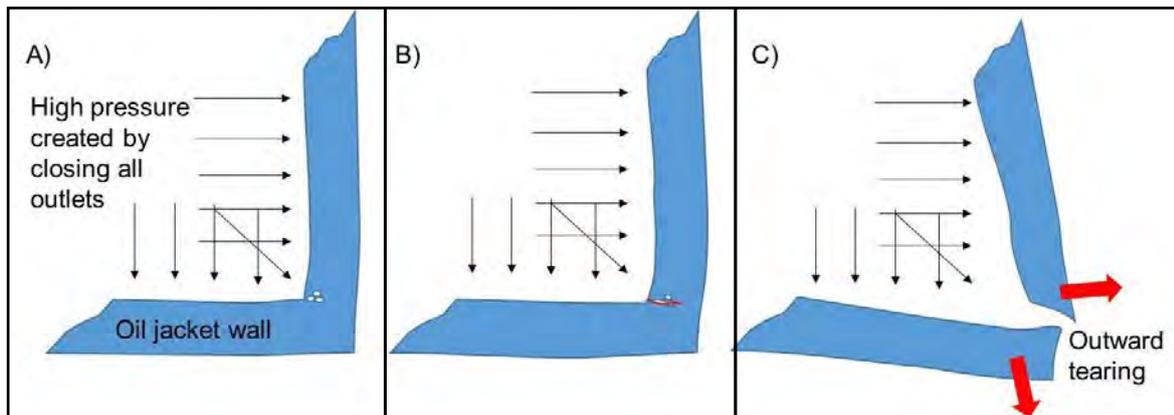
- 2 ➤ The presence of dimples was evidence of overloading fracture. The locations
4 of equiaxed and elongated dimples suggested that at regions adjacent to
6 internal side (with equiaxed dimples) had cracked open with direction
8 perpendicular to the fracture surface while the region adjacent to the external
side (with elongated dimples) had torn apart in an outward direction at final
instance of the rupture.

10 *Micro-mechanism of ductile fracture due to overload: A) High pressure from inside*
12 *the oil jacket leads to deformation of wall, void nucleation and crack. Evidenced by*
14 *equiaxed dimples. B) Wall deformed more with void growth and coalescence to*
16 *deeper cracks. C) Oil jacket wall fractured/torn apart and severely deformed*
18 *outward. Evidenced by elongated dimples.*

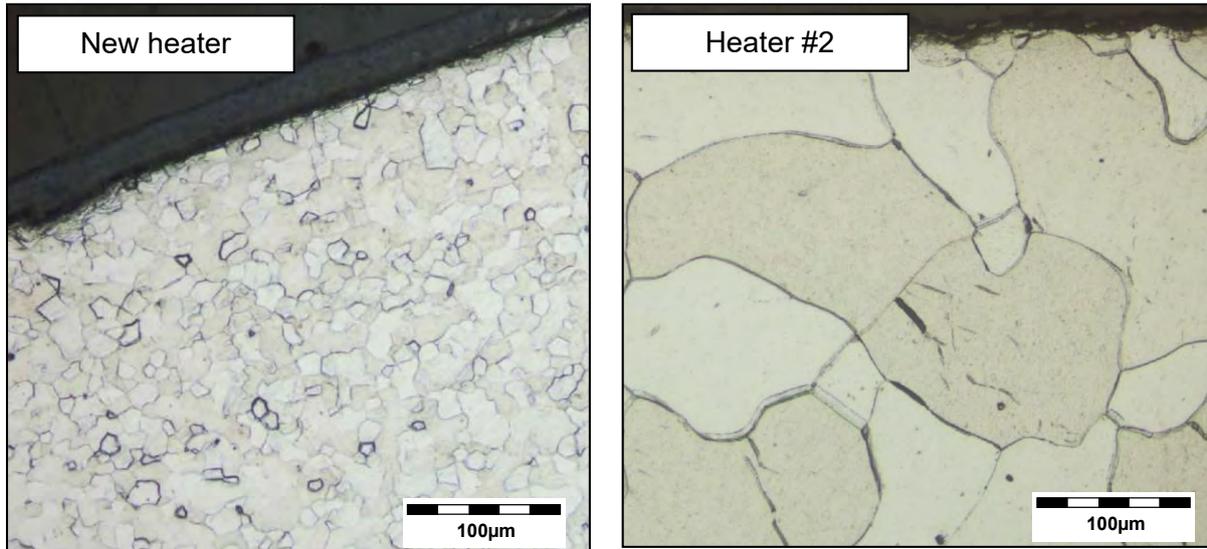
4 The grain growth (also known as grain coarsening) observed in the microstructures of
6 the resistance wires and metal tubes were also evidence of high metal temperature
8 experienced by the heating elements. For the metal tubes, increment in grain size in
10 the range of ASTM number 0 to 4 indicates that they had been exposed to temperature
830°C to 1095°C based on API 579-1 Fitness-For-Service standards, Curve B¹⁰ (see
graph below).

12 *Micrographs of metal tubes at 200X magnification, extracted from Figure 204 (left) and Figure 186 (right)*

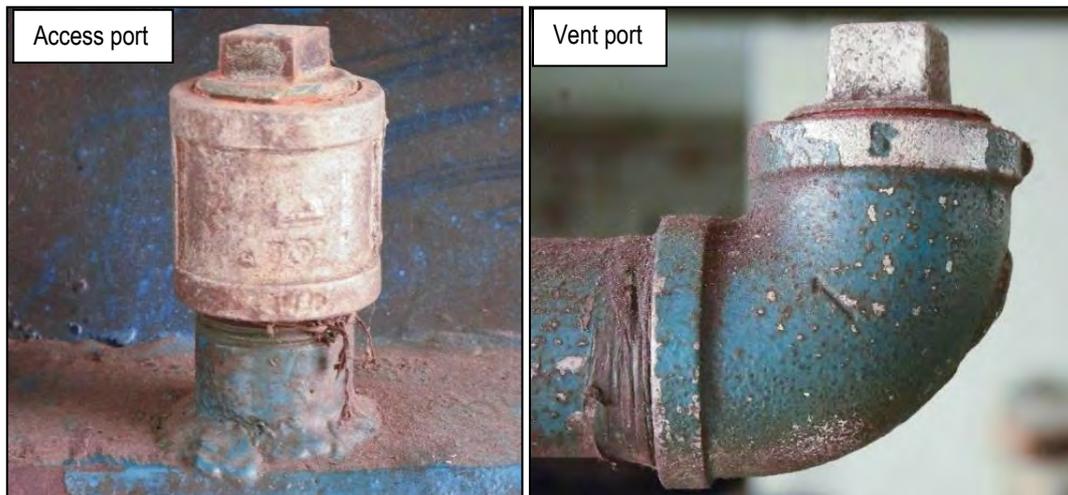
Extracted from Figure 97 and Figure 98

- 34 ➤ Both access and vent ports were plugged by square head plugs. Along with the closed drain port, all three of the oil jacket openings were closed (Figure 97 and Figure 98).
- 36
- 38 ➤ The oil funnel was not in use and was found at the ground floor of the Factory during the retrieval of the Mixer Machine onsite (Figure 99).

14 The boiling and evaporation of oil increased the (oil vapour) pressure inside the oil
16 jacket. With all the oil jacket's openings/ports blocked, the oil jacket was highly
18 pressured from inside and the applied load on the weld joint increased.

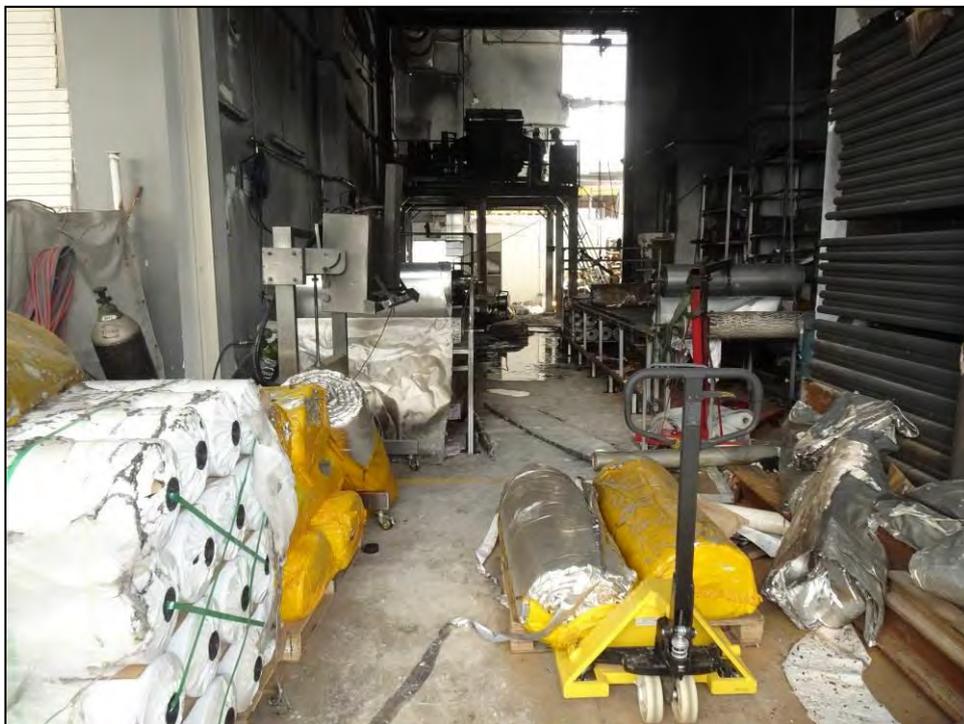
Front end of the incident unit

6 ➤ The front of the unit had a shutter door and was facing the common driveway.
8 Several rolls of fire rated products, either in white packaging or aluminium foils,
were found stacked on the open space area immediately outside the unit
(Figure 1).

Figure 1: **Front End of Unit.** The front of the unit had a shutter door and was facing the common driveway. Several rolls of fire rated products, either in white packaging or aluminium foils, were found stacked on the open space area immediately outside the unit.

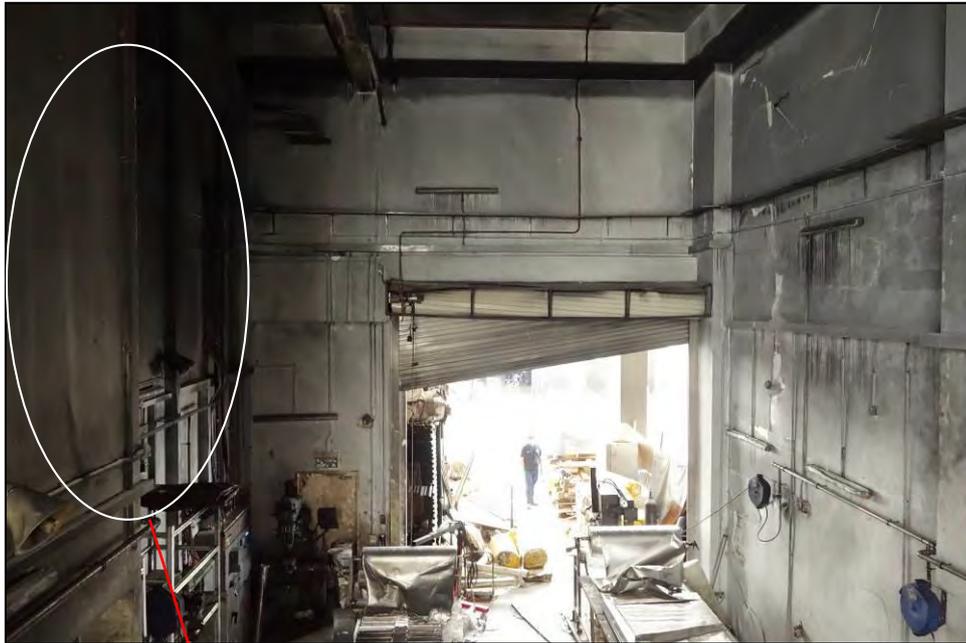
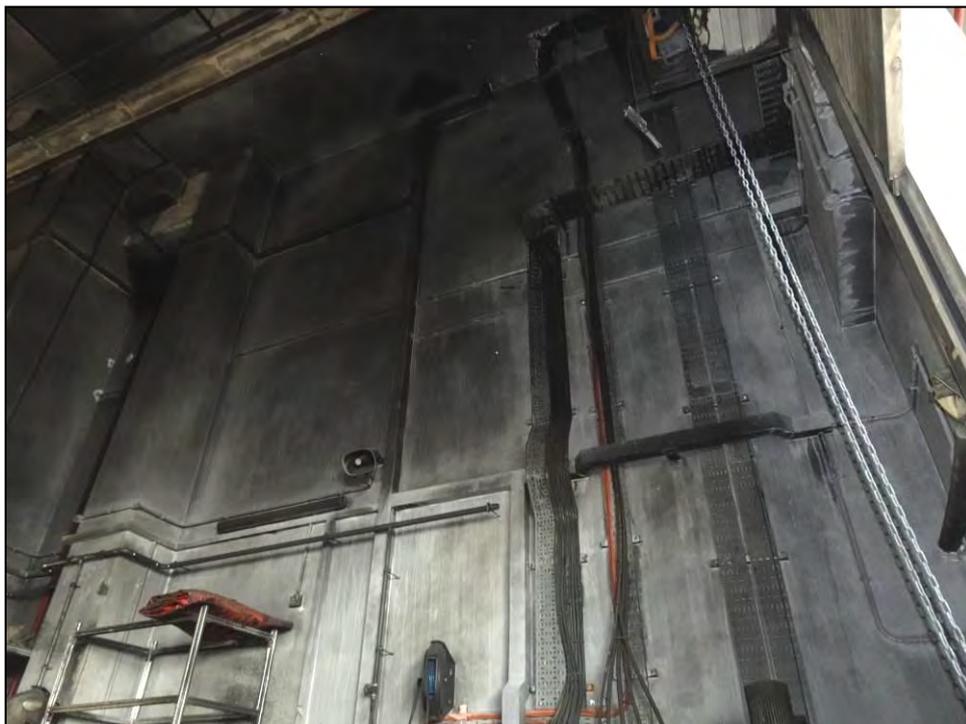
Charred walls towards the front of the unit

10 ➤ The internal walls of the unit revealed varying extent of charring, with the upper
half of the wall appearing more severe (Figure 2 to Figure 4).

Figure 2: Interior of the Unit. The internal walls of the unit revealed varying extent of charring, with the upper half of the wall appearing more severe.

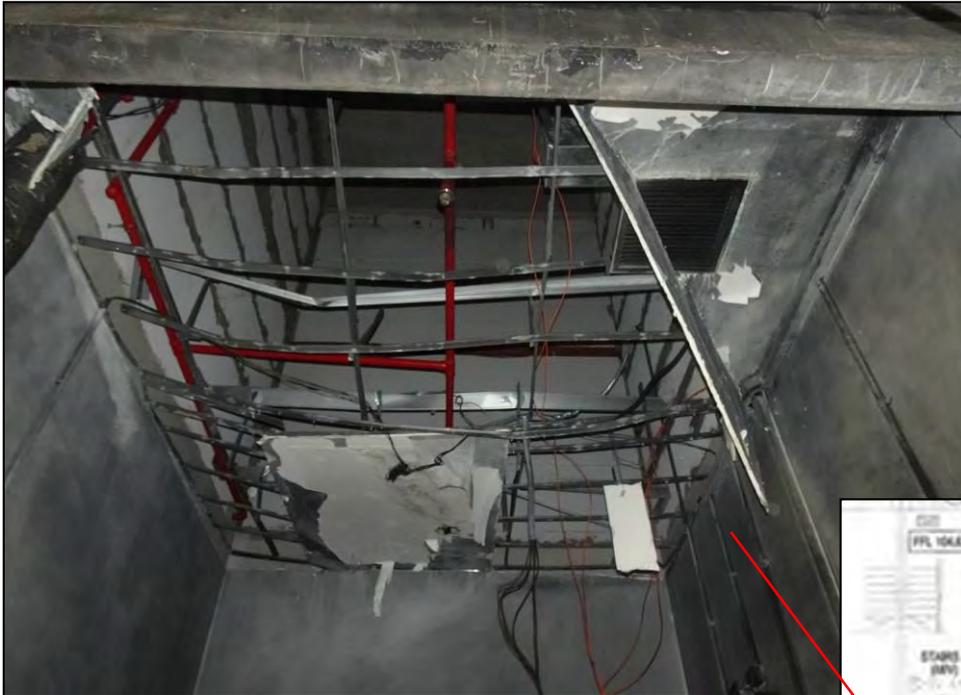
Top of the area near the lift

16 ➤ Cracks were also observed on the side walls next to the lift near to the Platform
floor (Figure 4).

Figure 4: Interior of the Unit. The internal walls of the unit revealed varying extent of charring, with the upper half of the wall appeared to be more severe. Cracks were observed on the side walls next to the lifts near to the Platform floor. The lighting fixtures in the vicinity of the Platform floor were more thermally deformed as compared to the ones further away.

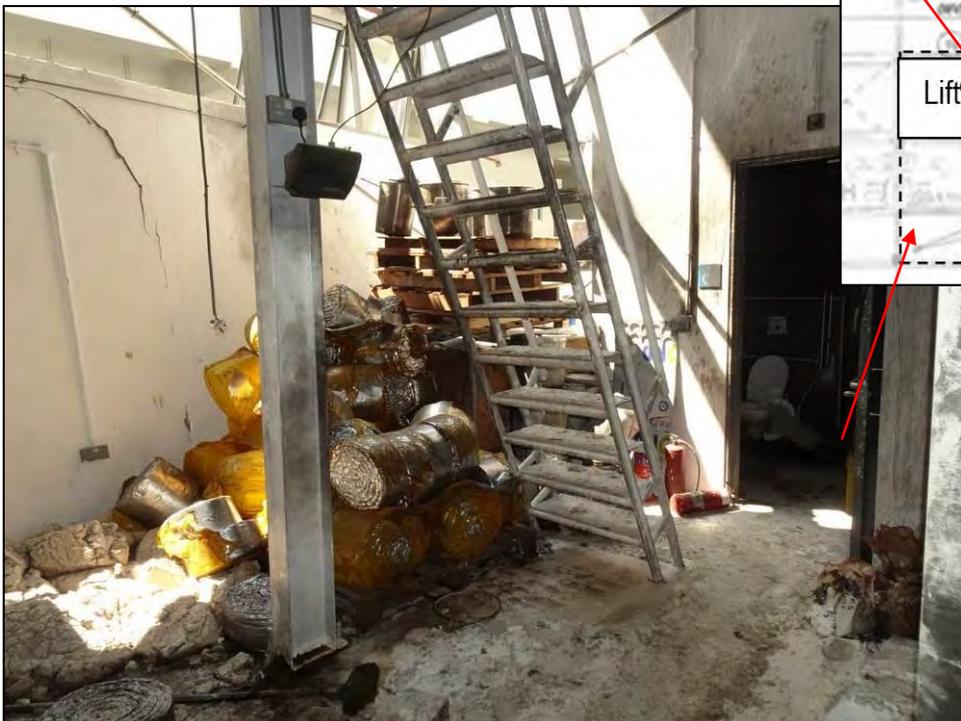
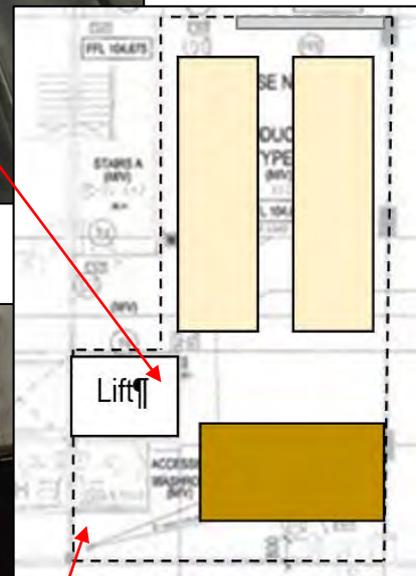
Rear end of the unit

Figure 5: Rear End of Unit. The top partition wall of the lift area was also damaged in the fire explosion incident. The rear walls were cracked and punctured through, especially for the top half sections.

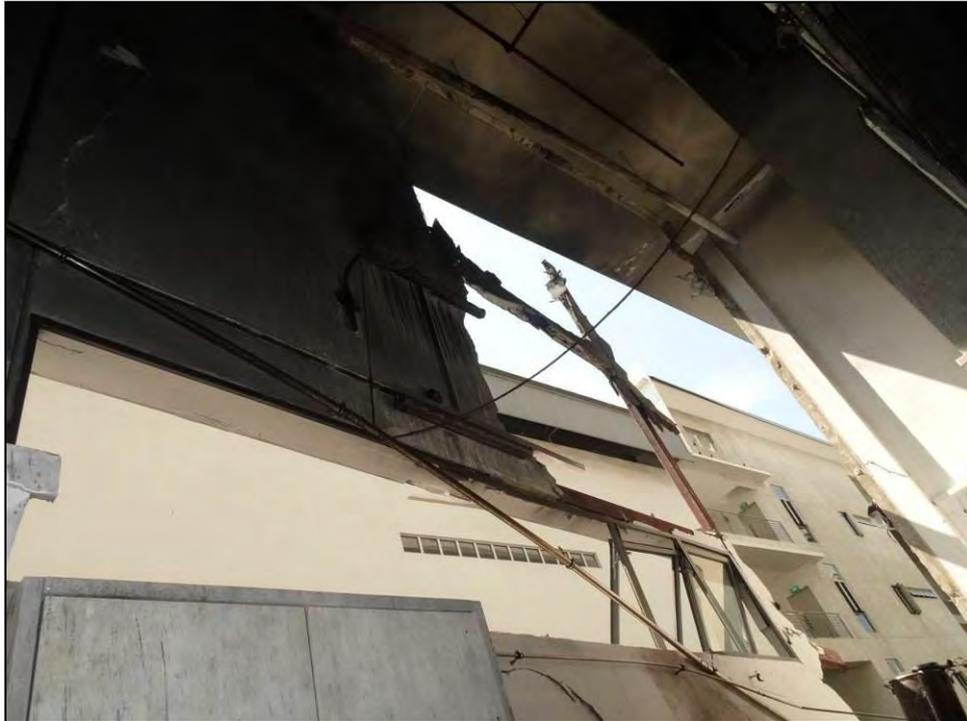
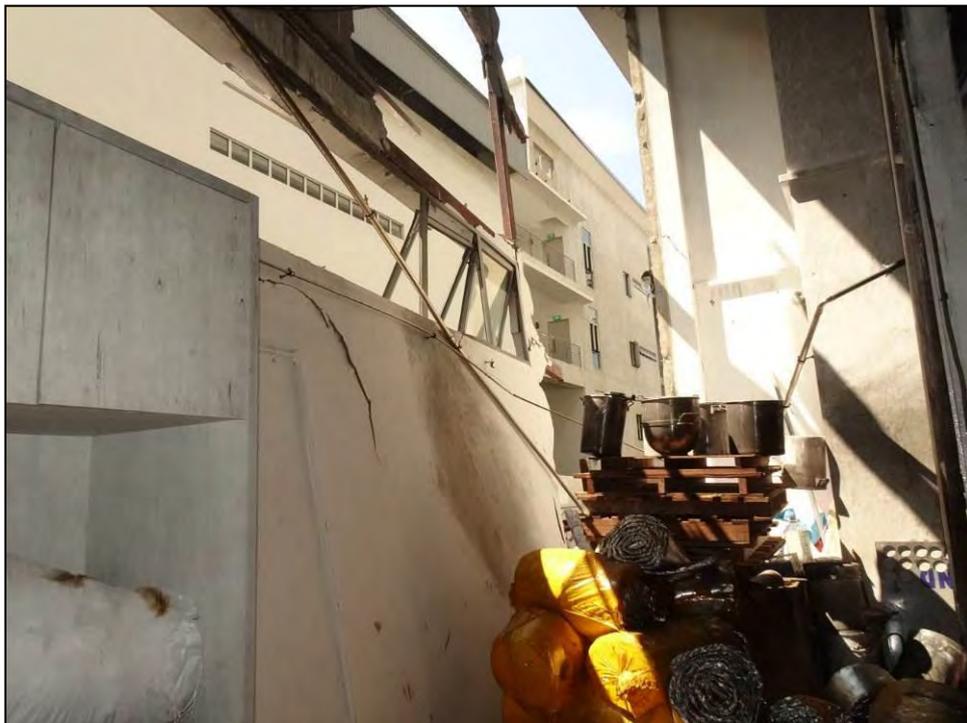
Punctured wall at the rear end of the unit

12 ➤ The explosion at the time of incident had cracked and punctured through the
14 side wall in the vicinity of the Platform floor as well as top half of the rear walls
(Figure 3 to Figure 7).

Figure 6: **Rear End of Unit**. The rear walls were cracked and punctured through, especially for the top half sections.

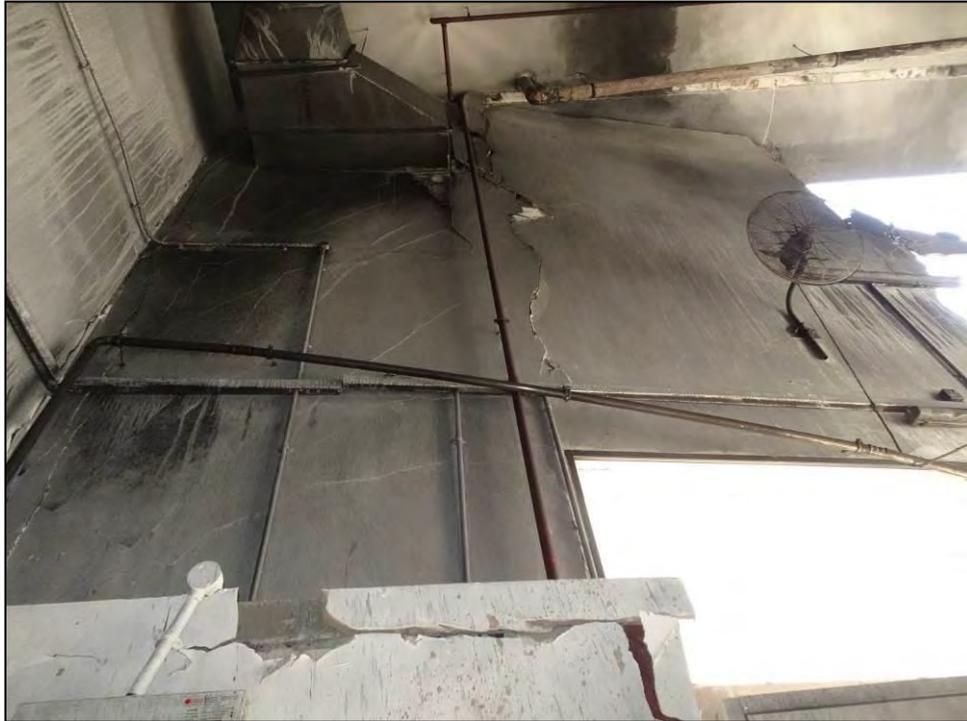
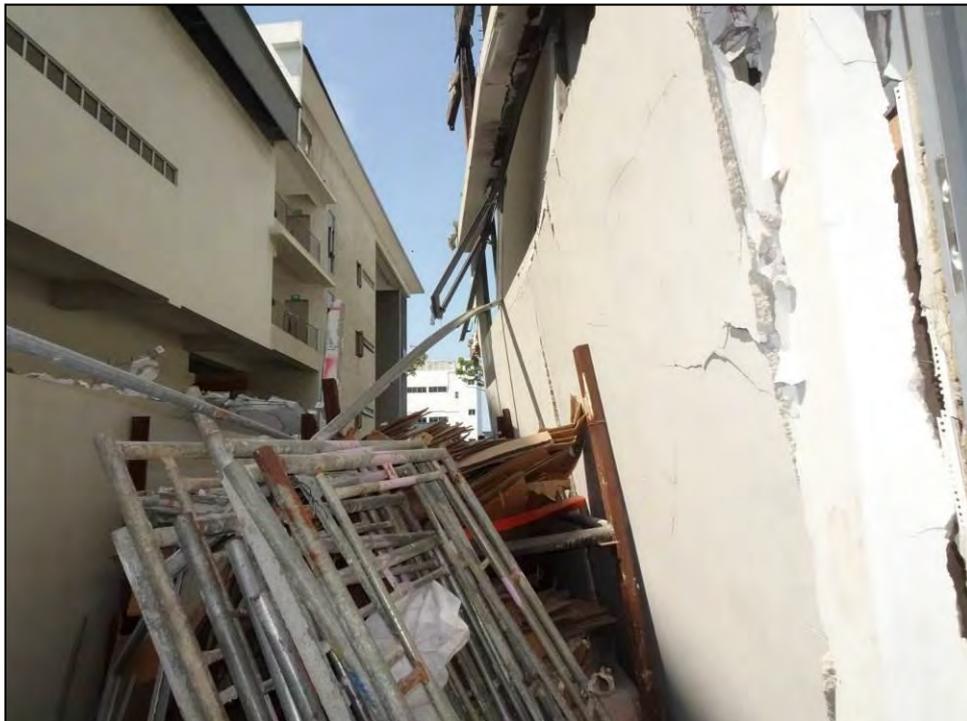
Cracked wall at the rear end of the unit

Figure 7: Rear End of Unit. The rear walls were cracked and punctured through, especially for the top half sections.

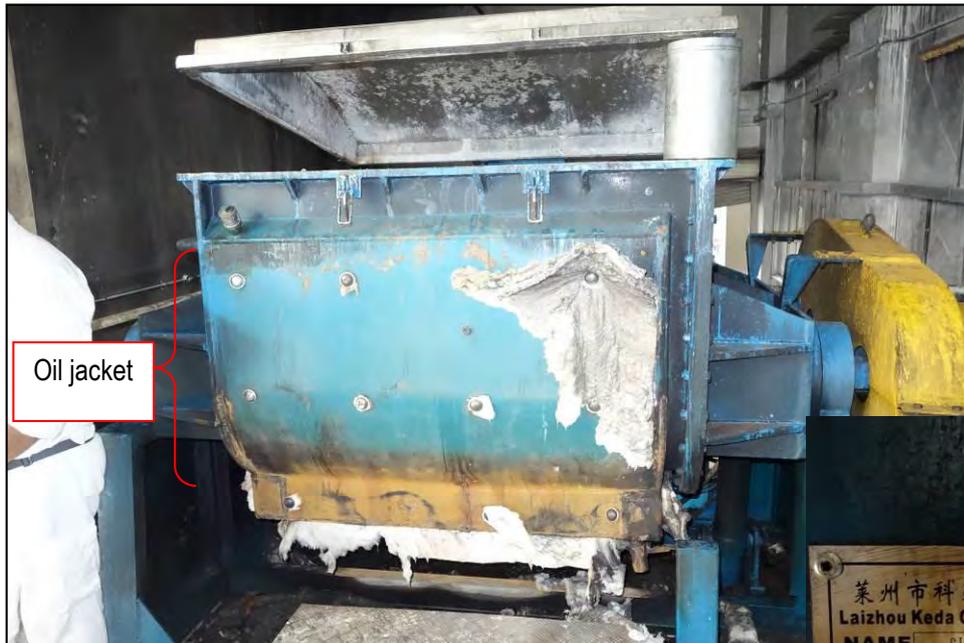
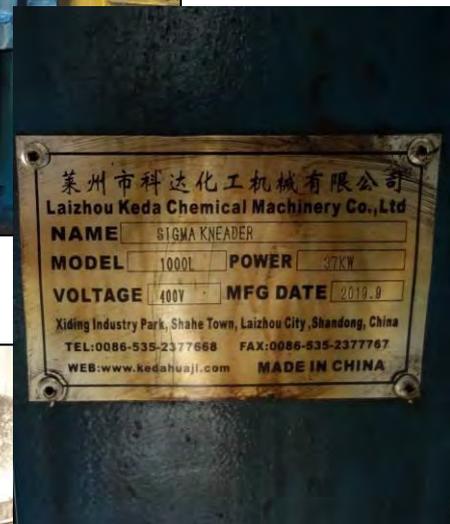
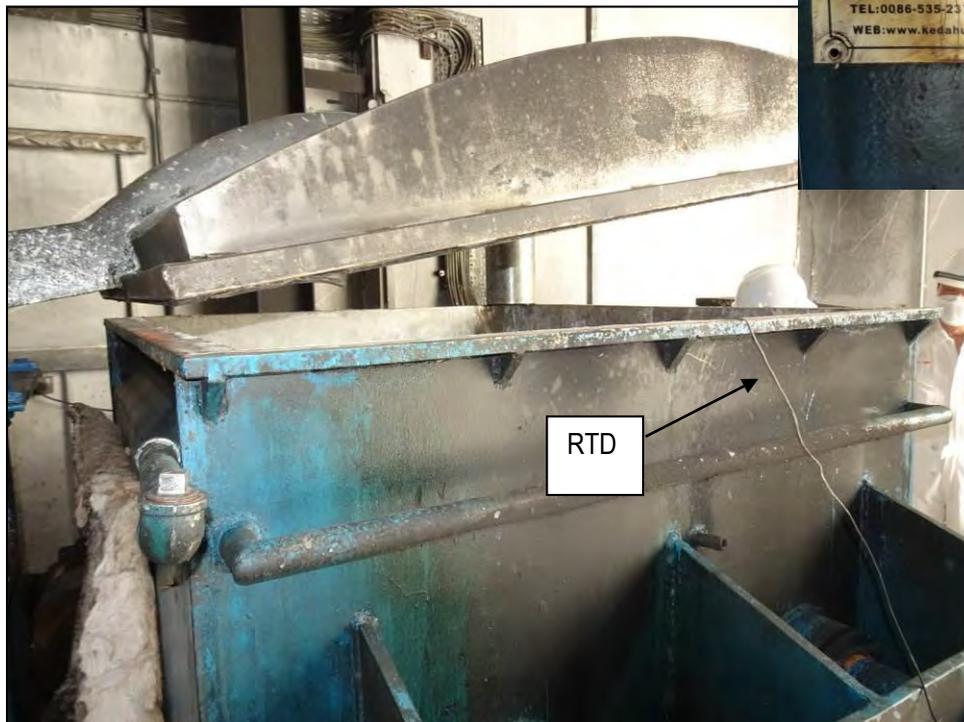
Front side of Mixer Machine

34 ➤ Remnant whitish insulation wool was observed to remain attached to the front
and rear sides of the oil jacket (Figure 8 and Figure 9). A resistance temperature
detector/sensor (RTD) was observed in the mixing tank, but not in the oil jacket.

42 As per the LEW Report (*Annex 3*), the heaters were interlocked only to the "Jacket Temp" thermostat where they would be turned off when the set temperature was attained. The RTD connected to the "Jacket Temp" thermostat was found inside the 44 mixing chamber instead of being affixed on screw-on fixture on the oil jacket (Figure 8).

Figure 8: Mixer Machine. Remnant whitish insulation wool was observed to remain secured to the front and rear sides of the Mixer Machine. A RTD sensor was observed in the mixing tank, but not in the oil jacket.

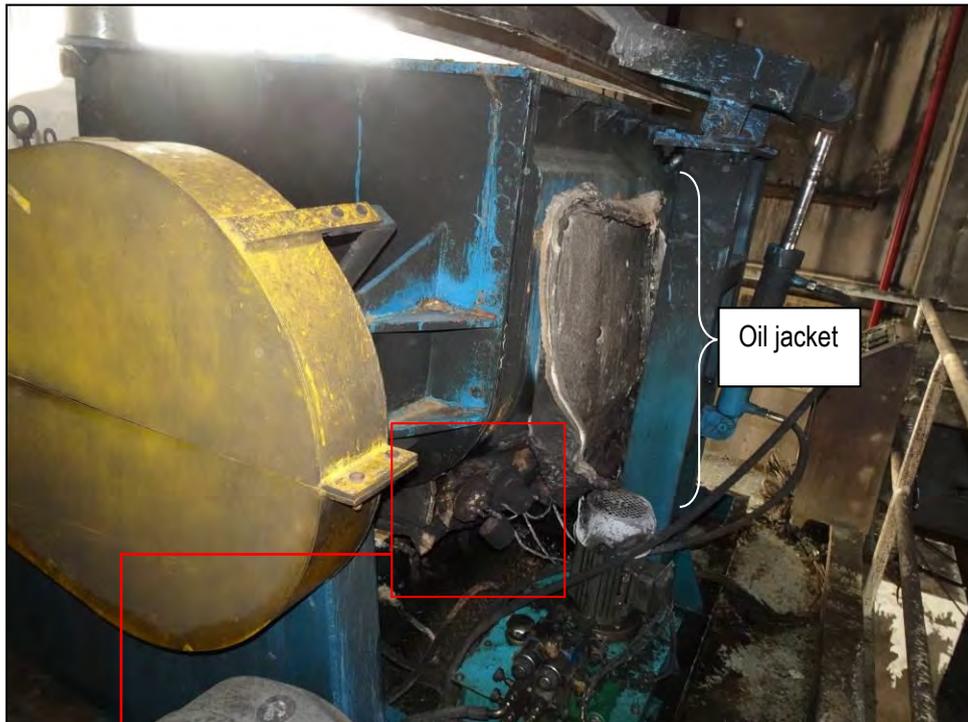
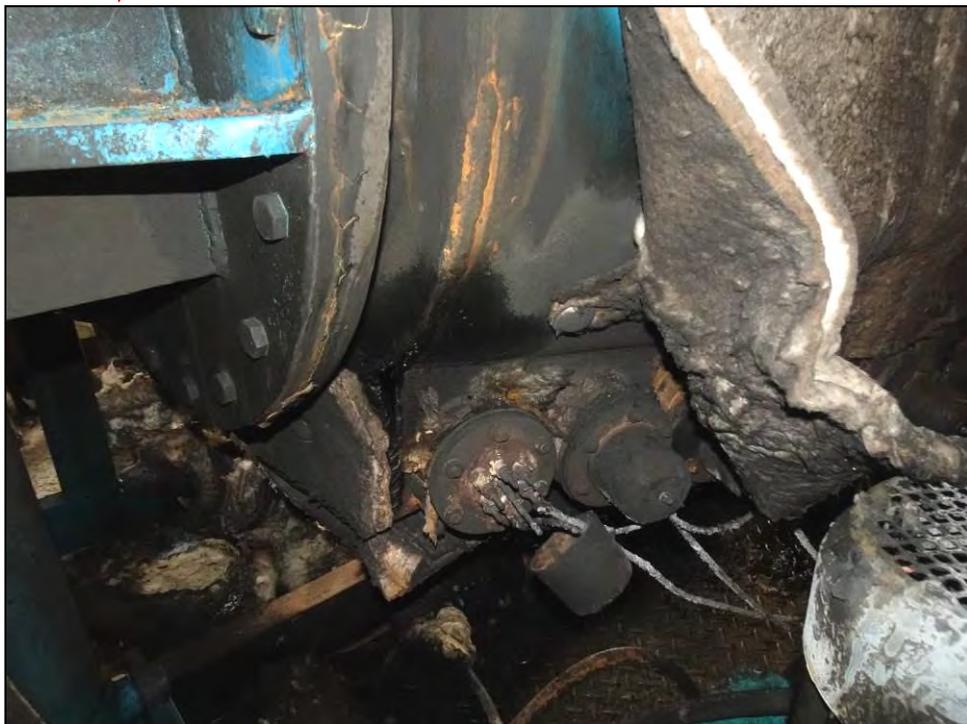
Tearing along the weld joint of the oil jacket around the heater

36 ➤ Close examination of the oil jacket revealed tearing damage along the bottom-
38 rear corner weld joints, adjacent to the heaters (Figure 9 and Figure 10). The
fractured bottom-rear corner weld joint configuration appeared different from
40 the original weld joints further away, suggesting that the fractured joints were
weld repair areas.

Figure 9: **Mixer Machine, Oil Jacket Around Heater.** Close examination of the oil jacket revealed tearing damage along the bottom-rear corner weld joints, adjacent to the heaters. The fractured bottom-rear weld joint configuration appeared different from the original weld joints further away.

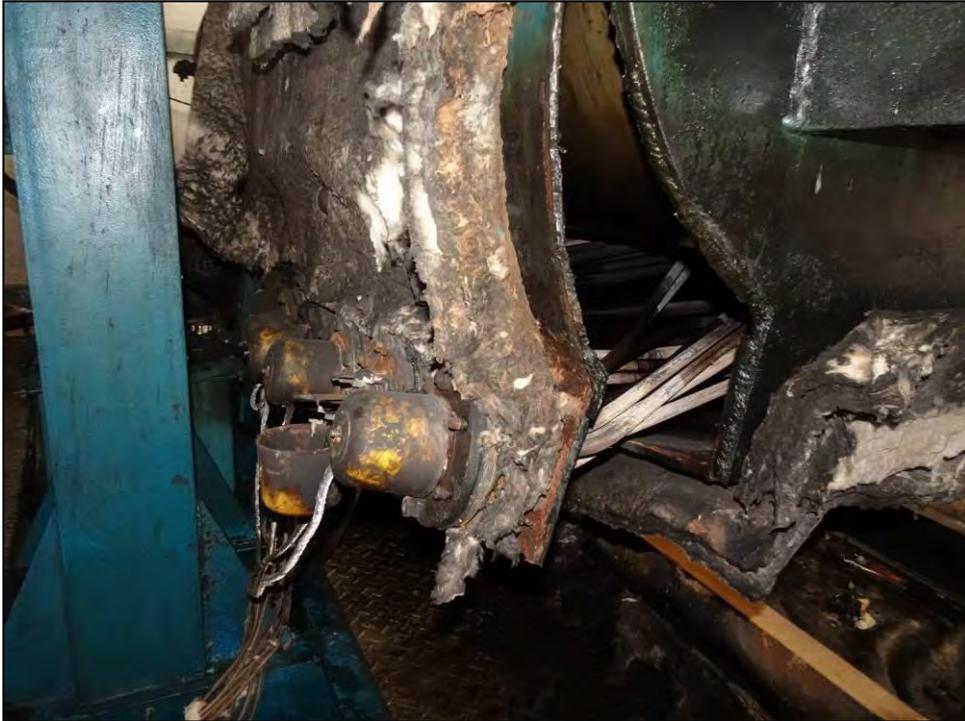
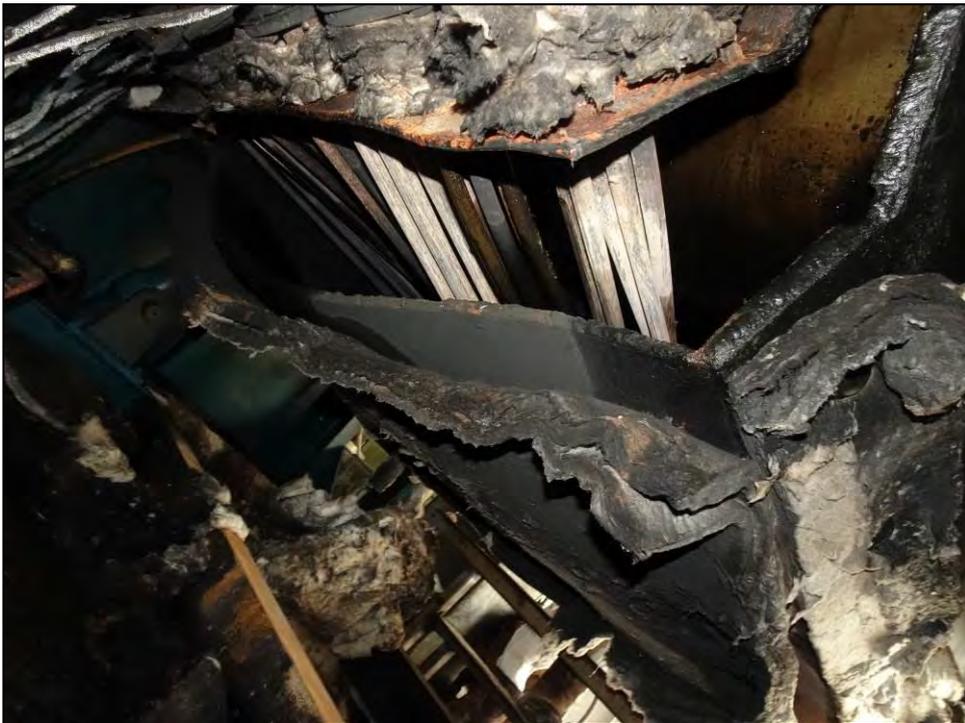
Tearing of oil jacket along the weld joint around the heater on the other end of the Mixer Machine

Figure 10: Mixer Machine, Oil Jacket Around Heater. Close examination of the oil jacket revealed tearing damage along the bottom-rear corner weld joints, adjacent to the heaters. The fractured bottom-rear weld joint configuration appeared different from the original weld joints further away.

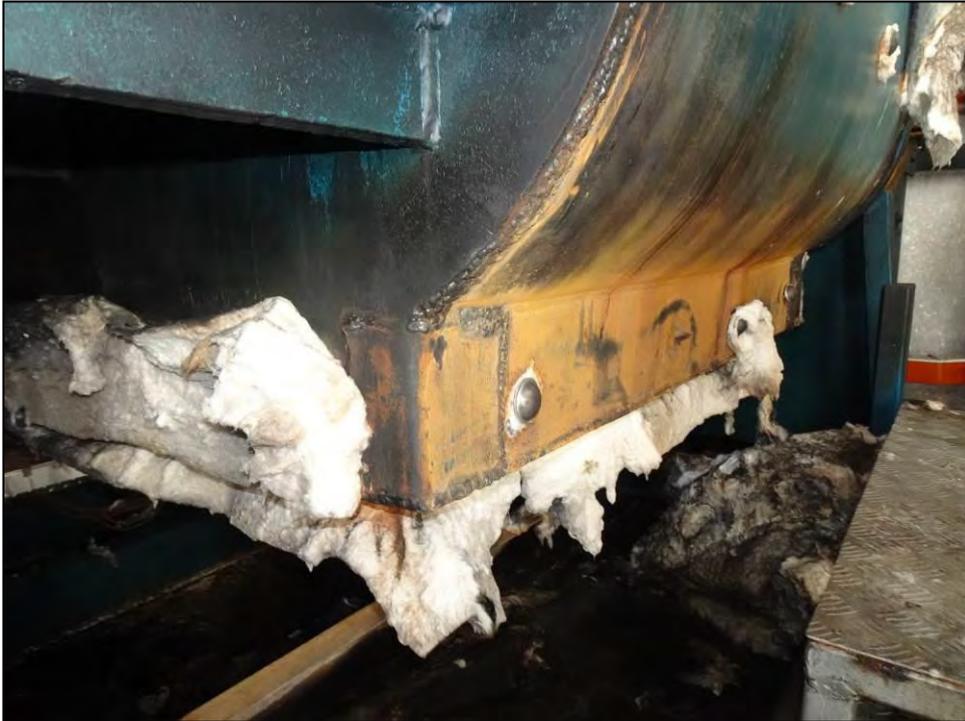
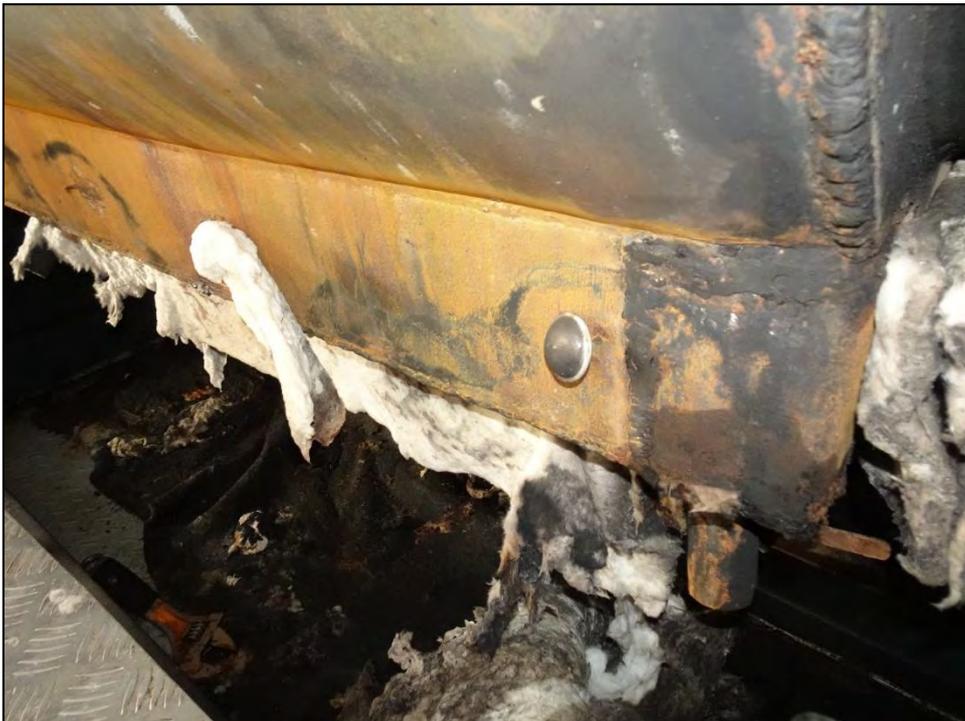
Weld repair area on the oil jacket at the front of the Mixer Machine

42 ➤ Further examination of the weld joints on the front side of the oil jacket revealed
that the bottom-front corner weld joints were weld repaired prior to the fire
explosion incident (Figure 11).

Figure 11: Mixer Machine, Oil Jacket at the Front Side. Examination of the weld joints on the front side of the oil jacket revealed that the bottom-front corner weld joints were weld repaired prior to the fire explosion incident.

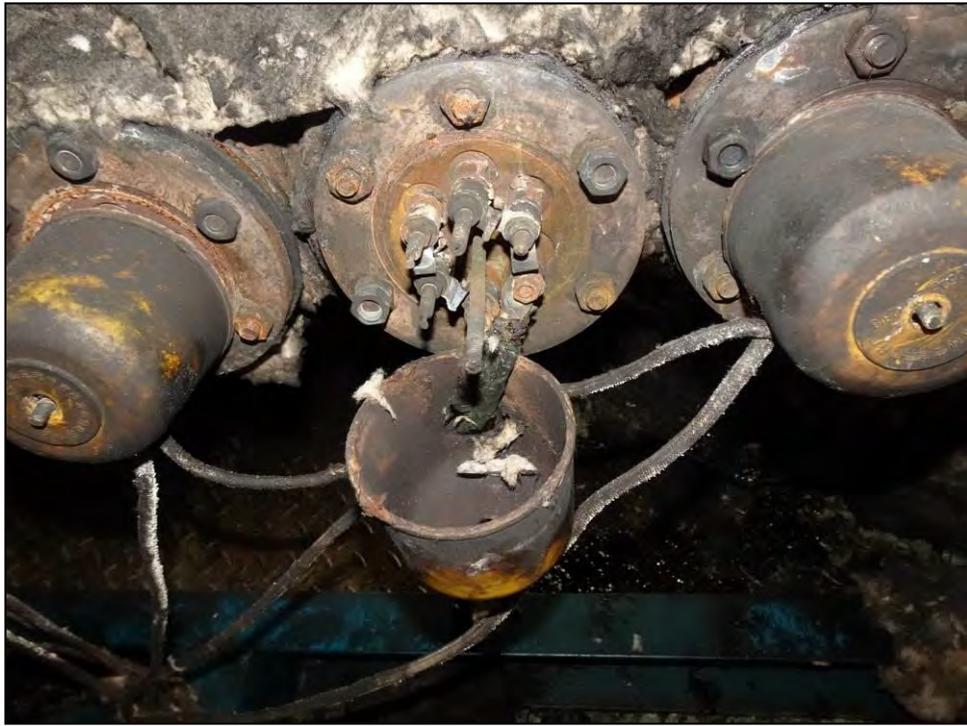
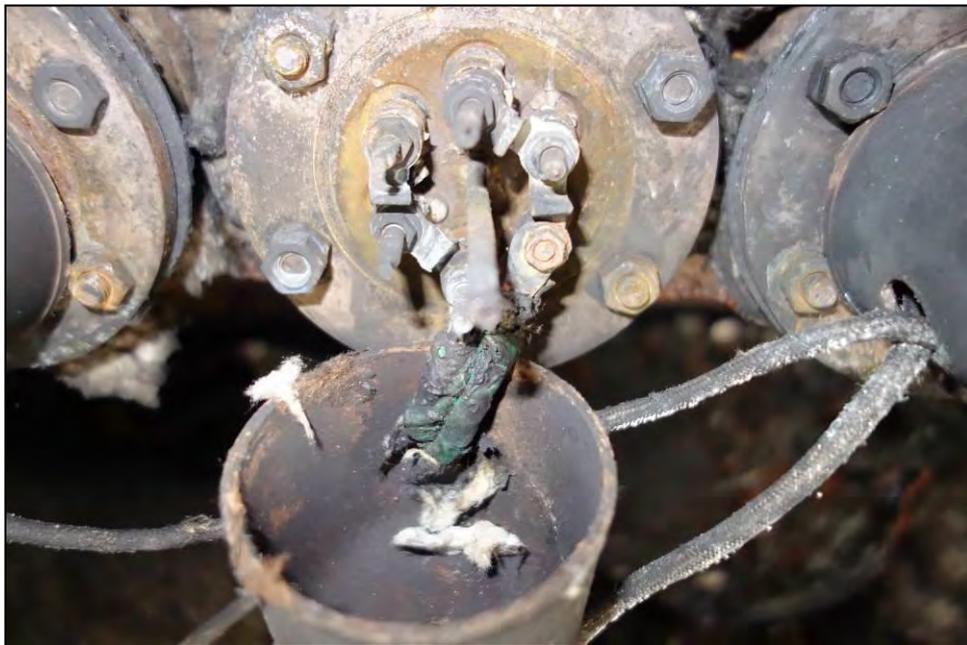
Faulty heater

Figure 12: Mixer Machine, Faulty Heater. Examination of the heaters revealed faulty connections on the second heater.

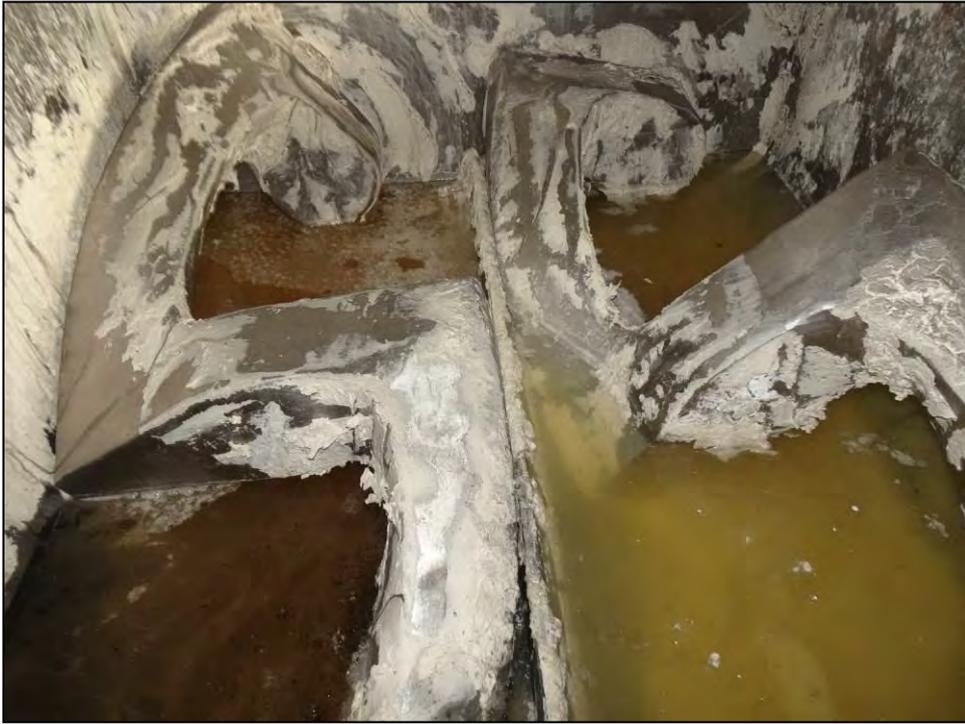
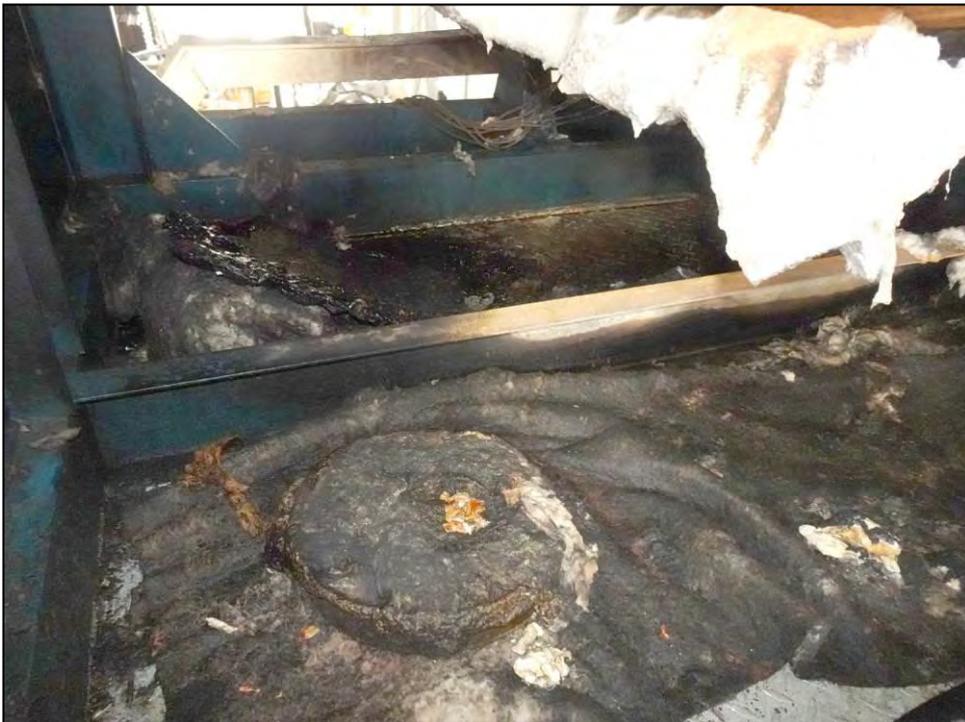
Charred insulation wools on the Platform floor under the oil jacket

Figure 13: **Mixer Machine, Internal Condition and Bottom Area.** The interior of the mixing tank was partially filled with water and dough-form product mixture, apart from the sigma blades. Some remnant insulation wools at the bottom of the Mixer Machine on the Platform floor were charred.

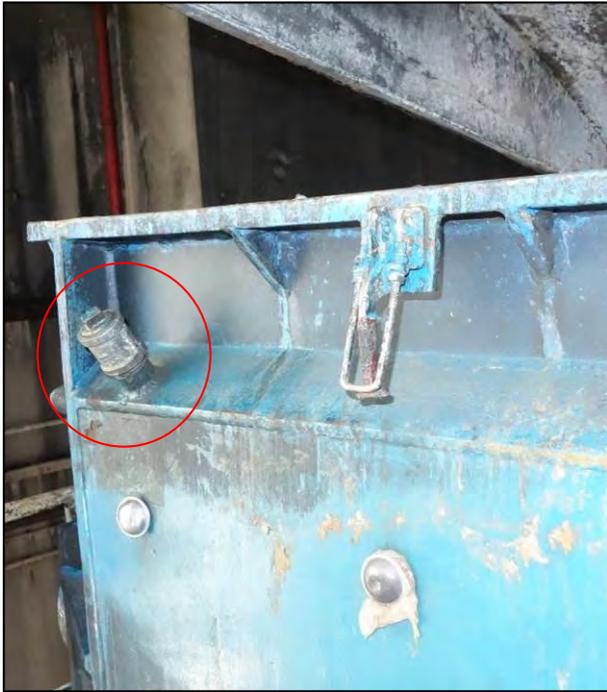
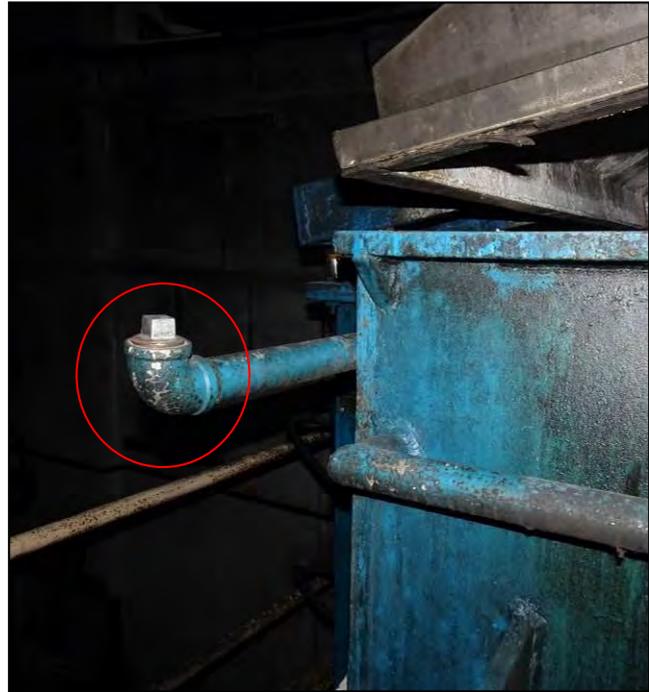
Access port to top up oil (circled, left) and vent port of oil jacket at the rear side (circled, right)

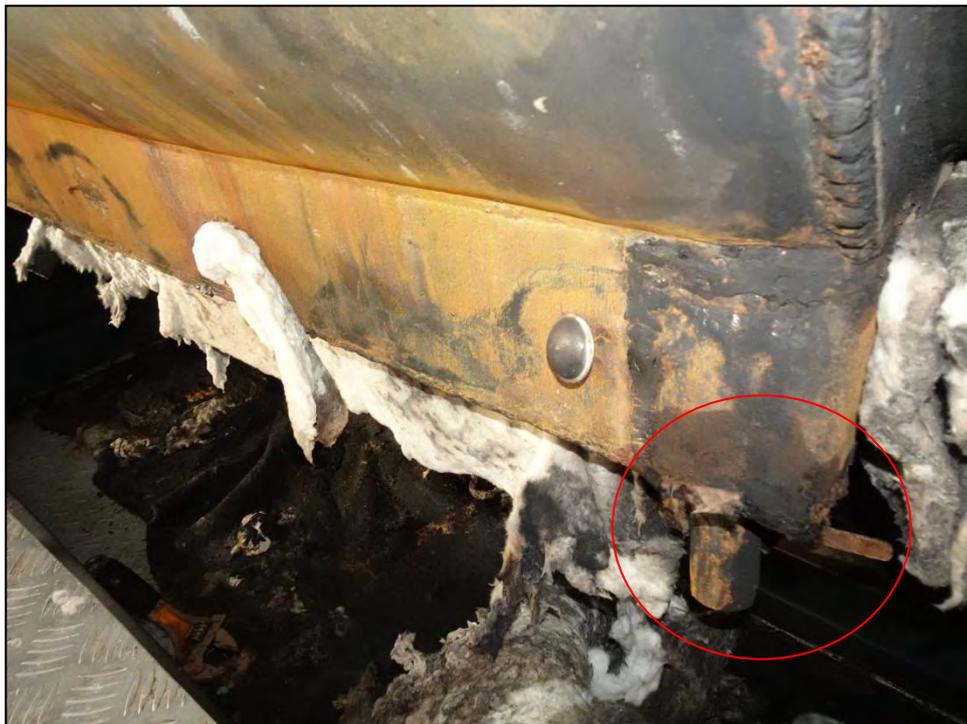
12 ➤ The access and vent ports of the oil jacket were in closed mode at the time of
inspection (Figure 14). The drain port at the bottom of the oil jacket was also in
a closed state.

Drain port for oil jacket (circled)

Figure 14: Mixer Machine, Access, Vent and Drain Ports for Oil Jacket. The access and vent ports of the oil jacket were in closed mode at the time of inspection. The drain port at the bottom of the oil jacket was also in closed state.

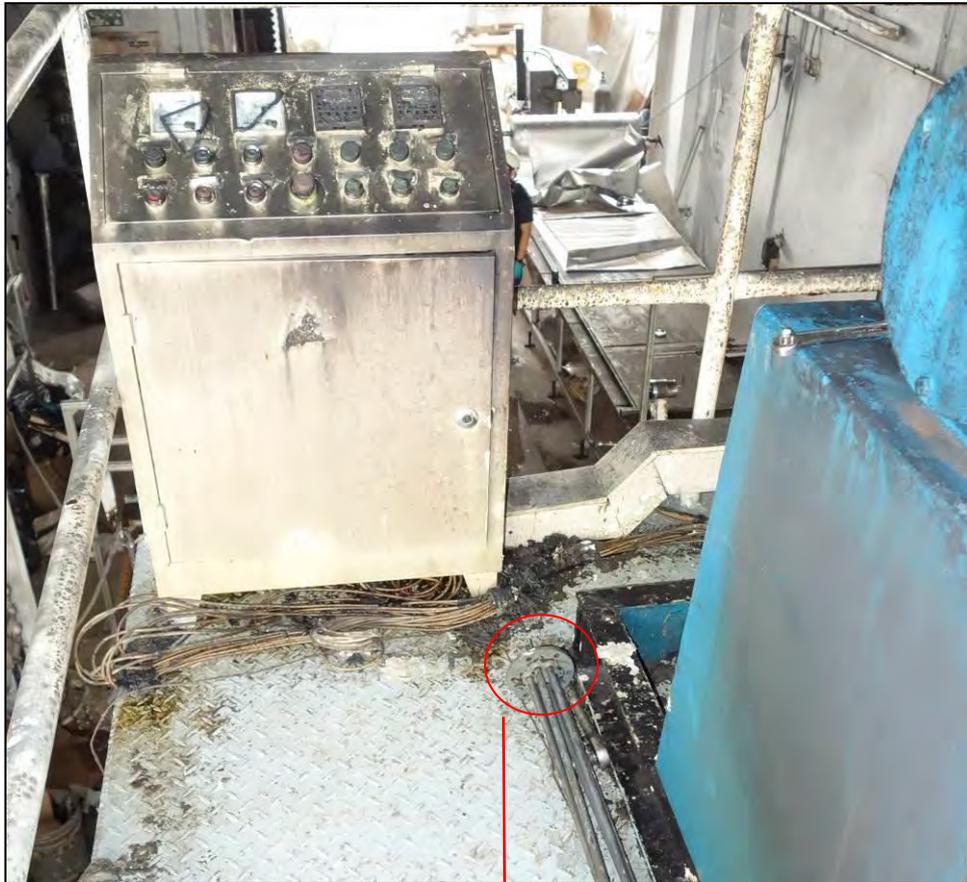
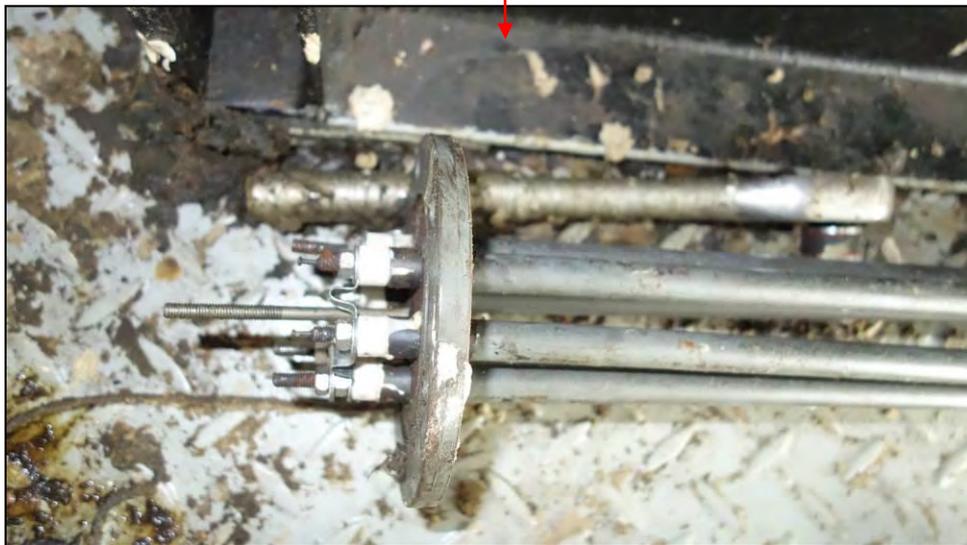
4 ➤ Examinations of the heaters revealed faulty connections on the second coil set
6 (Figure 12). A new heater, that was placed next to the Mixer Machine, appeared
relatively unaffected by the fire explosion (Figure 15).

14 ➤ The electrical switches and buttons as well as the display screens on the
electrical panel were damaged by the fire explosion (Figure 15 and Figure 16).

Electrical panel box (top, left) and new heater (circled)

Figure 15: **Electrical Panel Box and New Heater.** A new heater, that was placed next to the Mixer Machine, appeared relatively unaffected by the fire explosion. The electrical switches and buttons as well as the display screens on the electrical panel box were damaged by the fire explosion.
