**Report of the Inquiry
Committee for the accident
at Stars Engrg Pte Ltd on
24 February 2021
(PART II – ANNEXES)**

TECHNICAL REPORT

| Title of Report: Failure Analysis of a Failed Mixer Machine Retrieved from Unit 32E of Platinum @ Pioneer Building involved in a Fire Explosion Incident | | Date of Last Revision/Revision No: |

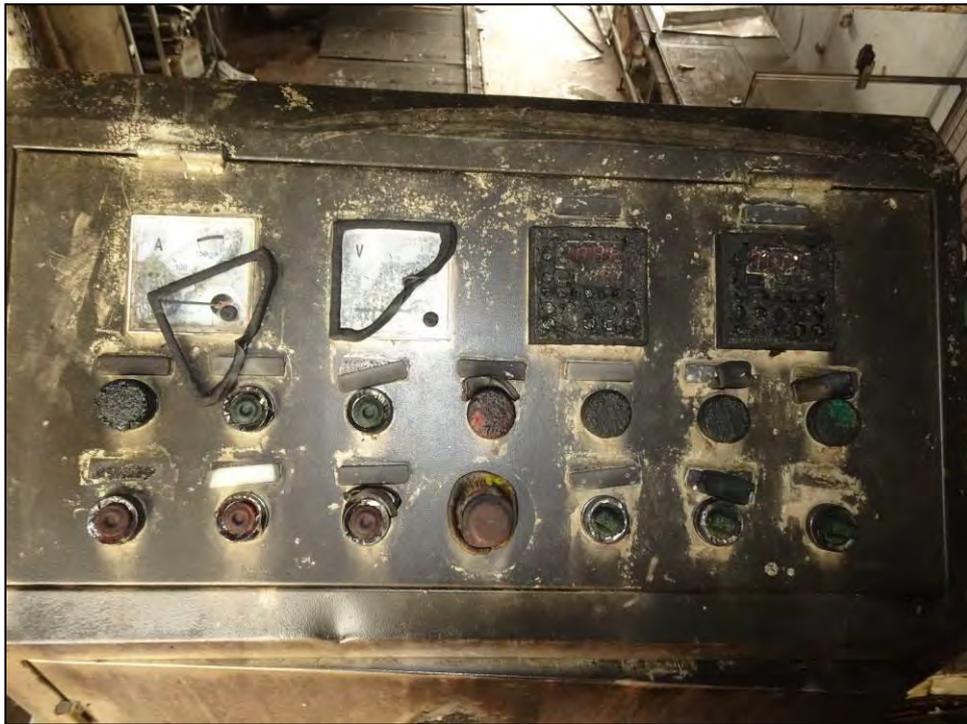
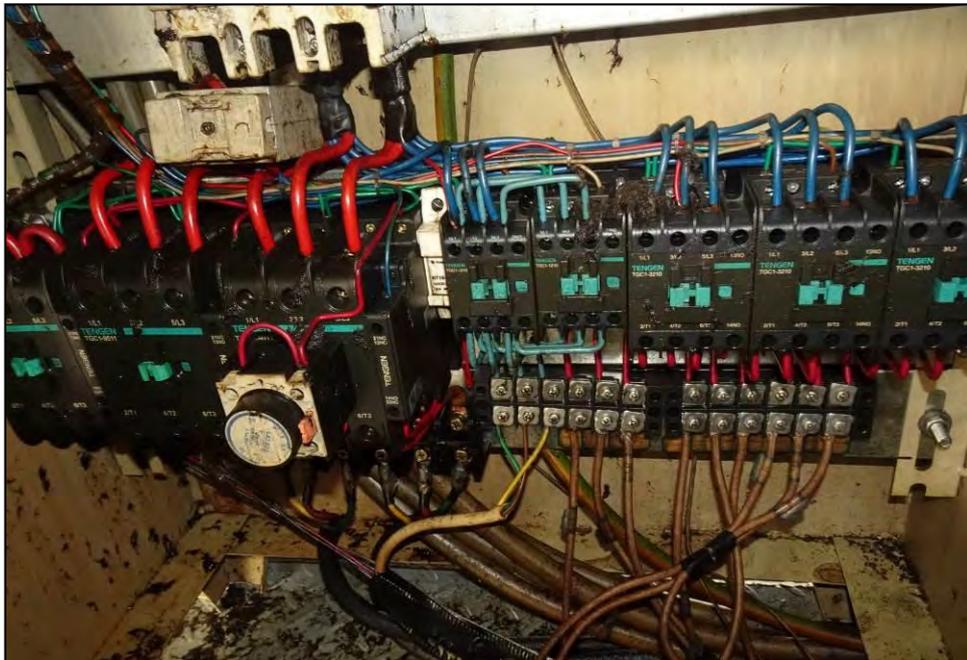
14 ➤ The electrical switches and buttons as well as the display screens on the
electrical panel were damaged by the fire explosion (Figure 15 and Figure 16).

16 ➤ The electrical circuit system within the panel box appeared relatively intact
(Figure 16).

Partially melted electrical switches and buttons

Intact electrical wiring within the panel box

Figure 16: **Electrical Panel.** The electrical switches and buttons as well as the display screens on the electrical panel were damaged by the fire explosion. The electrical circuit system within the panel box appeared relatively intact.

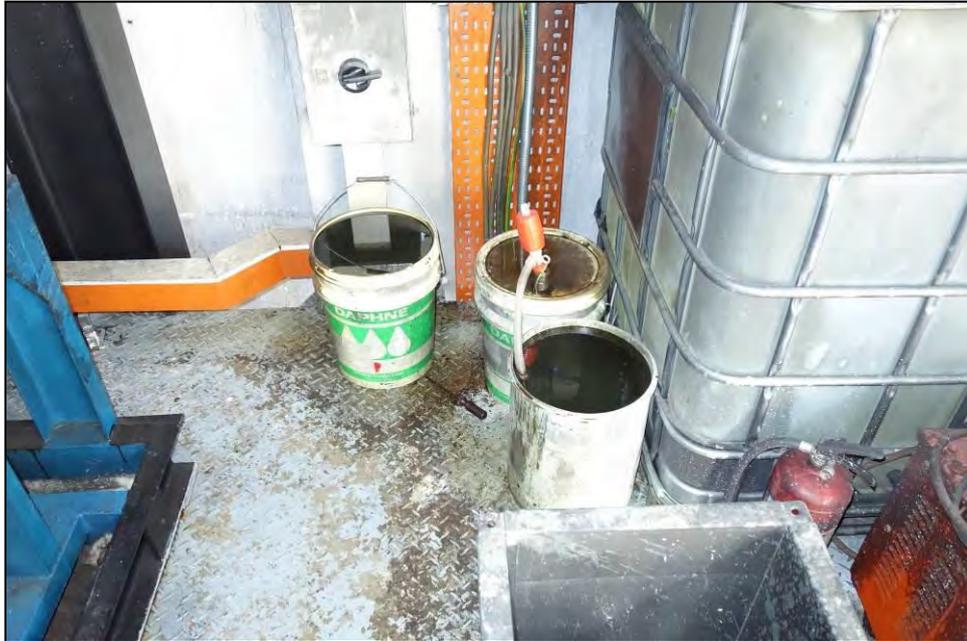
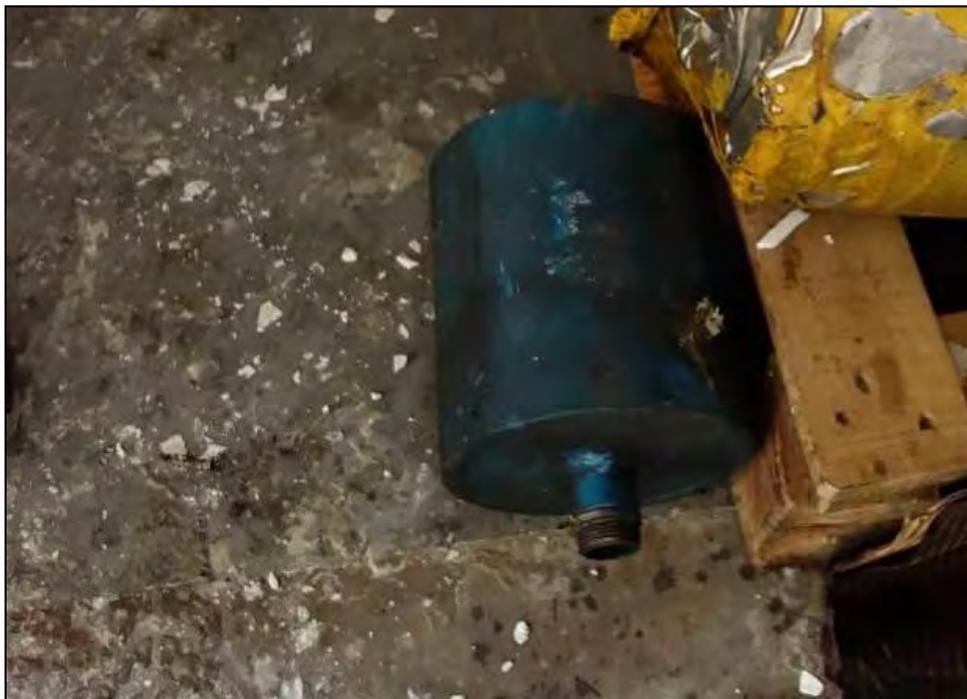
18 ➤ Three oil tubs, which were contaminated by water, were found on the Platform
floor next to the hopper (Figure 17).

20 ➤ The oil funnel, which was used to top up oil in oil jacket, was found on the
ground floor at the time of inspection (Figure 17).

Oil pails on Platform floor

Oil funnel

Figure 17: **Oil Pails and Funnel.** Three oil tubs, which were contaminated by water, were found on the Platform floor next to the hopper. The oil funnel was found on the ground floor at the time of inspection.

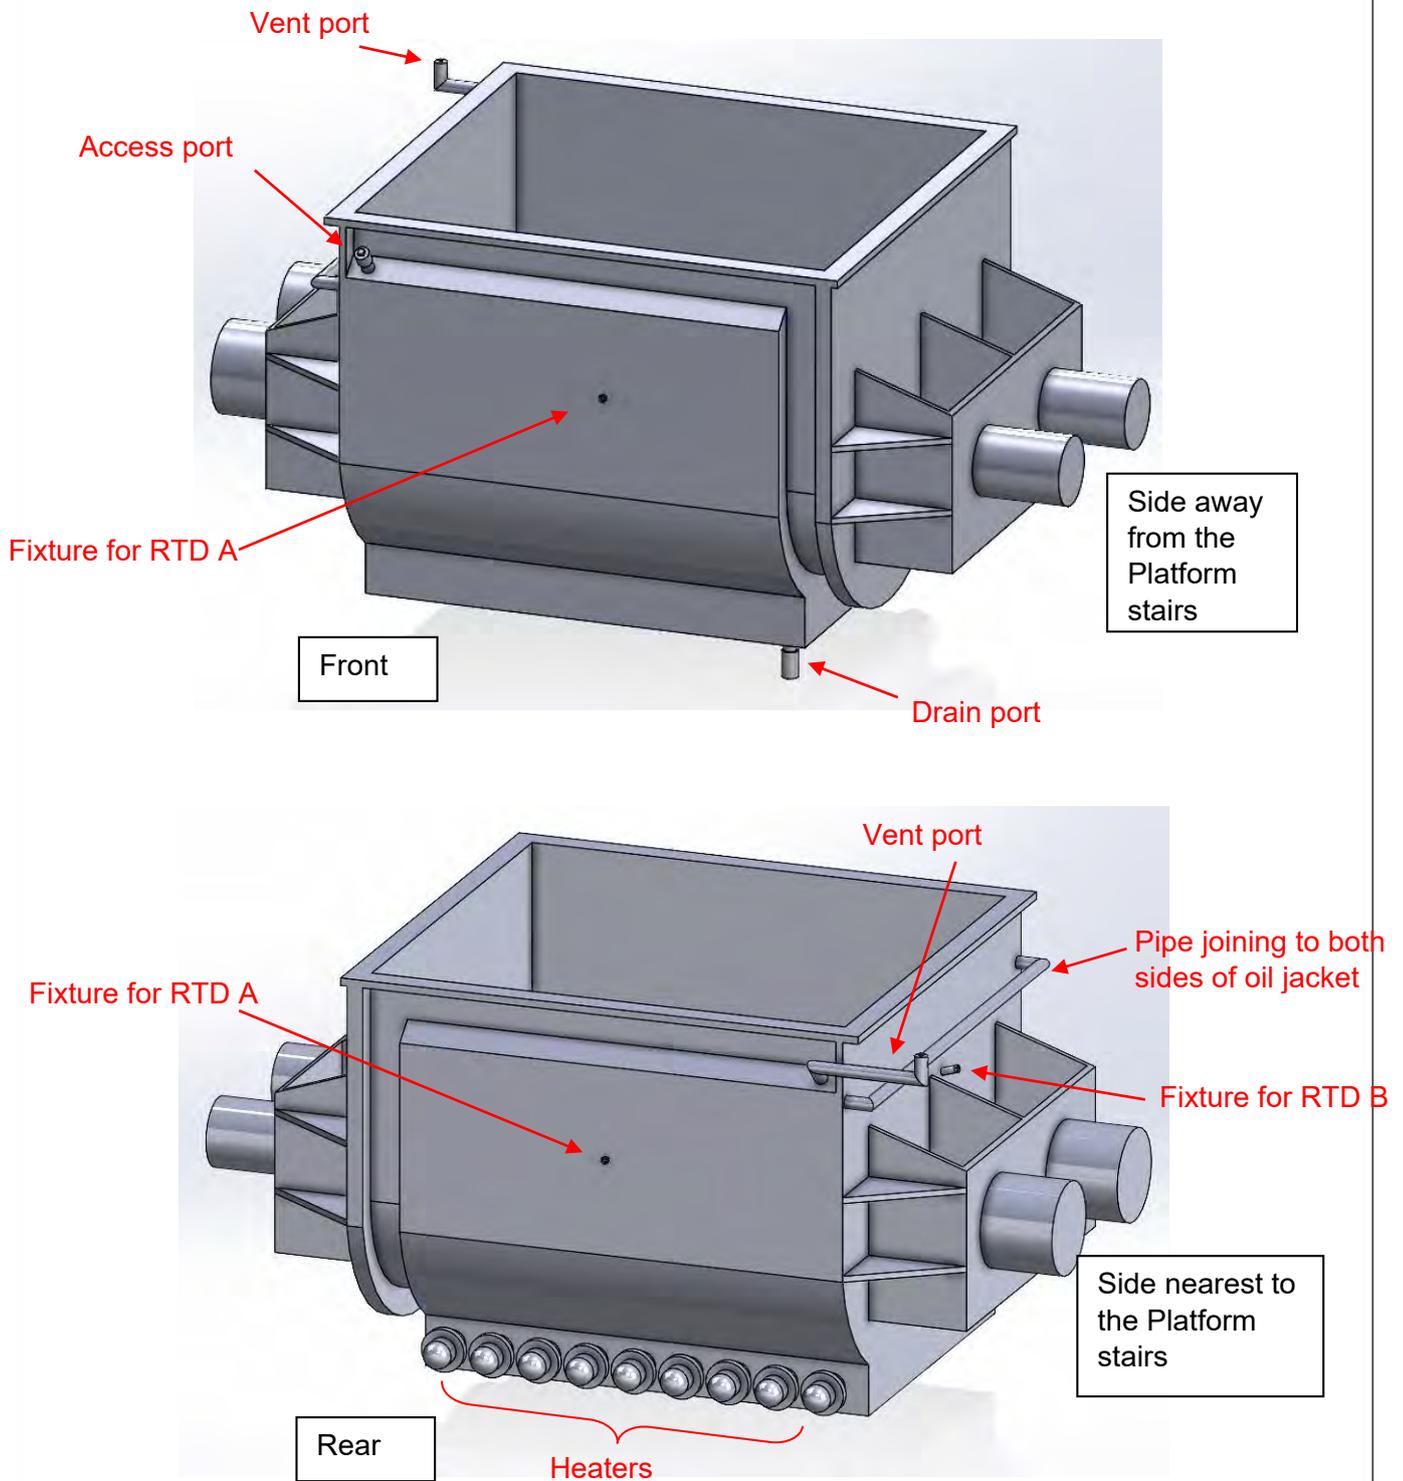
Figure 18: Mixer Machine and some used terminologies.

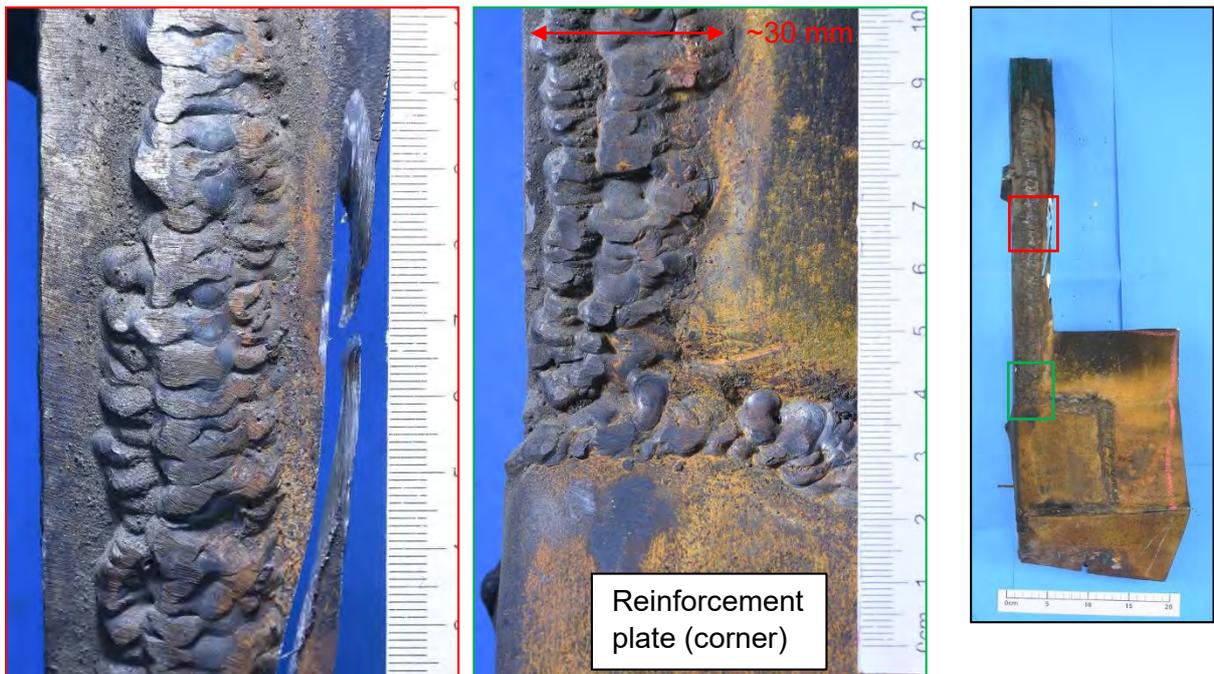
- 6 ➤ At the front side, left edge weld, the face width³ of the repair weld increased towards the bottom, measuring up to about 30 mm (Figure 42 and Figure 43).
- The weld root of the original weld had an irregular shape (Figure 46).
- 8 ➤ The root of the repair weld had a root surface width of about 4 mm and increased up to 9 mm towards the bottom. Some areas of the weld root had gaps and lack of penetration⁴ (Figure 46 and Figure 47).
- 10 ➤ A sector near the bottom end of the curved part (just above the vertical plane) an insert plate with length of 120 mm was observed at the weld root (Figure 47). See also Section 3.4 for chemical analysis and Figure 153 for cross sectional examination.
- 12
- 14

Figure 43: Close up view of side weld. The face width of the weld increases towards the bottom and reinforcement corner plate. The face width was up to about 30 mm.

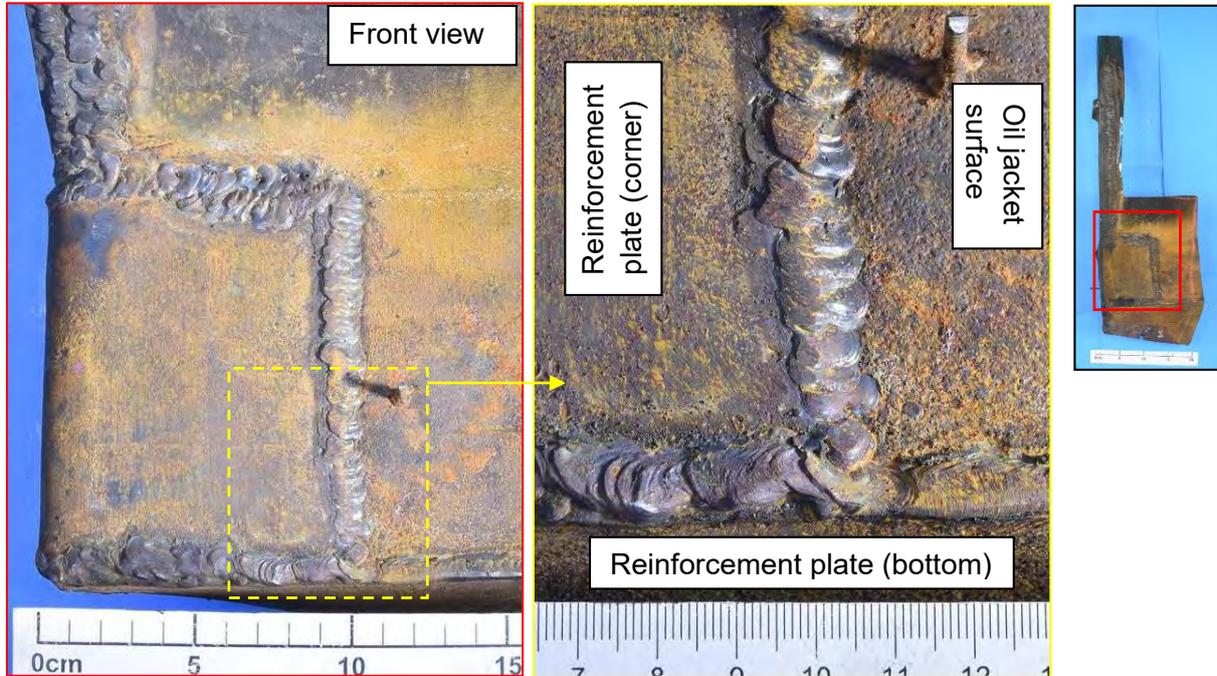
Figure 44: Close up view of bottom corner. The reinforcement plate was added at the corner by welding.

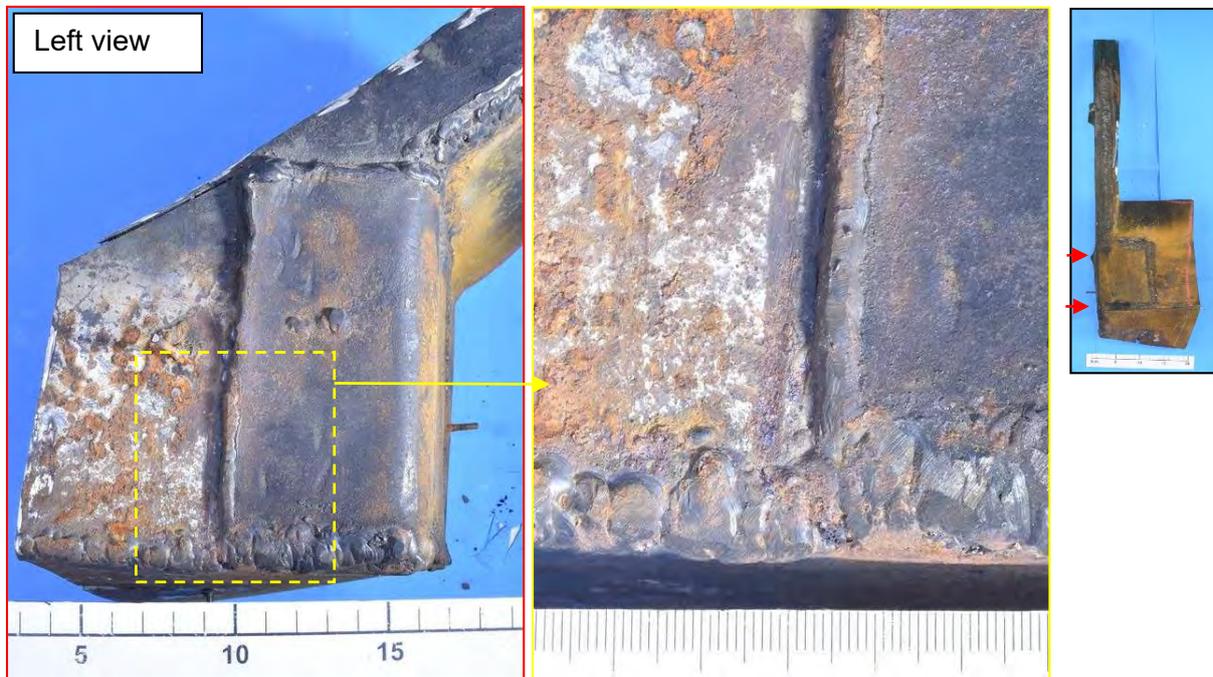
Figure 45: Close up view of bottom corner from another angle. Similar welding done to the oil jacket wall to add the reinforcement plate.

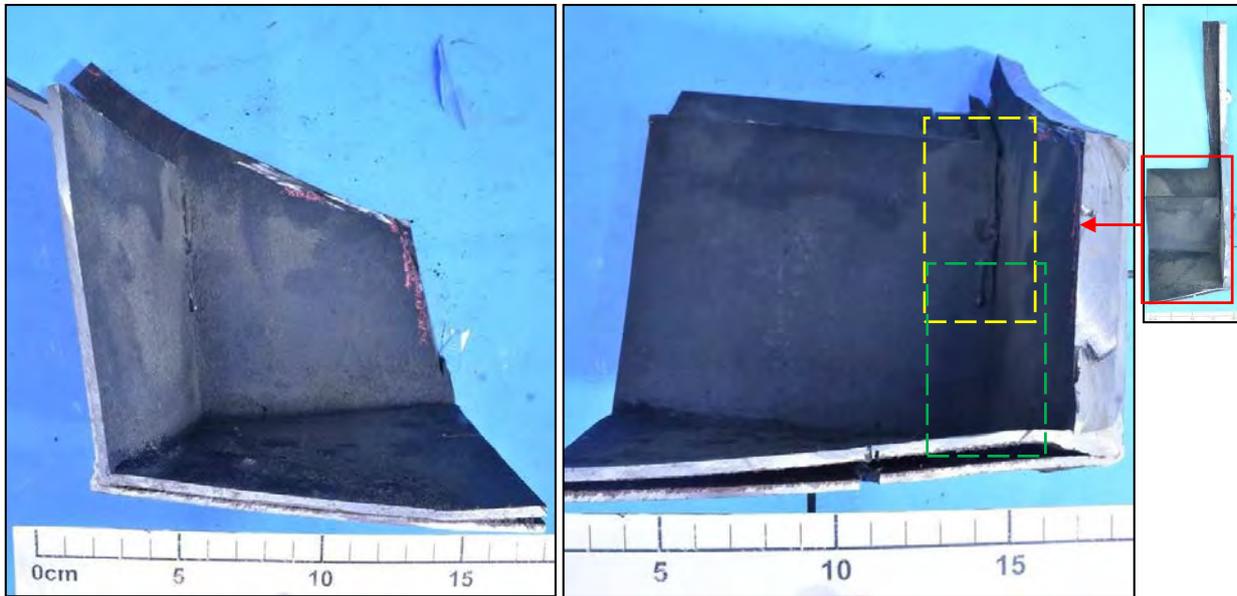
Figure 48: Condition of the internal surface of oil jacket corner. Close up views presented below with their respective colour borders.

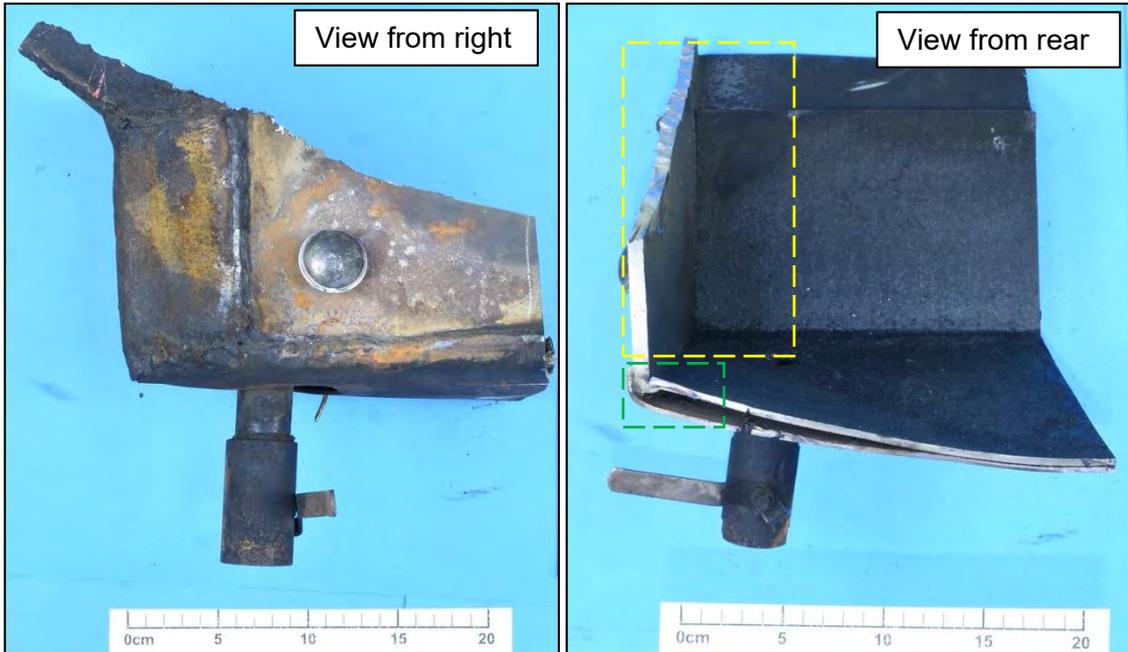
Figure 53: Condition of the internal surface of oil jacket corner. Close up views presented below with their respective colour borders.

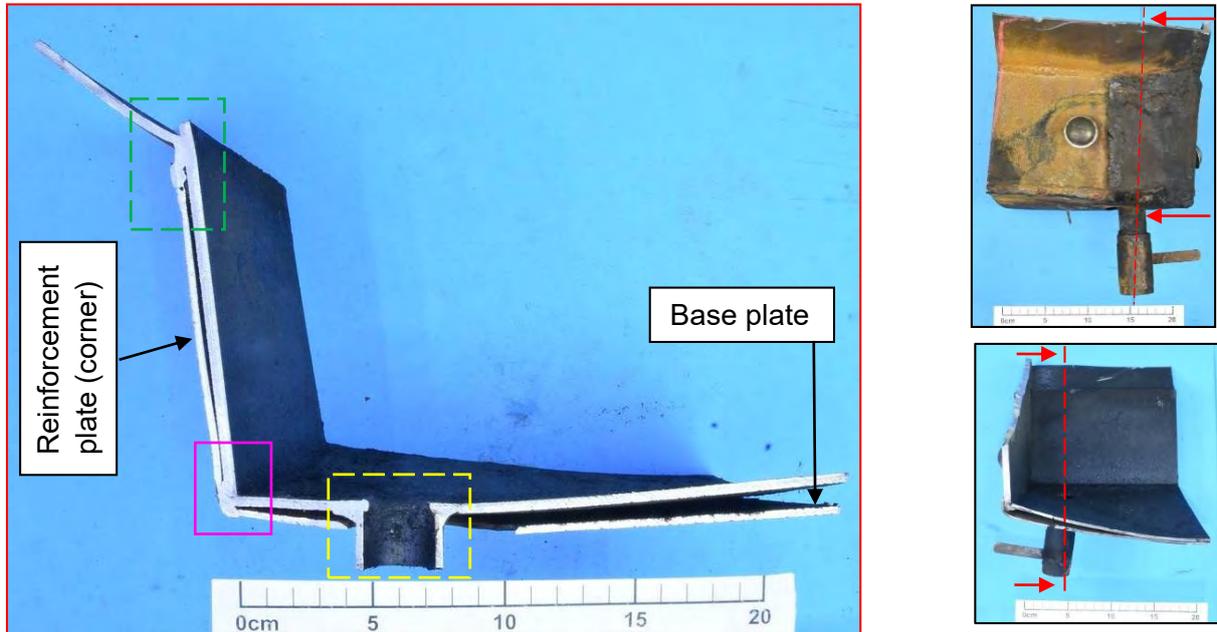
Figure 55: A cross section was made vertically across the drain port, revealing the weld configuration of the corner plate, base plate and the drain port weld. Close up views presented below with their respective colour borders.

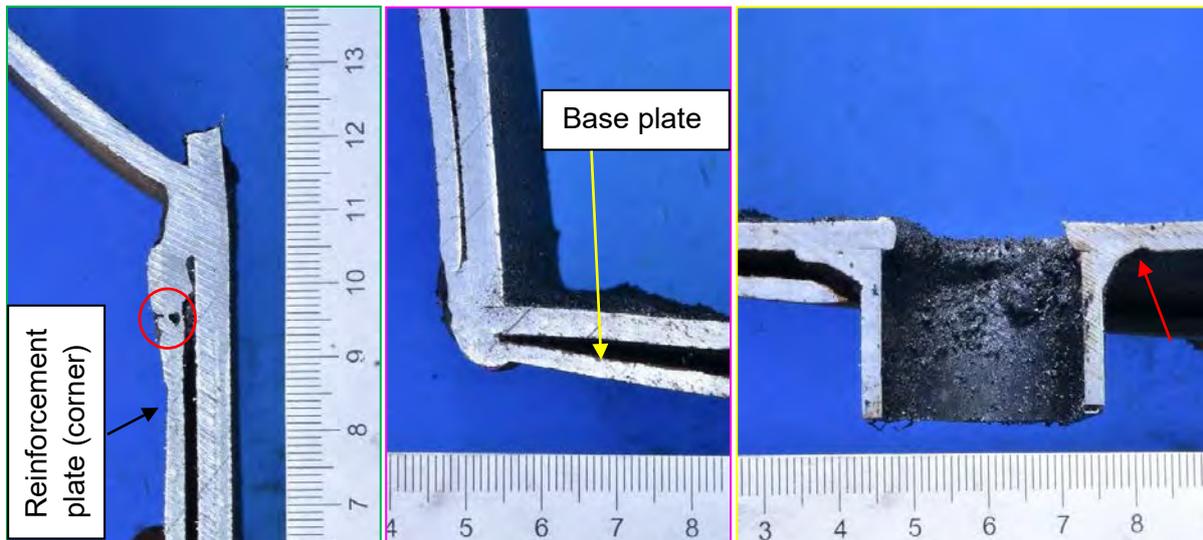
Figure 56: Cross section revealed the corner and base plates were welded together at the bottom edge of the oil jacket (middle figure). Void was visible at the corner reinforcement plate weld (left figure). The drain port weld had an undercut at the weld toe (right figure).

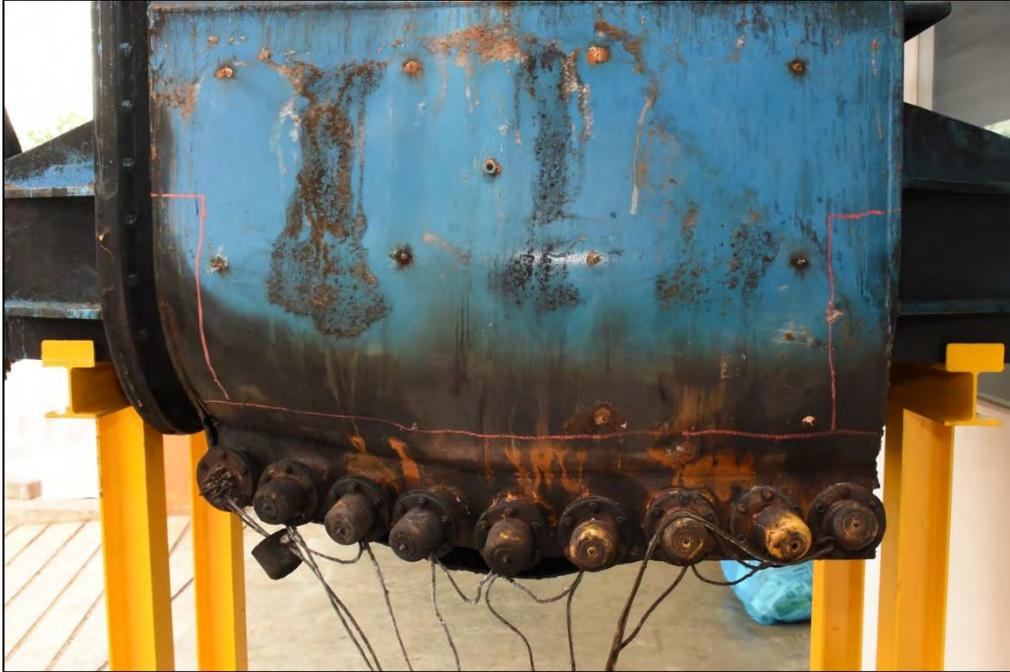
Figure 57: Marked out locations on the front for detailed examination.

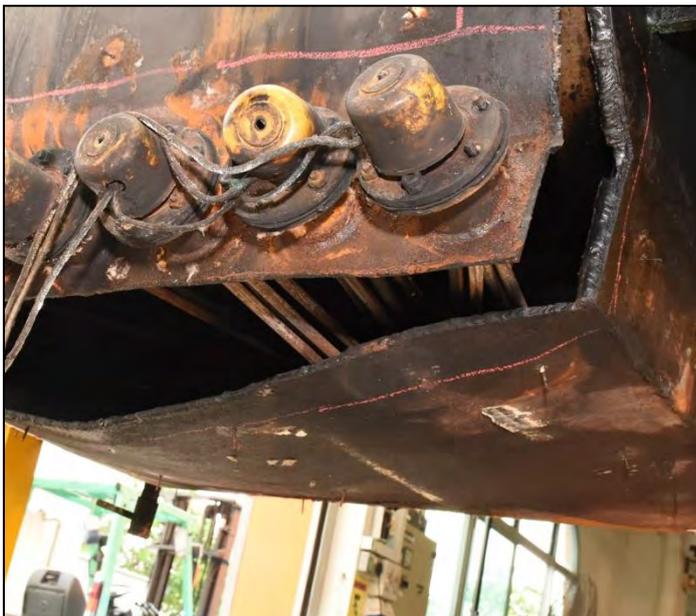
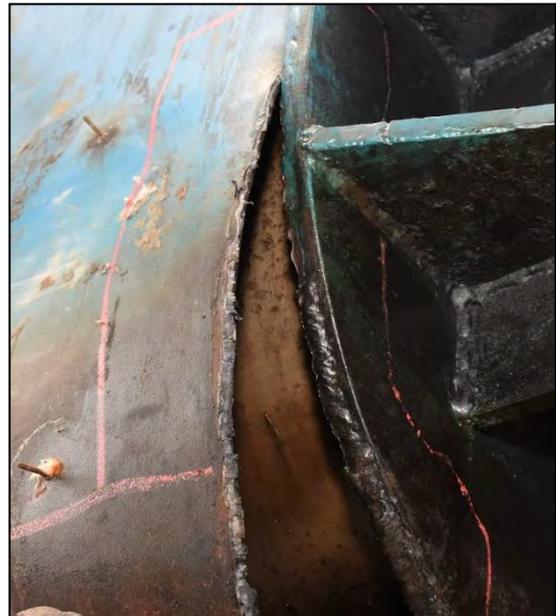
Figure 58: Marked out locations on the rear edges and corners for detailed examination.

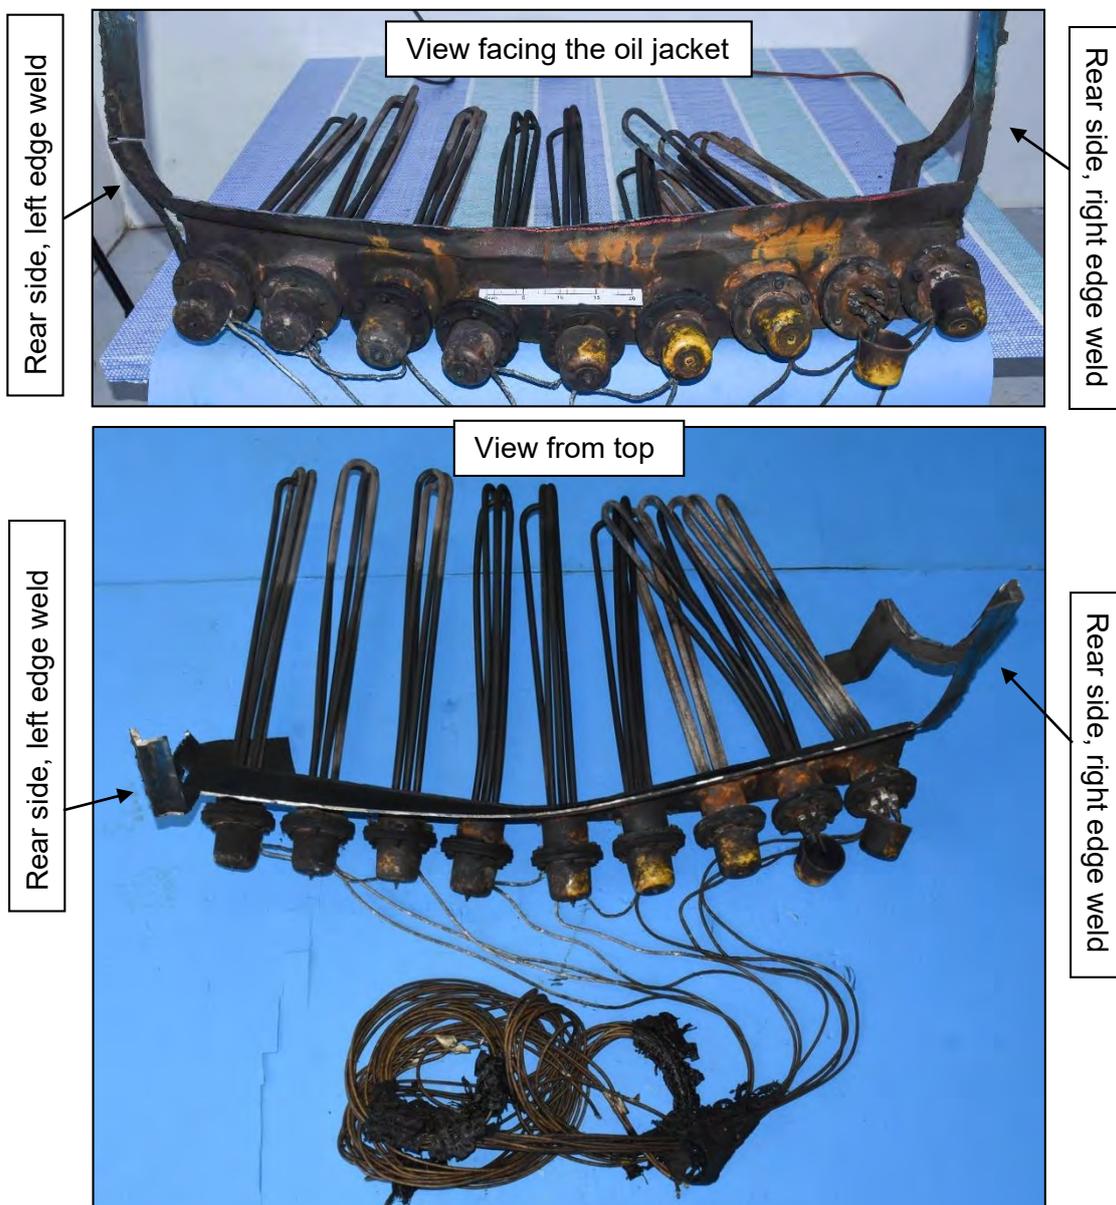
Figure 61: Cut out section consisting of the side welds and heaters. The side welds are referenced as rear side, left edge and rear side, right edge welds.

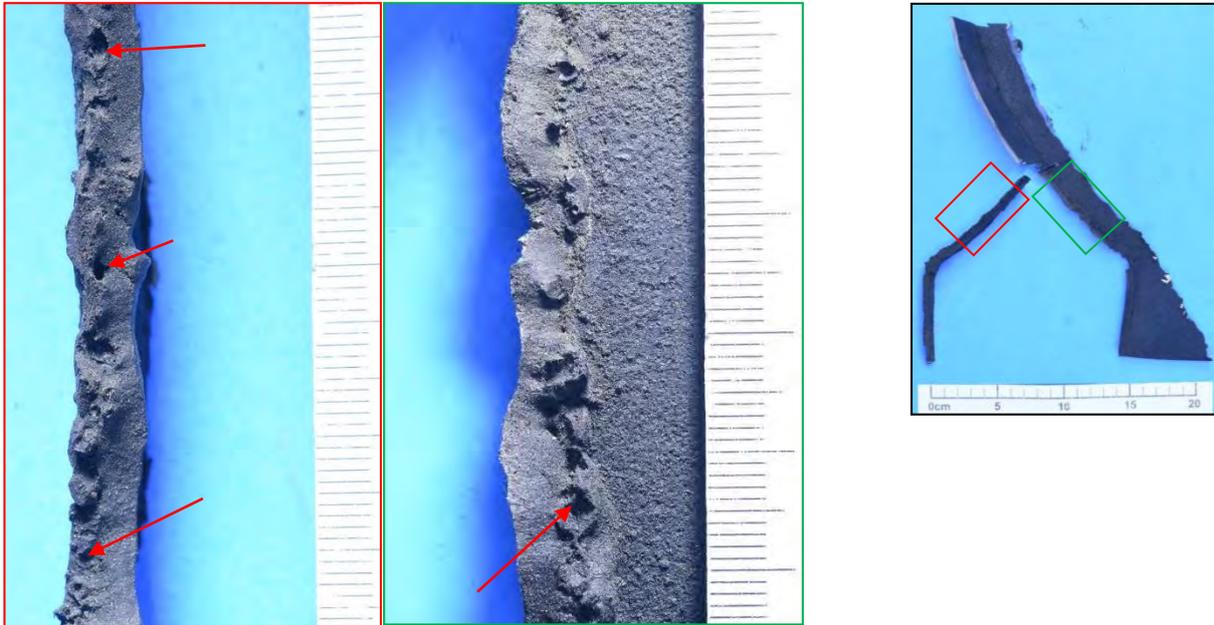
Figure 63: Close up view of side weld fracture surface at the curved part. Voids were visible along the fracture surface. (see also Figure 119)

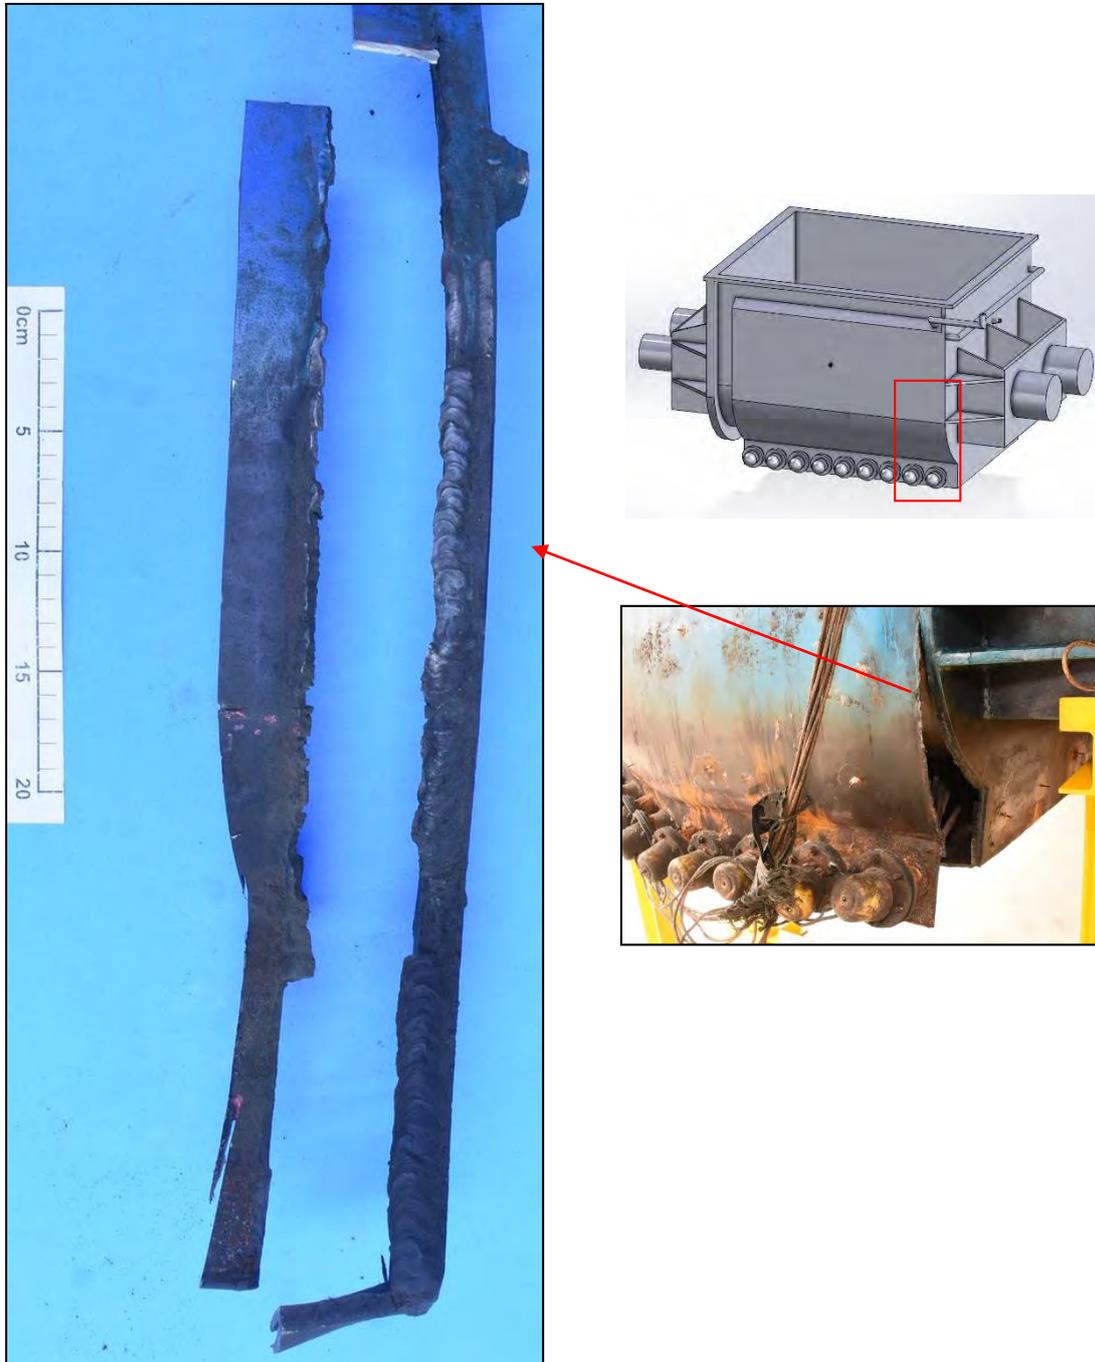
Figure 65: Cut out section of the rear side, right edge weld. The observations made in the following figures were generally similar to the rear side, left edge weld. (see also Figure 62)

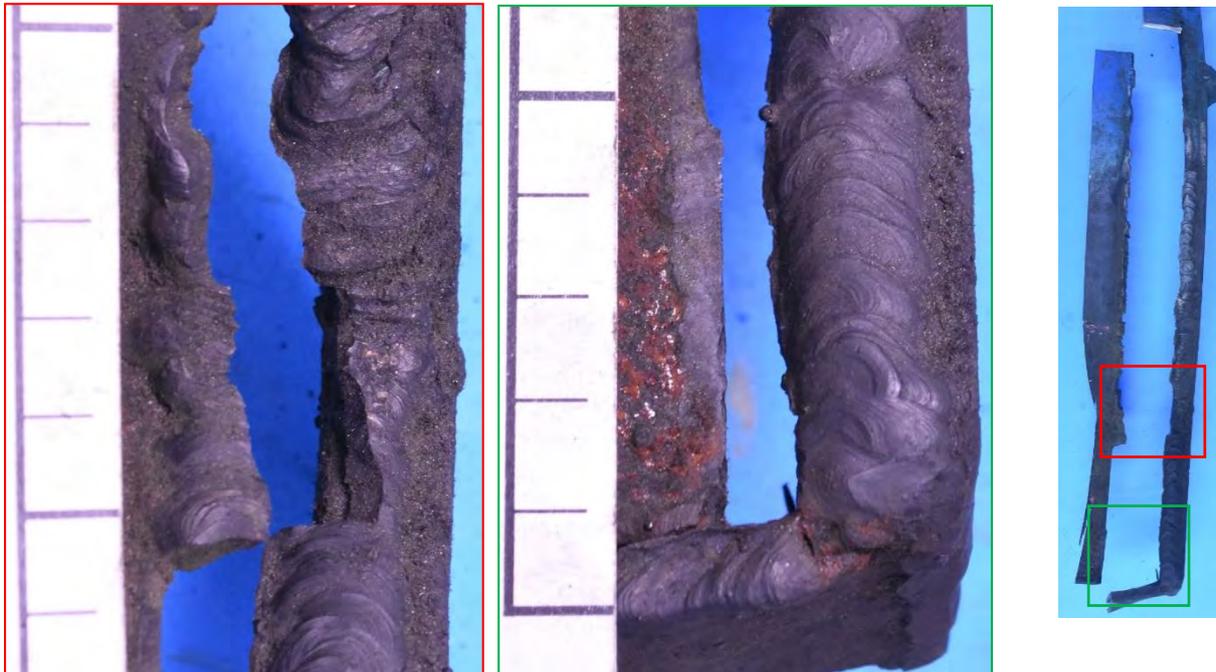
Figure 67: Close up view of side weld fracture surface at the straight and vertical part. The fracture path changes and propagated along the weld toe at the vertical plane of the oil jacket.

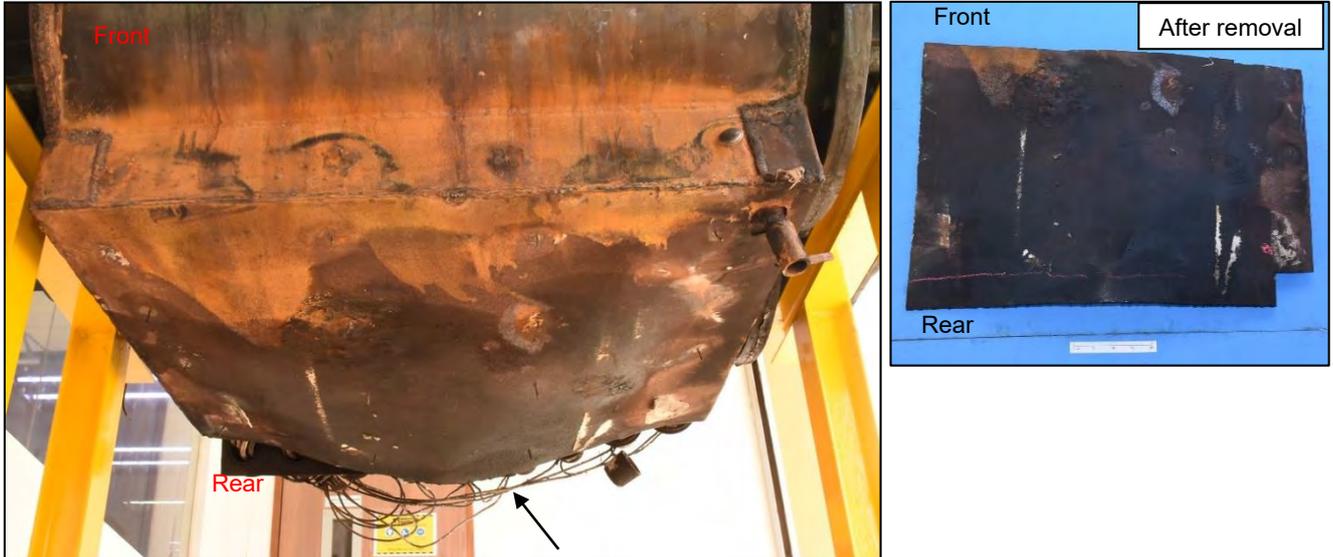
Figure 69: Bottom view of the Mixer Machine. The rear side bottom had bulged outwards.

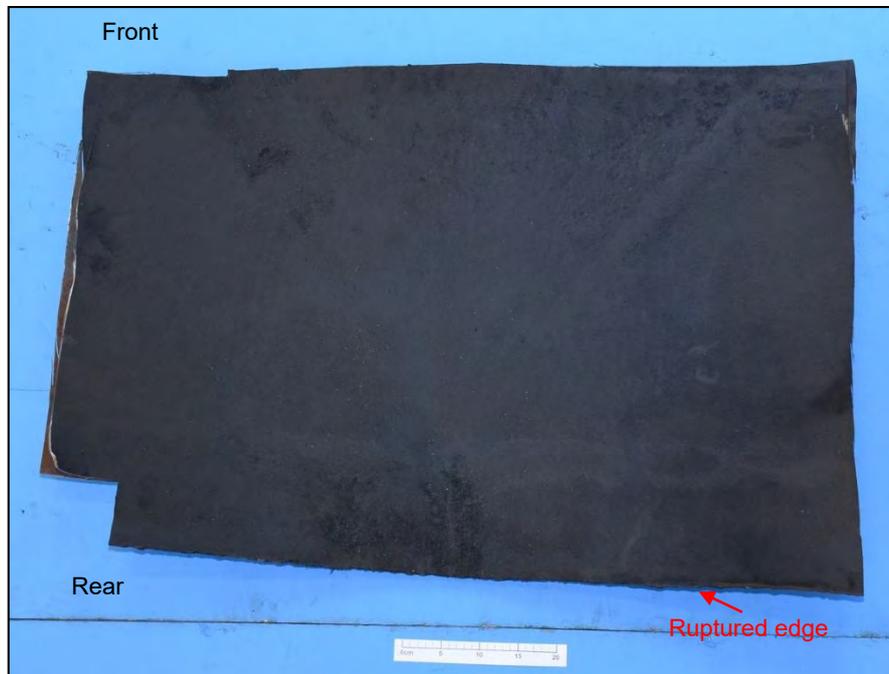
Figure 70: Internal condition of the bottom face. The internal surface was generally covered in black soot.

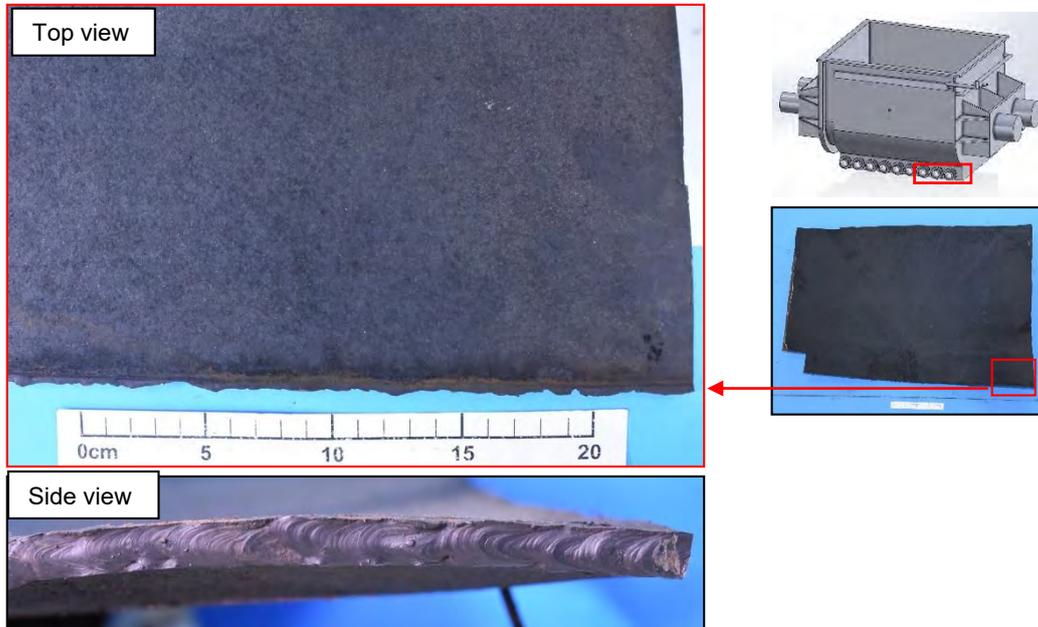
Figure 71: Close up on weld condition of the bottom plate. The fracture was generally along the weld toe.

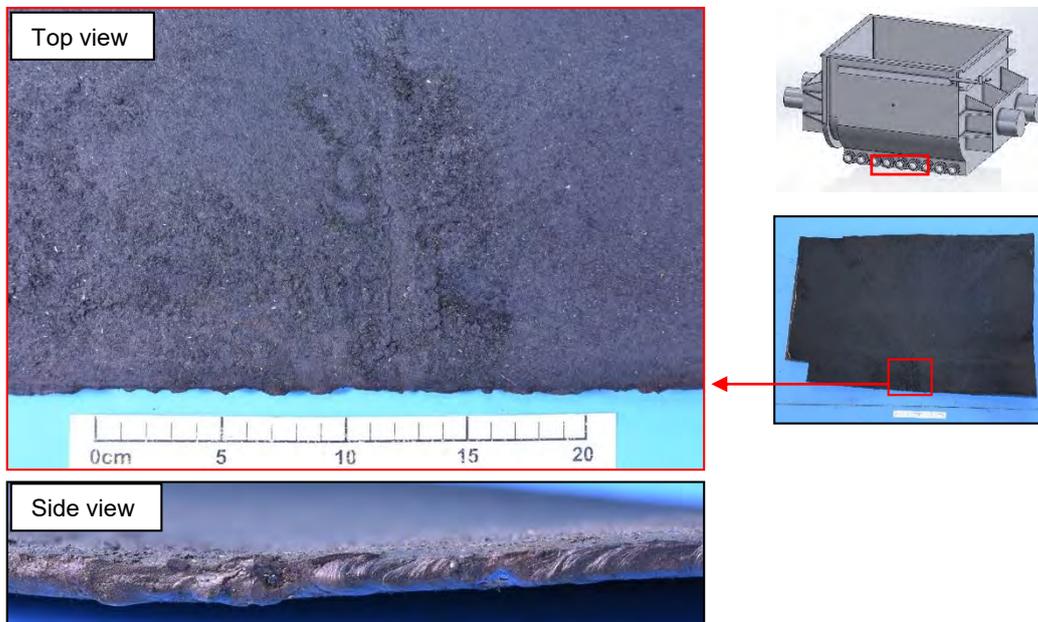
Figure 72: Close up on weld condition of the bottom plate. The fracture was generally along the weld toe.

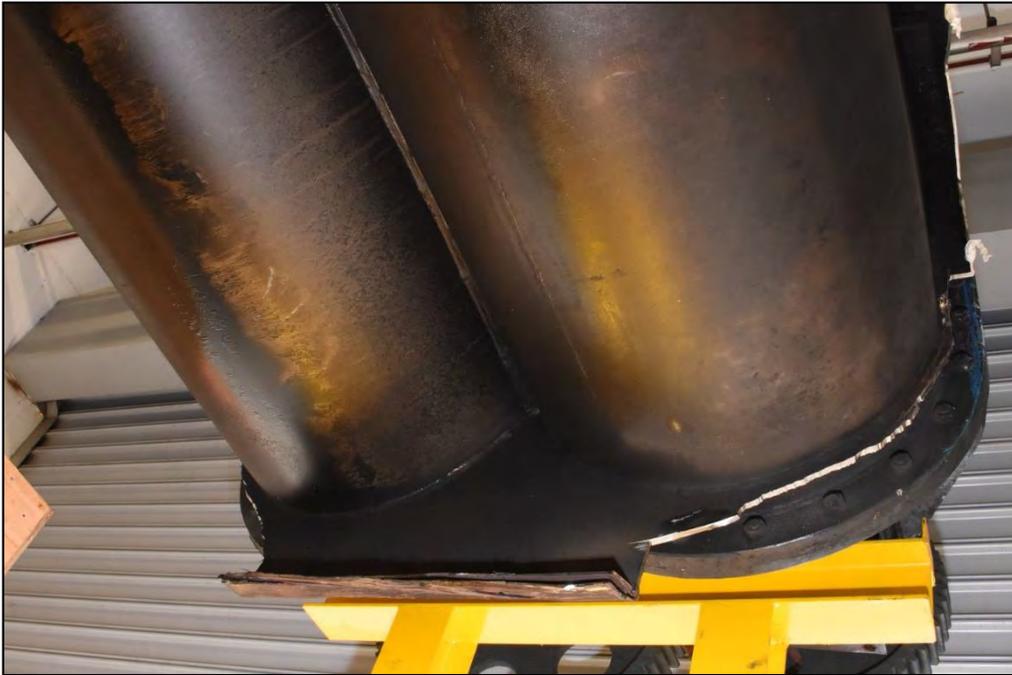
Figure 73: Internal condition of the oil jacket surface, view from the bottom showing the “W” shape of the mixing chamber formed by joining two half cylinders. Surface was generally covered with soot and oil remnant.

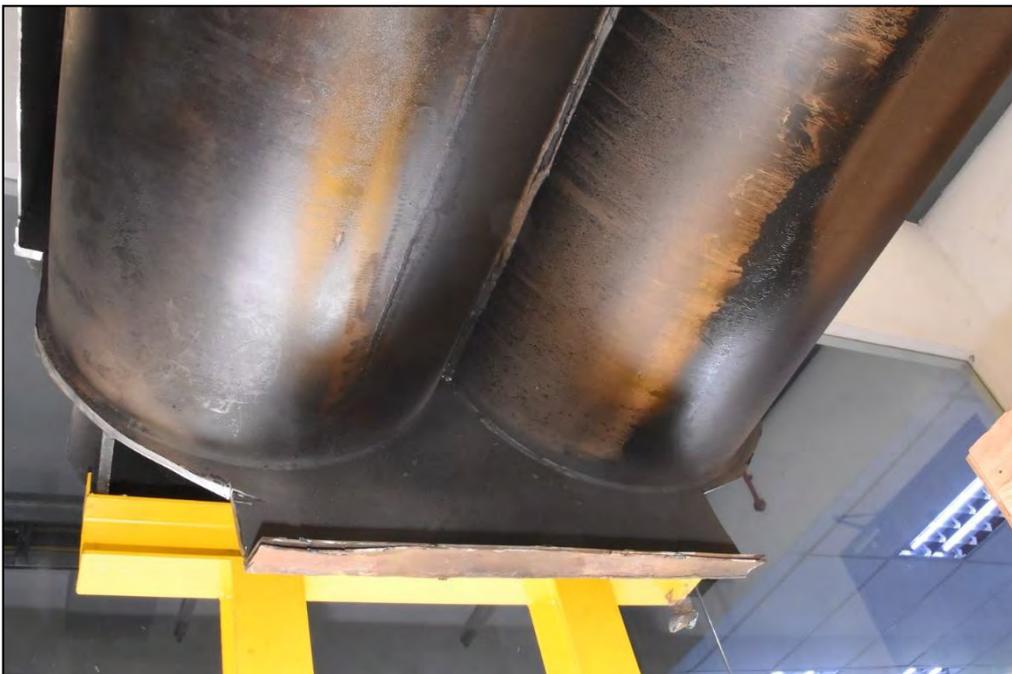
Figure 74: Internal condition of the oil jacket surface, view from the bottom. Surface was generally covered with soot and oil remnant.

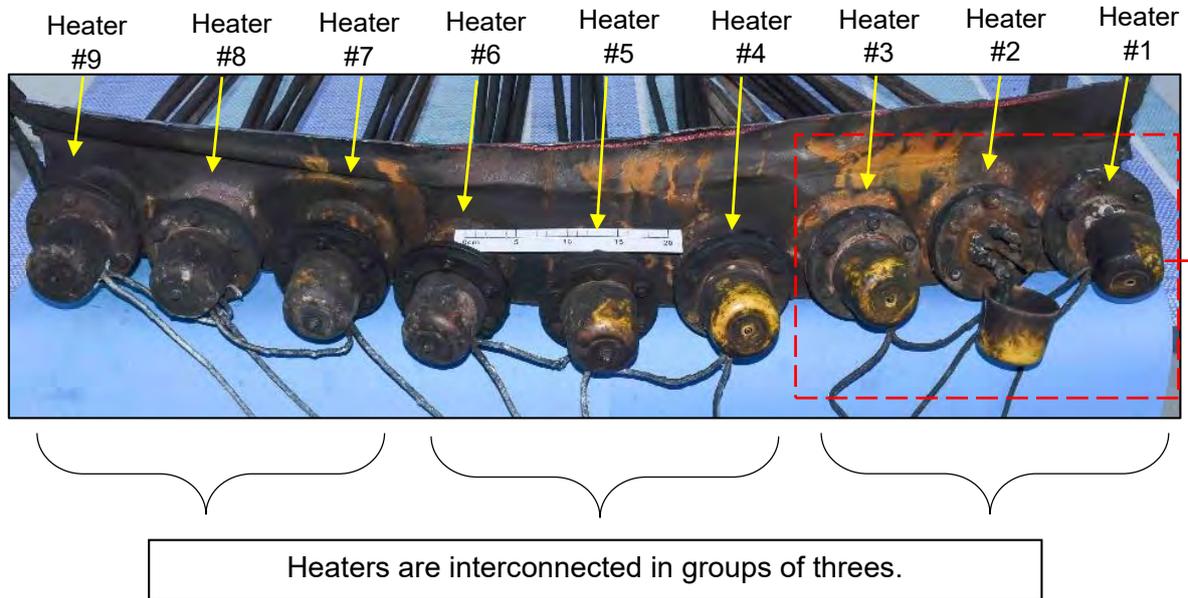
Figure 75: From right, heaters are referred to as heater #1 to #9.

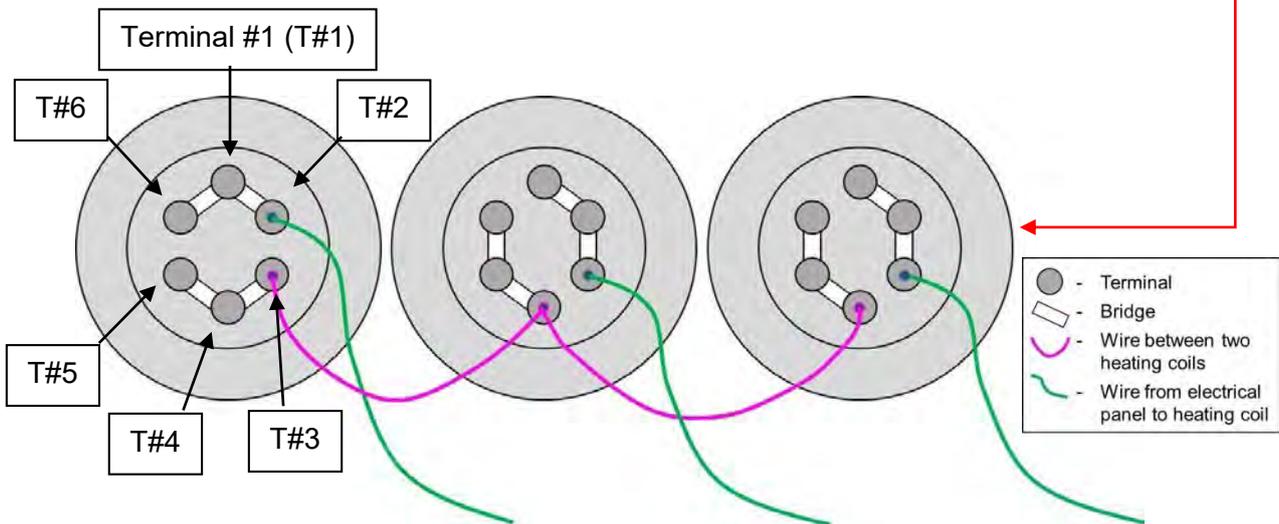
Figure 76: For ease of reference, the terminals are numbered clockwise in increasing order, starting from the topmost terminal as terminal #1. Each heater is connected in two ways. First, each heater is connected to the electrical panel by a wire between the electrical panel and one of its terminals. Second, within each group of three heaters, two wires connect the middle heater to each of the heaters on its left and right side by one of their terminals. The position of the connected terminals and terminal bridges vary depending on the flange orientation during bolting.
