**Report of the Inquiry
Committee for the accident
at Stars Engrg Pte Ltd on
24 February 2021
(PART II – ANNEXES)**

TECHNICAL REPORT

| Title of Report: Failure Analysis of a Failed Mixer Machine Retrieved from Unit 32E of Platinum @ Pioneer Building involved in a Fire Explosion Incident | | Date of Last Revision/Revision No: |

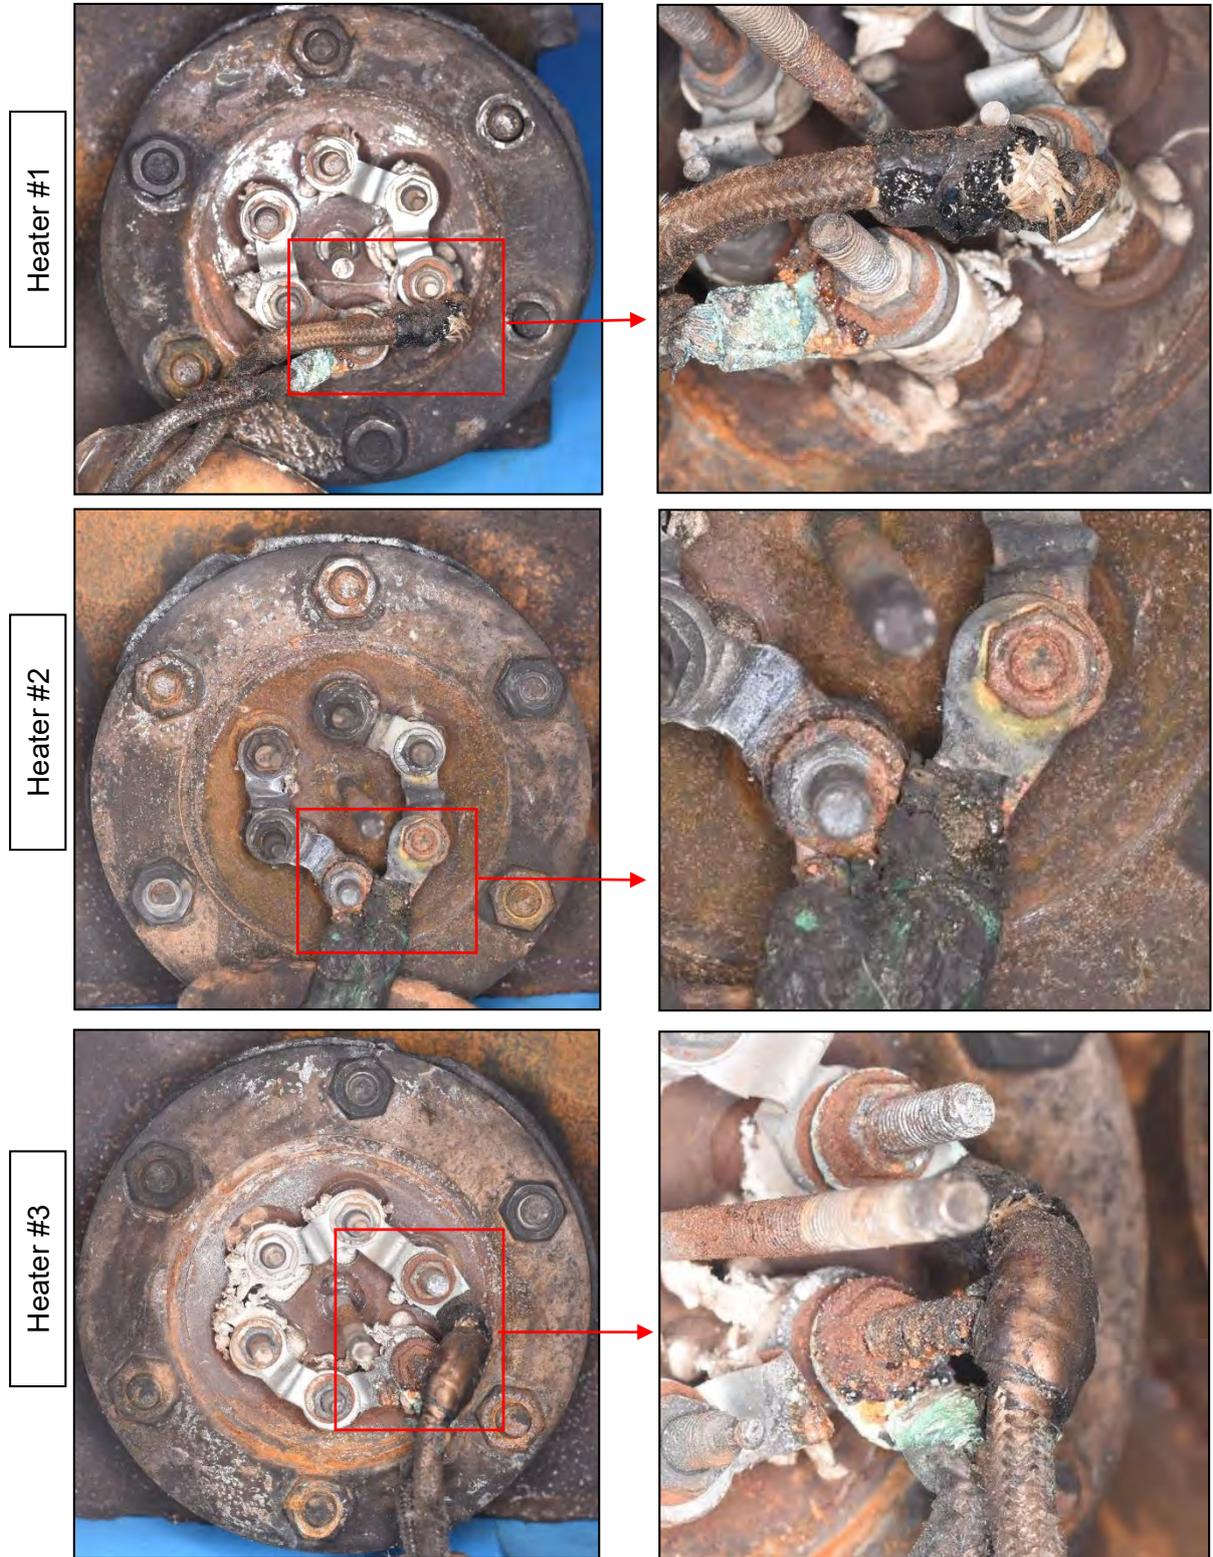
Figure 78: From top, heaters #1, #2 and #3, with close up view of their terminals.

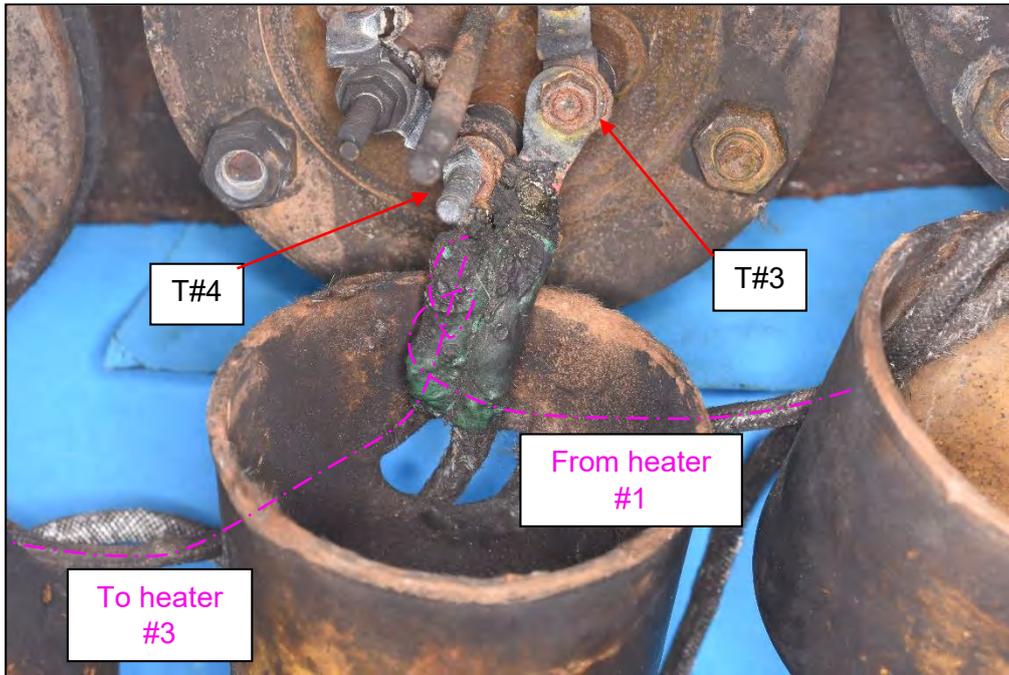
Figure 79: Green tapes were observed wrapped around the wires of both terminal #3 and terminal #4 of heater #2. The position of both wire lugs were close together.

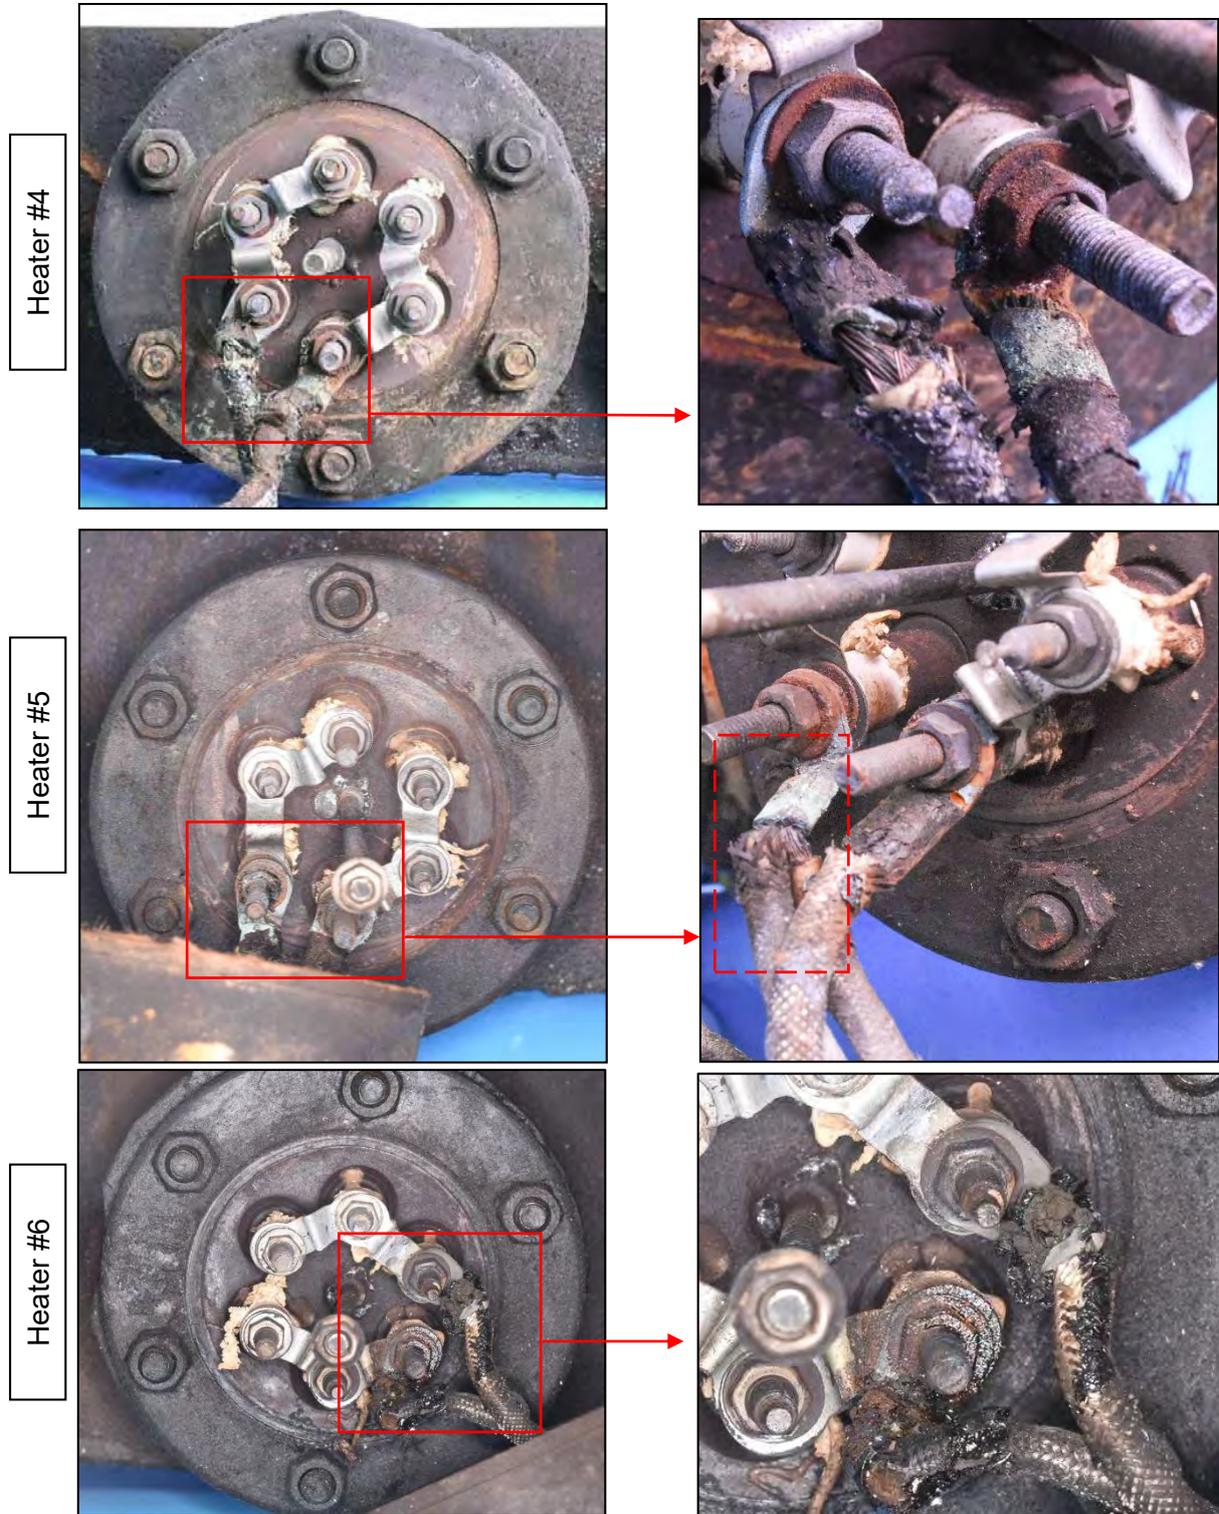
- 12
- 14
- 16 ➤ Taking heater #5 as reference for how the wires were connected to the lugs, the end of the wires from/to heater #4 and heater #6 were clamped together by a single lug (Figure 82).

Figure 82: From top, heaters #4, #5 and #6, with close up view of their terminals. For heater #5, the wires from/to heaters #4 and #6 were clamp together by the lug (see red dotted line).

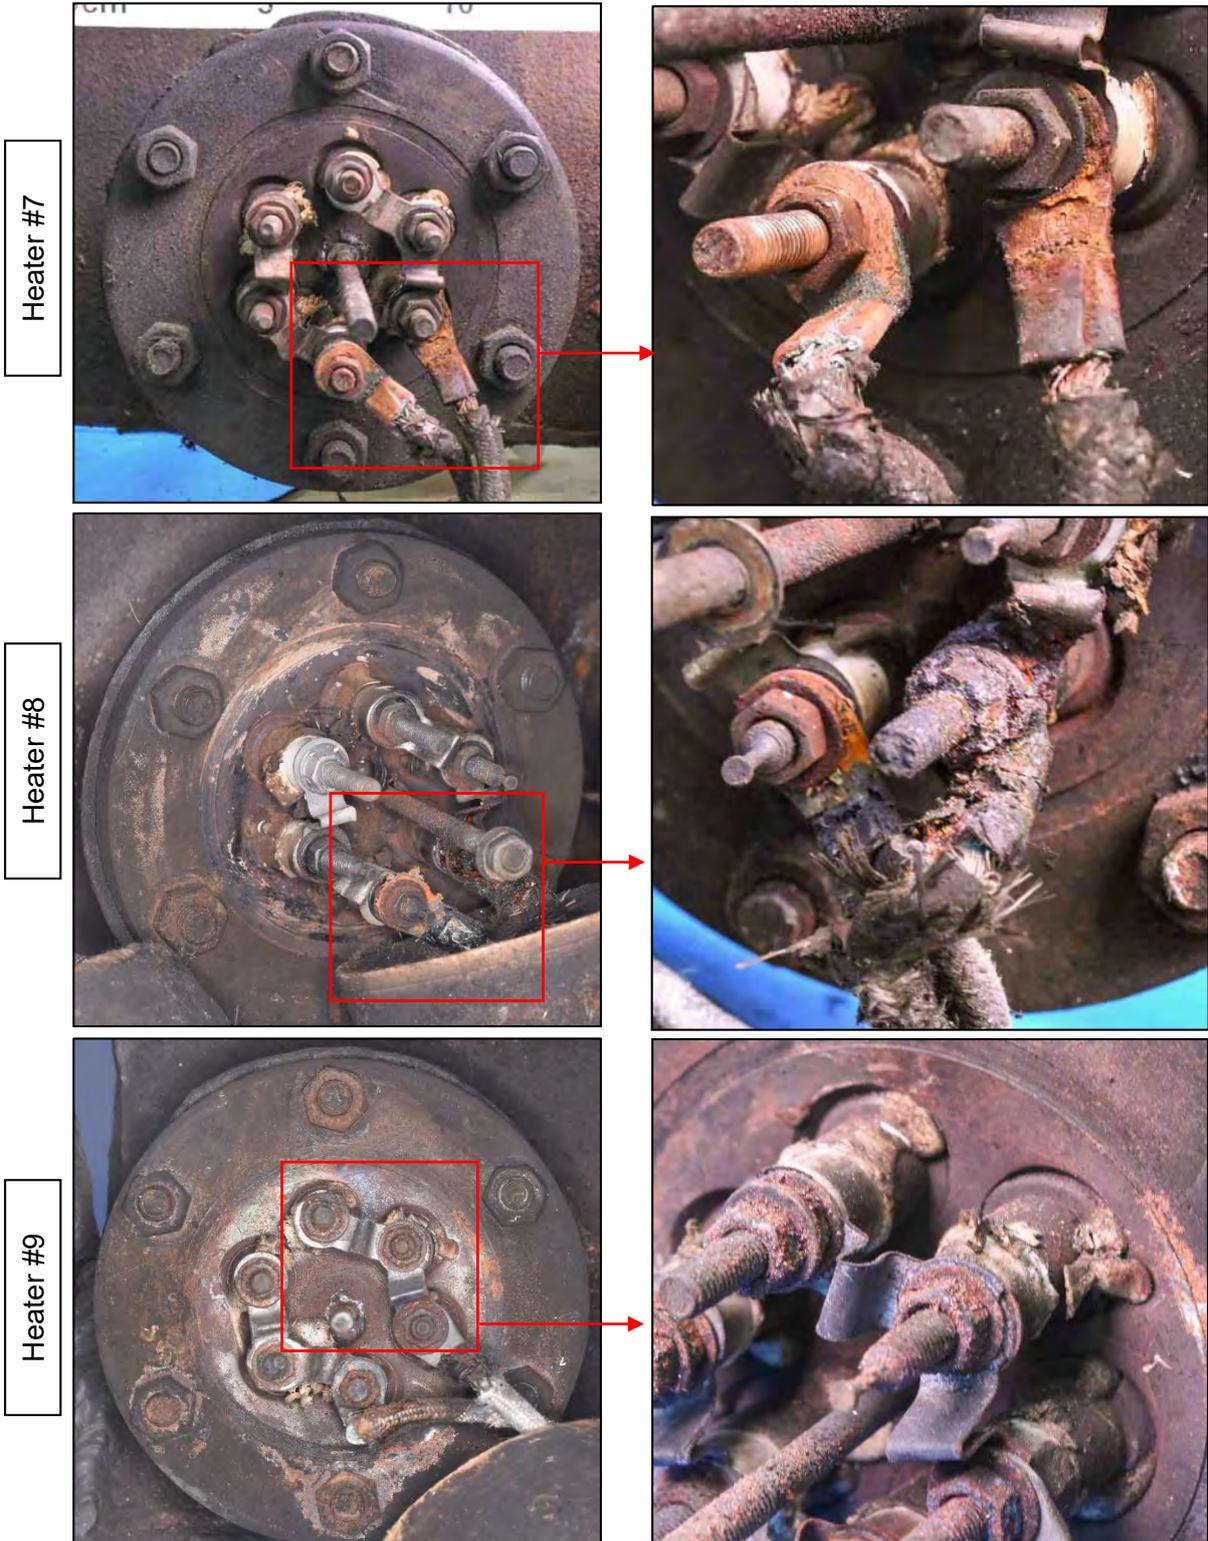
Figure 84: From top, heaters #7, #8 and #9, with close ups of their terminals.

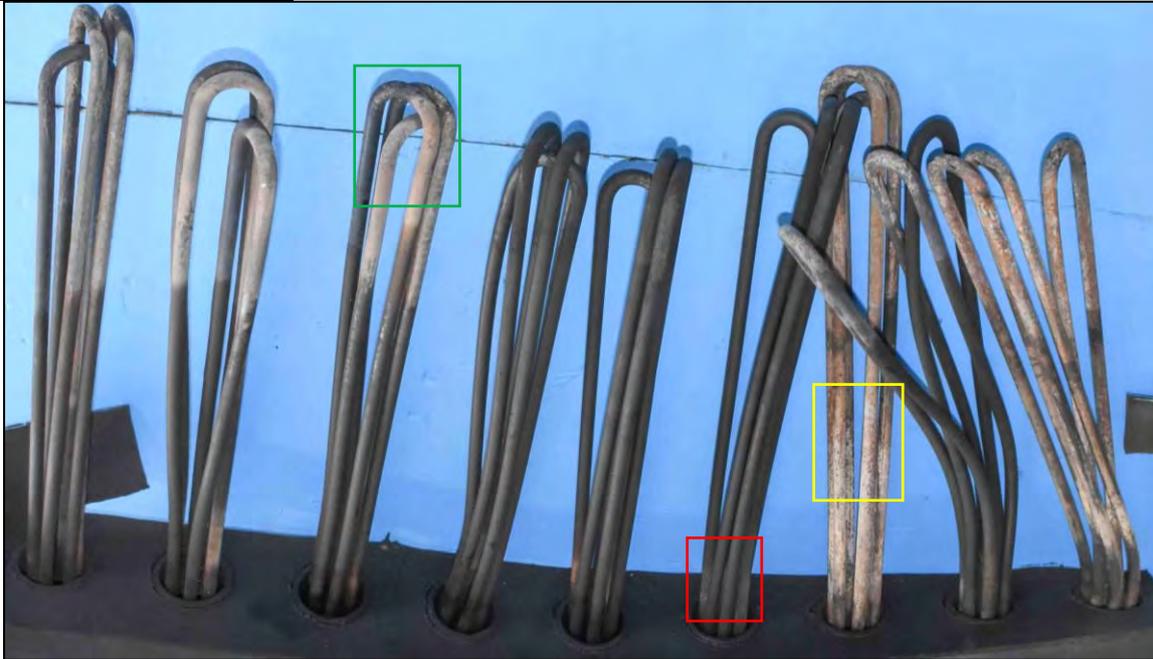
Figure 85: The heaters are sheathed-type heating elements (also known as Calrod™ heaters). The metal tubes of every heater sustained various degrees of deformation, which heaters #1 and #2 being most severe.

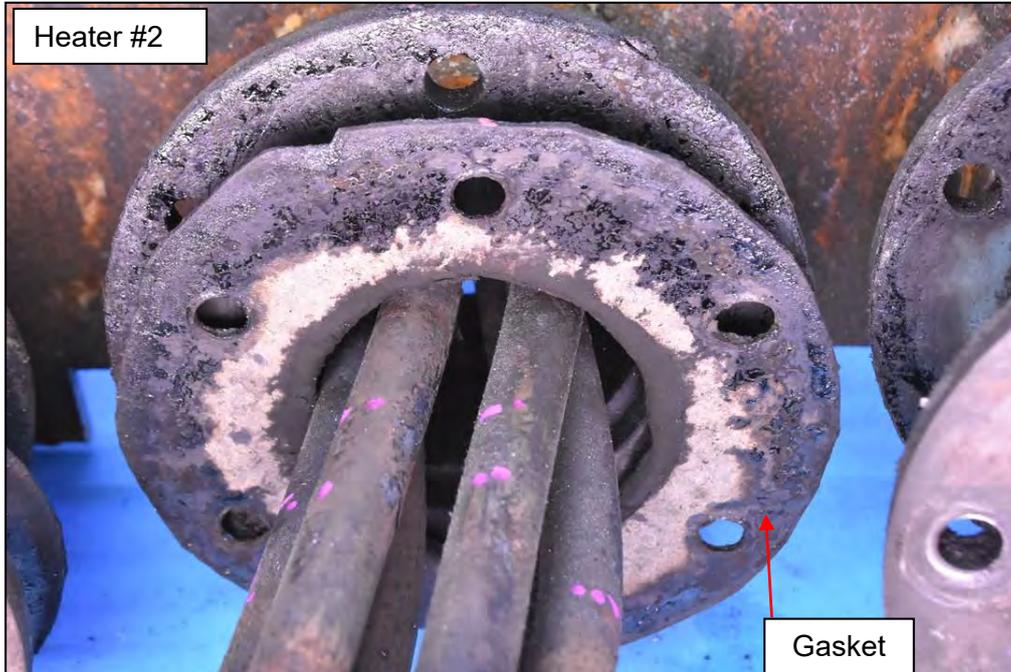
- 18
- 20 ➤ Signs of corrosion and peeling of coating were observed at various parts of the metal tubes (Figure 86).
- 22 ➤ All the gaskets had degraded and were generally brittle to the point where they broke with slight pressure (Figure 87 and Figure 90).

Figure 87: Due to the severe deformation, heaters #1, #2 and #3 cannot be removed without cutting the metal tubes. The gaskets were generally brittle with some parts still adhering to the flanges' surface.

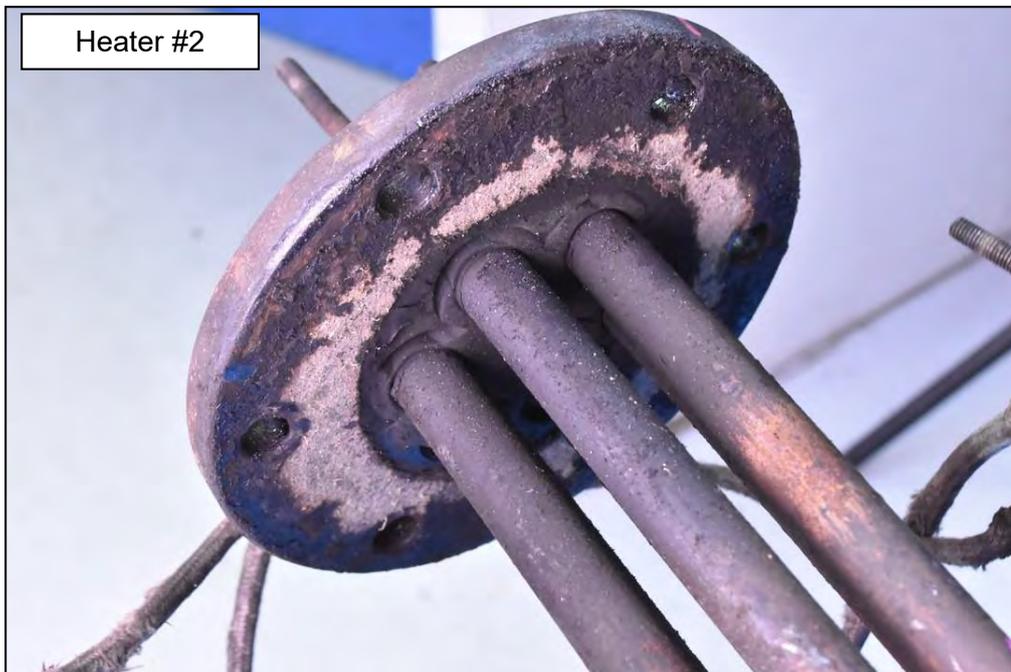
Figure 88: Heater flange condition from the side adhering to the gasket.

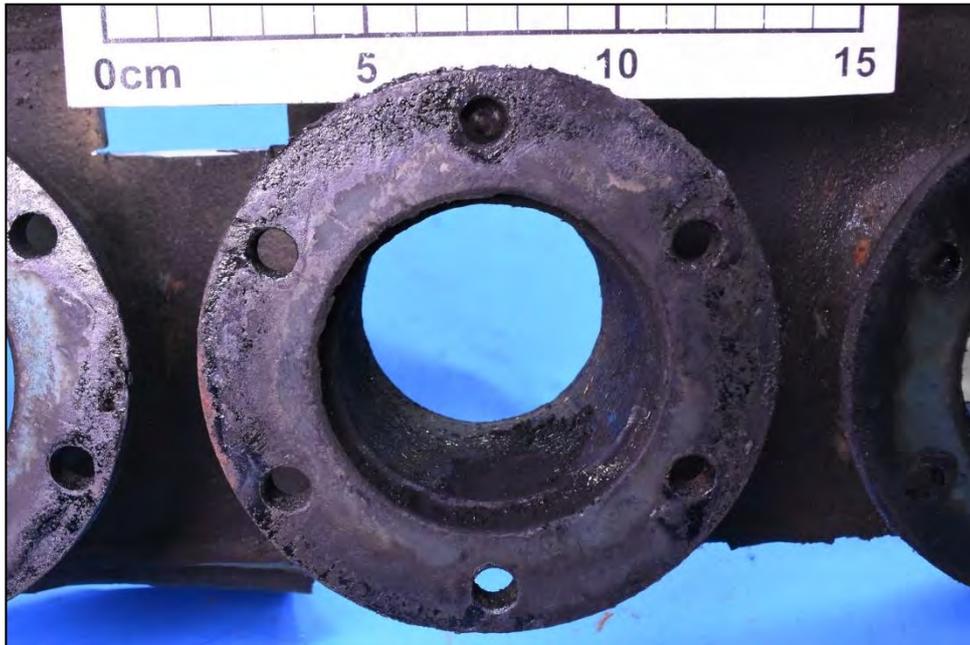
Figure 89: The rest of the heaters were removed, revealing generally similar flange condition. Oil residue were present inside.

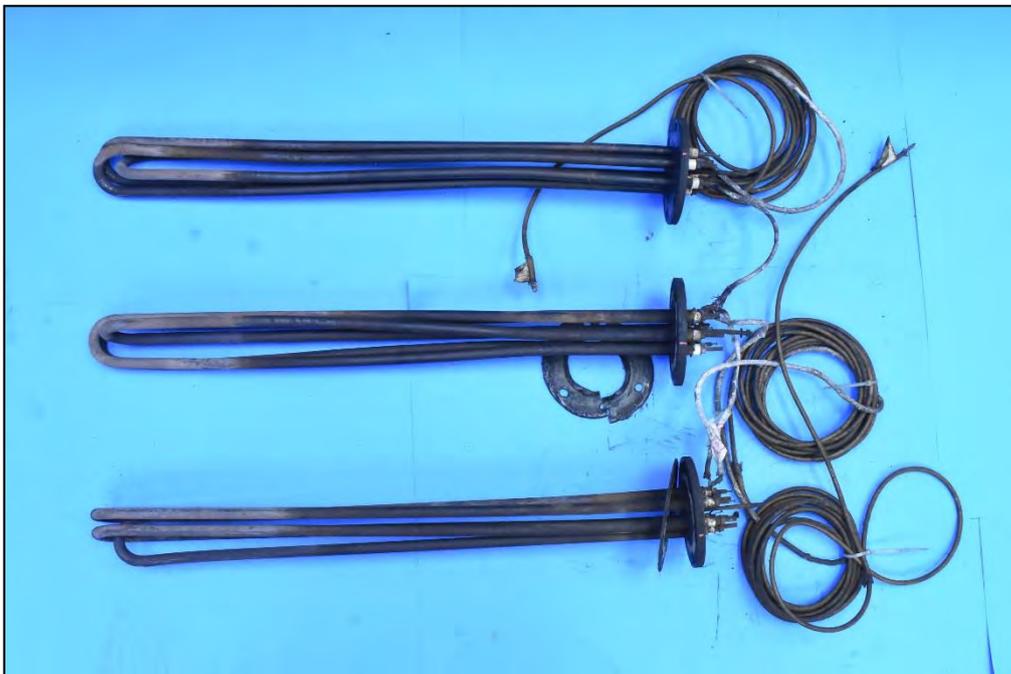
Figure 90: All the gaskets had degraded and were generally brittle to the point where they broke with slight pressure. Some broke during the removal of heaters.

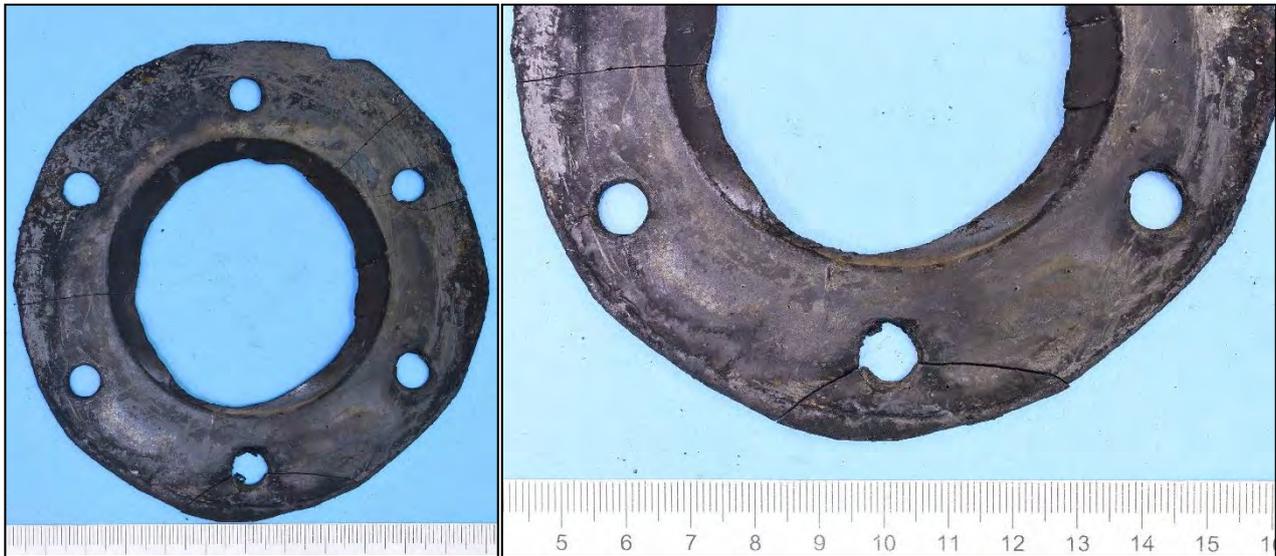
Figure 91: General view of gasket for heater #2. Some parts were broken during the shore hardness testing.

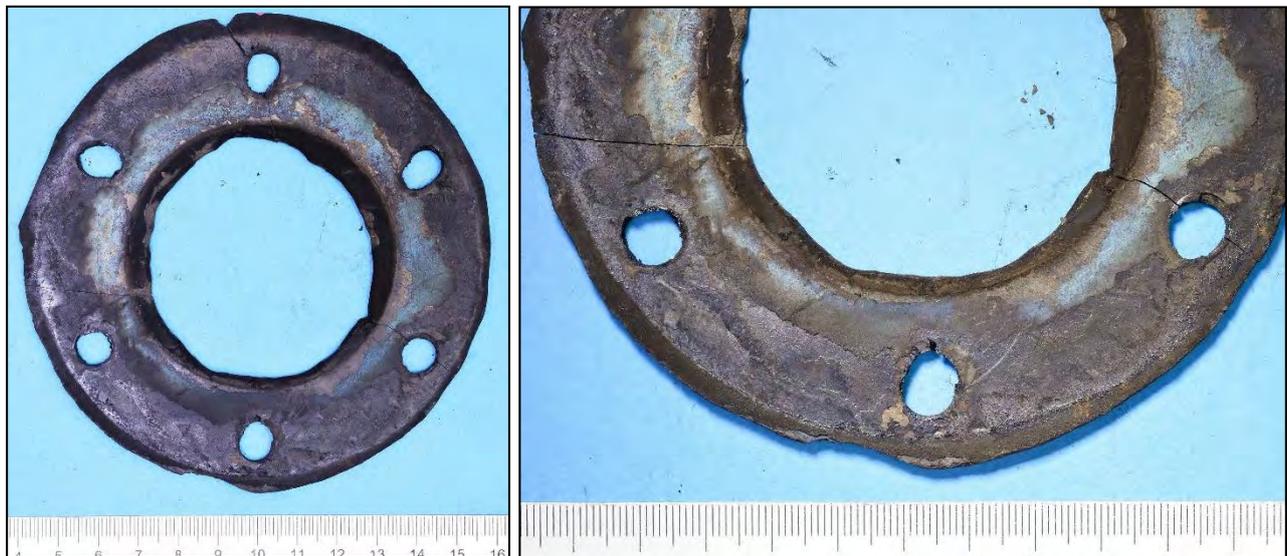
Figure 92: For comparison, gasket for heater #9 which was located furthest from the main rupture zone and heater #2, was selected to undergo shore hardness testing. Similarly, parts of it were broken during the testing.

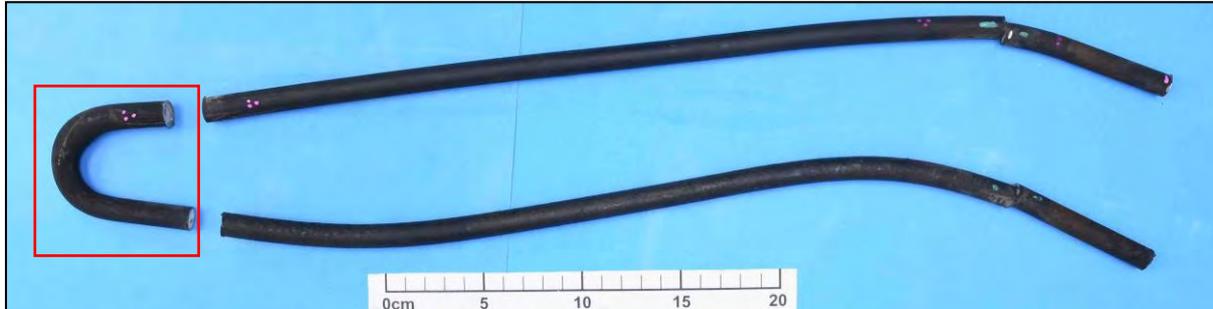
- 24 ➤ The LEW reported that heater #2 had an unusually high resistance among the coils.⁵ Examination revealed that the metal tube between terminals #3 and #6 had a bulging area of about 15.5 mm diameter (the normal diameter of the metal tube is 11.9 mm) (Figure 93 and Figure 94).

Figure 93: The LEW reported that heater #2 had unusual high resistance among the coils. With that reporting, the metal tubes were examined and the tube between terminals #3 and #6 were found to have a bulged area.

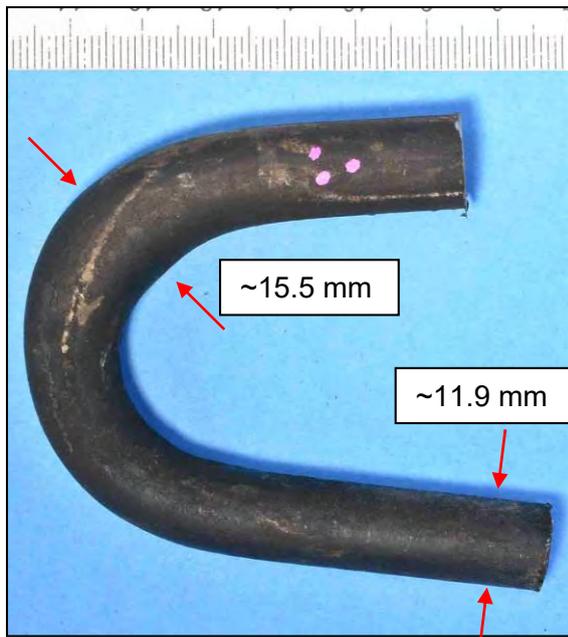
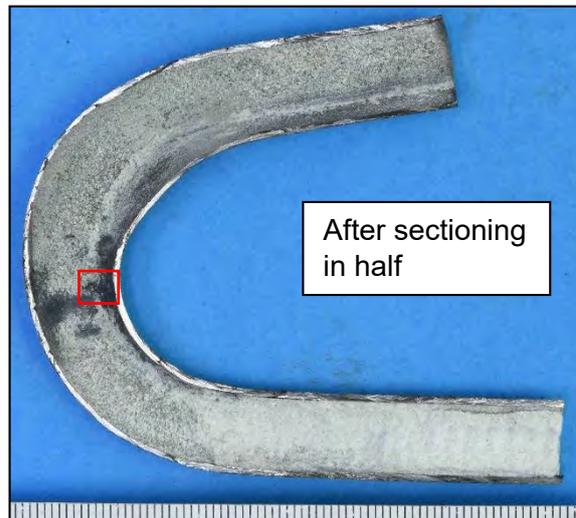
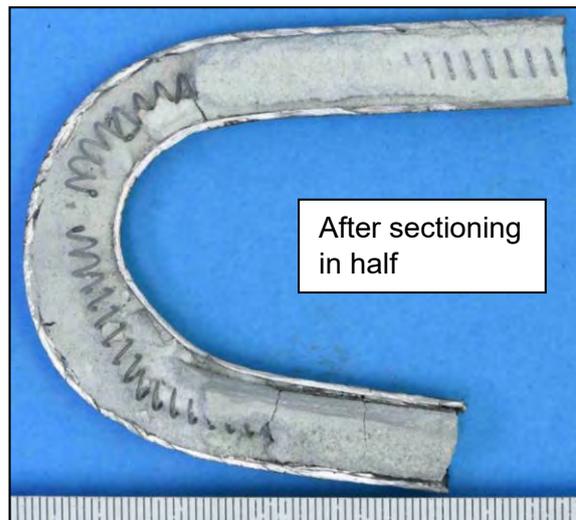
Figure 94: The normal outer diameter was approximately 11.9 mm while the bulged area had a maximum outer diameter of about 15.5 mm. The area was sectioned in half to reveal the internal condition. The resistance wire inside had separated and the surrounding insulation powder were very loose.

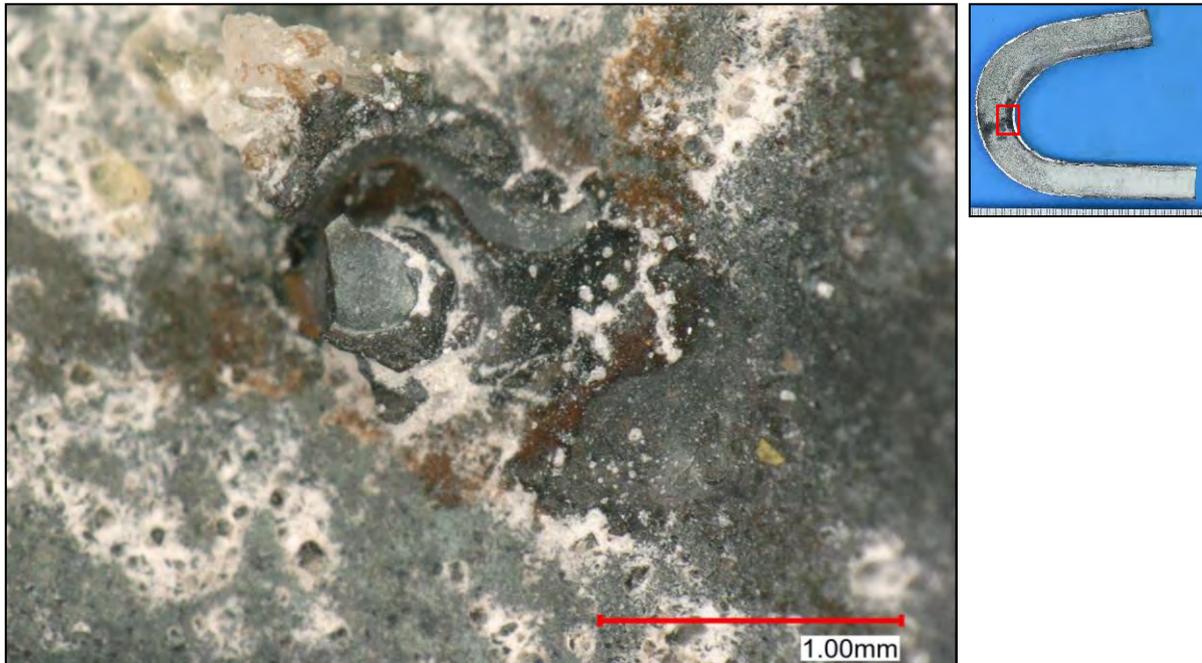
- 26
- 28 ➤ The resistance wire inside the metal tube between terminals #3 and #6 had separated by melting and the surrounding insulation powder was very loose (Figure 96). There was a small melted bulb adhering to the inner wall of the metal tube at this location (Figure 95). This suggested that the unusually high resistance in heater #2 was caused by damaged resistance wire.

Figure 95: At the metal tube inner diameter wall corresponding to the location of the separated wire, a small melted bulb was observed adhering to the wall. .

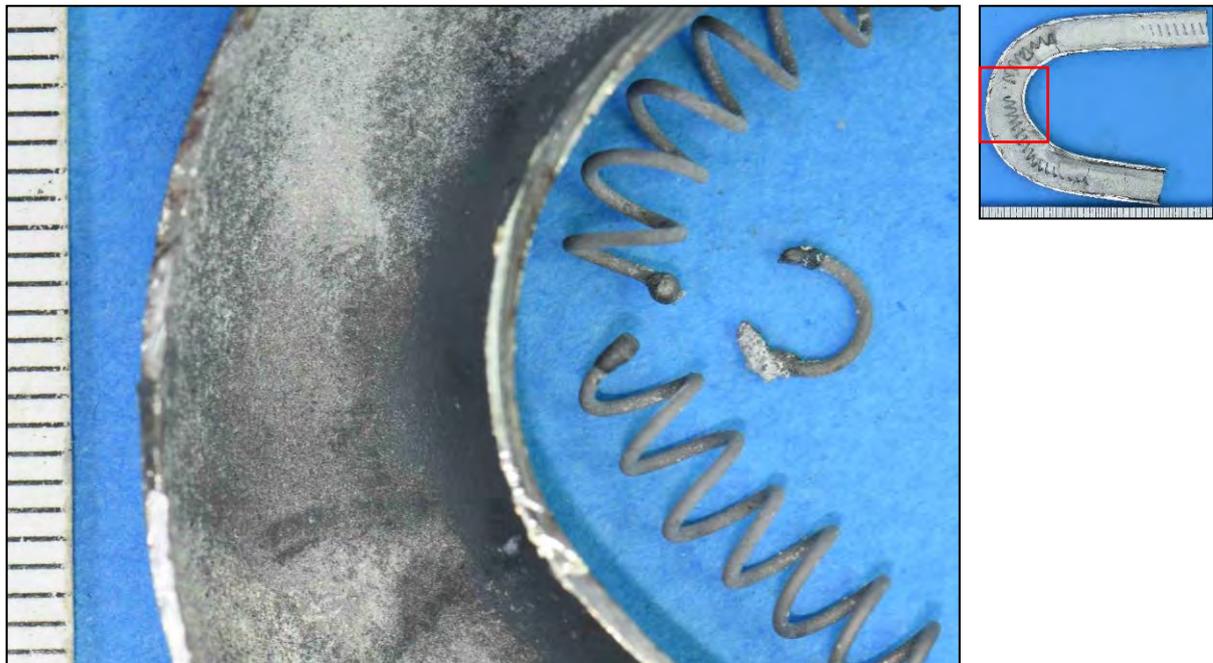
Figure 96: The tips of the wire had melted with some of the insulation powder fused onto the tip.

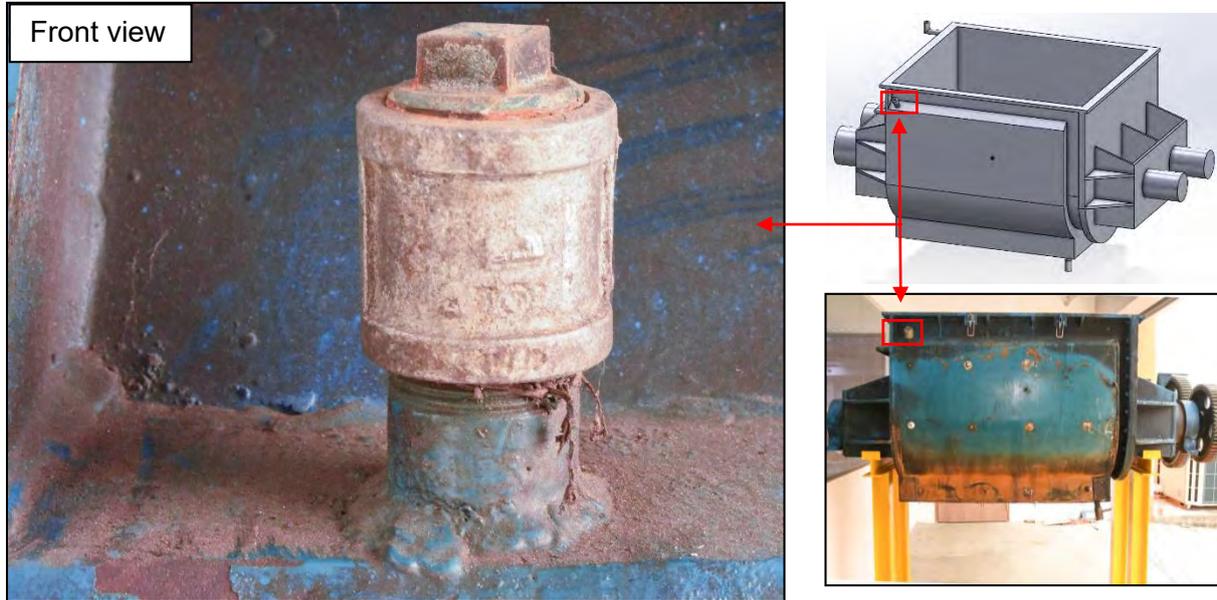
- 34 ➤ Both access and vent ports were plugged by square head plugs. Along with the closed drain port, all three of the oil jacket openings were closed (Figure 97 and Figure 98).
- 36
- 38 ➤ The oil funnel was not in use and was found at the ground floor of the Factory during the retrieval of the Mixer Machine onsite (Figure 99).

Figure 97: The access port had been plugged by a square head plug.

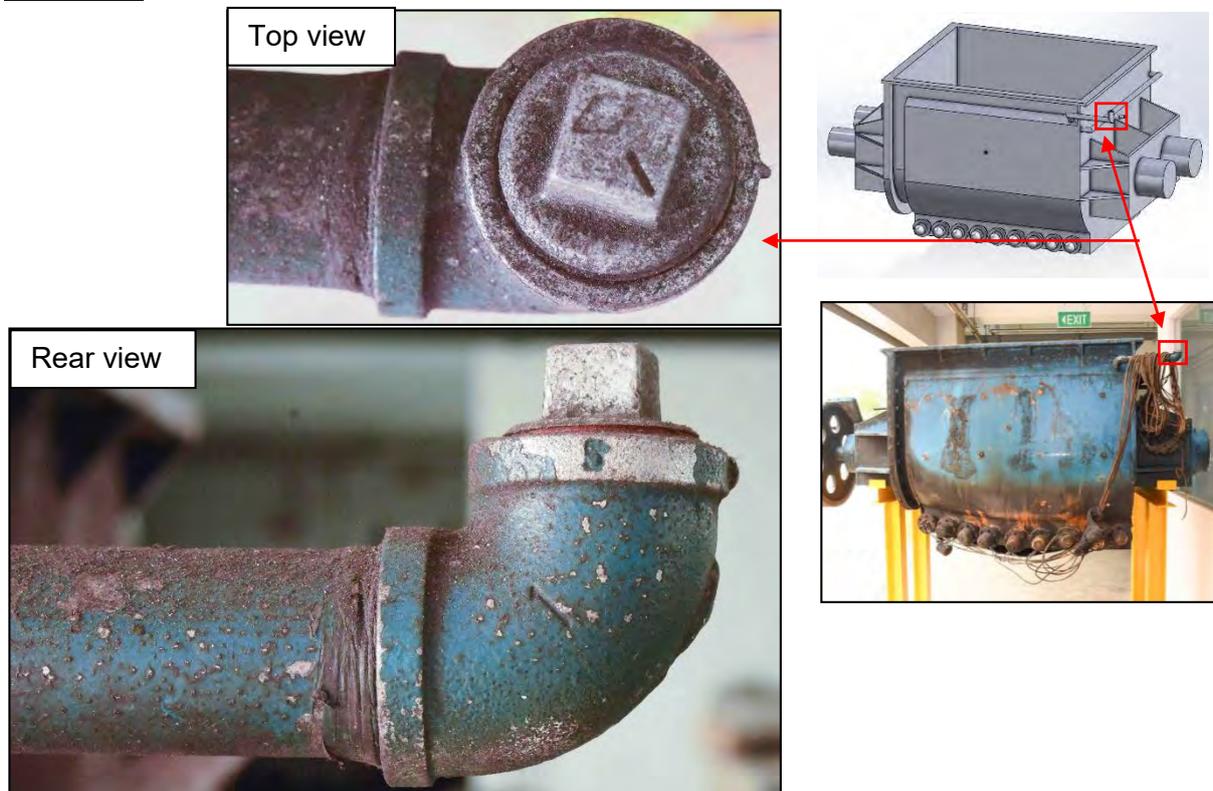
Figure 98: The vent port was also plugged by a square head plug.

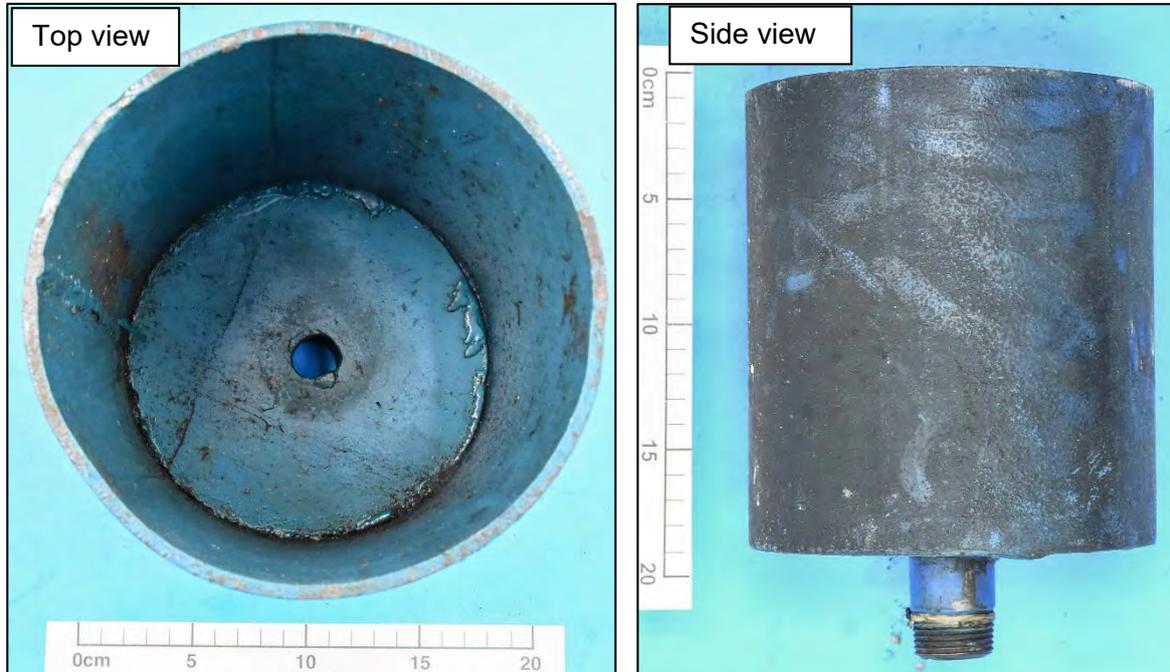
Figure 99: The oil funnel was not in use and was found at the ground floor of the Factory during the retrieval of the Mixer Machine onsite.

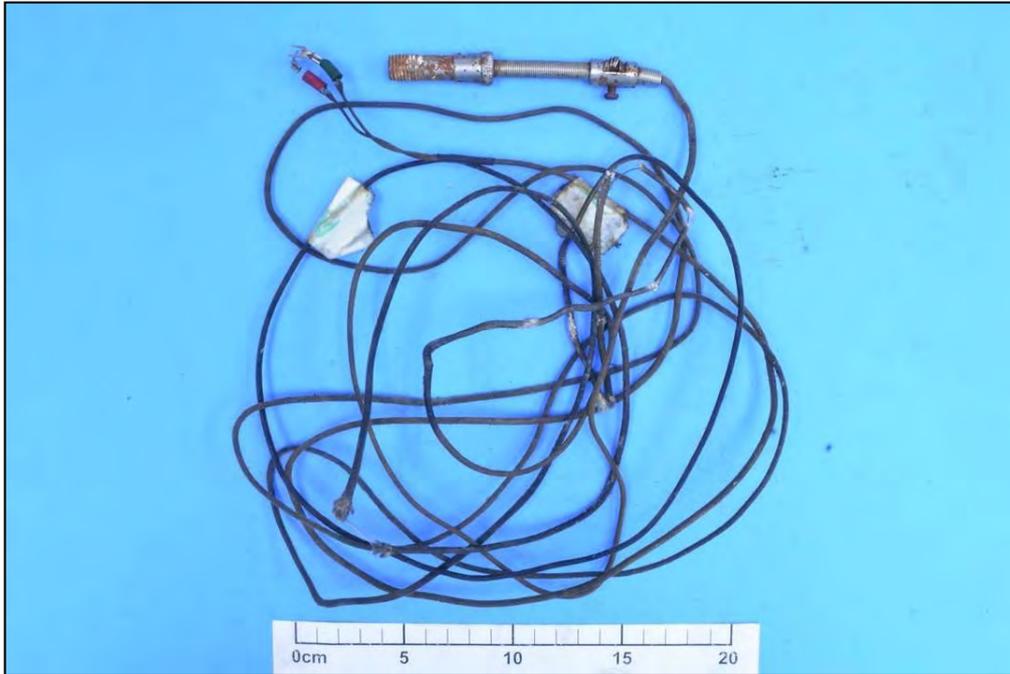
14 ➤ For RTD A, the sensor end was found inside the mixing chamber while the wire
was still connected to the electrical panel (Figure 100 and Figure 101). RTD A
16 was still intact, with the sensor in working condition.⁶ The wire connectors (red
and green) were still intact, which was originally connected to the “Jacket temp”
thermostat (see Figure 107 and Figure 108).

Figure 100: RTD A retrieved onsite.

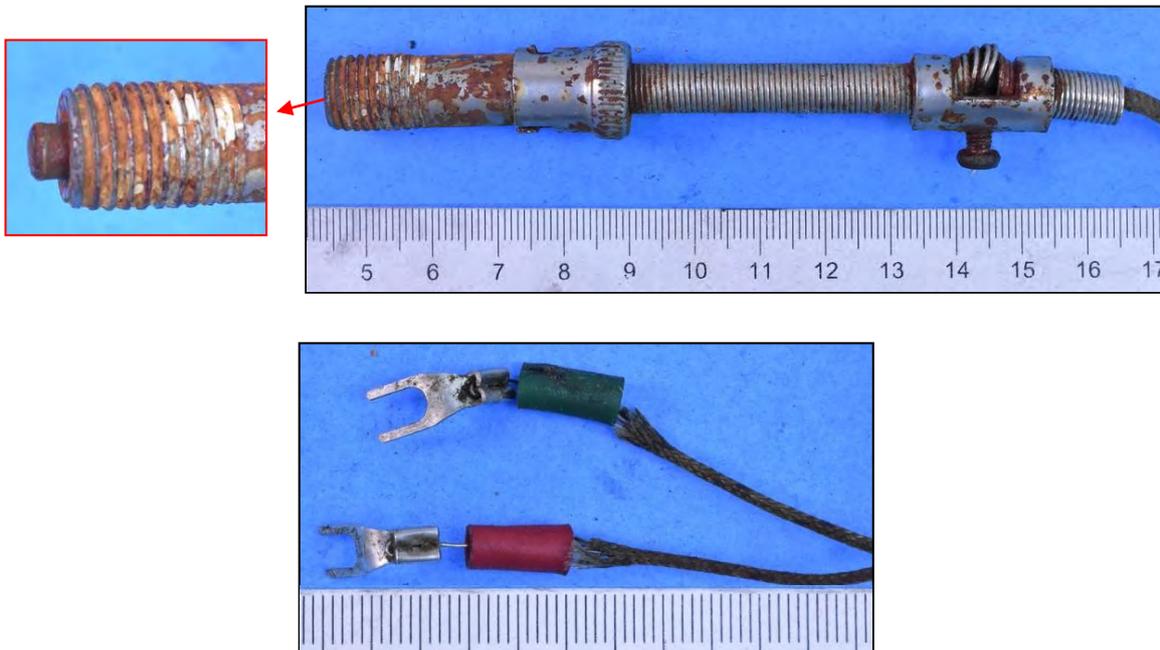
Figure 101: The RTD was still intact with the sensor. The wire connectors (red and green) were still intact, which was originally connected to the "Jacket temp" thermostat. See Figure 107.

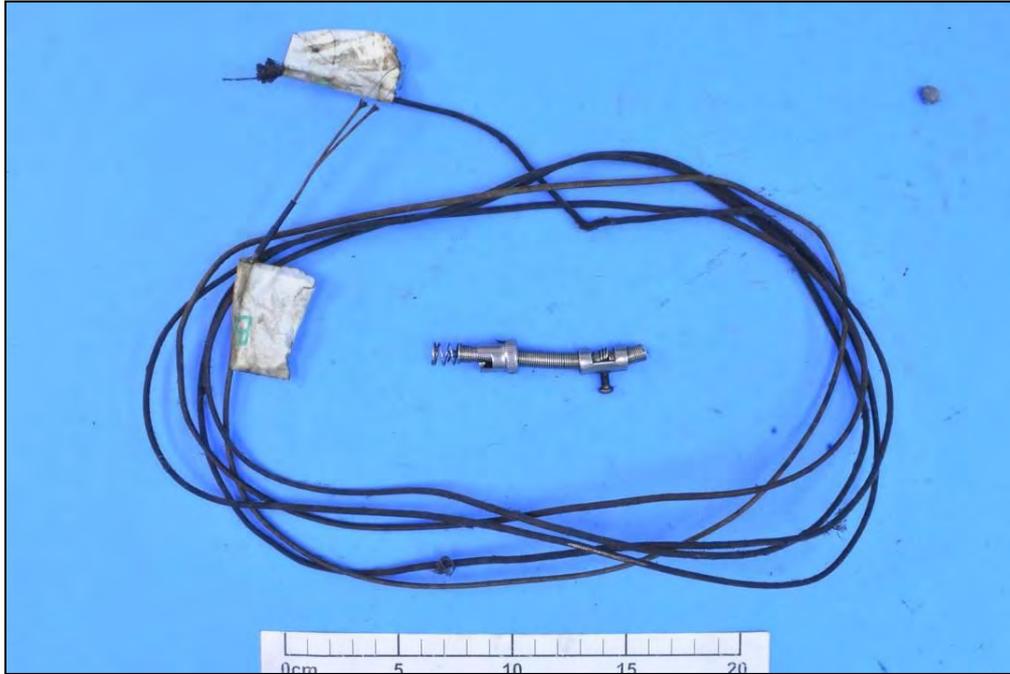
18 ➤ For RTD B, only the holder was found onsite (Figure 102 and Figure 103). There
was no sensor inside the holder - the sensor had separated from the wire.
20 Although this RTD was not attached to the electrical panel during the onsite
inspection, the wires were originally connected to the “Material temp”
22 thermostat as the connectors were still in place inside the panel (see Figure
107 and Figure 108).

Figure 102: RTD B remnants retrieved onsite. Although this RTD was not attached to the electrical panel during the onsite inspection, the wires were originally connected to the “Material temp” thermostat as the connectors were still in place inside the panel. See Figure 107.

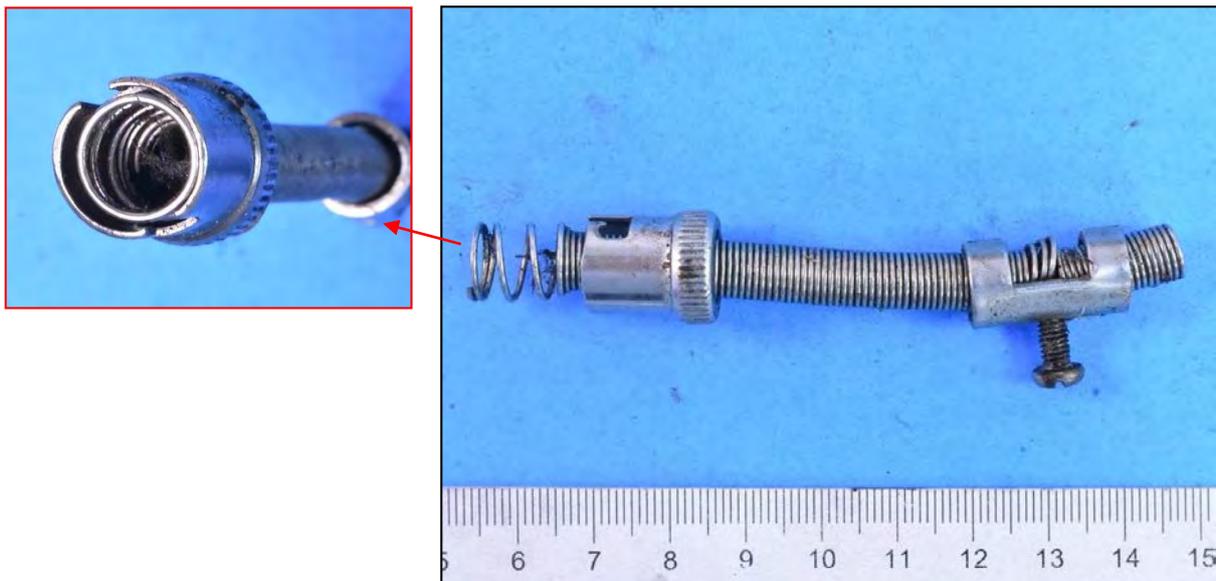
Figure 103: There was no sensor inside the holder.

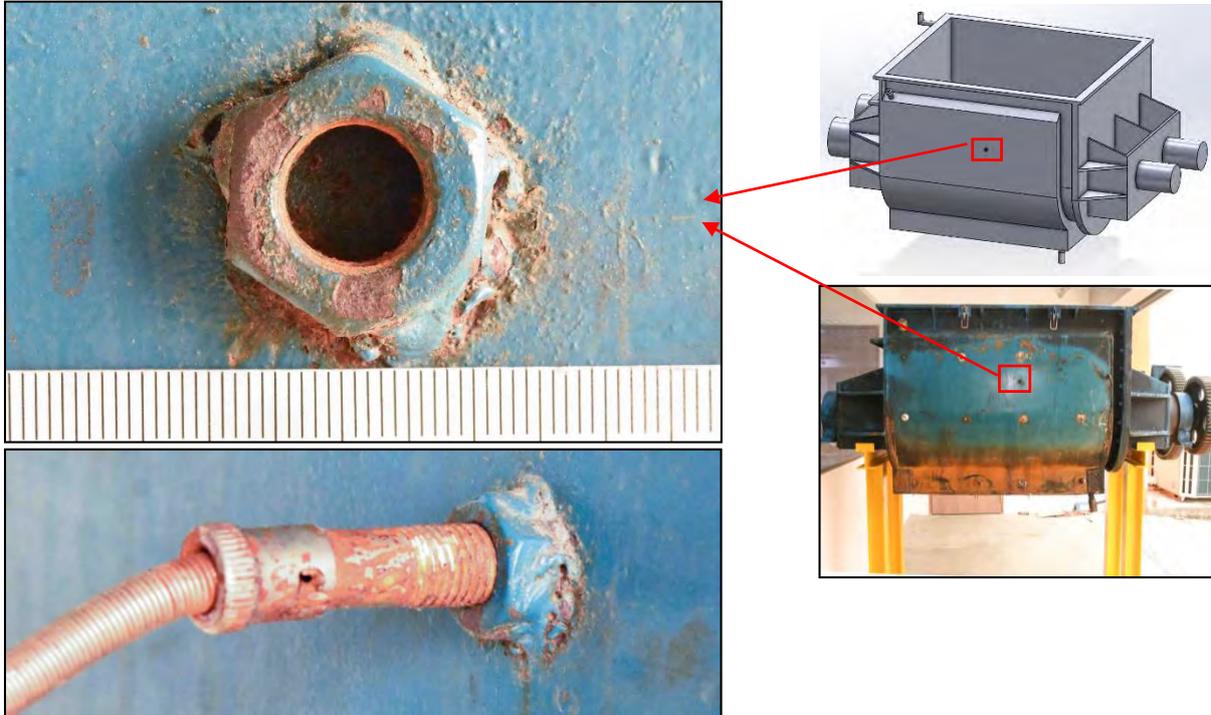
Figure 104: Close up view of the fixture intended for the RTD placement at the front side of the oil jacket. The fixture allows the sensor to reach the external surface of the oil jacket wall.

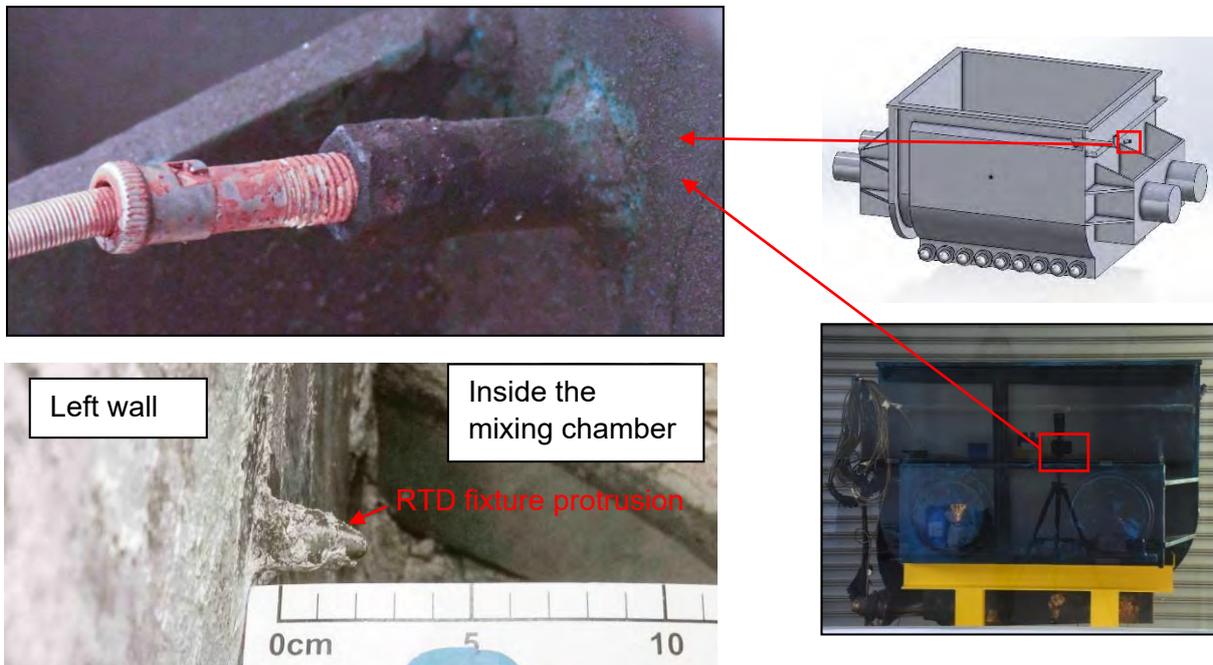
Figure 105: Close up view of the fixture intended for the RTD placement at the side of Mixer Machine nearest to the Platform stairs. This left wall is the wall containing the mixing material. The fixture slightly protruded into the wall thickness.
