**Report of the Inquiry
Committee for the accident
at Stars Engrg Pte Ltd on
24 February 2021
(PART II – ANNEXES)**

TECHNICAL REPORT

| Title of Report: Failure Analysis of a Failed Mixer Machine Retrieved from Unit 32E of Platinum @ Pioneer Building involved in a Fire Explosion Incident | | Date of Last Revision/Revision No: |

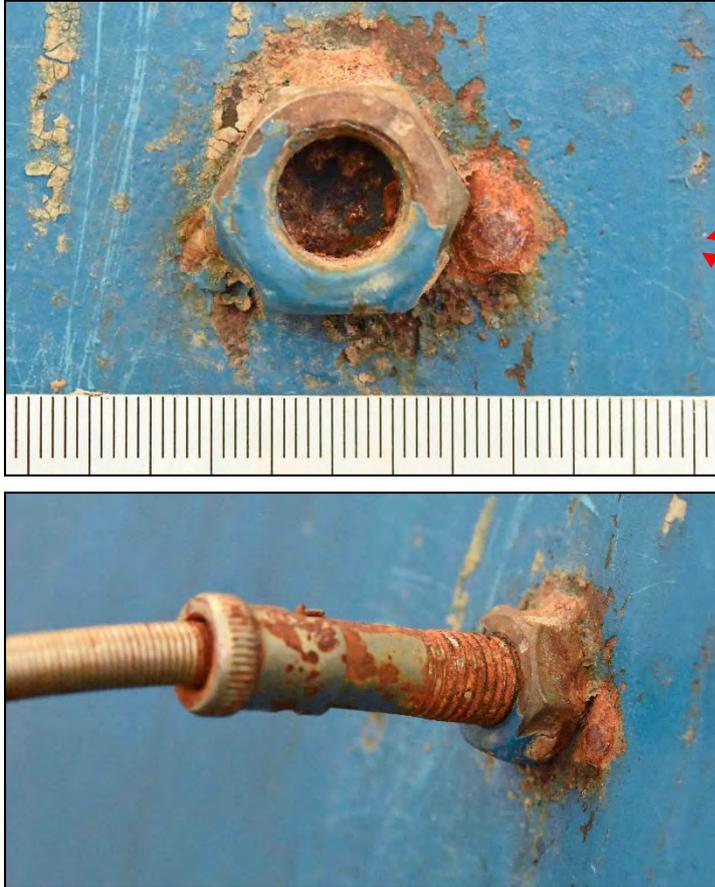
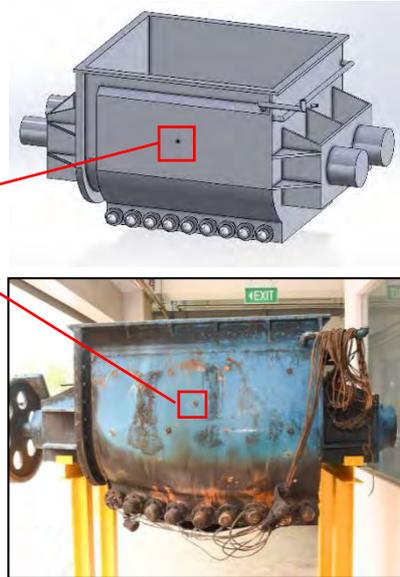
Figure 106: Close up view of the fixture intended for the RTD placement at the rear side of the oil jacket. The fixture allows the sensor to reach the external surface of the oil jacket wall.

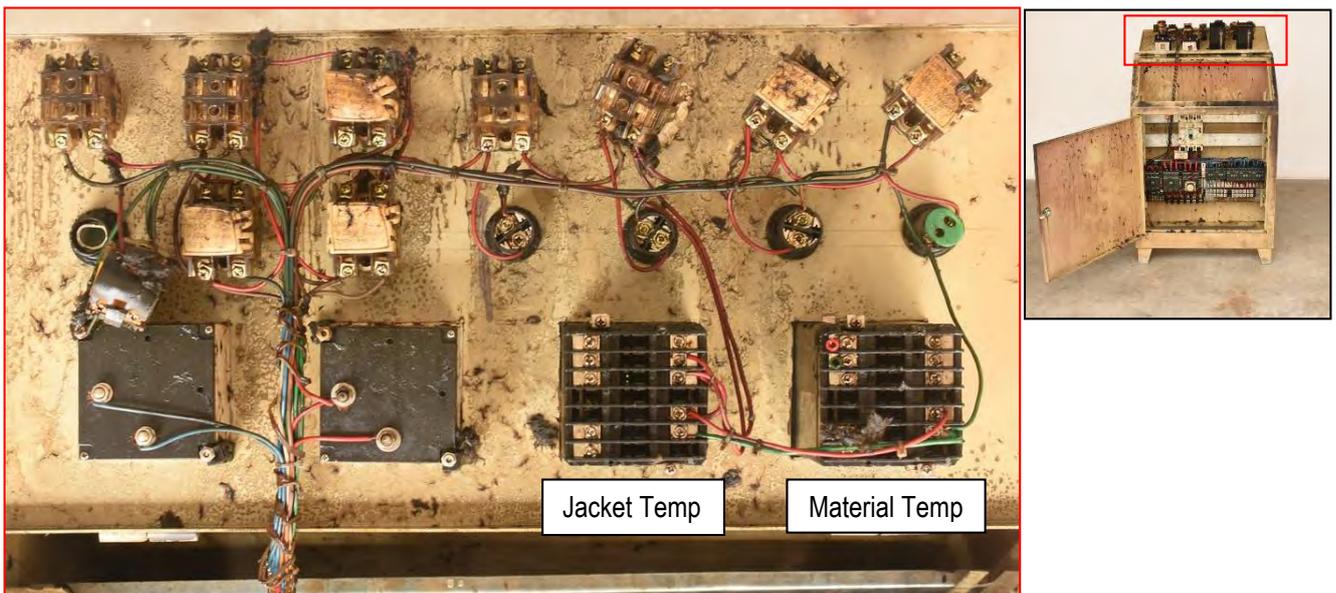
Figure 108: Inside of the electrical panel – top area.

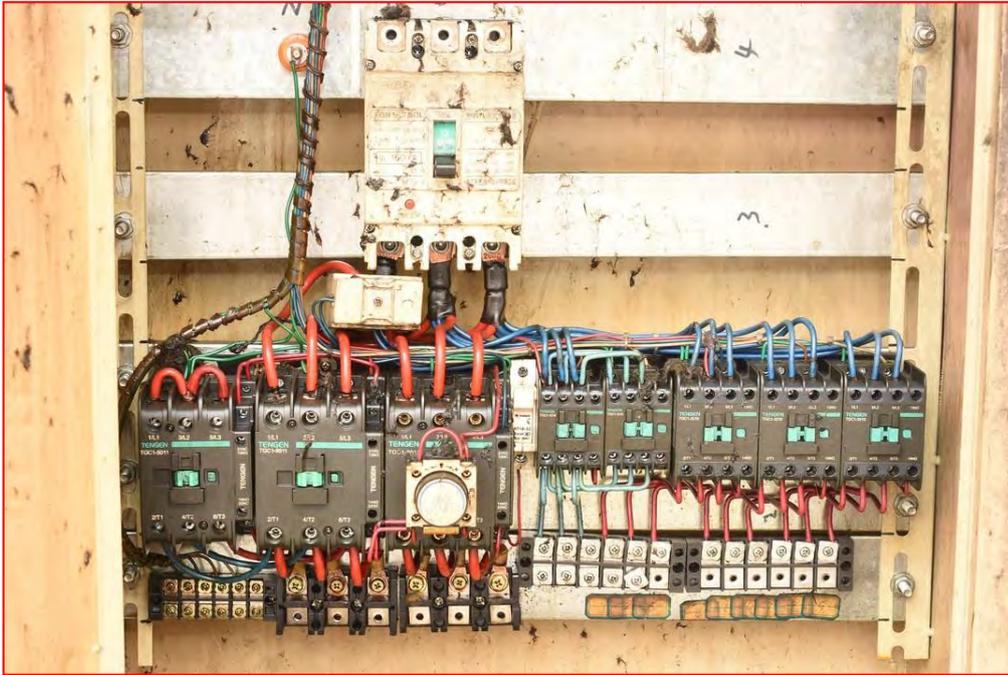
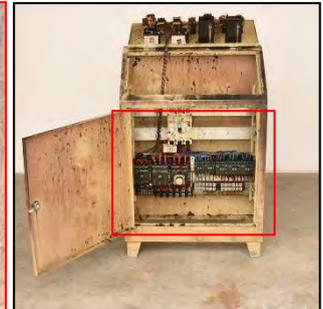
Figure 109: Electrical panel – bottom area.

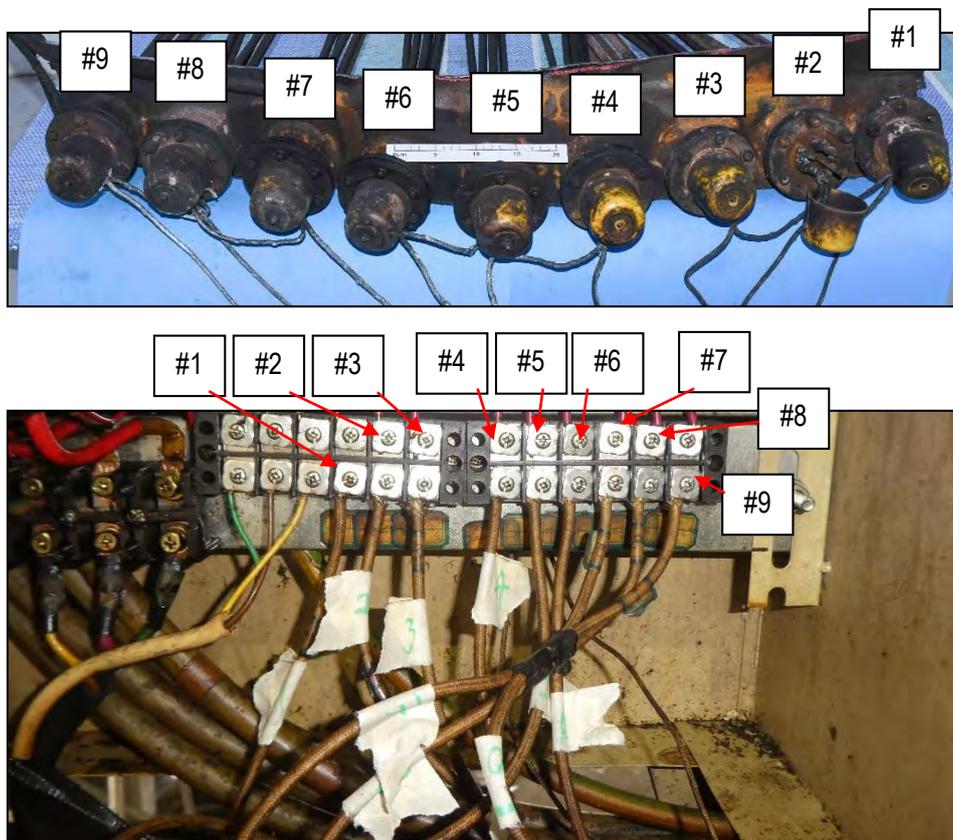
Figure 110: □ The wires inside the electrical panel were generally intact before the removal of the Mixer Machine to Matcor's laboratory.

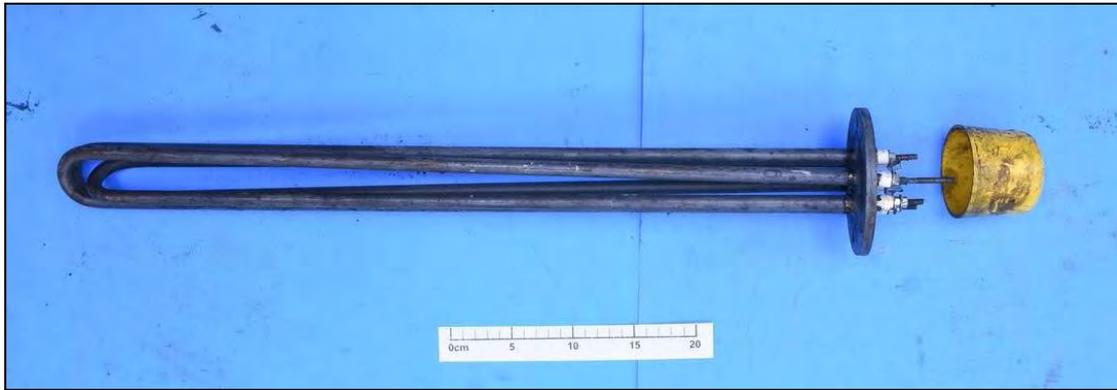
44 ➤ The heater found on the Platform beside the Mixer Machine had no significant
46 damage or sign of usage observed, therefore the heater was most likely a new
heater (Figure 111).

Figure 111: Heater found on the Platform beside the Mixer Machine. No significant damage was observed.

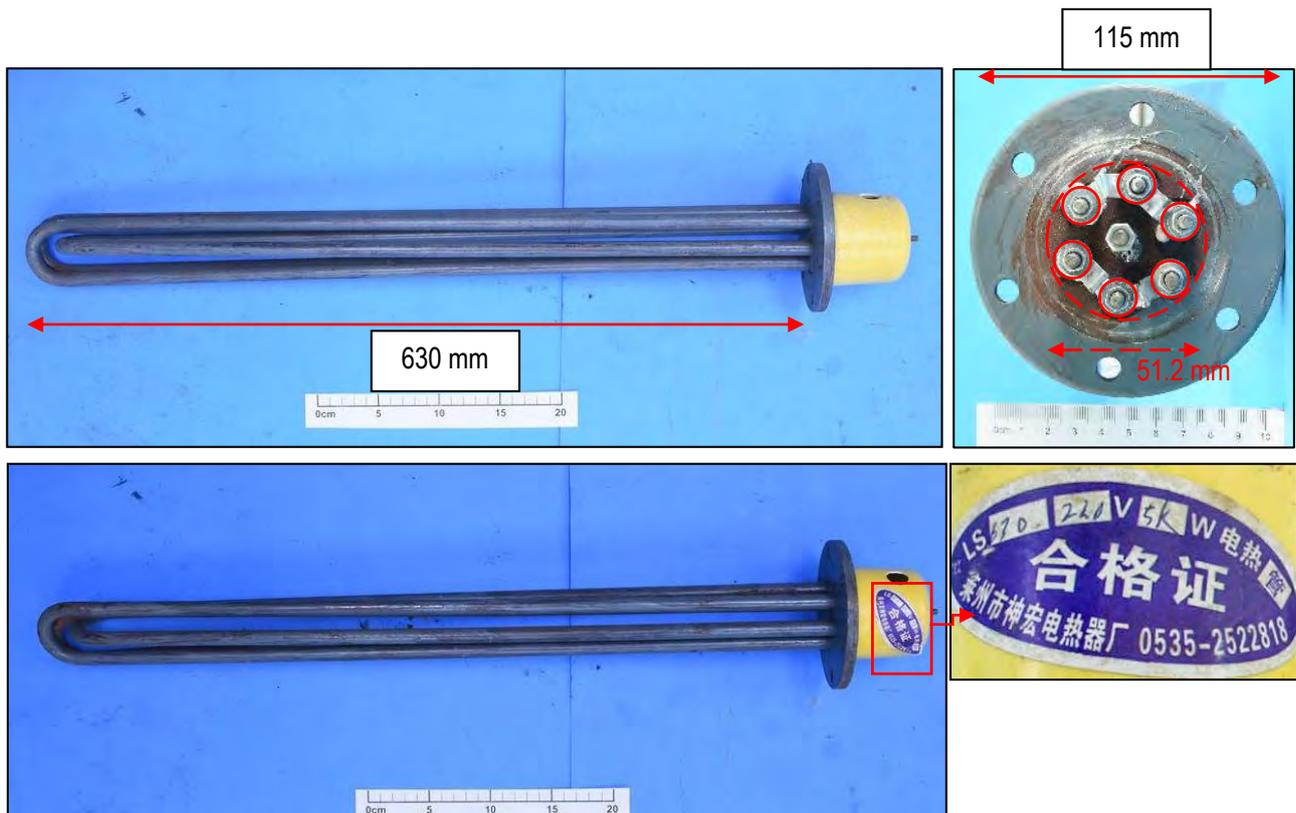
4 ➤ Two new heaters retrieved from storeroom on the second level of 32E Tuas
6 Avenue 11 were used as reference. These two new heaters had labels on their
terminal covers, indicating that the heaters were designed with specifications
of 220V and 5kW (Figure 112).

8 ➤ The measured length of the heater coils was about 630 mm, the outer perimeter
10 (circular) of the coils was about 51.2 mm and the flange's outer diameter was
about 115 mm (Figure 112).

Figure 112: Two new heaters retrieved from storeroom on the second level of 32E Tuas Avenue 11 were used as reference. The measured length of the heater coils was about 630 mm, the outer perimeter (circular) of the coils was about 51.2 mm and the flange's outer diameter was about 115 mm. The label indicated that the heaters were designed with specifications of 220V and 5kW.

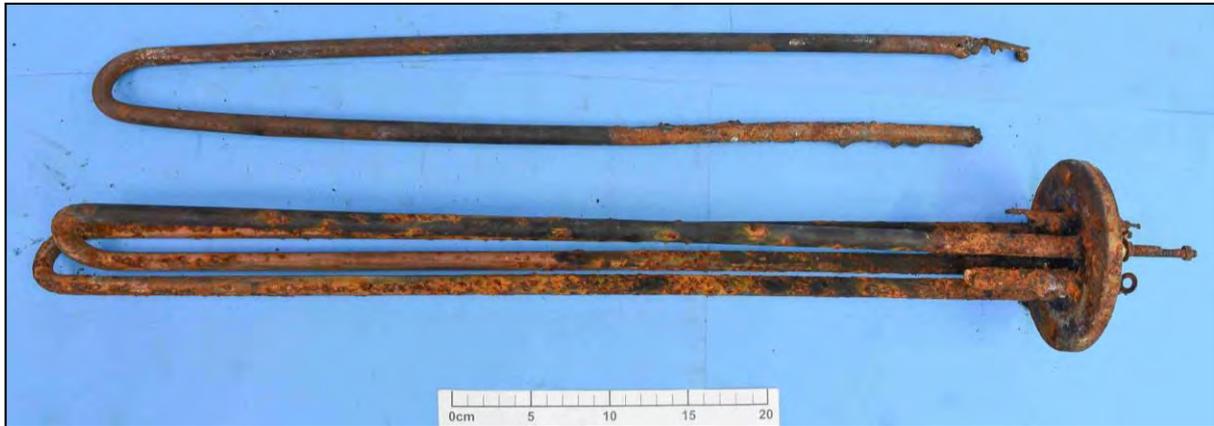
12 ➤ The used/failed heater received for analysis on 28th May 2021 was reportedly
replaced in August 2020 after failing (Figure 113). One of the coils had broken
14 off. The metal tube had deformed and melted off around the breakage location
as evidenced by the bulbous and droplet-like shape of the metal (Figure 114).
16 This was an indication of high temperature experienced by the metal tube,
leading to localised melting of tube.

Figure 113: Used heater that were replaced after failure (received for analysis on 28th May 2021). This heater was reportedly replaced in August 2020 after it failed.

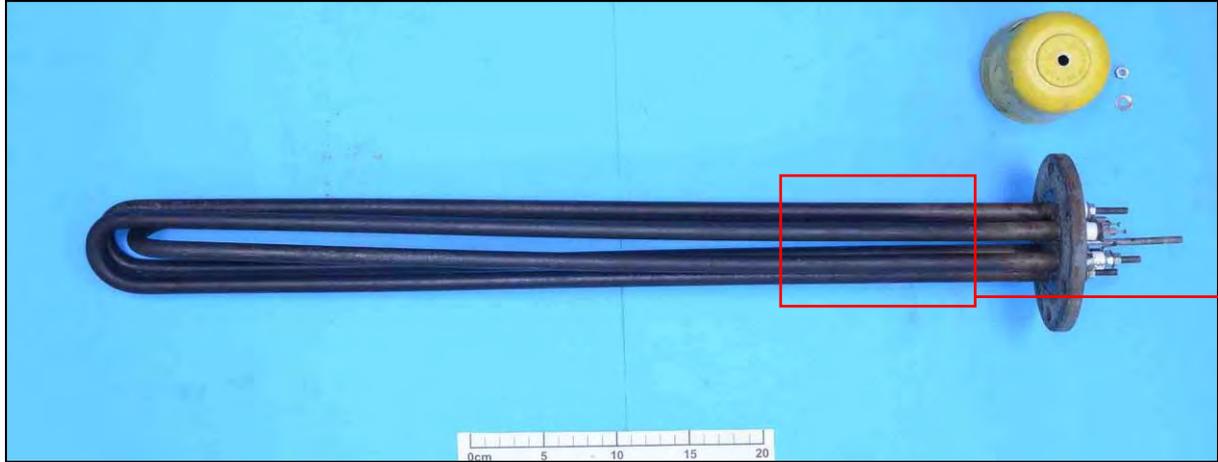
18 ➤ The other heater was received for analysis on 1st June 2021 (Figure 115 and
Figure 116). The metal tubes had black appearance similar to the heaters inside
the Mixer Machine. Several blisters of up to about 5 mm were also observed on
20 the metal tubes. These observations suggested that this heater had been used
before (see also Chapter 4.5.3 for metallographic examination findings). There
22 was no information provided on when and why this heater was replaced.

Figure 115: A heater that was used and replaced (received for analysis on 1st June 2021). Not much information was provided about this heater.

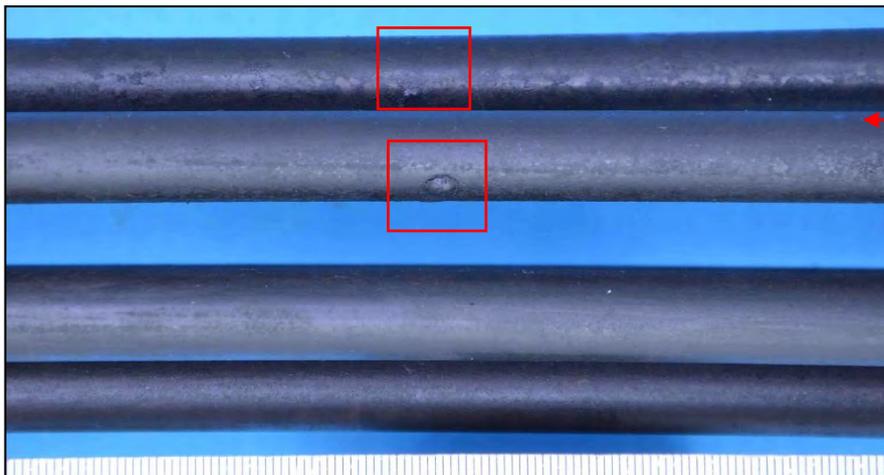
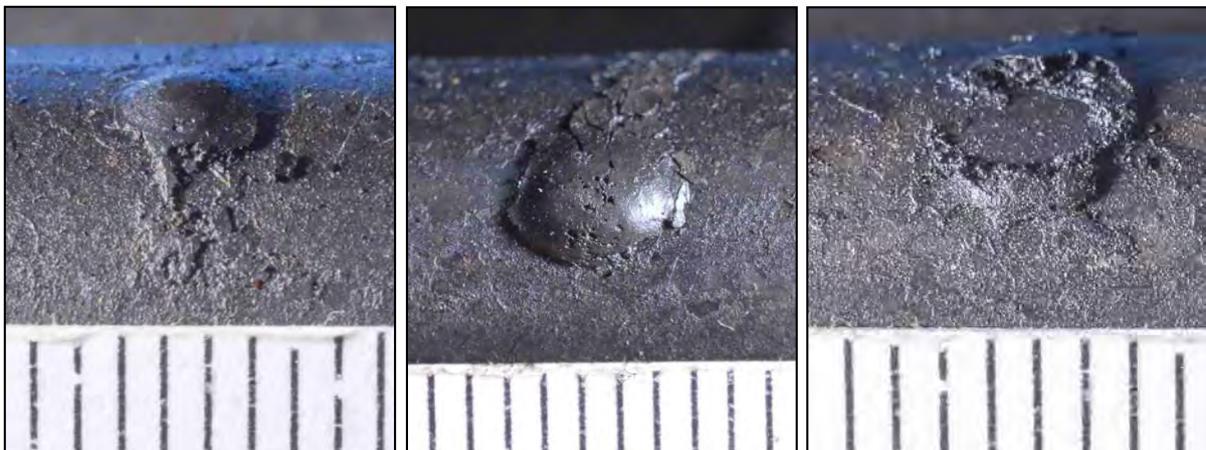
Figure 116: Several blisters of up to about 5 mm were observed on the metal tubes.

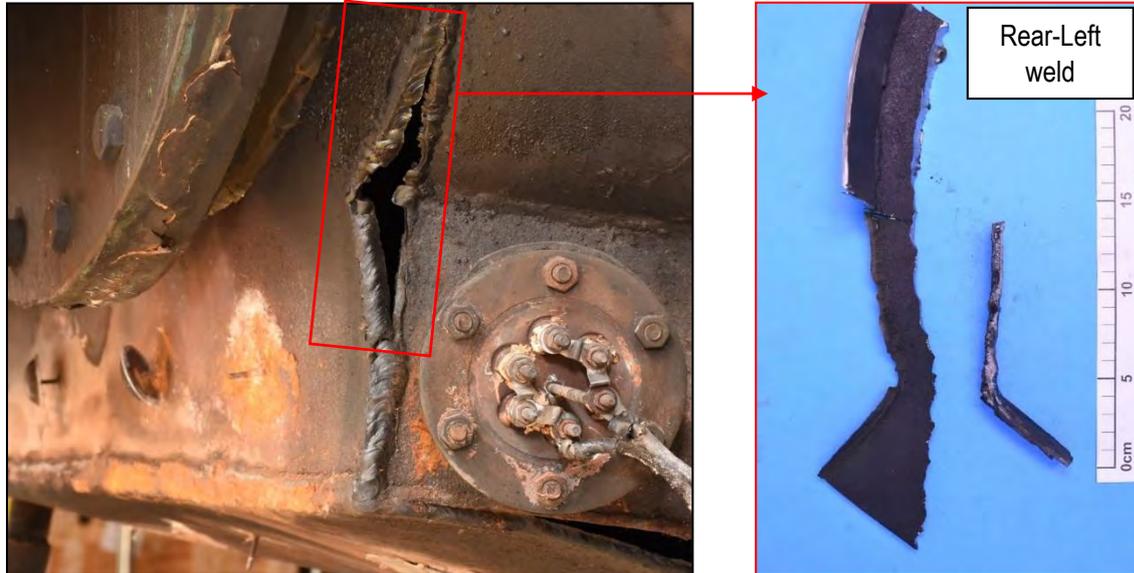
Figure 117: SEM examination was conducted on this part of the tank's rear-left weld. See Figure 119 to Figure 124.

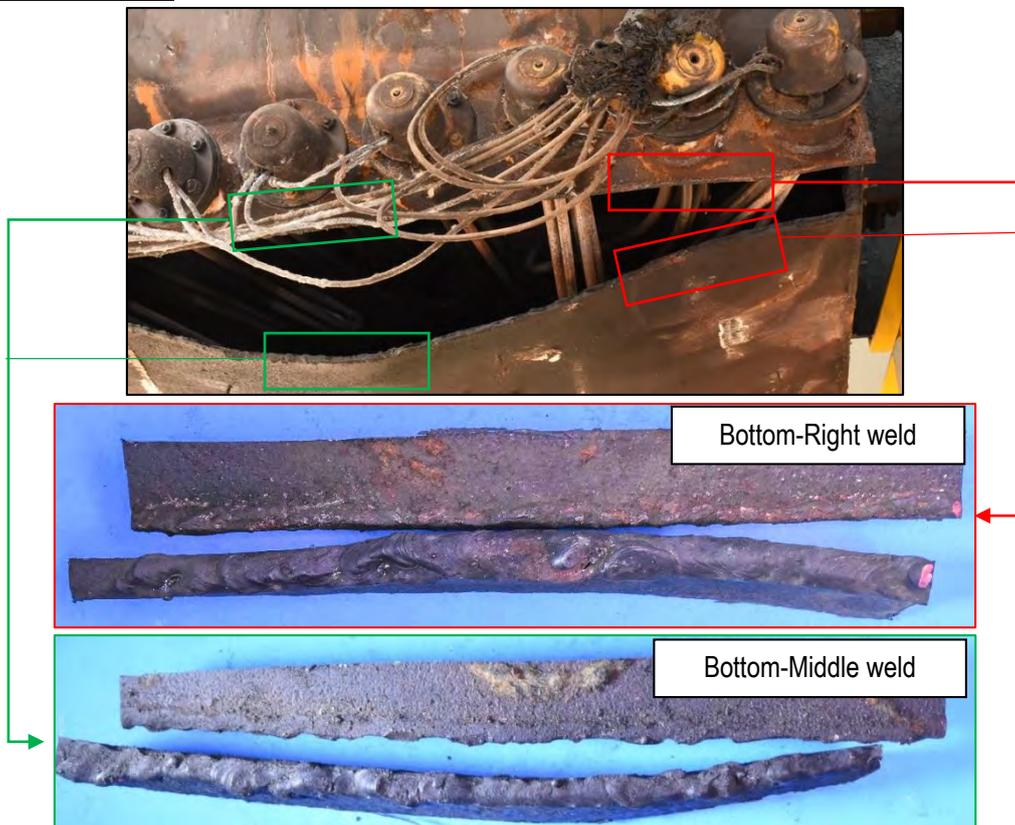
Figure 118: SEM examination was conducted on this part of the tank's bottom welds. See Figure 125 to Figure 130.

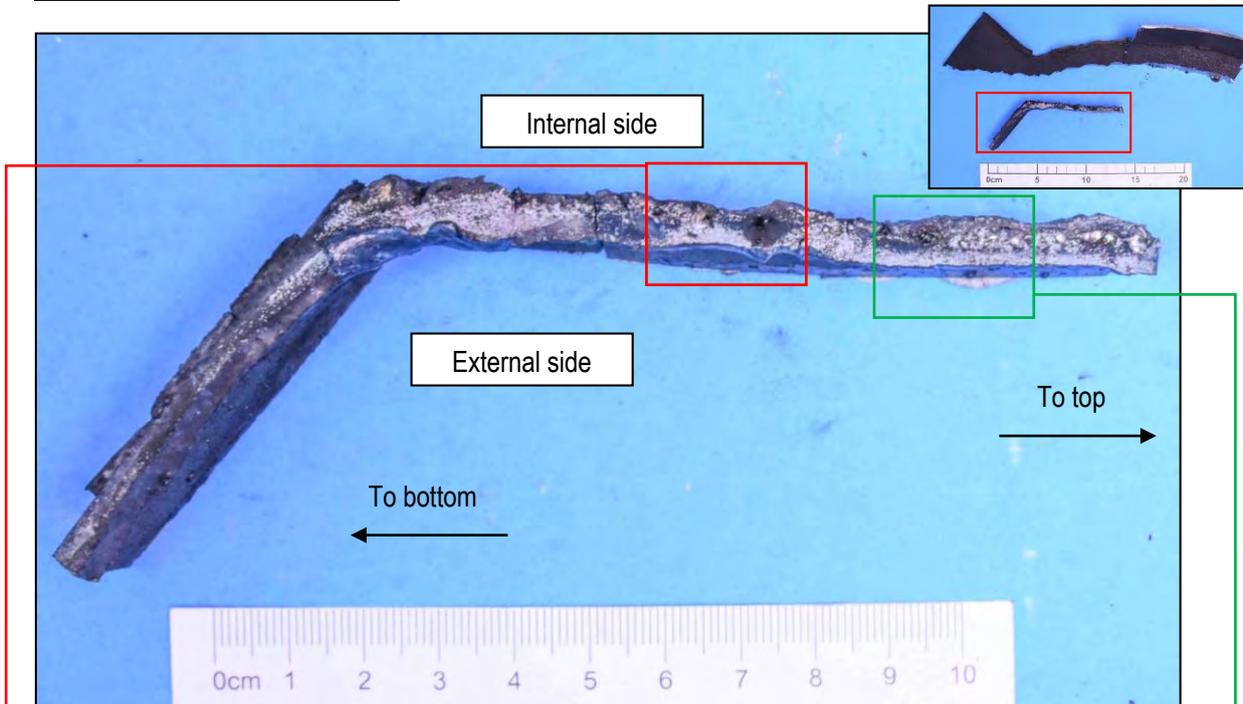
Figure 119: Fracture surface after cleaning in an ultrasonic bath of Alconox solution and subjected to SEM examination.

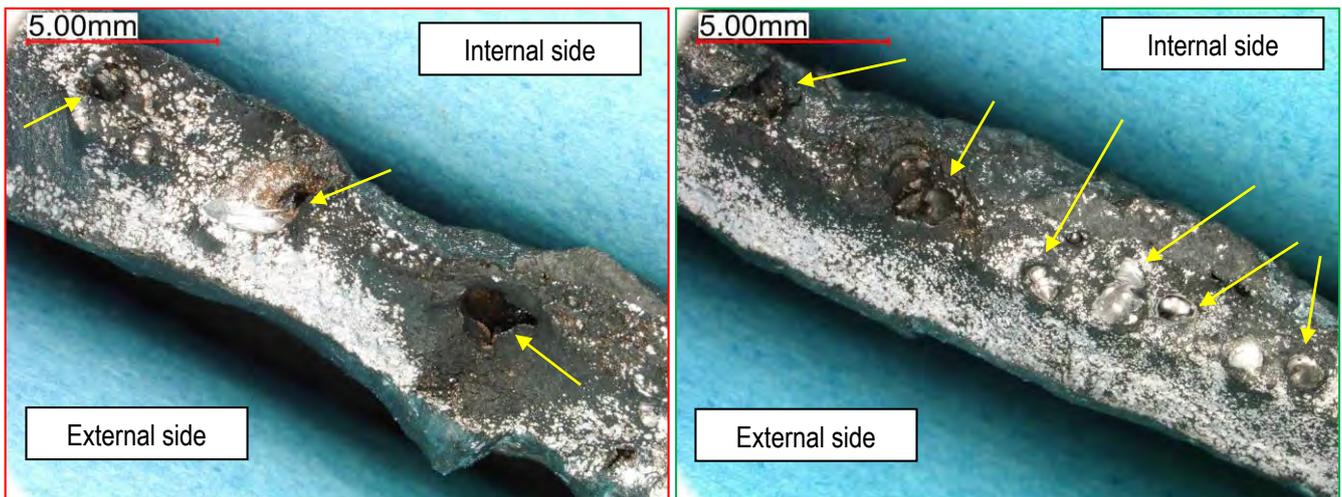
34 ➤ Macroscopic view of fracture surface revealed weld porosities throughout the
fracture surface (which was the weld metal), predominantly at about the
36 mid-depth from the external surface (Figure 120).

Figure 120: Macroscopic view of fracture surface. Weld porosities were observed throughout the fracture surface (which is the weld metal), predominantly at about the mid-depth from the external surface (indicated with yellow arrows).

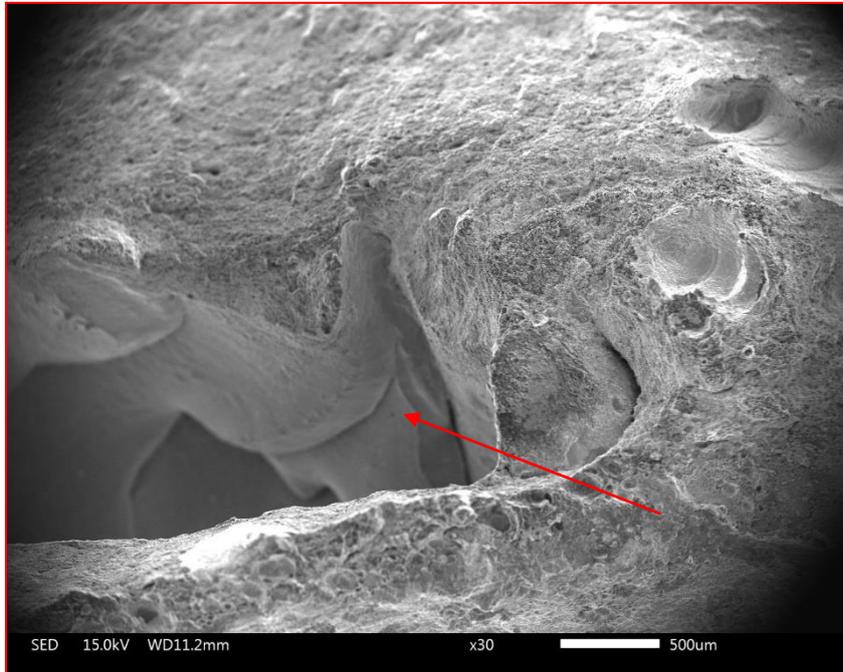
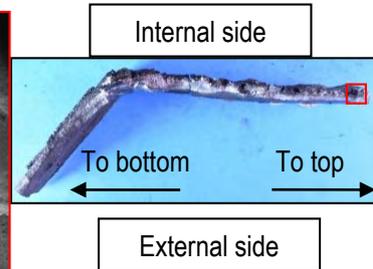
➤ Voids were confirmed under the SEM (Figure 121 and Figure 122).

Figure 121: Voids were observed scattered on the fracture surface, consistent with weld porosities.

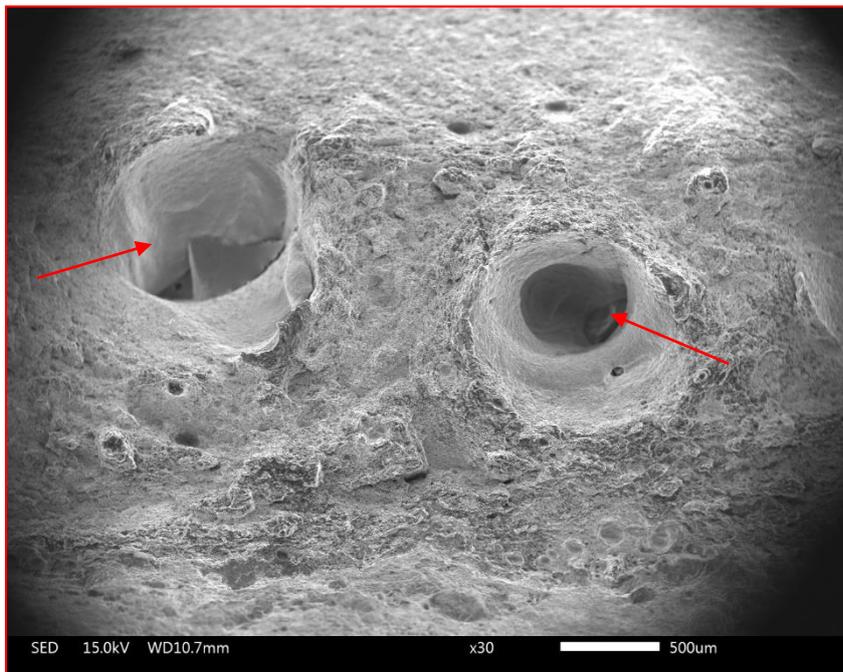
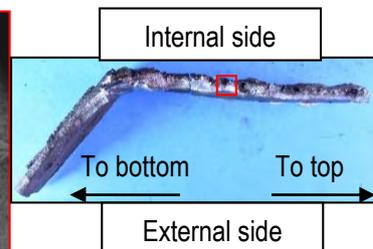
Figure 122: Voids were observed scattered on the fracture surface, consistent with weld porosities.

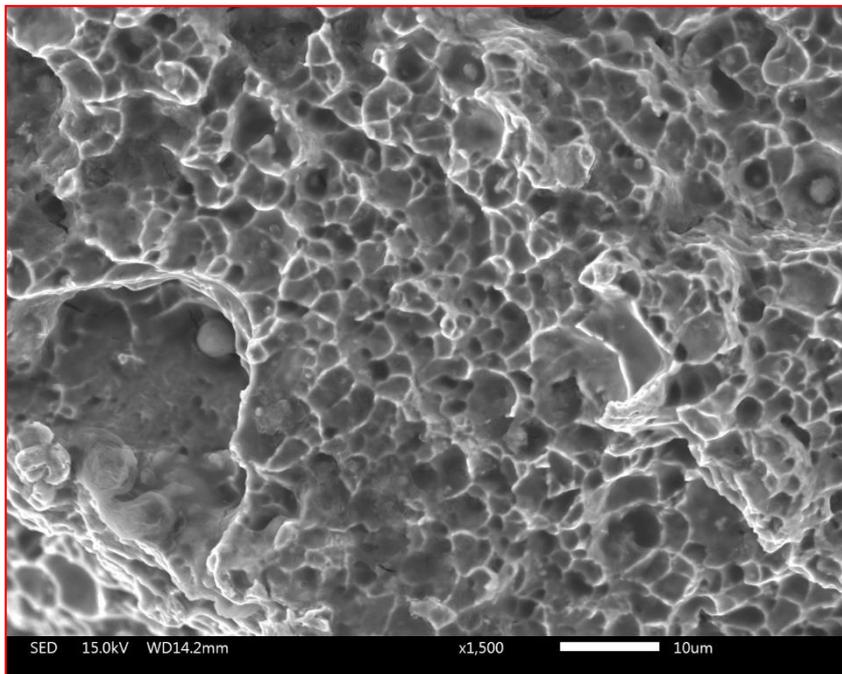
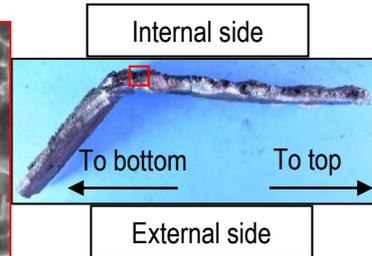
38 ➤ Relatively equiaxed dimples were generally observed throughout the fracture
surface at regions adjacent to the internal side (Figure 123).

Figure 123: Relatively equiaxed dimples were generally observed throughout the fracture surface at regions adjacent to the internal side.

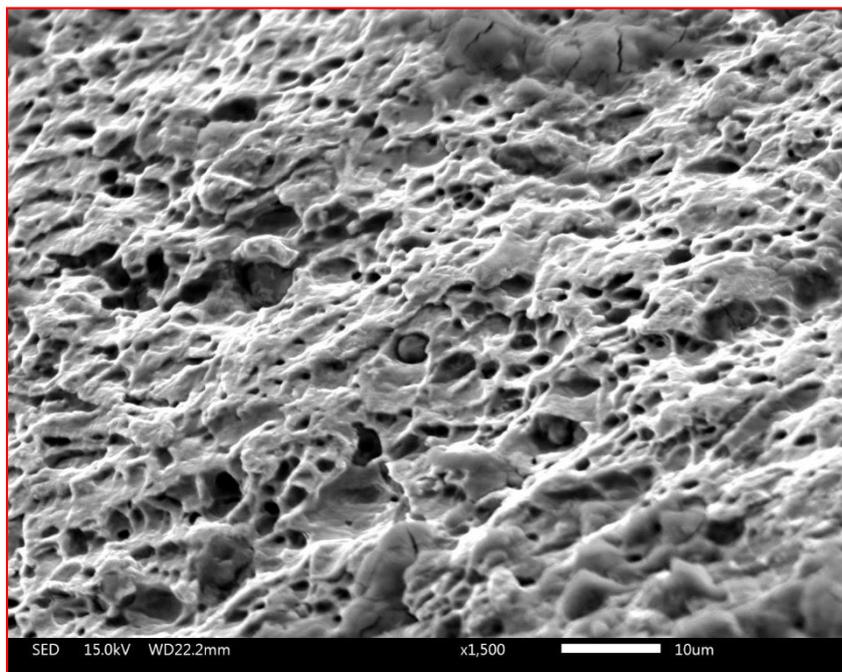
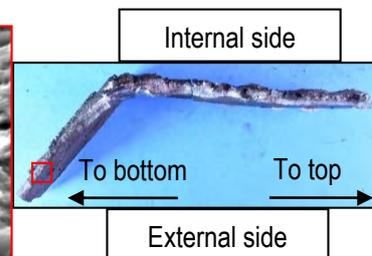
40 ➤ Elongated dimples were observed at regions adjacent to the external side
(Figure 124).

Figure 124: Elongated dimples were generally observed throughout the fracture surface at regions adjacent to the external side.

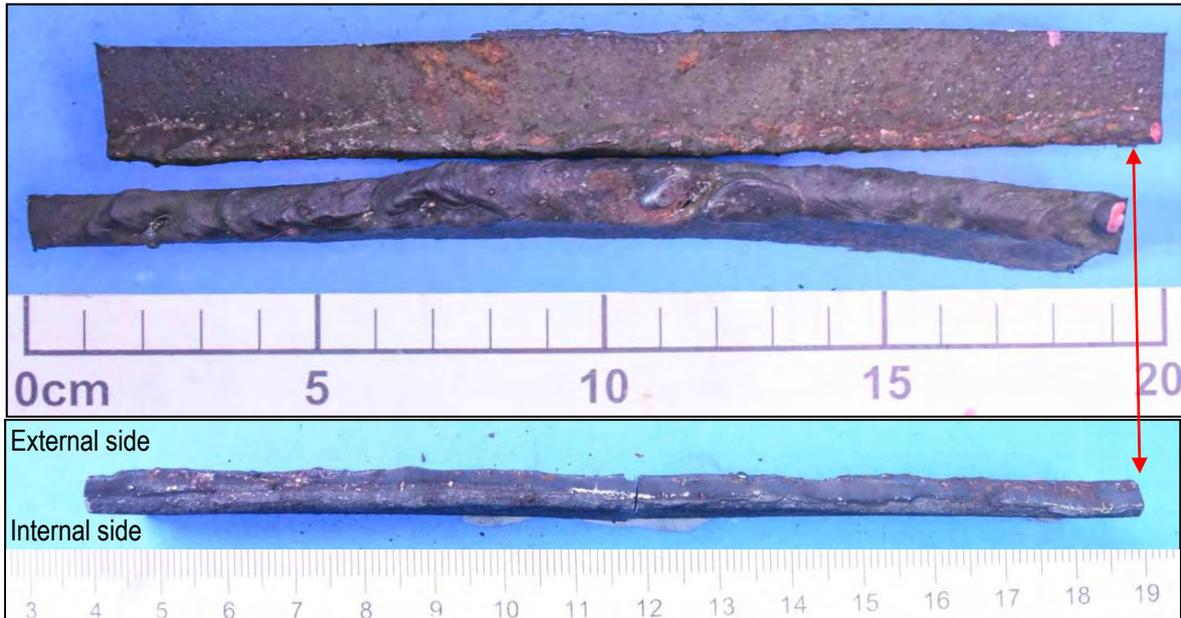
Figure 125: Rear side, bottom right weld. Fracture surface condition after cleaning in an ultrasonic bath of Alconox solution (bottom figure). See Figure 127 to Figure 128.

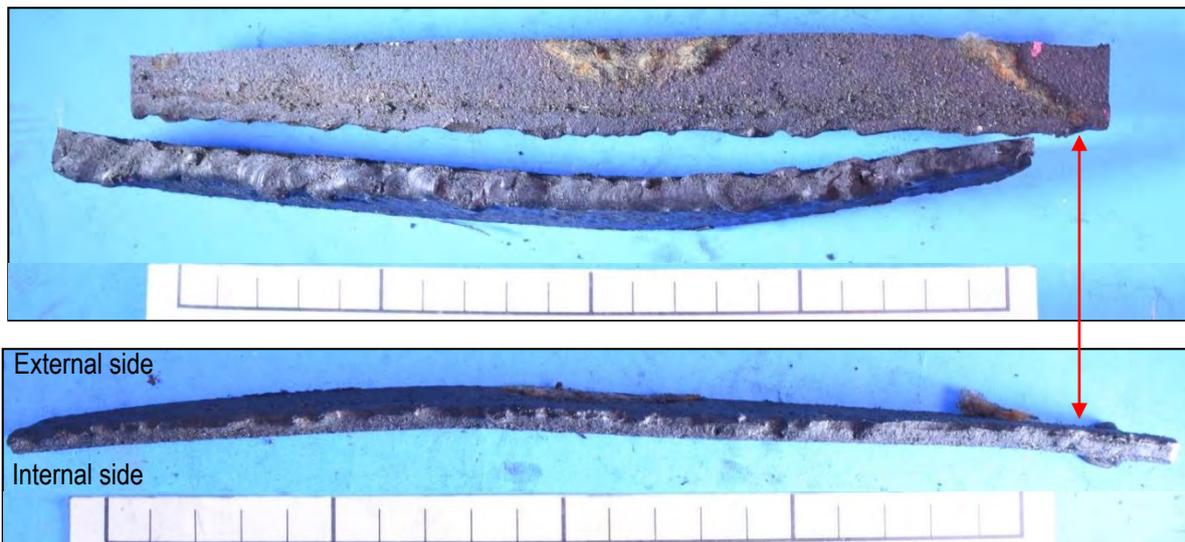
Figure 126: Rear side, bottom middle weld. Fracture surface condition after cleaning in an ultrasonic bath of Alconox solution (bottom figure). See Figure 129 to Figure 130.

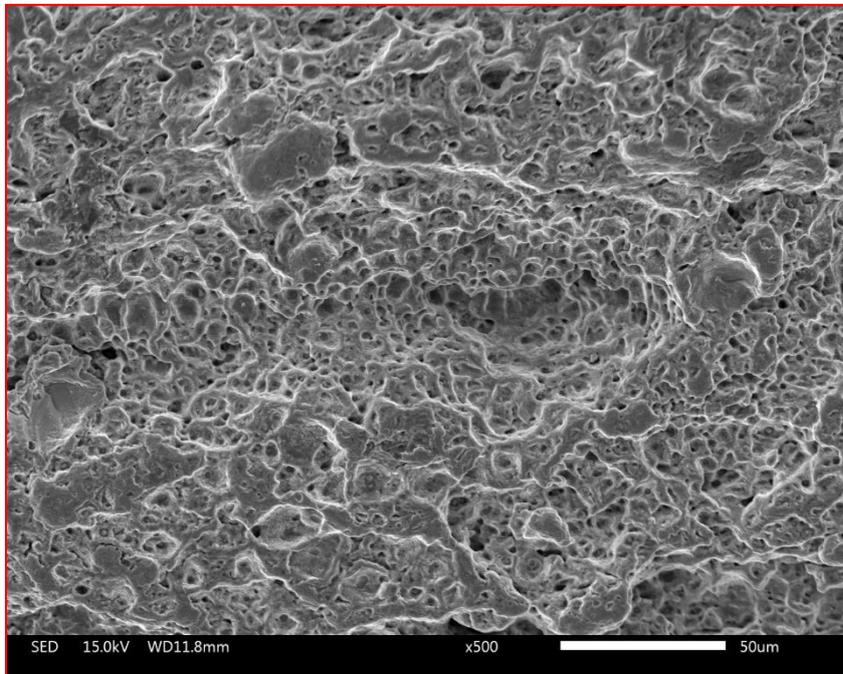
Figure 127: Equiaxed dimples were generally observed throughout the fracture surface at regions adjacent to the internal side.

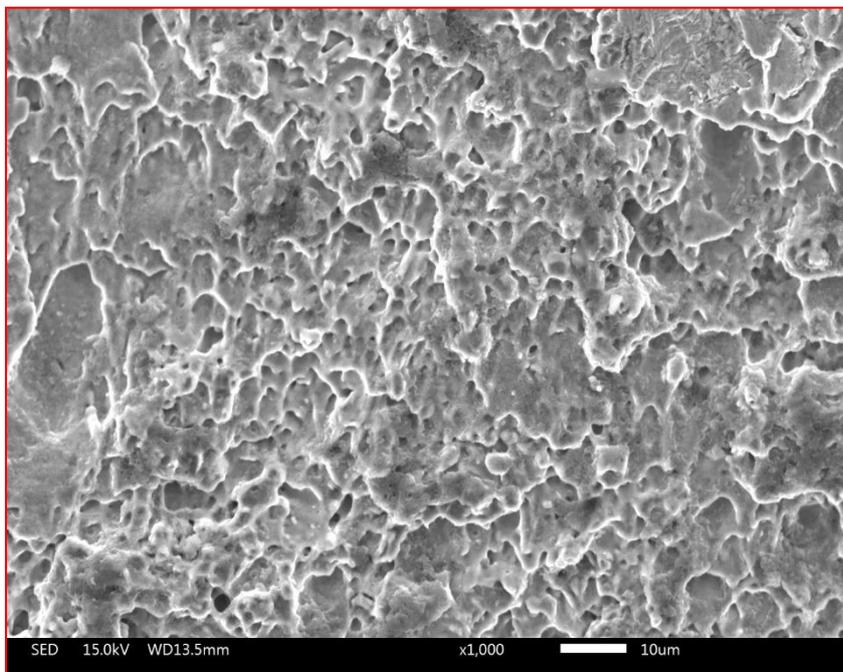
Figure 128: Elongated dimples were generally observed throughout the fracture surface at regions adjacent to the external side.

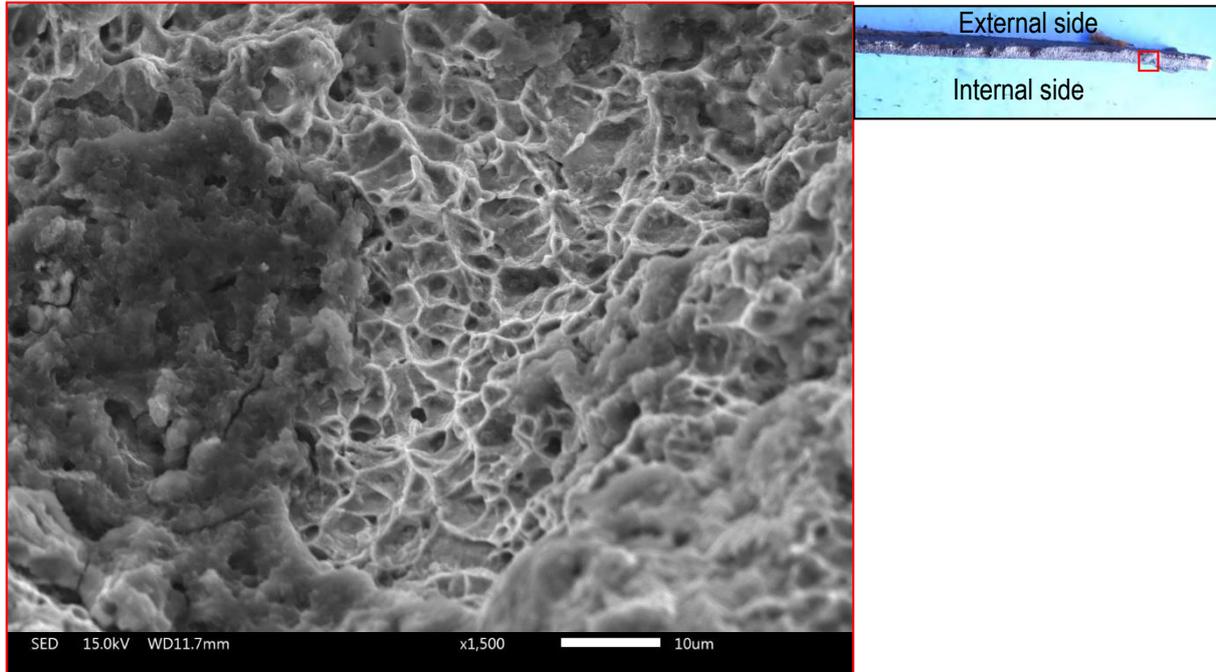
- 18 ➤ Similarly, dimples were observed throughout the fracture surface of both
20 examined samples. Equiaxed dimples were observed on the fracture surface
22 at the regions adjacent to the internal side while elongated dimples were
observed at the regions adjacent to the external side (Figure 129 and Figure
130).

Figure 129: Equiaxed dimples were generally observed throughout the fracture surface at regions adjacent to the internal side.

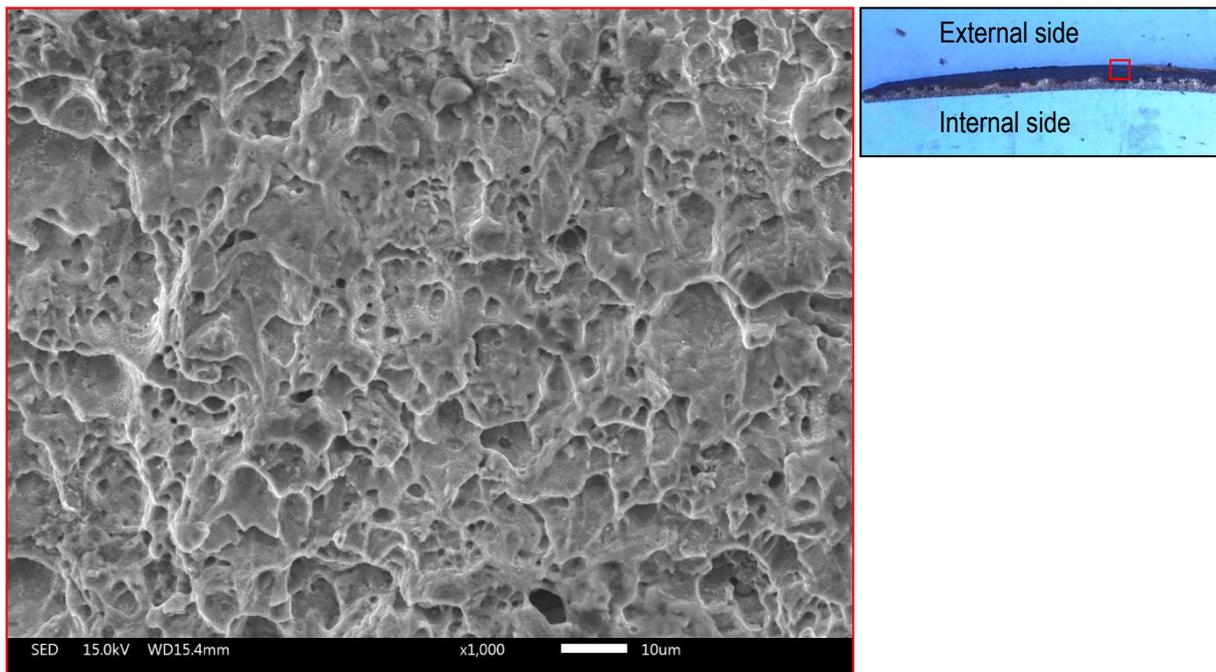
Figure 130: Elongated dimples were generally observed throughout the fracture surface at regions adjacent to the external side.

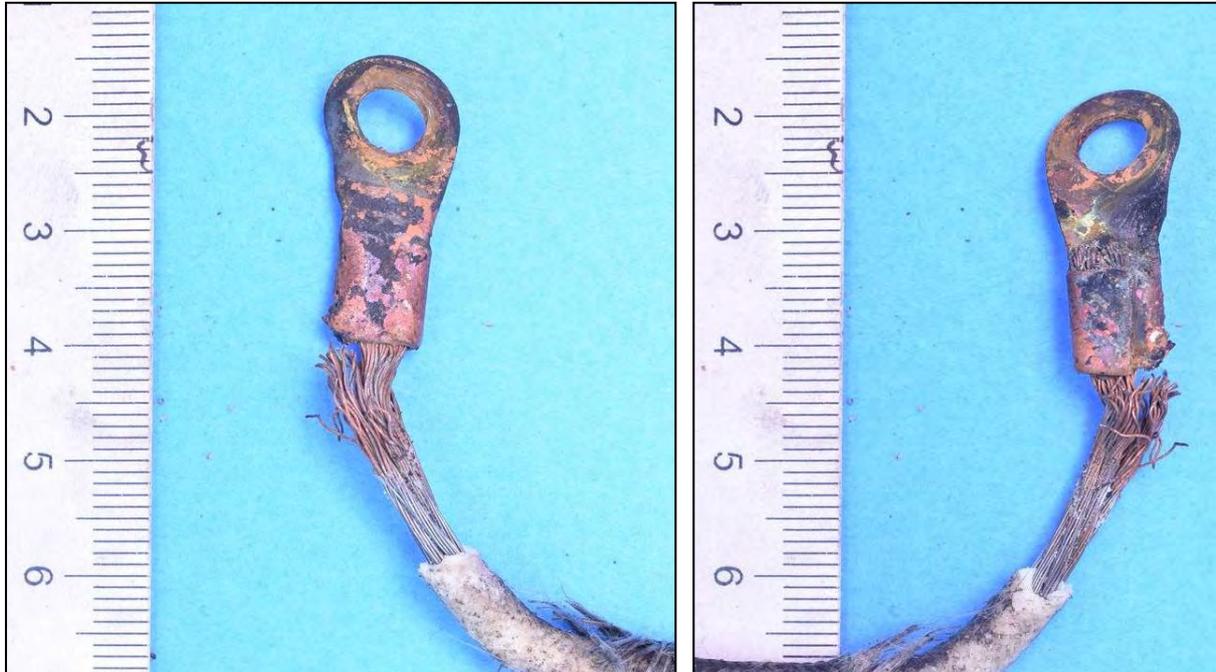
Lug from terminal 3

Figure 131: Wire and lug of heater #2, terminal 3.

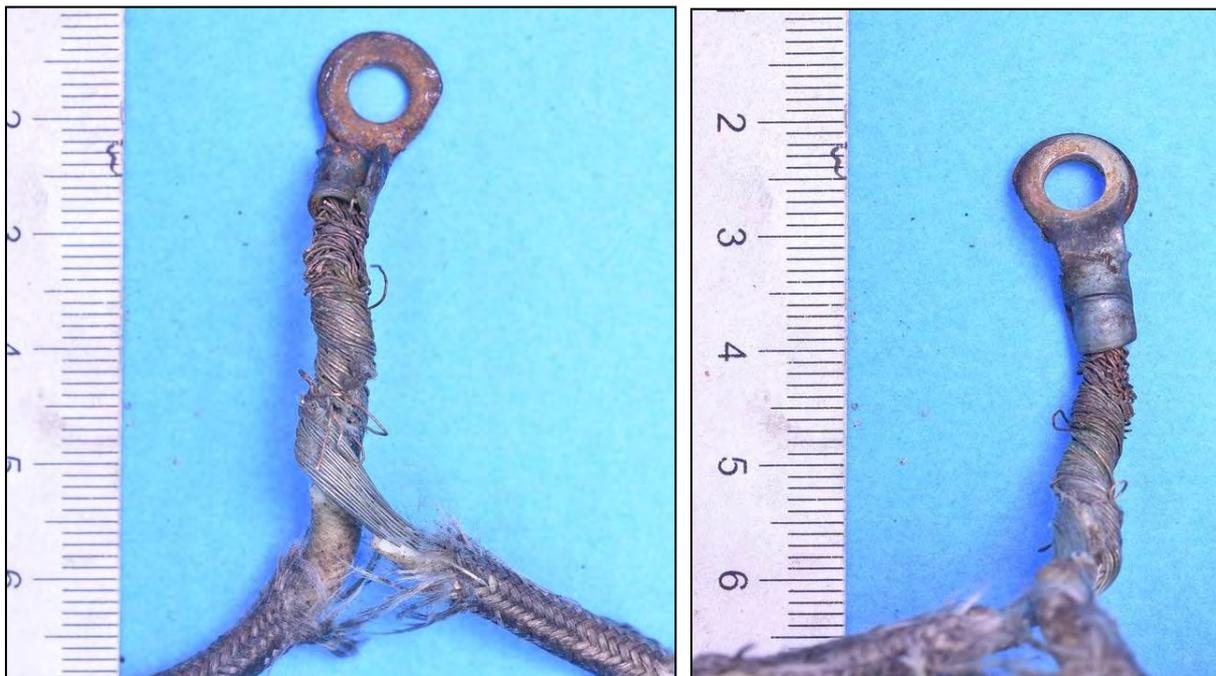
Lug from terminal 4

Figure 132: Wire and lug of heater #2, terminal 4.

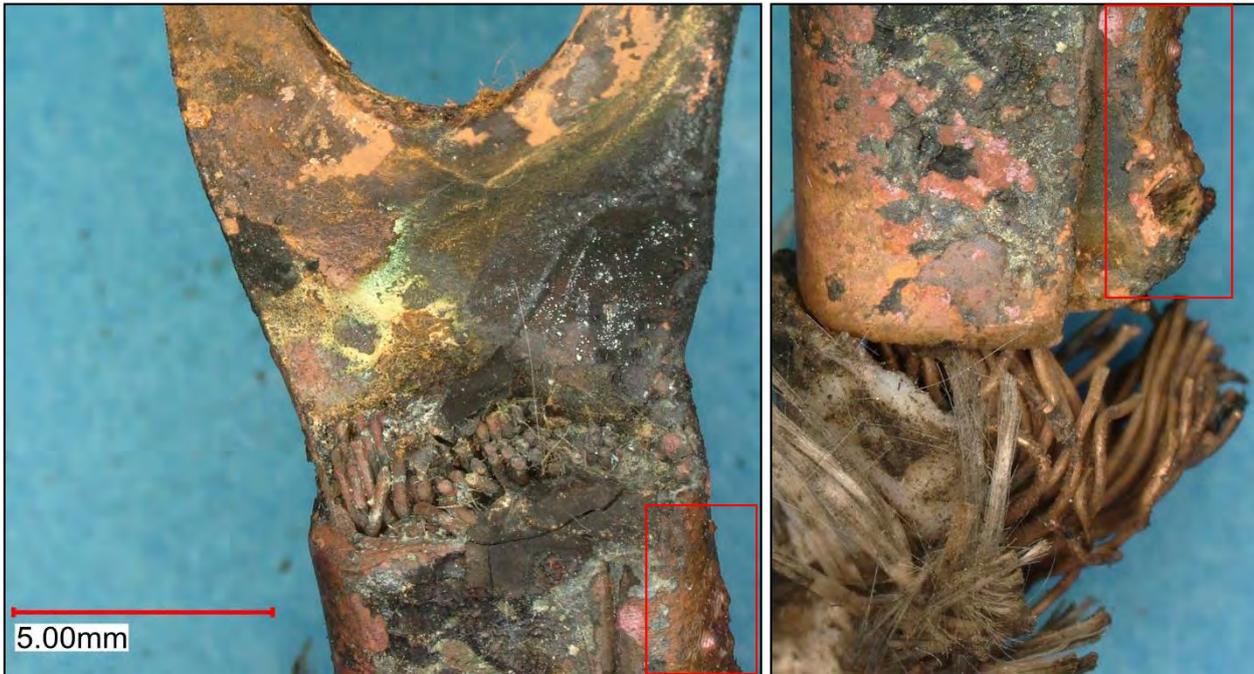
- 26 ➤ Resolidification waves and great extent of porosity, characteristics of arcing
28 damage, were observed at the bottom edge of the lug from terminal 3 (Figure
30 133 and Figure 134). SEM examination confirmed the arcing characteristic with
large percentage of voids and concentric rings observed to be emanating from
the centre of the arcing⁷ damage (Figure 135 and Figure 136).
- 32 ➤ Similarly, for the lug from terminal 4, resolidification waves were observed at
34 the lug and washer that had fused them together (Figure 137 and Figure 138).
SEM examination confirmed the arcing characteristic with concentric rings
observed to be emanating from the centre of the arcing damage (Figure 139
and Figure 140).

Figure 133: Condition of lug before cleaning.

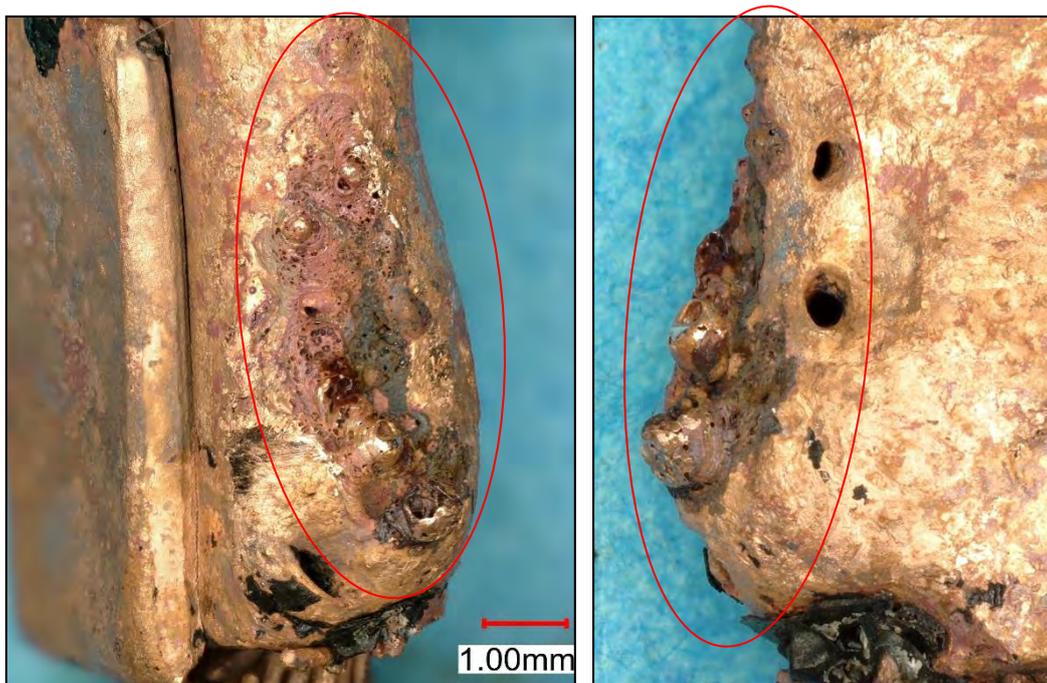
Figure 134: Condition of lug after cleaning in an ultrasonic bath of Alconox solution. Resolidification waves and high porosity, characteristics of arcing damage, were observed at the bottom edge of the lug.

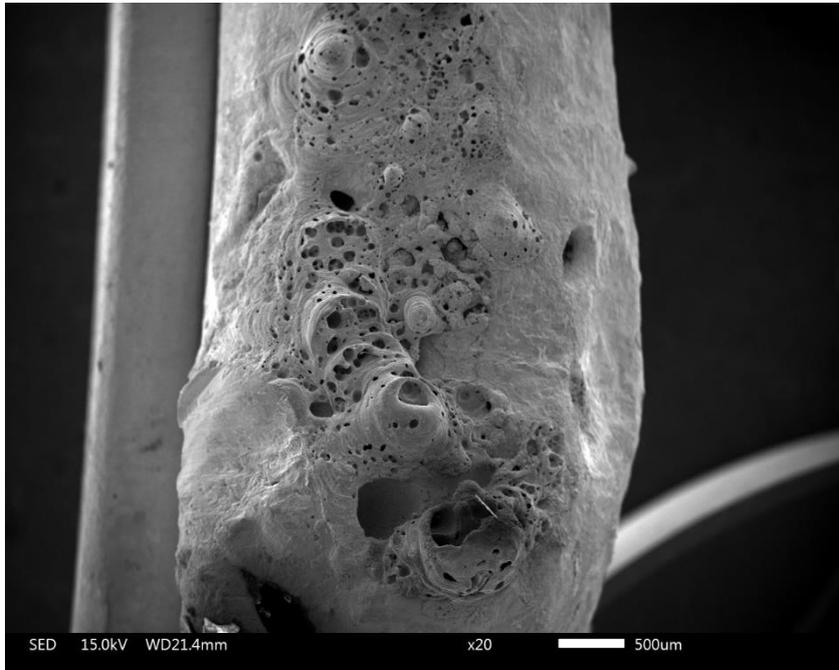
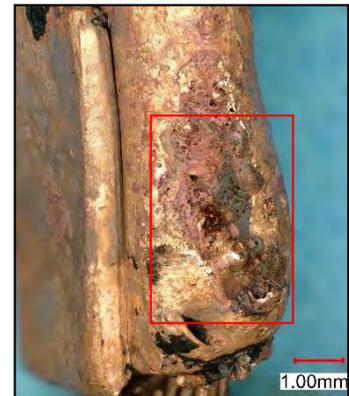
Figure 135: SEM confirms the arcing characteristic with large percentage of voids.

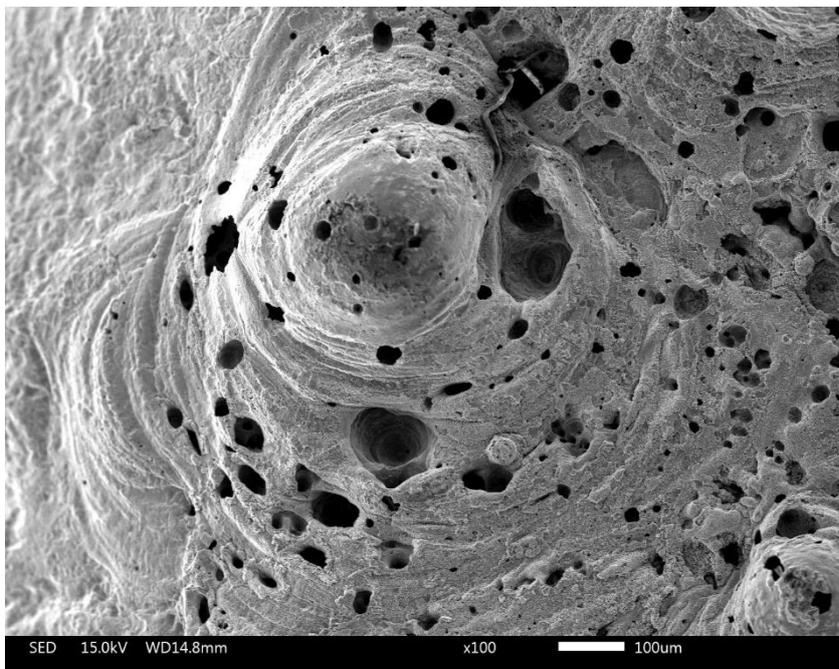
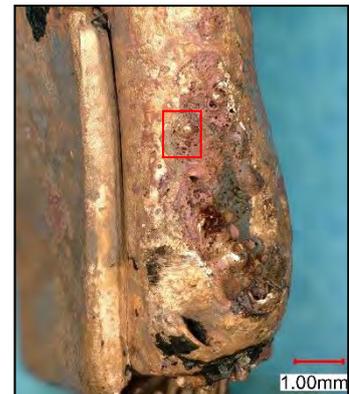
Figure 136: SEM confirms the arcing characteristic with large percentage of voids and concentric rings observed to be emanating from the centre of the arcing damage.
