**Report of the Inquiry
Committee for the accident
at Stars Engrg Pte Ltd on
24 February 2021
(PART II – ANNEXES)**

TECHNICAL REPORT

| Title of Report: Failure Analysis of a Failed Mixer Machine Retrieved from Unit 32E of Platinum @ Pioneer Building involved in a Fire Explosion Incident | | Date of Last Revision/Revision No: |

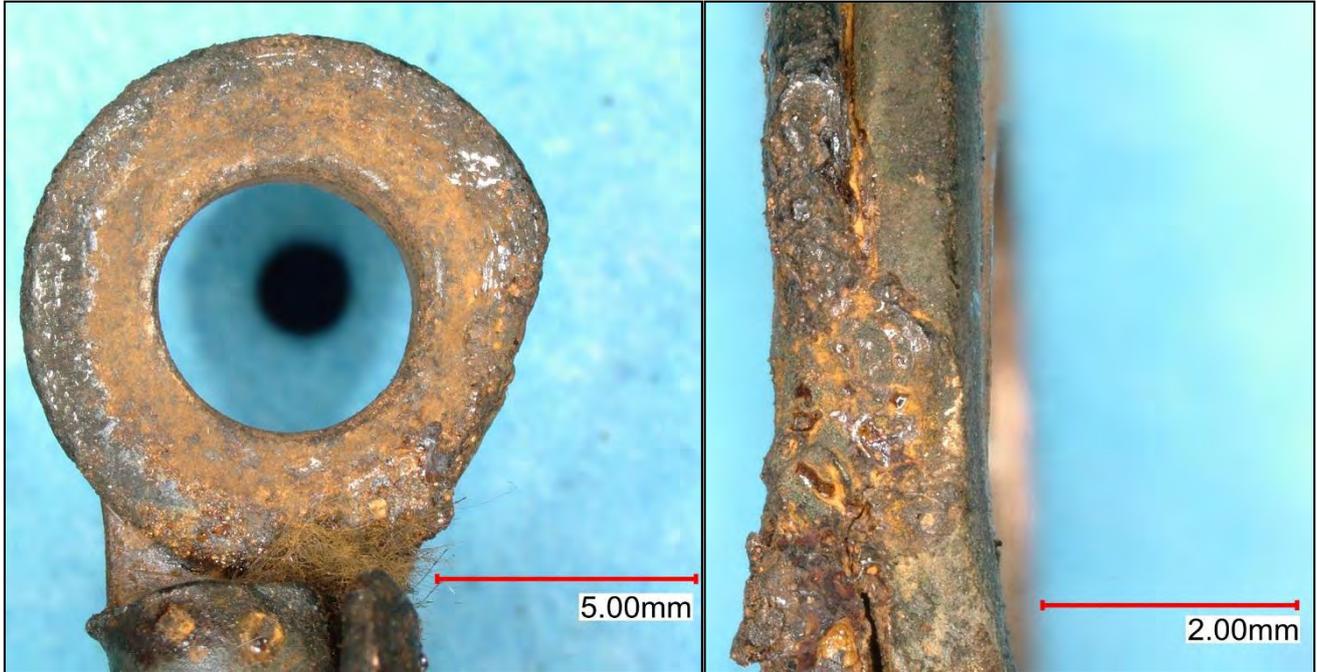
Lug from terminal 4

Figure 137: Condition before cleaning.

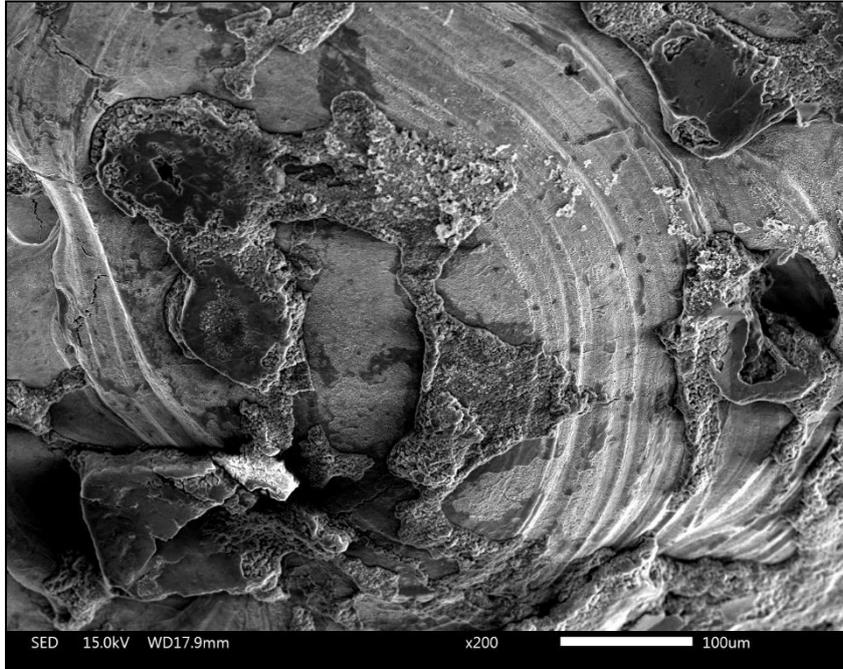
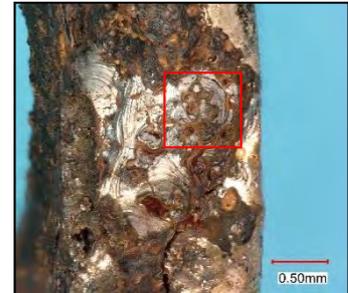
Figure 139: SEM confirms the arcing characteristic with concentric rings observed to be emanating from the centre of the arcing damage.

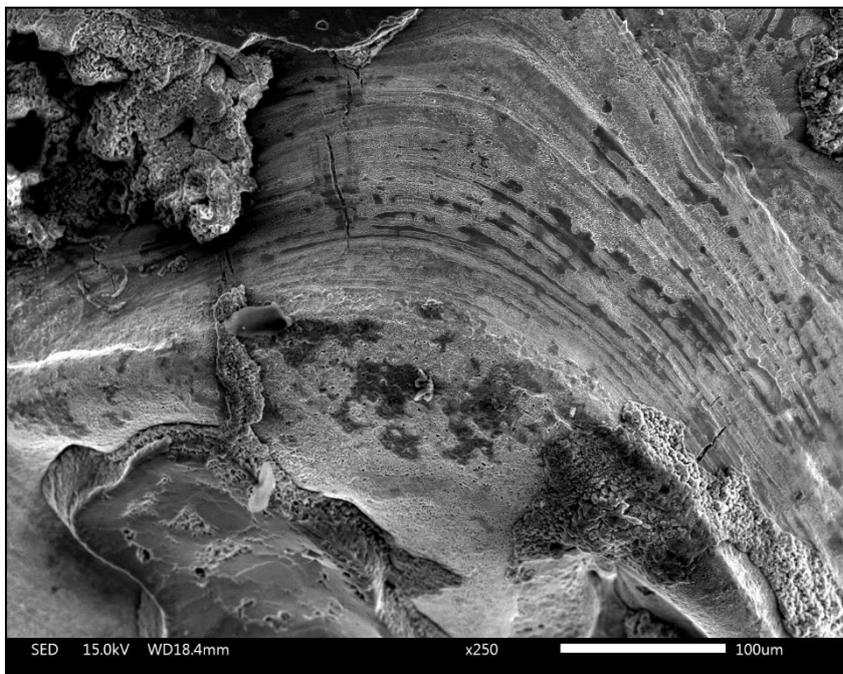
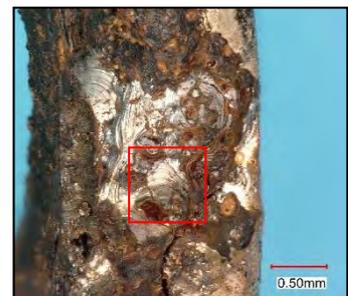
Figure 140: SEM confirms the arcing characteristic with concentric rings observed to be emanating from the centre of the arcing damage.

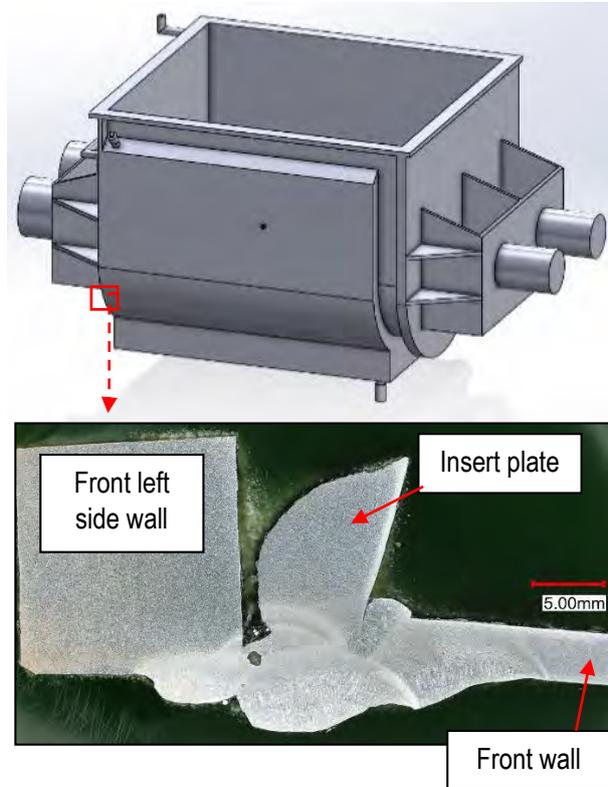
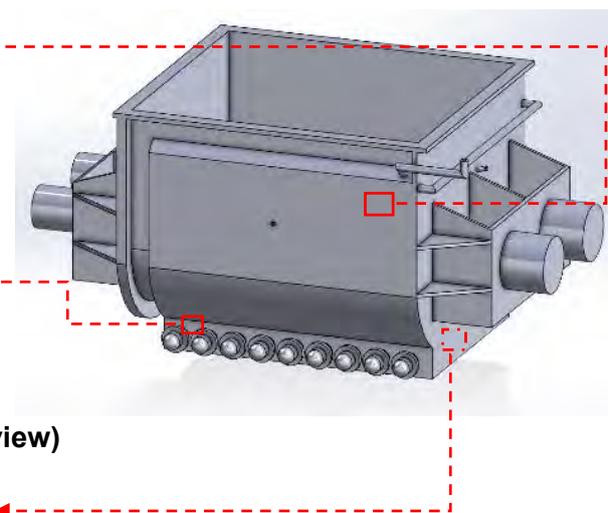
Figure 141: Chemical analysis conducted on the various oil jacket walls revealed elements typical of low carbon steel material.

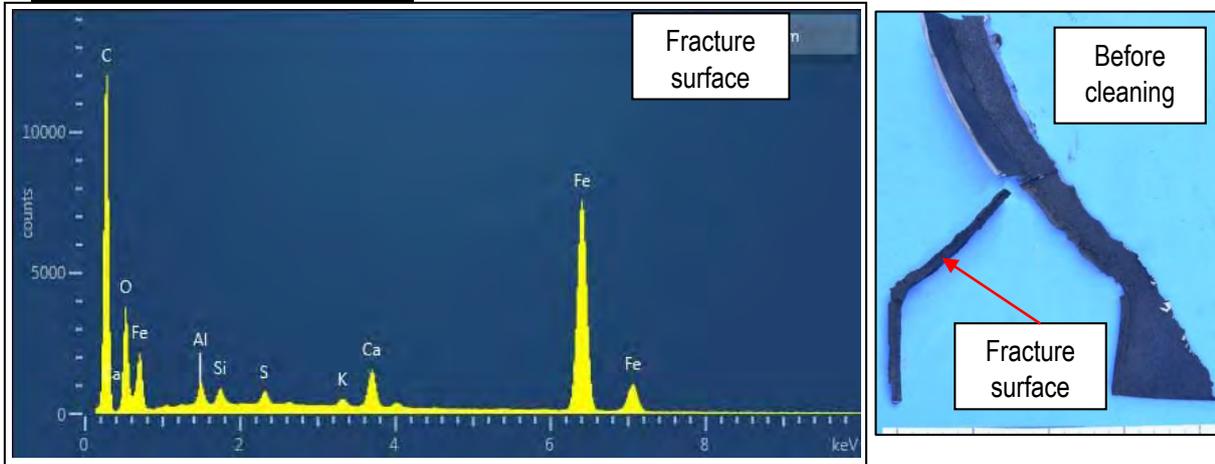
Fracture surface (of weld)

Figure 142: The major elements detected on the fracture surface were generally associated with the weld metal and constituents of the service medium.

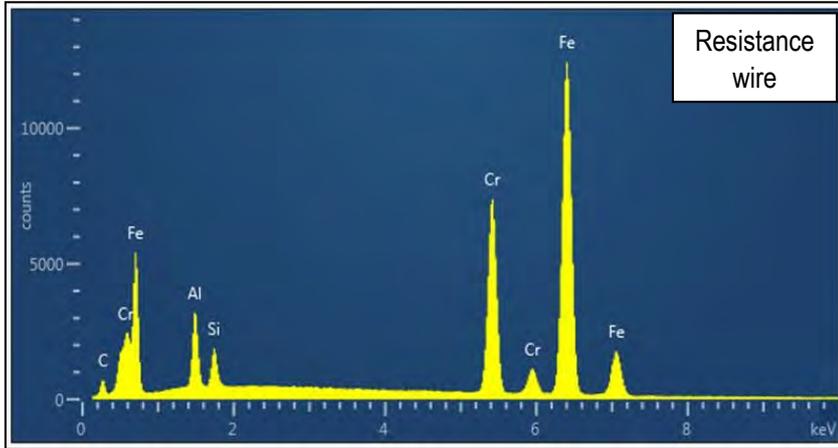
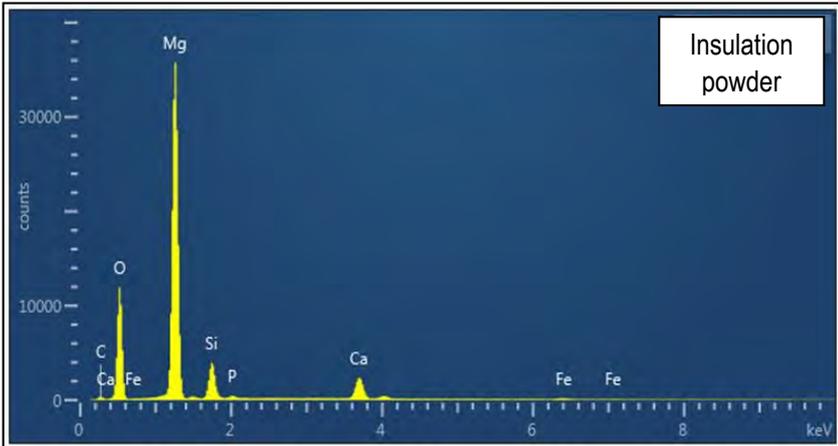
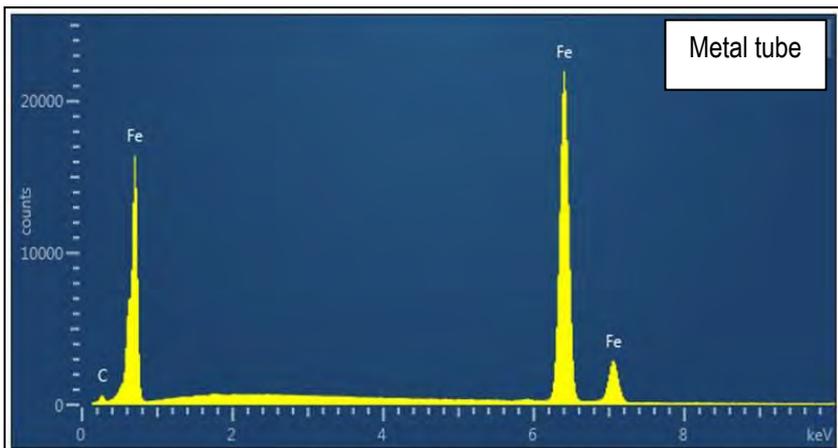
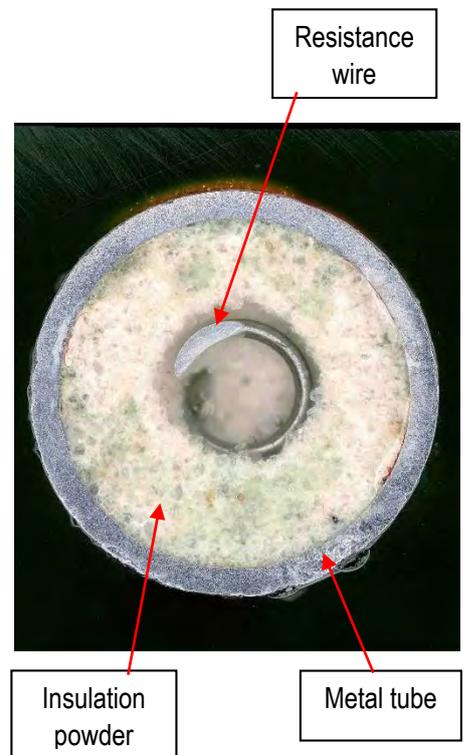
Heater materials

Figure 144: Based on the major elements detected, the resistance wire is most likely constructed using Kanthal or Fe–Cr–Al material. The insulation powder is mainly magnesium oxide. The metal tube is constructed using carbon steel. All the material are typical of heating element construction.

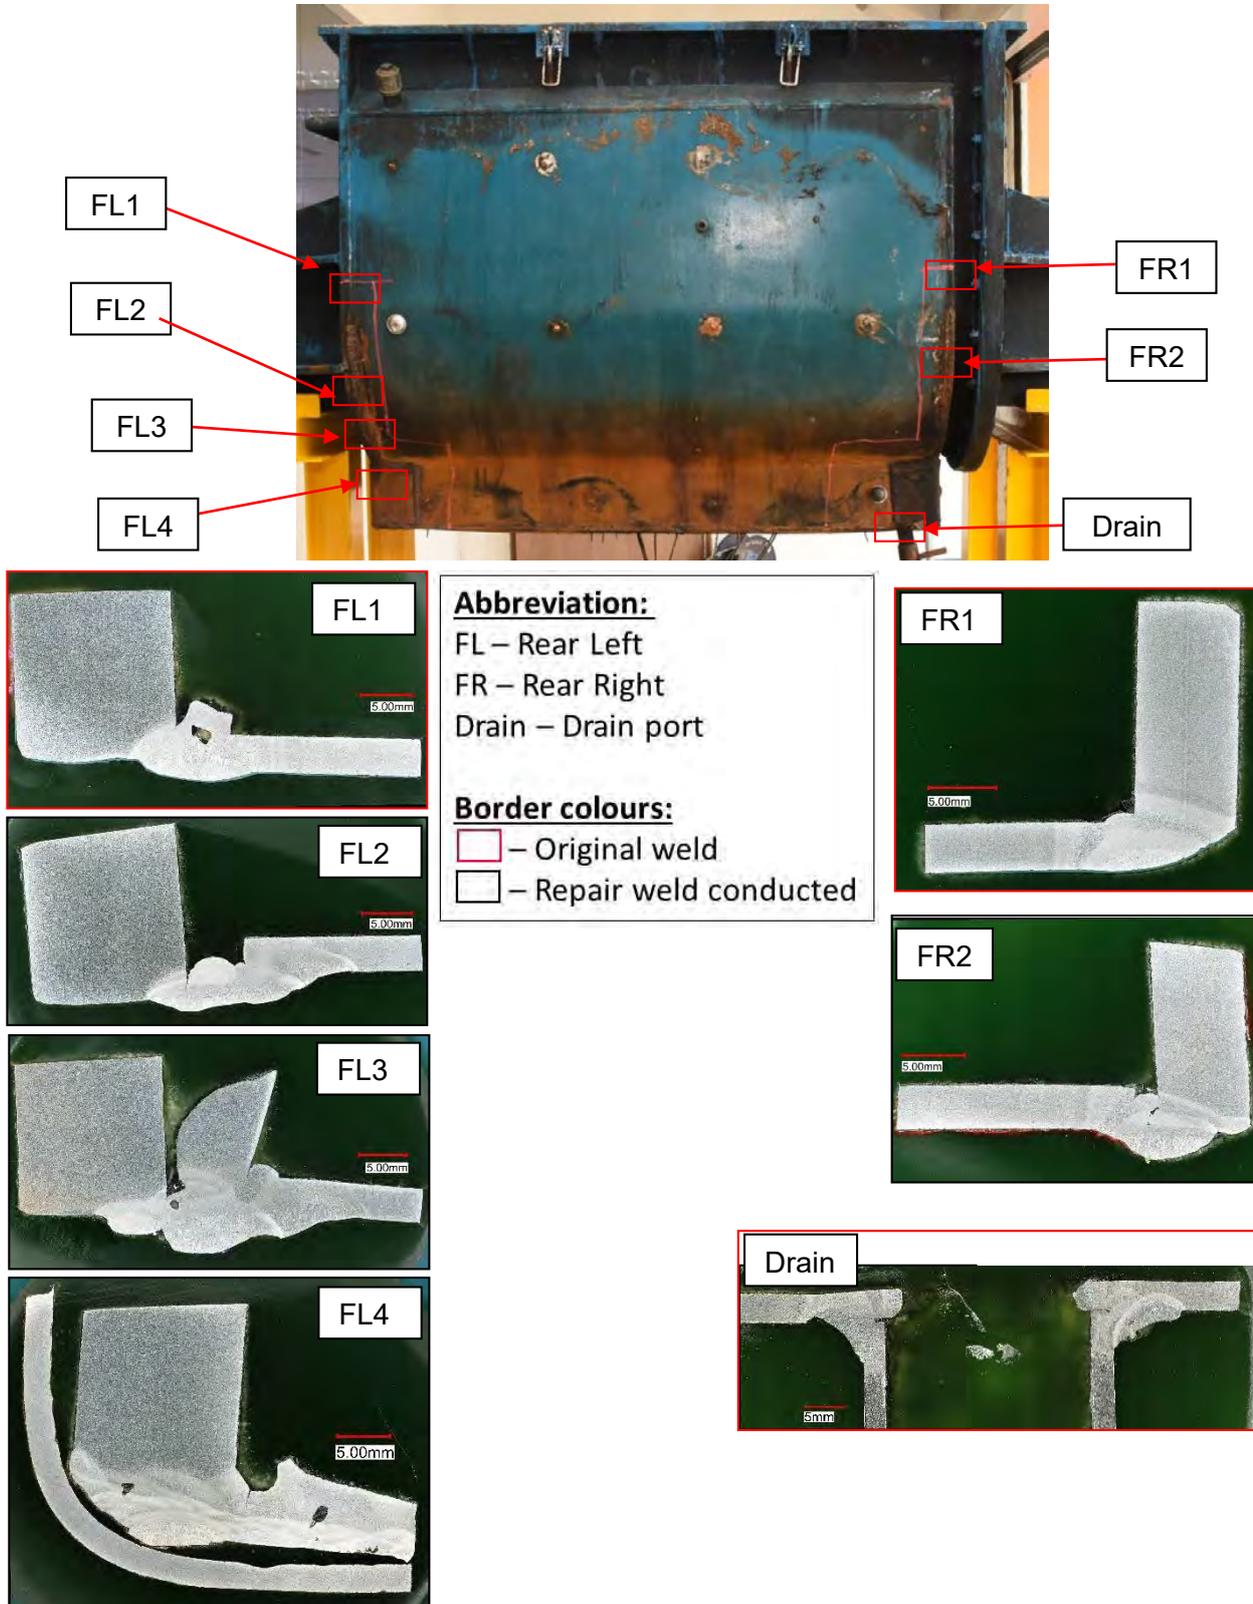
Figure 145: Samples for sectional metallographic examination.

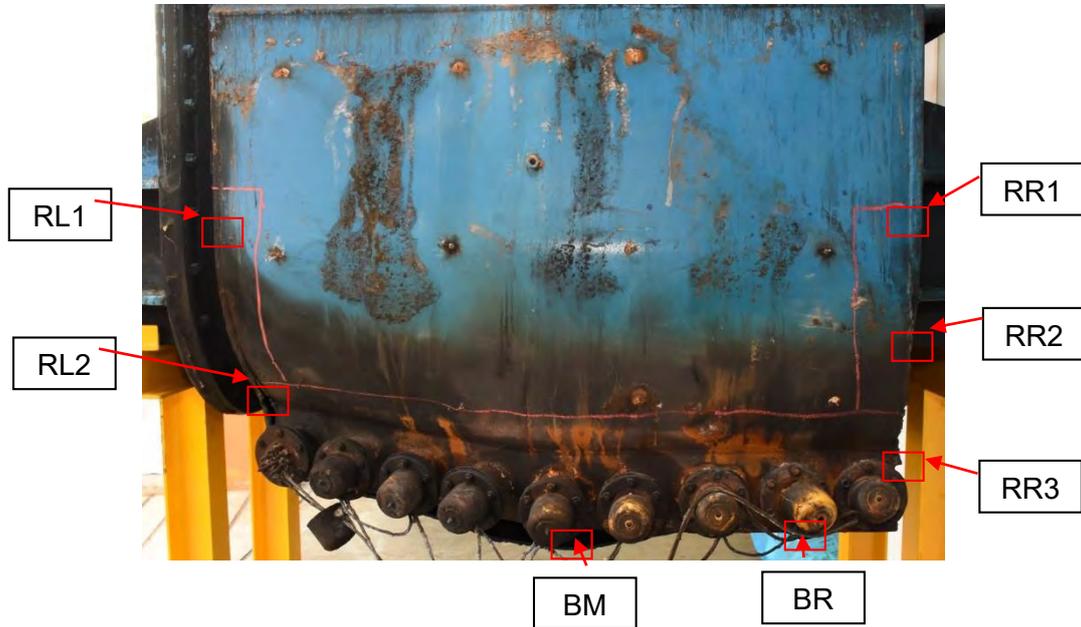
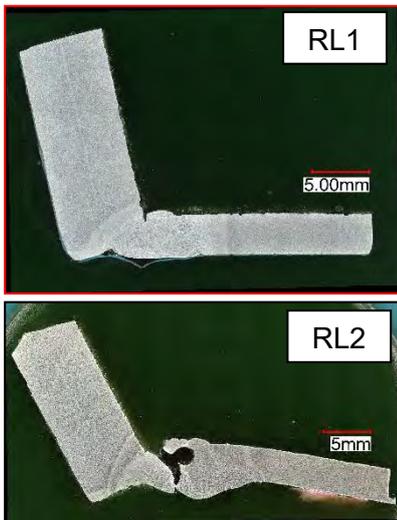
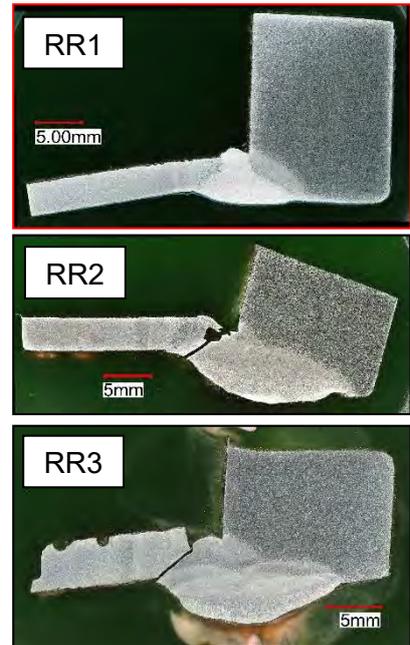
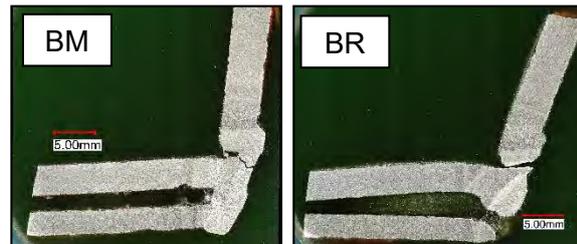
Figure 146: Samples for sectional metallographic examination.

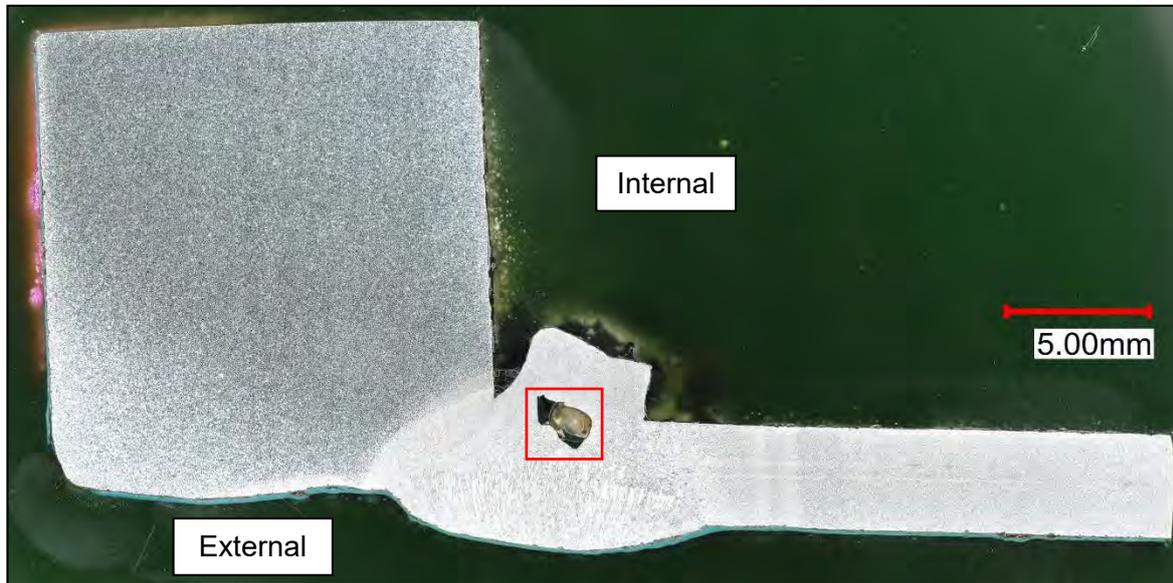
Front Left 1 (FL1)

- Apart from location FL1, the weld joint examined at FR1 (Figure 157), RL1 (Figure 163) and RR1 (Figure 167) were generally similar with no discontinuity found.
- The weld at location FL1 had excessive root penetration with a void of about 2 mm wide (Figure 147).
- Incipient cracks were observed at location FL1 (Figure 148), RL1 (Figure 164) and RR1 (Figure 168).

Figure 147: Section metallographic examination was conducted across the original weld. Excessive root penetration was observed at this weld area. About 2 mm width void was observed in the middle of the weld root.

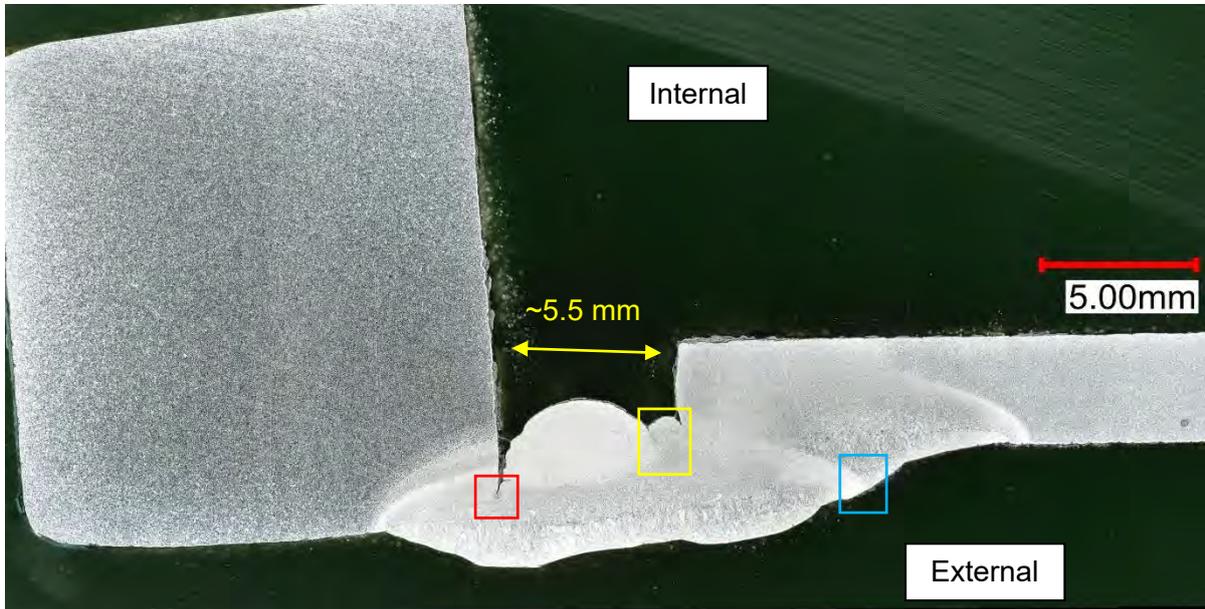
Front Left 2 (FL2)

- All nine examined locations either had through-thickness cracks (RL2 [Figure 165], RR2 [Figure 169], RR3 [Figure 171], BM [Figure 173] and BR [Figure 175]) or incipient cracks (FL2 [Figure 149], FL3 [Figure 151], FL4 [Figure 155], FR2 [Figure 159]) that initiated from the weld root and propagated towards the external surface of the weld. Most of the incipient cracks were observed to be oxide filled.

10 ➤ Four out of nine locations had lack of root penetration with root openings of up
12 to about 5.5 mm wide (FL2 [Figure 149], FL4 [Figure 155], FR2 [Figure 159]
 and RR3 [Figure 171]).

26 ➤ The weld at the repair weld locations had an obtuse joint angle (i.e. Figure 169)
28 or large root opening (i.e. Figure 149) compared to the original weld locations
 that had relatively right angle joint. This suggested that severe deformation and
 opening of the weld seams had occurred before repairs were conducted.

24 The lack of root penetration with wide root opening (up to about 5.5 mm wide) at the
26 repair welds of the oil jacket edges strongly suggested that the original welds had
28 ruptured open before repair weld and reinforcement plates were added (Figure 149,
30 Figure 155, Figure 159, Figure 171). Such large root gaps are evidence of severe
deformation in the oil jacket walls, typical of overpressure failure. The deformation of
the walls prevented a close fit for repair welding, leading to lack of root penetration.
When the rupture was repaired, the macro and micro features of earlier cracks were
removed/destroyed.

Figure 149: Sectional metallographic examination was conducted across the repair weld. Lack of root penetration was observed with a root opening of about 5.5 mm. Closer examination was made in the following colour bordered figures.

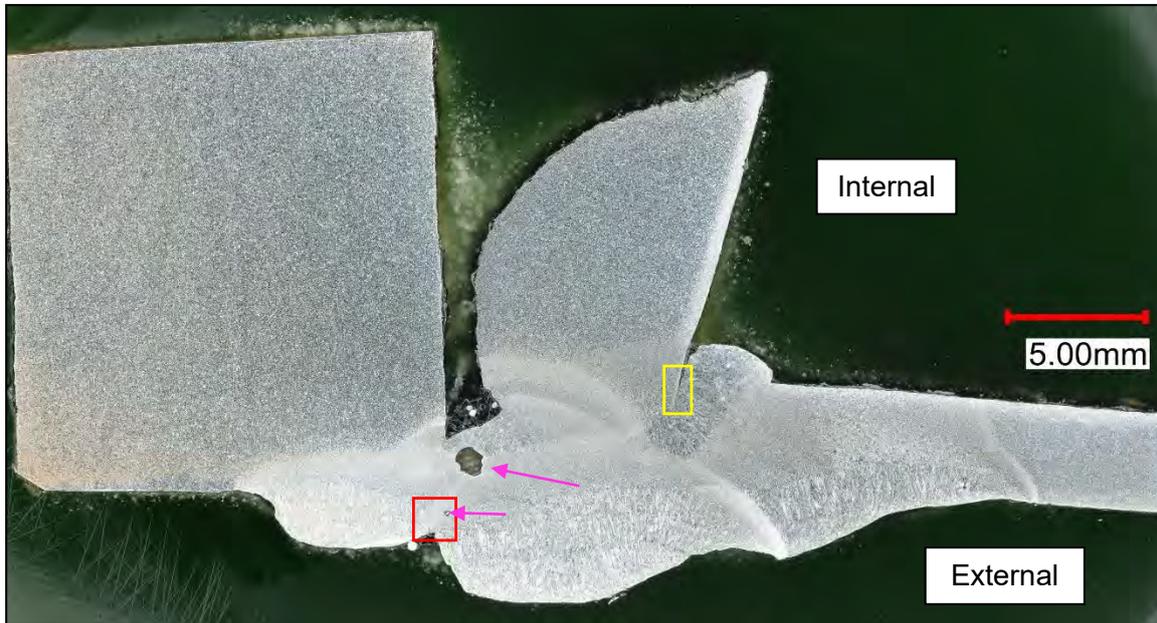
Front Left 3 (FL3)

4 ➤ Seven out of nine examined locations had voids scattered within the weld metal
6 (FL3 [Figure 151], FL4 [Figure 155], FR2 [Figure 159], RL2 [Figure 165], RR2
 [Figure 169], BM [Figure 173] and BR [Figure 175]). The voids were up to
 2.5 mm wide in size.

Figure 151: Sectional metallographic examination was conducted across the repair weld with a visible insert plate from the internal side (see Figure 47). Voids up to about 1.0 mm were observed (in pink).

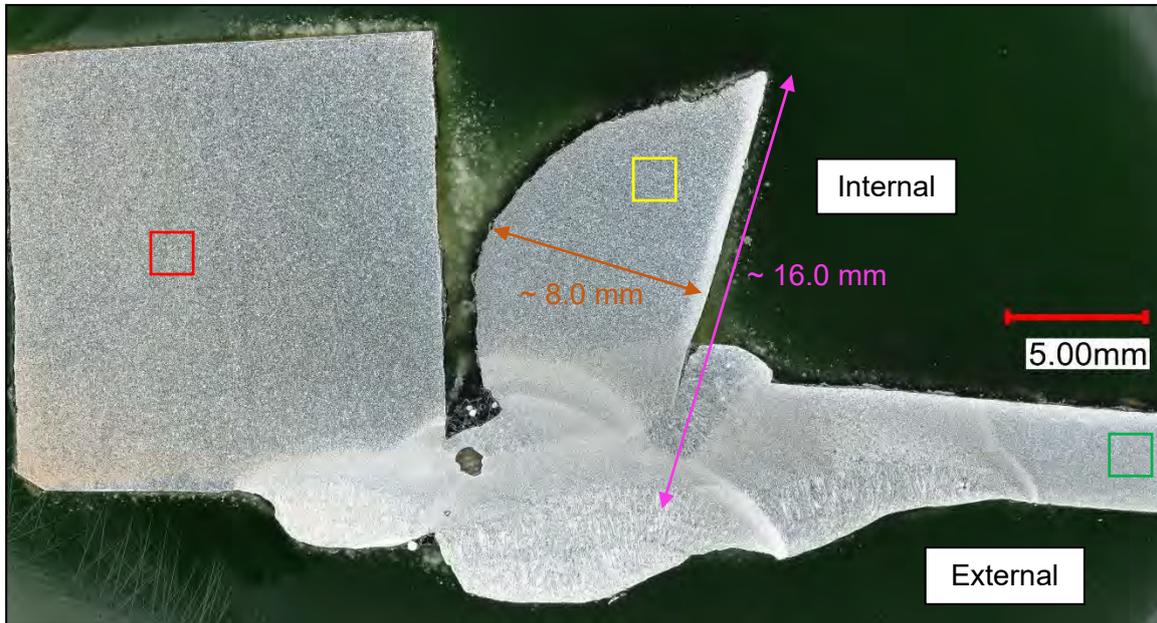
Front Left 3 (FL3)

14 ➤ At location FL3 (Figure 153 and Figure 154), the insert plate between the weld
16 joint was confirmed to be a separate (and different) metal piece that was welded
18 in between the front left side and front walls. Although their microstructures
 consisted of ferrite with pearlite, their microstructures differ such that the front
 left wall has flow lines from rolling process (manufacturing), the insert plate
 does not have flow lines and the front wall has finer grains.

20 ➤ The width and thickness of the insert plate were approximately 8.0 mm and
22 16.0 mm respectively (the length was measured earlier at about 120.0 mm, see
 also Figure 47). At the time of reporting, the source of the insert plate and when
 it was welded into the oil jacket were unknown.

Figure 153: The insert plate is confirmed to be a separate metal piece welded between the front left side and front walls. The width and thickness of the insert plate were approximately 8.0 mm and 16.0 mm respectively (the length was measured earlier at about 120.0 mm).

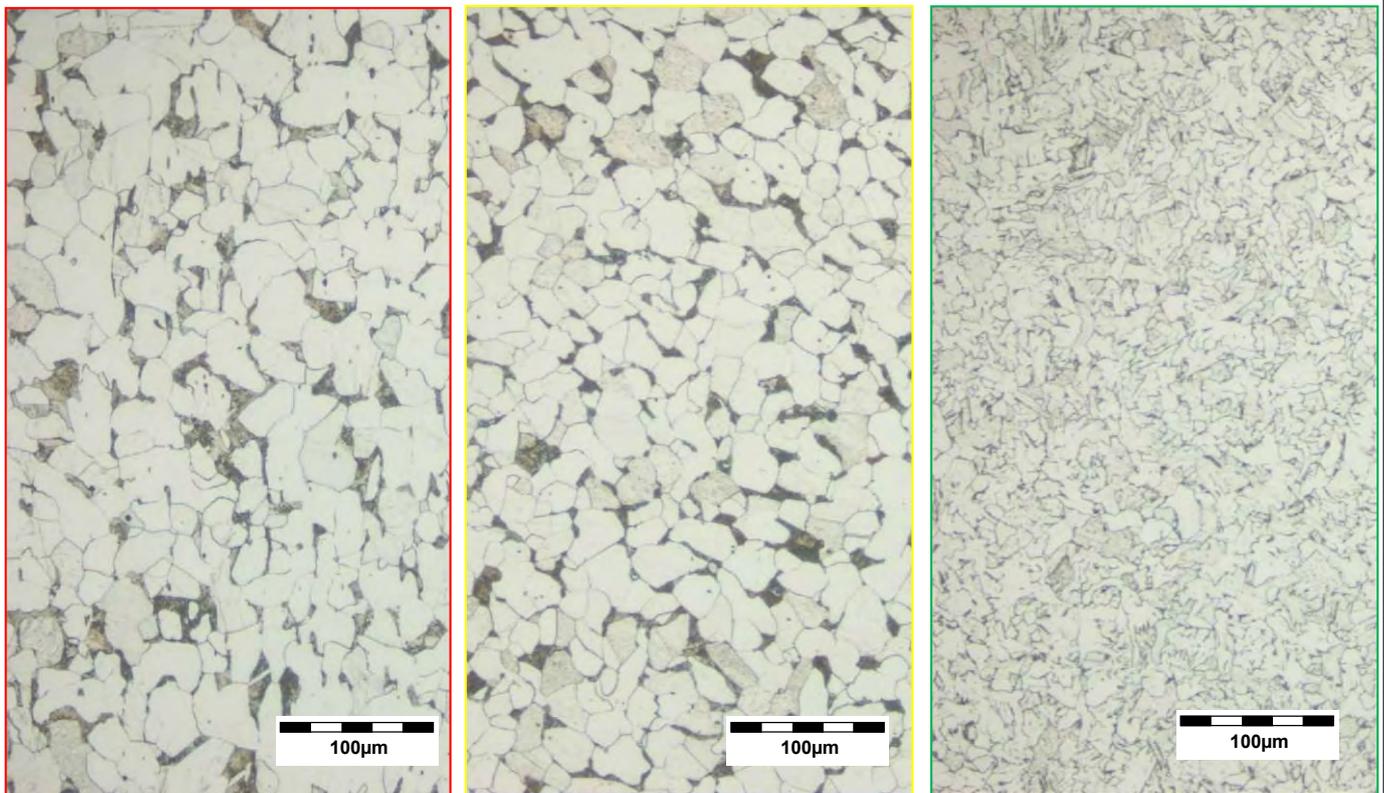
Figure 154: Micrographs at 200x magnification. The base metals of the oil jacket walls (left and right) and the added metal piece (middle) consisted of ferrite pearlite microstructure. Their microstructures differ such that the front left wall has flow lines from rolling process (manufacturing), the insert plate does not have flow lines and the front wall has finer grains.

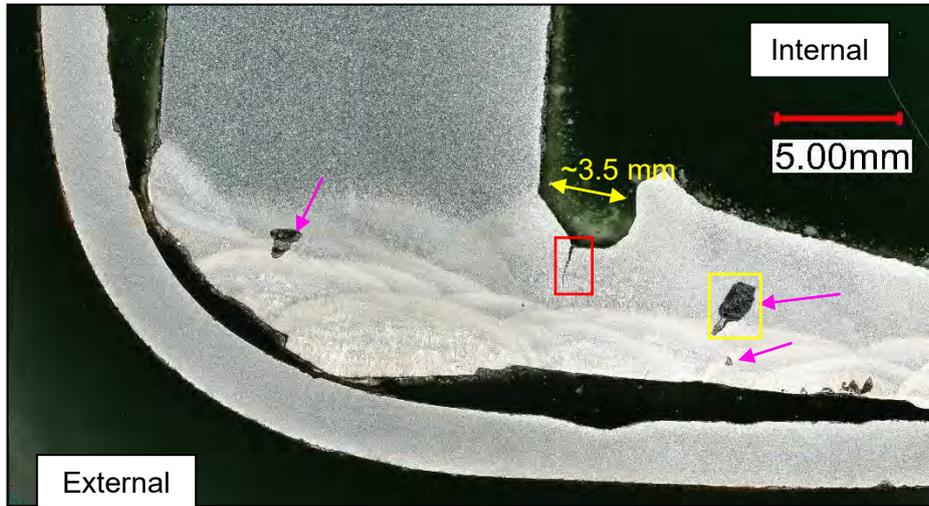
Front Left 4 (FL4)

Figure 155: Sectional metallographic examination was conducted across the repair weld and corner reinforcement plate. Lack of root penetration was observed with a root opening of about 3.5 mm wide. Voids of up to 2.5 mm wide were scattered in the weld metal (in pink).

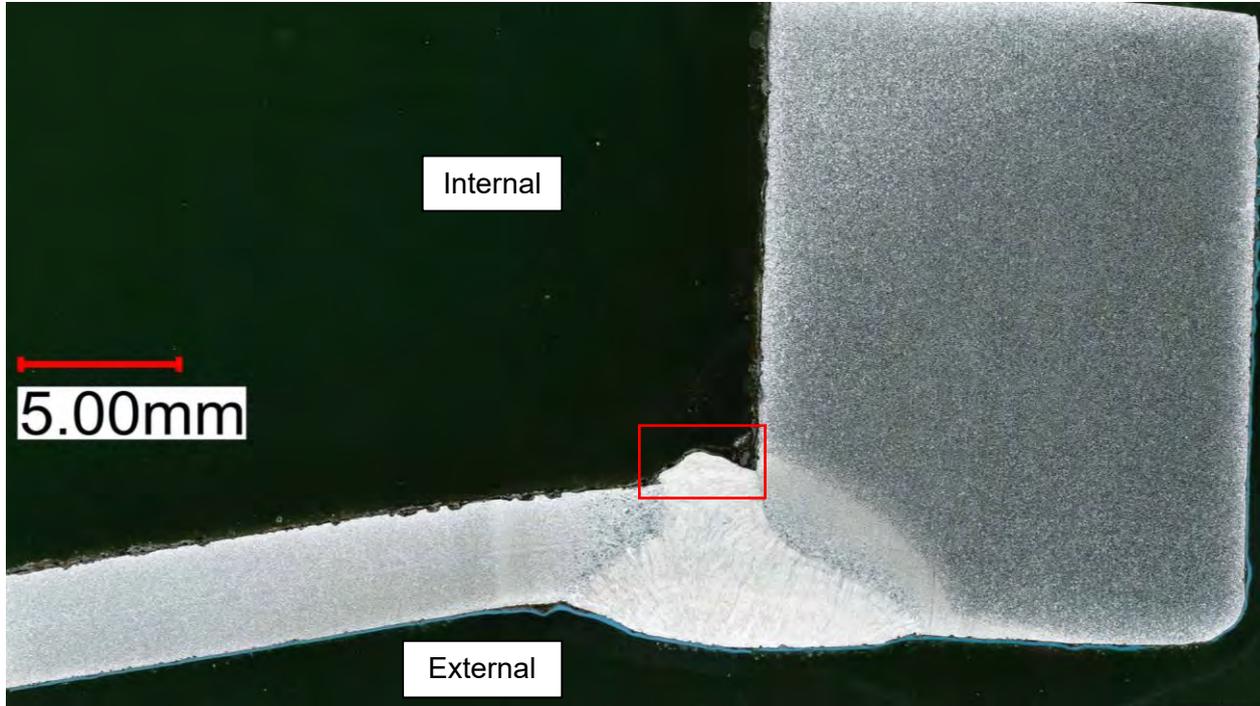
Front Right 1 (FR1)

Figure 157: Sectional metallographic examination was conducted across an original weld. No discontinuity found at this weld joint.

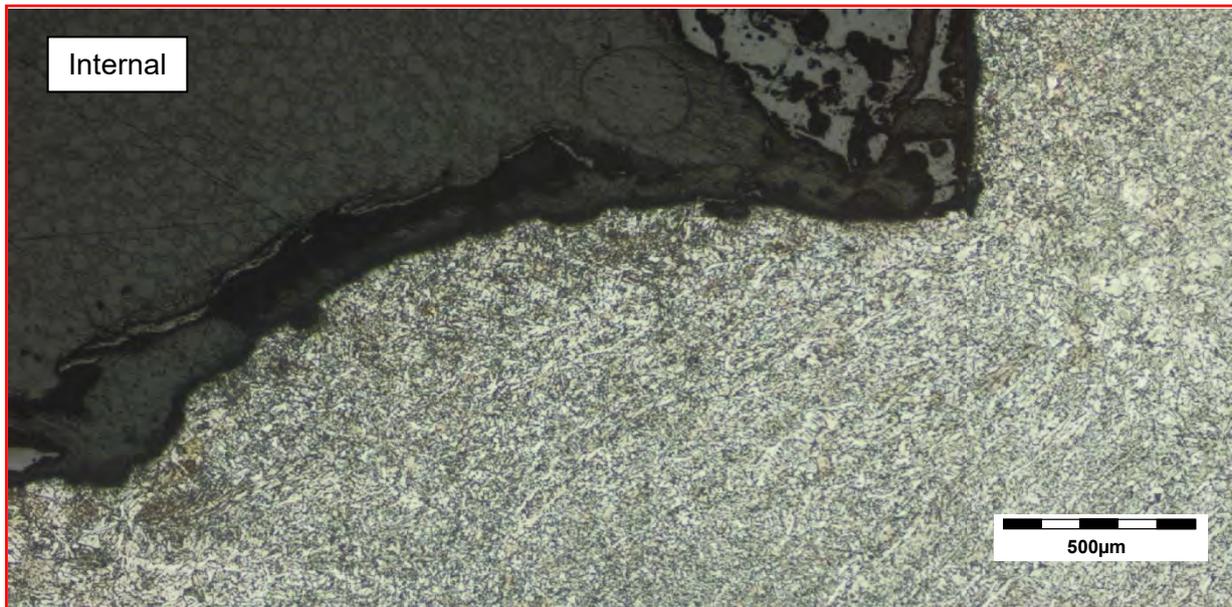
Figure 158: Micrograph at 50x magnification.

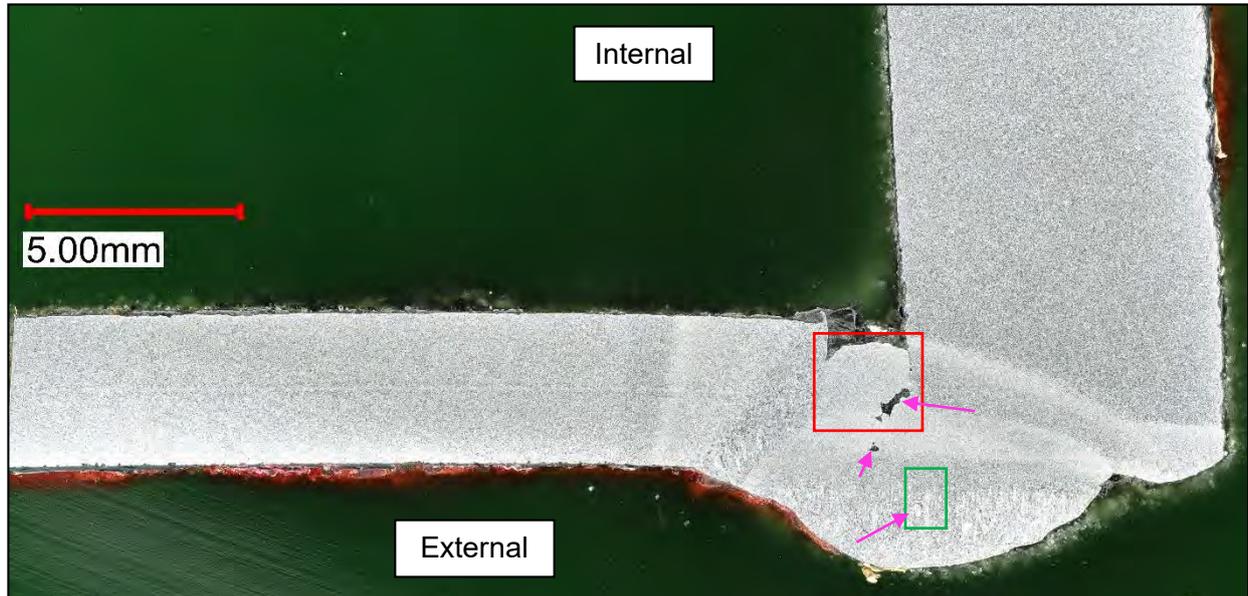
Front Right 2 (FR2)

Figure 159: Sectional metallographic examination was conducted across the repair weld. Lack of root penetration was observed with a root opening of about 1.6 mm wide. Voids up to about 1.0 mm were observed in the weld metal.

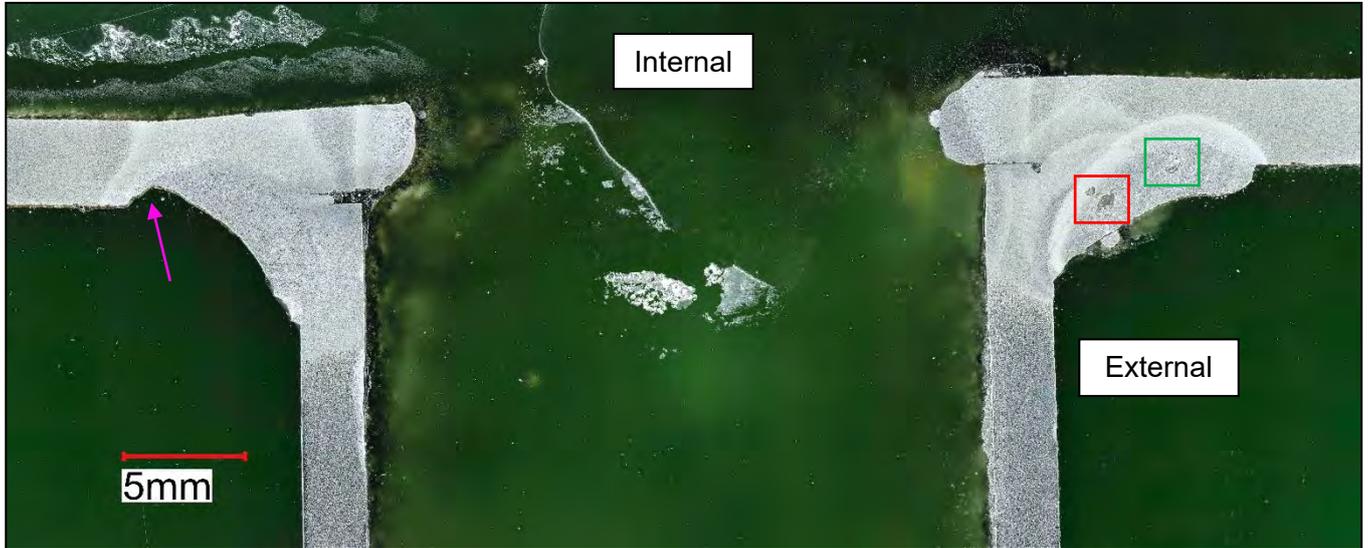
Drain

32 ➤ The weld had undercut at the weld toe (Figure 161). Voids of up to about
34 1.0 mm wide were observed scattered in the weld metal. The weld metal had a
 non-uniform distribution of weld structure (Figure 162).

Figure 161: Sectional metallographic examination was conducted across the drain port. The weld had undercut at the weld toe (in pink arrow). Voids up to about 1.0 mm wide were observed scattered in the weld metal.

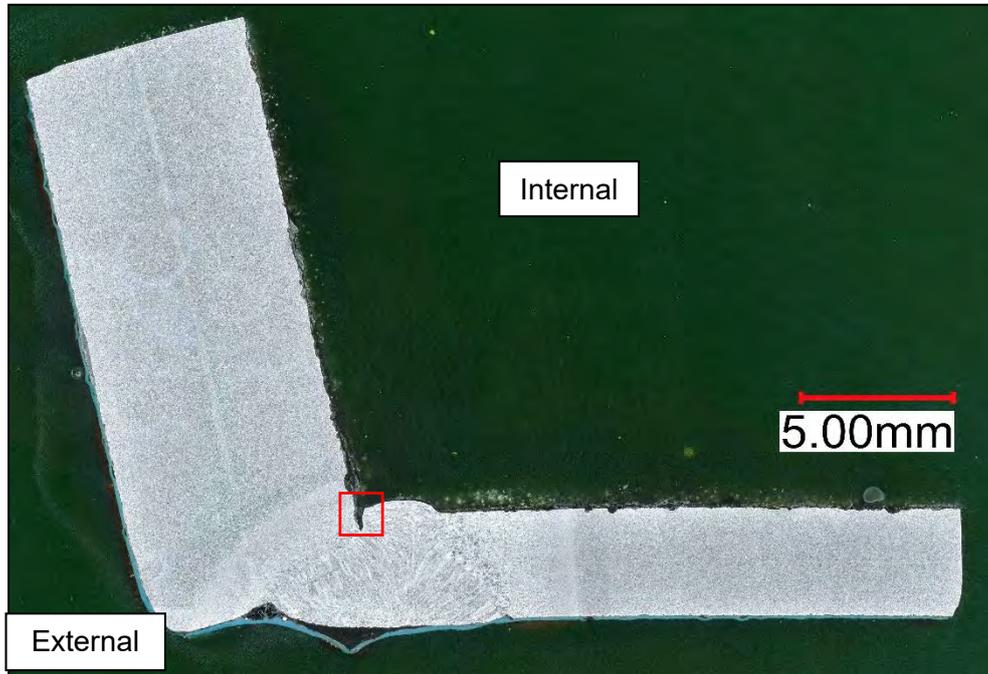
Rear Left 1 (RL1)

Figure 163: Sectional metallographic examination was conducted across the original weld. Incipient crack was observed at the weld root, propagated towards the weld face. Apart from that, no significant weld discontinuity was found.

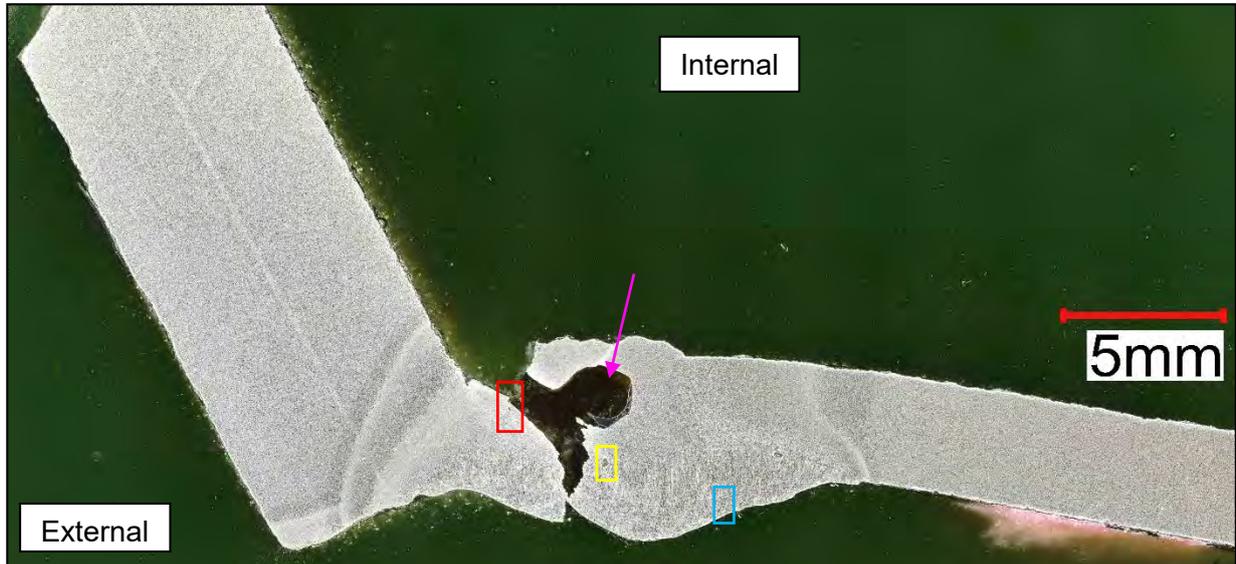
Rear Left #2

Figure 165: Sectional metallographic examination was conducted across the repair weld which had cracked through. Multiple voids were observed scattered in the weld metal with size up to about 1.7 mm wide.

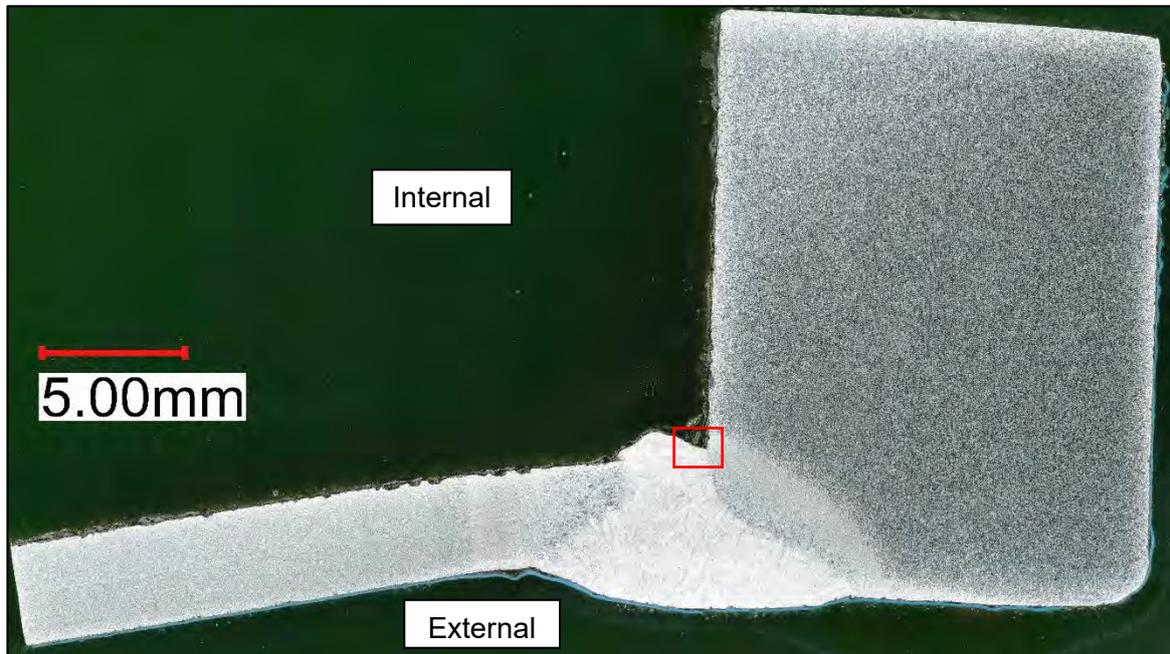
Rear Right #1

Figure 167: Sectional metallographic examination was conducted across the original weld. Apart from a small incipient crack initiated from the weld root, no weld discontinuity was found.

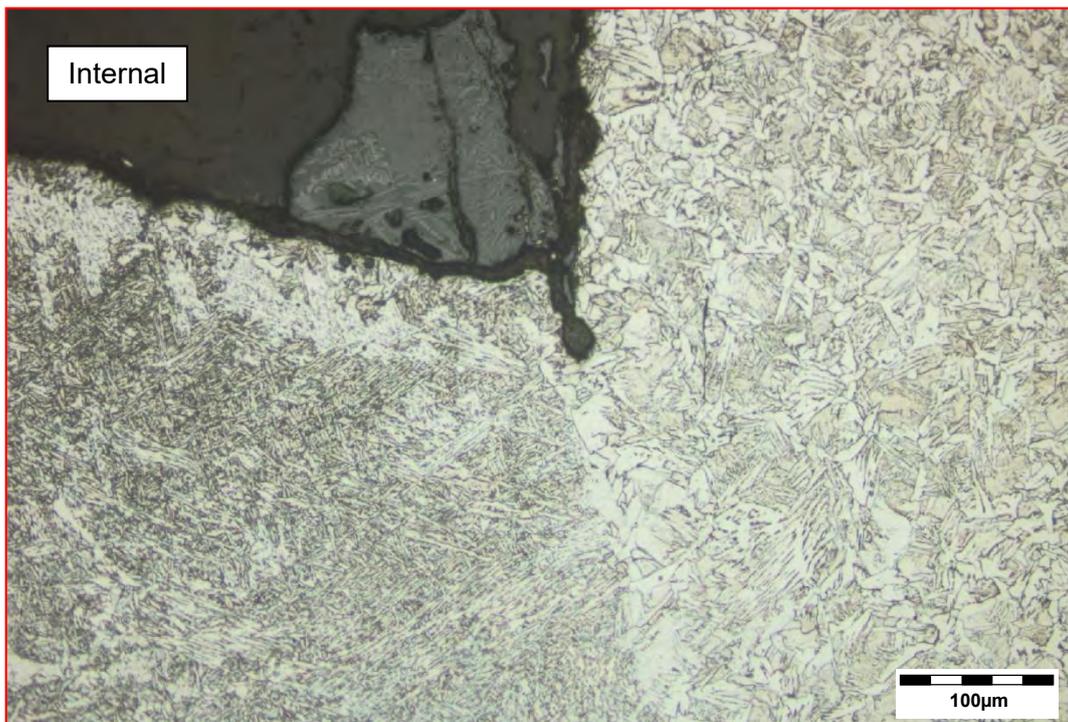
Figure 168: Micrograph at 200x magnification. A 60µm incipient crack (with some oxide scale) was observed at the weld root.

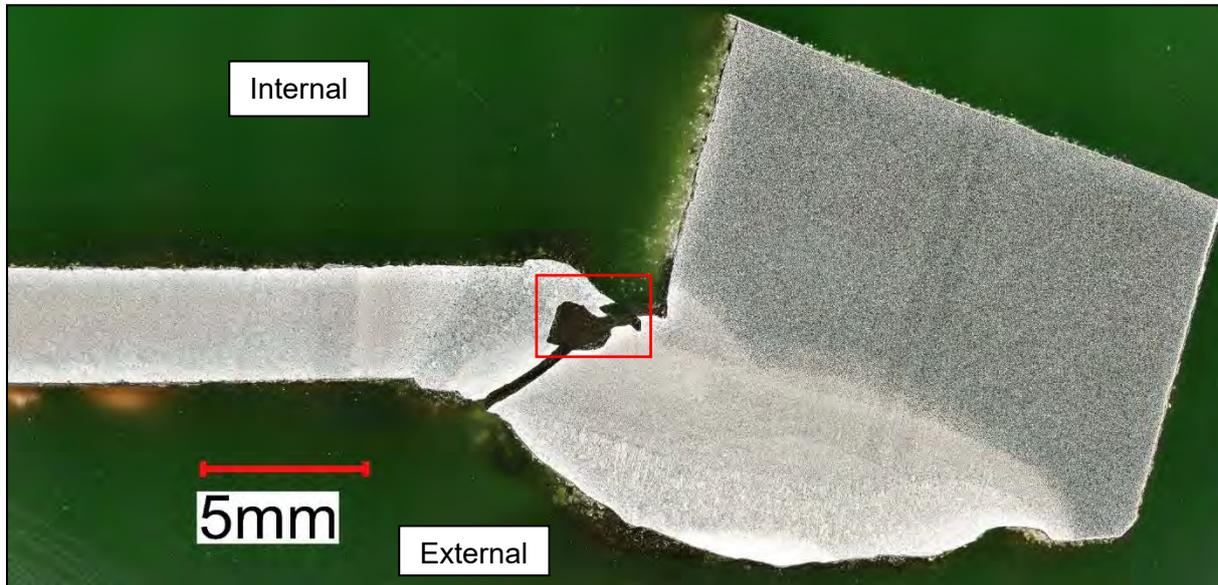
Rear Right #2

Figure 169: Sectional metallographic examination was conducted across the repair weld which had cracked through. Voids up to about 1.5 mm wide were in the weld metal (red box).

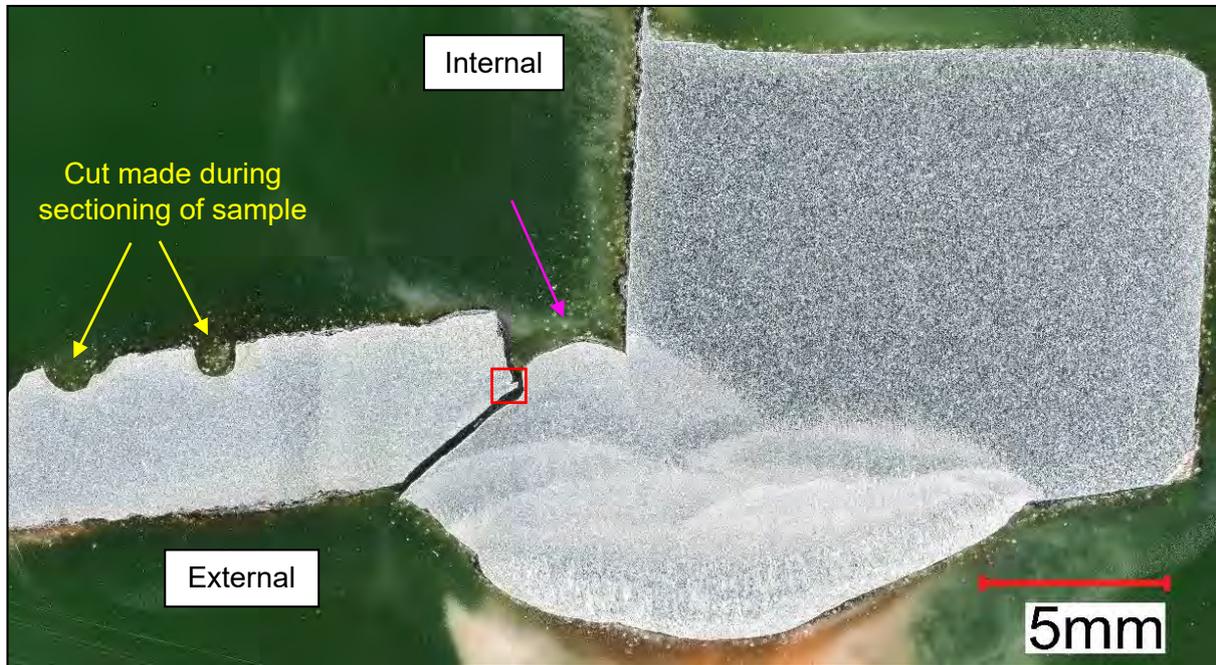
Rear Right #3

Figure 171: Sectional metallographic examination was conducted across the repair weld and through crack. The weld had lack of root penetration with root opening of about 3.0 mm wide (pink arrow).
