**Report of the Inquiry
Committee for the accident
at Stars Engrg Pte Ltd on
24 February 2021
(PART II – ANNEXES)**

TECHNICAL REPORT

| Title of Report: Failure Analysis of a Failed Mixer Machine Retrieved from Unit 32E of Platinum @ Pioneer Building involved in a Fire Explosion Incident | | Date of Last Revision/Revision No: |

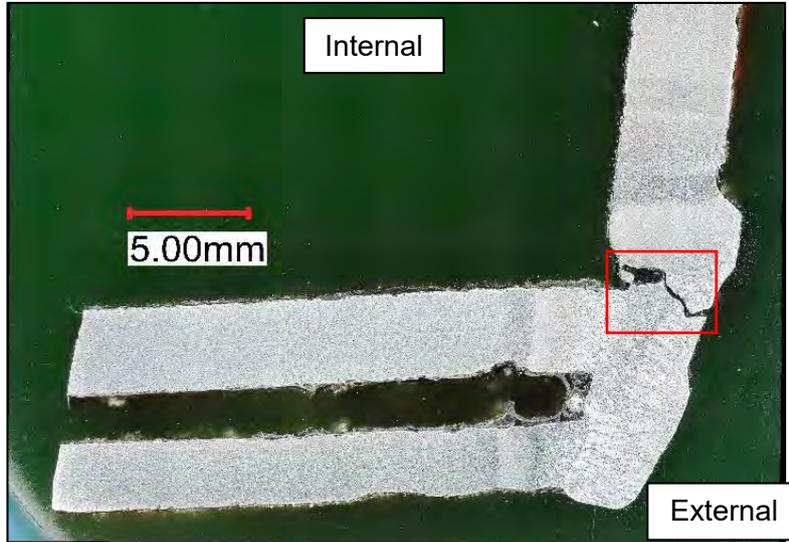
Bottom Middle

- All nine examined locations either had through-thickness cracks (RL2 [Figure 165], RR2 [Figure 169], RR3 [Figure 171], BM [Figure 173] and BR [Figure 175]) or incipient cracks (FL2 [Figure 149], FL3 [Figure 151], FL4 [Figure 155], FR2 [Figure 159]) that initiated from the weld root and propagated towards the external surface of the weld. Most of the incipient cracks were observed to be oxide filled.

4 ➤ Seven out of nine examined locations had voids scattered within the weld metal
6 (FL3 [Figure 151], FL4 [Figure 155], FR2 [Figure 159], RL2 [Figure 165], RR2
 [Figure 169], BM [Figure 173] and BR [Figure 175]). The voids were up to
 2.5 mm wide in size.

Figure 173: Sectional metallographic examination was conducted across the weld between bottom plate and reinforcement plate. A void of about 1.0 mm was observed (red box) along the through crack path.

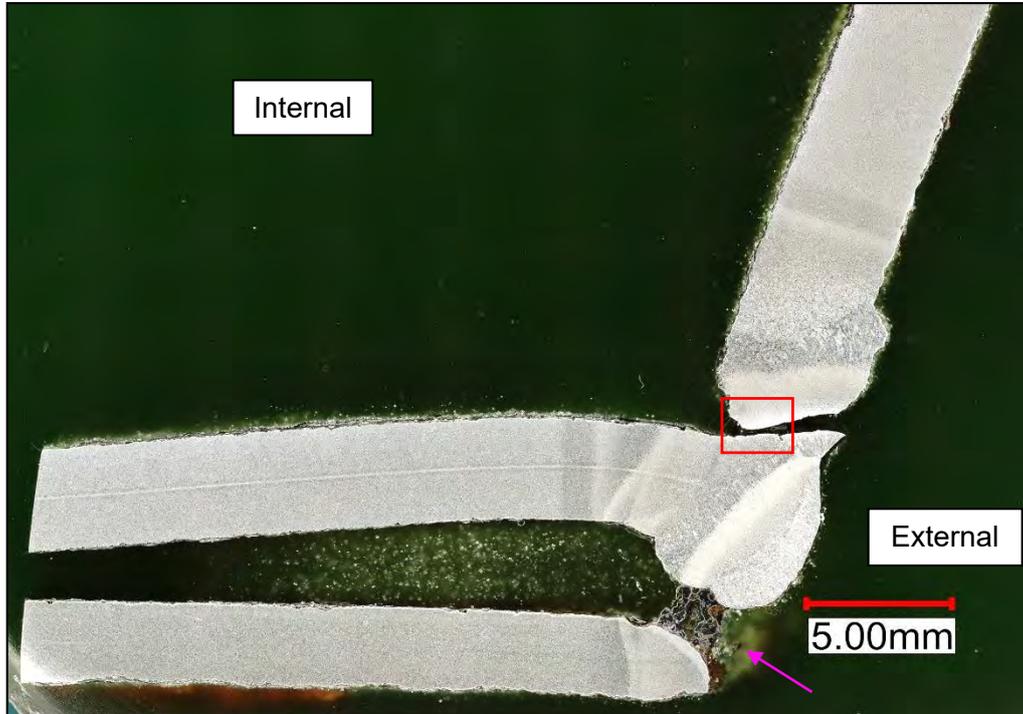
Bottom Right

Figure 175: Sectional metallographic examination was conducted across the weld between the bottom plate and reinforcement plate. A through-thickness void was observed at the weld joint of the reinforcement plate (pink arrow).

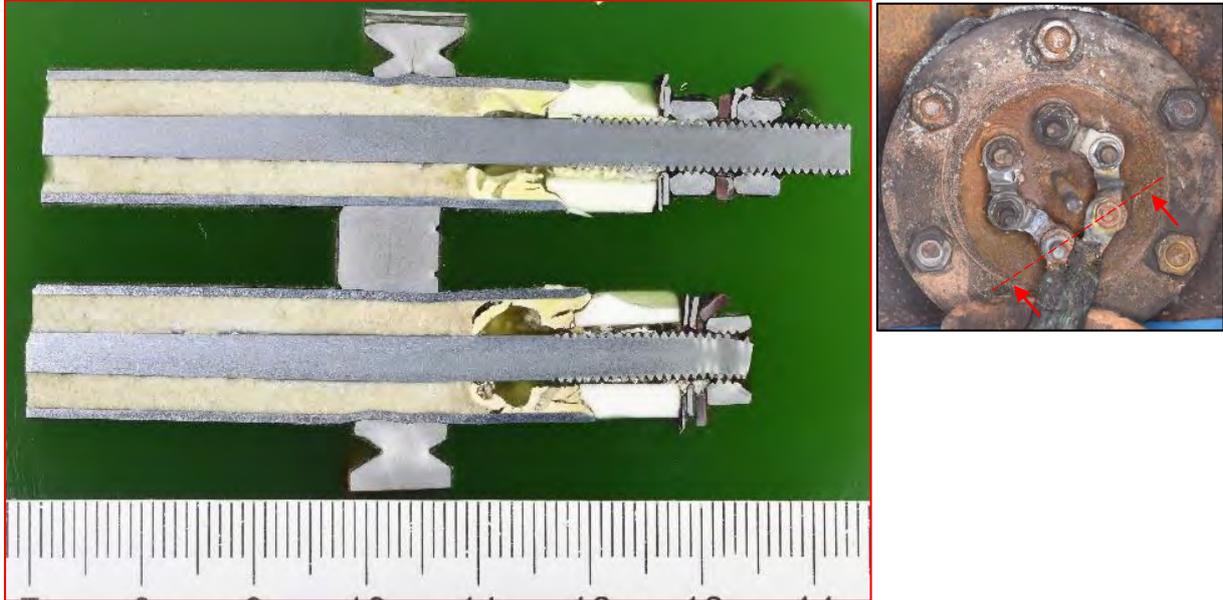
Figure 177: A section was made across the two lug-connected-terminals and flange of heater #2. The lug with arcing point was adjusted slightly to achieve the cross sectional view of it.

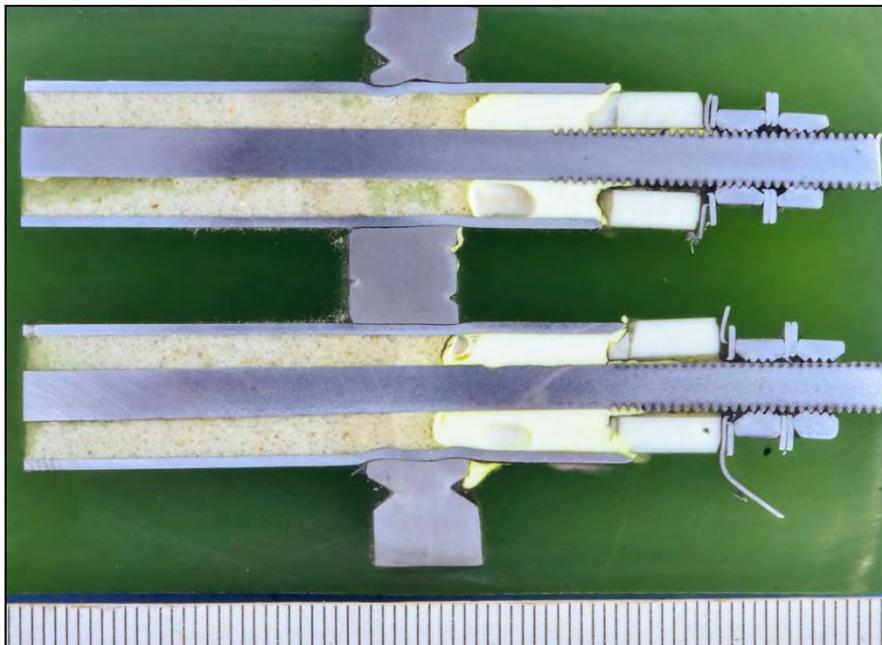
Figure 178: A section was made across two terminals and flange of a new heater as reference.

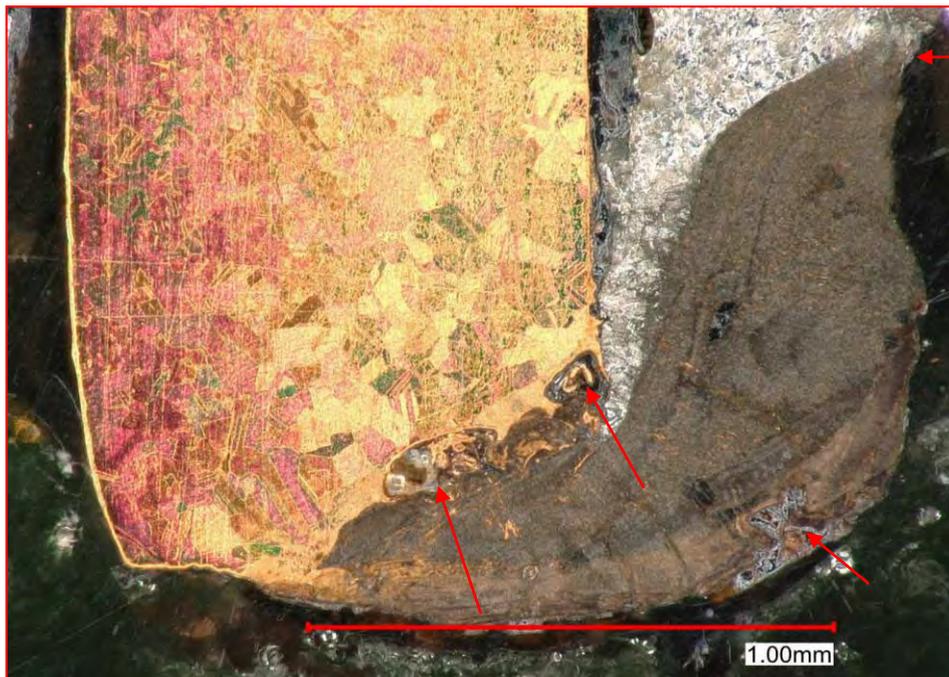
42 ➤ Close up view of the arcing location on the lug (see also Figure 122) revealed
44 emanating pattern of metal melting and porosities which confirmed the
 occurrence of arcing (Figure 180).

Figure 180: Close up view of the arcing location of the lug (see also Figure 138). The emanating pattern of melting and porosity (red arrows) confirm the arcing at this location.

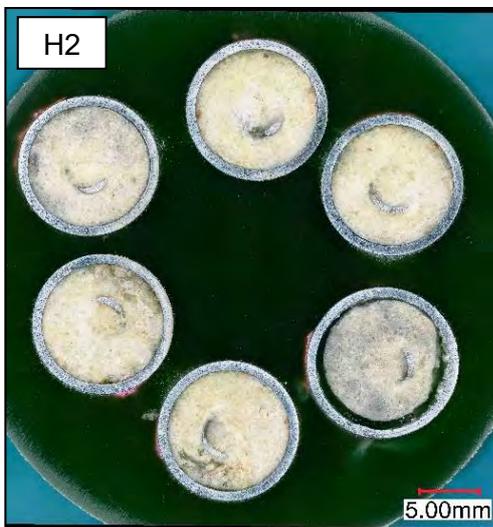
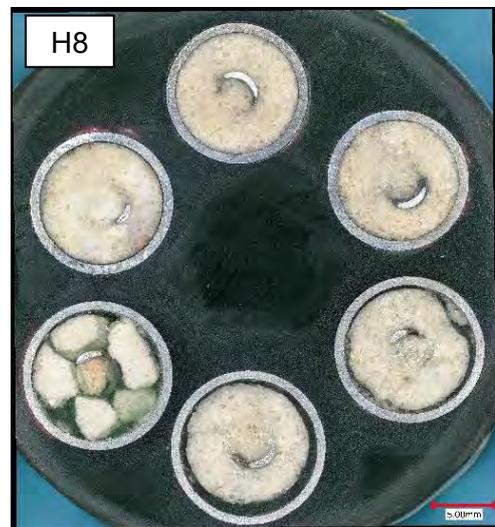
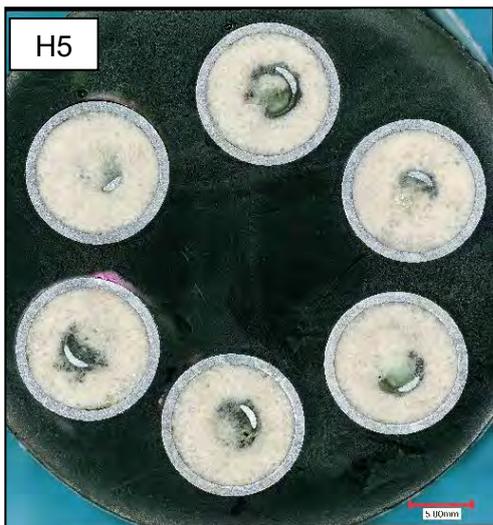
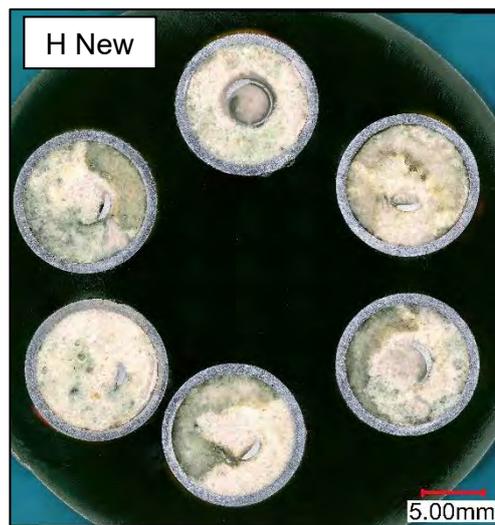
Figure 182: Cross sections for heater #2 (abbreviated as H2), heater #5 (abbreviated as H5), heater #8 (abbreviated as H8), new heater (abbreviated as H New).

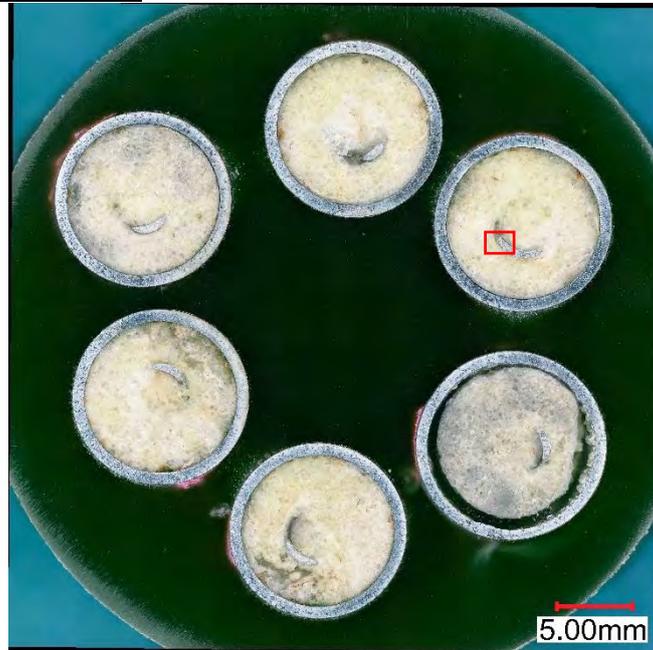
Figure 183: Sectional metallographic examination was conducted across metal tubes of heater #2.

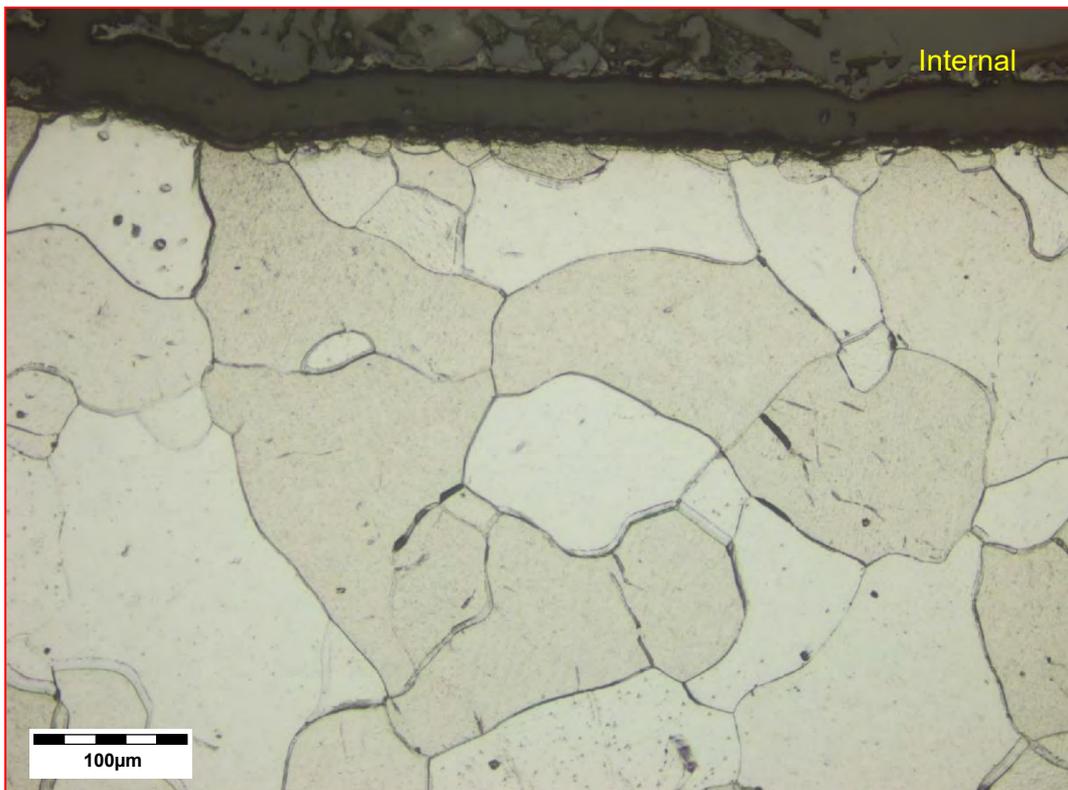
24 ➤ Heater #2 had an average grain size of about 222 µm or ASTM number range
of 0 – 3 at metal tube corresponding to position of terminal #2 (upper half of
26 metal tubes located above the centreline of the bore of the heater flange, Figure
185 and Figure 186) and about 124 µm or ASTM number range of 3 – 4 at metal
28 tube corresponding to orientation of terminal 4 (lower half of metal tubes located
below centreline of the bore the heater flange, Figure 187 and Figure 188). The
centreline of the bore of the heater flange was indicated in Figure 212.

Figure 186: Micrograph of the metal tube at 200X magnification (compared with H New, Figure 204).

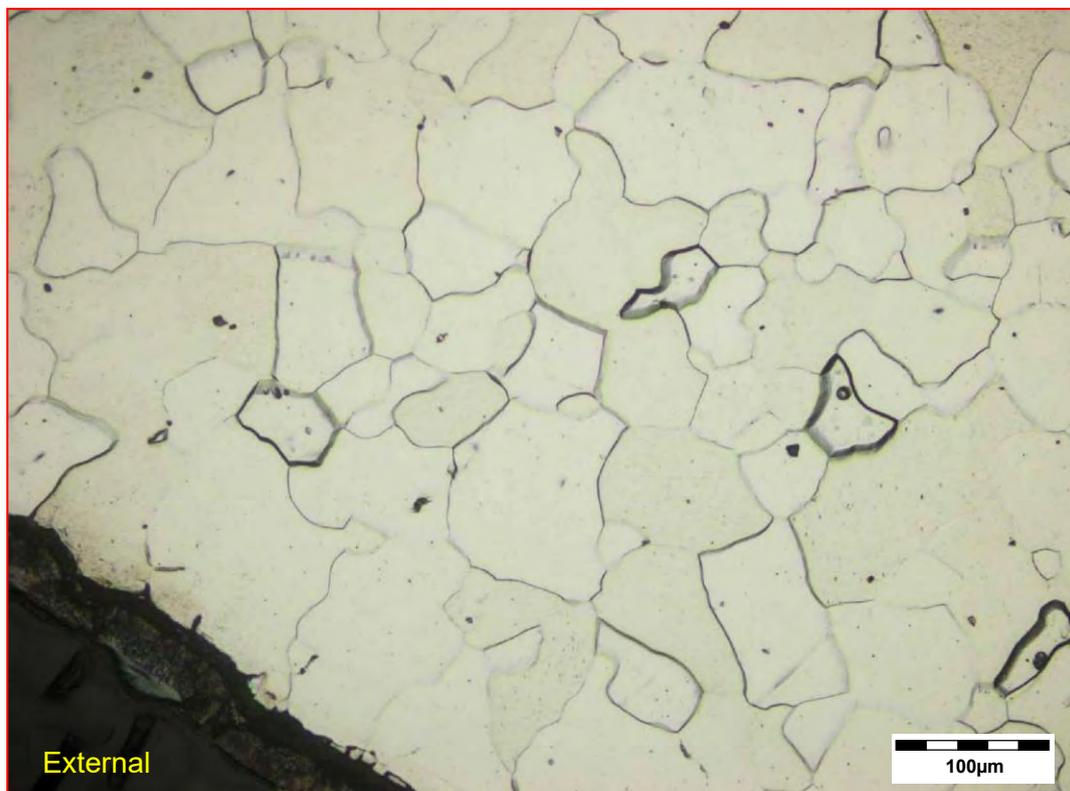
Figure 188: Micrograph of the metal tube at 200X magnification (compared with H New, Figure 204).

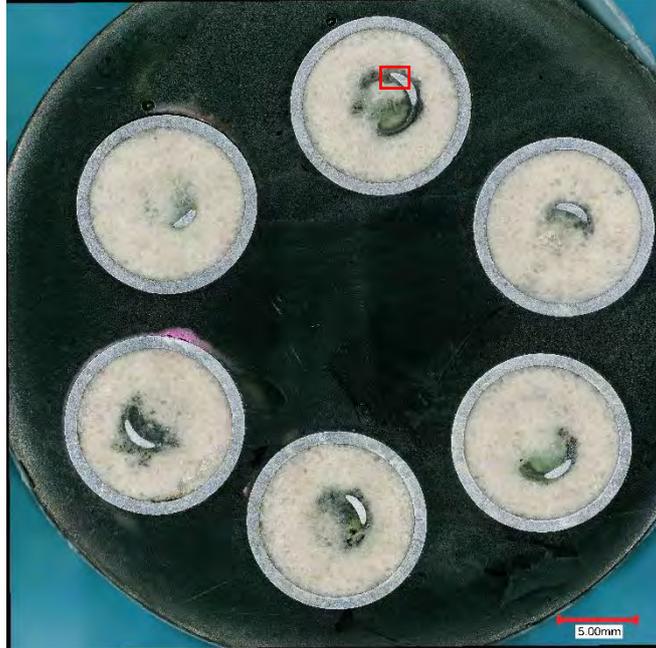
Figure 189: Sectional metallographic examination was conducted across metal tubes of heater #5.

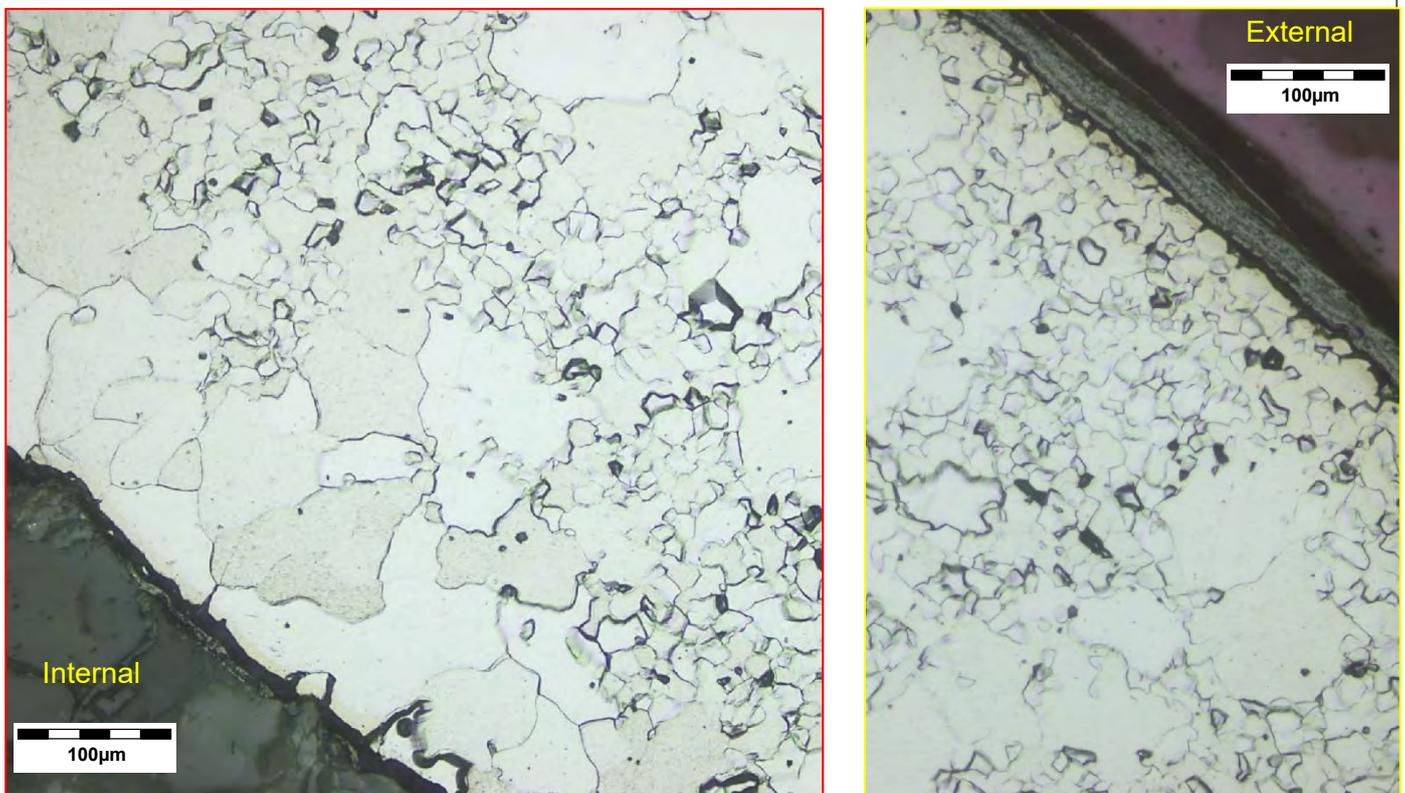
30 ➤ Heater #5 had a mixture of grain sizes where the upper half of the metal tubes
32 had higher density of large grains compared to lower half of metal tubes. The
tubes had an average grains size of about 63 µm at metal tube corresponding
34 to position of terminal 1 (upper half of tubes, Figure 191 and Figure 192) and
about 58 µm at metal tube corresponding to orientation of terminal 4 (lower half
36 of tubes, Figure 193 and Figure 194). Both metal tubes’ had grains with a mix
of sizes ranging between ASTM number 3 – 4 and 8 – 9.

Figure 192: Micrographs of the metal tube at 200X magnification (compared with H New, Figure 204).

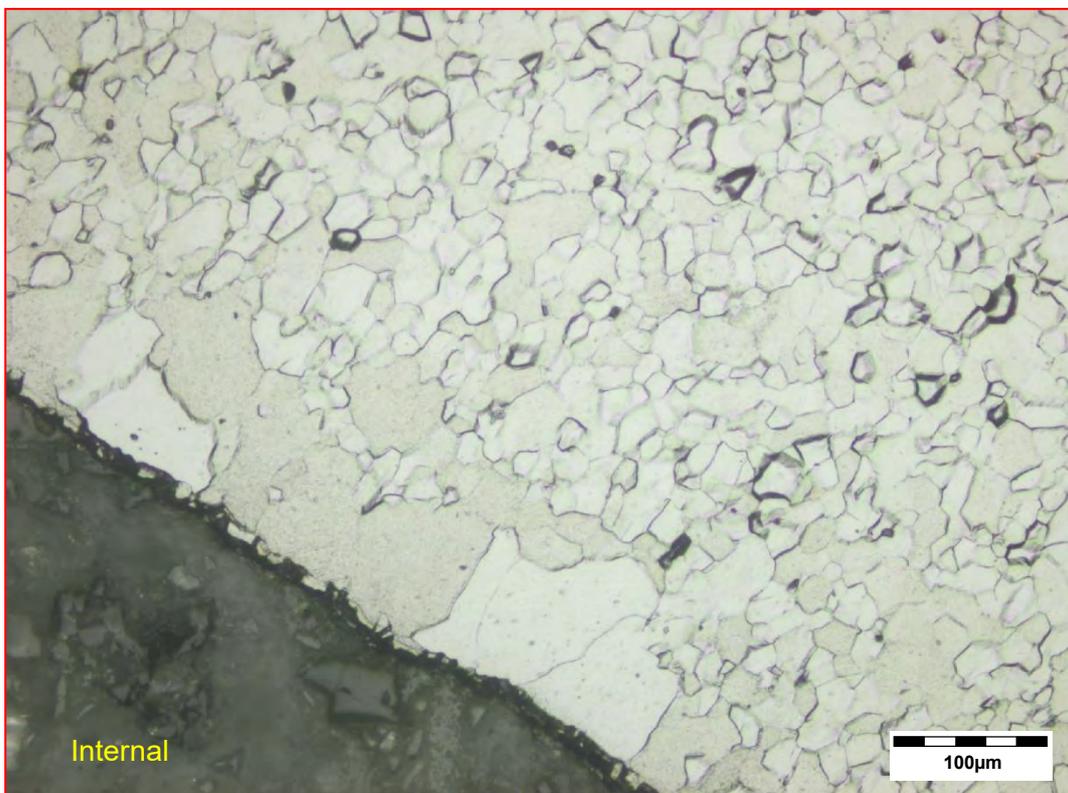
Figure 194: Micrograph of the metal tube at 200X magnification (compared with H New, Figure 204).

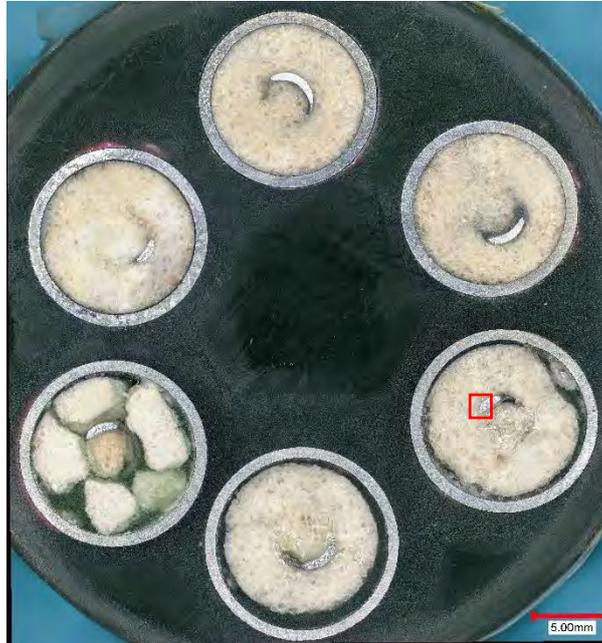
Figure 195: Sectional metallographic examination was conducted across metal tubes of heater #8.

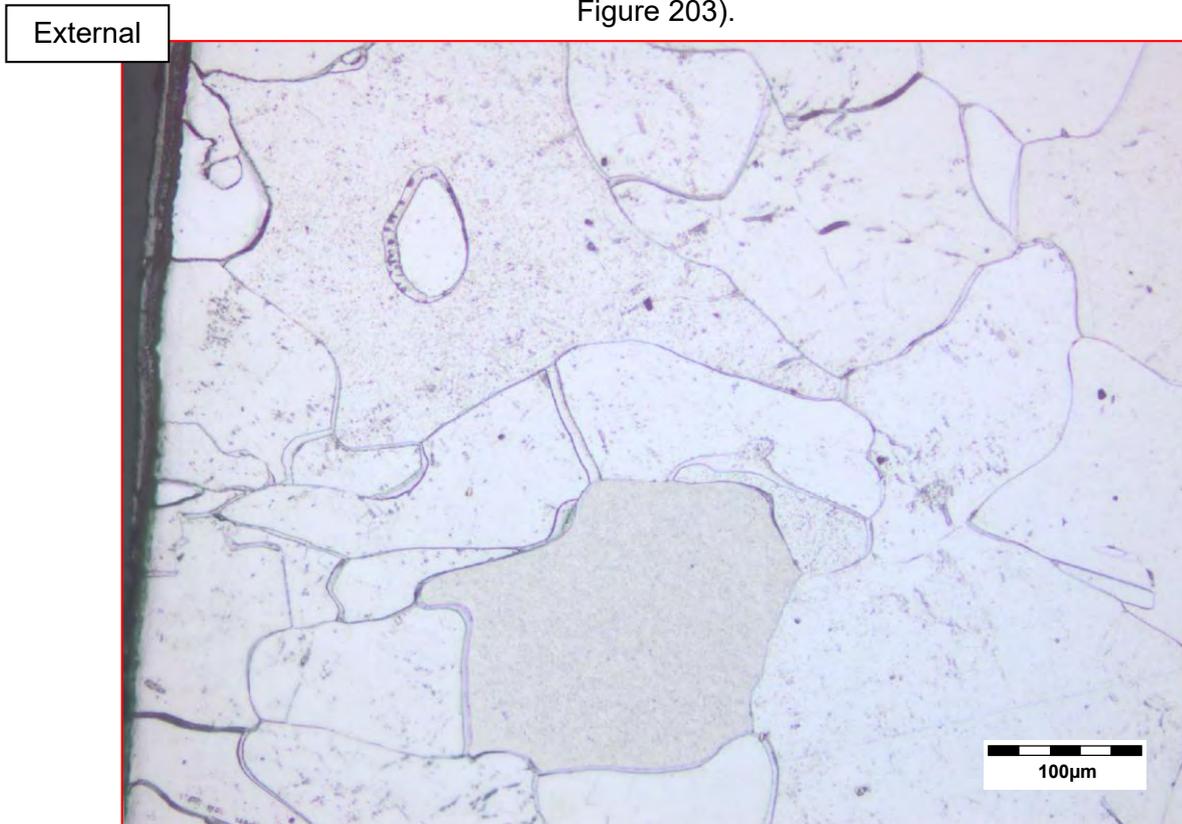
38 ➤ Heater #8 had an average grain size of about 188 µm or ASTM number range
of 0 – 3 at metal tube corresponding to position of terminal 6 (upper half of
40 tubes, Figure 197 and Figure 198) and about 110 µm or ASTM number range
of 3 – 5 at metal tube corresponding to orientation of terminal 3 (lower half of
tubes, Figure 199 and Figure 200).

Figure 198: Micrograph of the metal tube at 200X magnification (compared with H New, Figure 204).

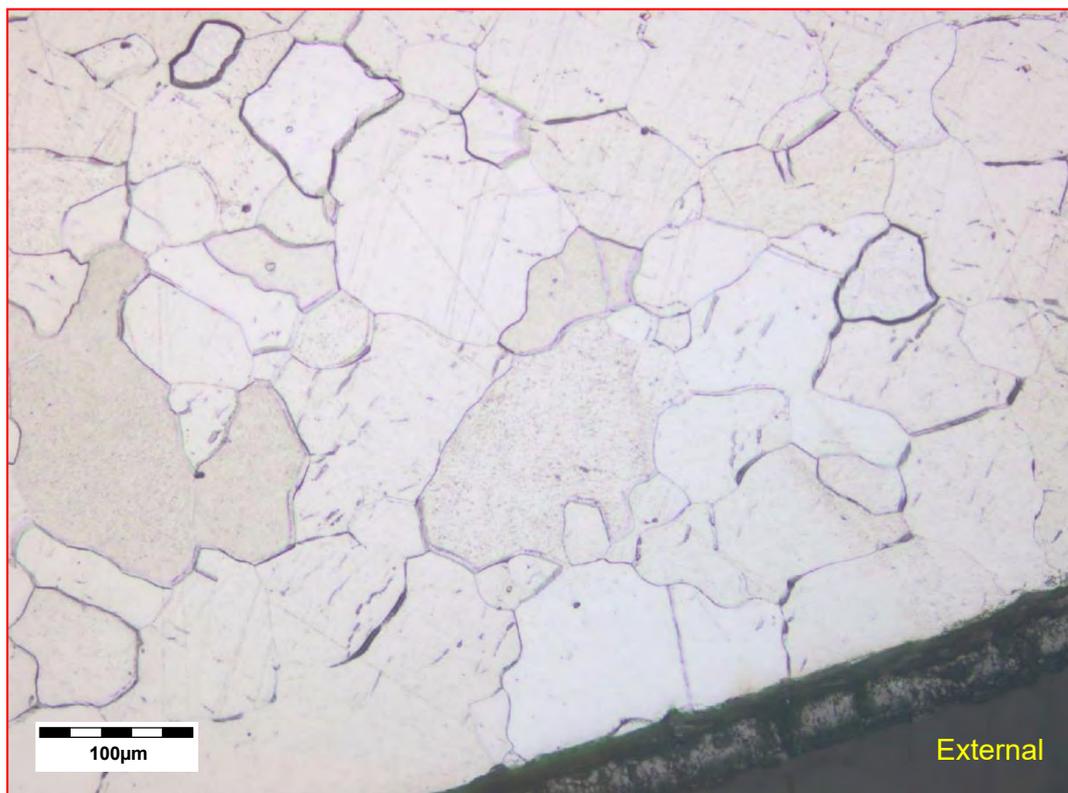
Figure 200: Micrograph of the metal tube at 200X magnification (compared with H New, Figure 204).

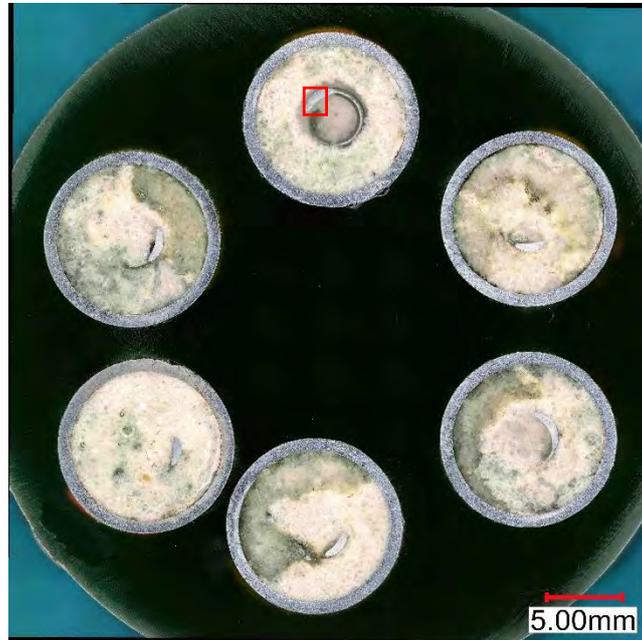
Figure 201: Sectional metallographic examination was conducted across metal tubes of new heater.

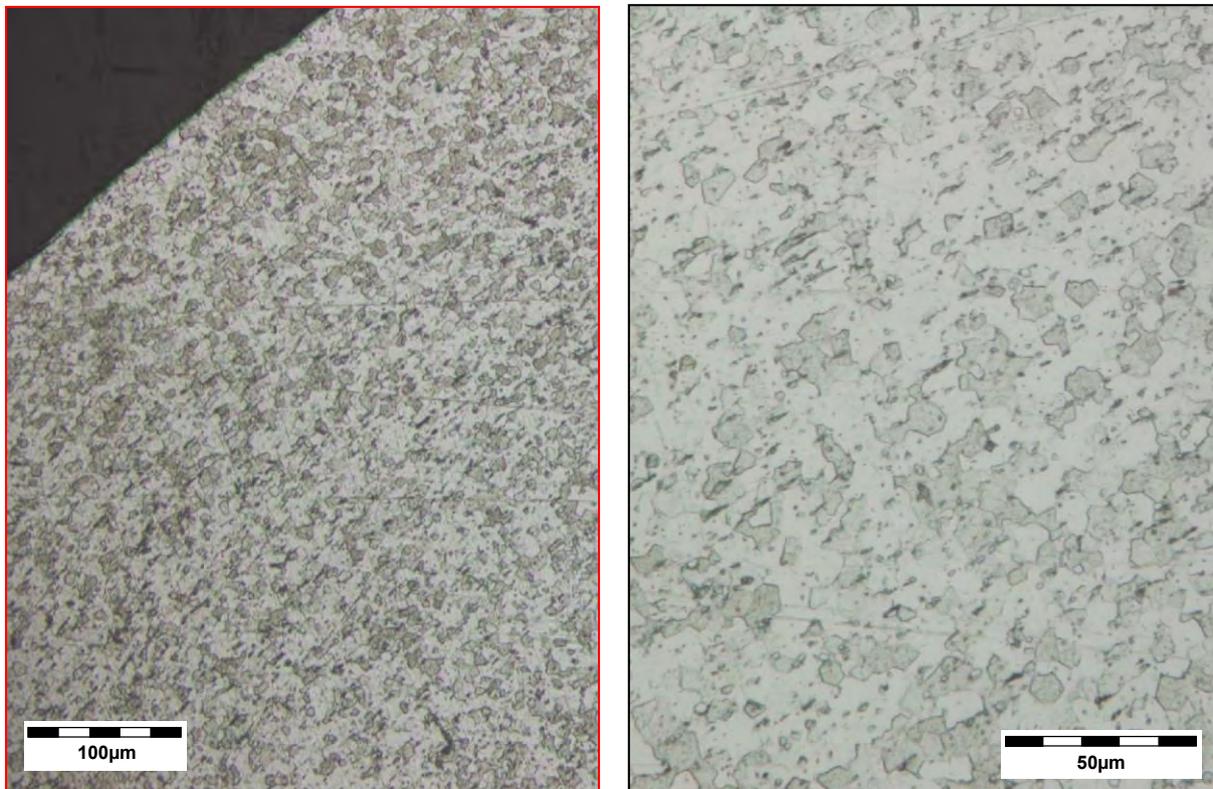
16 ➤ All the resistance wires within the metal tubes of heaters #2 (Figure 184), #5
18 (Figure 190) and #8 (Figure 196) were generally similar in microstructure and
had experienced grain growth to similar degree when compared to the
resistance wire in the new and unused heaters (Figure 202).

Figure 202: Micrographs of the resistance wire at 200X (left) and 500X (right) magnifications. All the resistance wires were generally similar in microstructure and grain size. The grain size is significantly smaller compared with the other examined heaters.

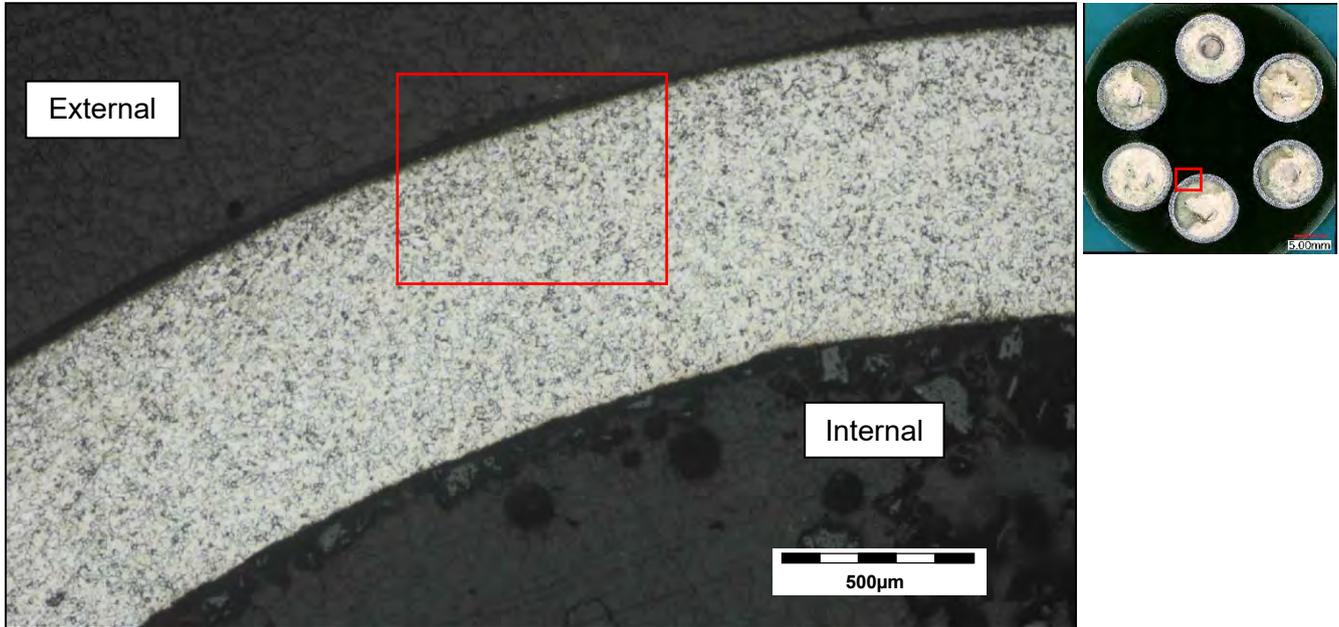
14 ➤ The new heater had an average grains size of about 9 µm or ASTM number
range of 9 – 10 throughout all the metal tubes (Figure 203 and Figure 204).

Figure 203: Micrograph of the metal tube at 50X magnification. All the metal tubes were generally similar in microstructure. The grain size is significantly smaller compared with the other examined heaters.

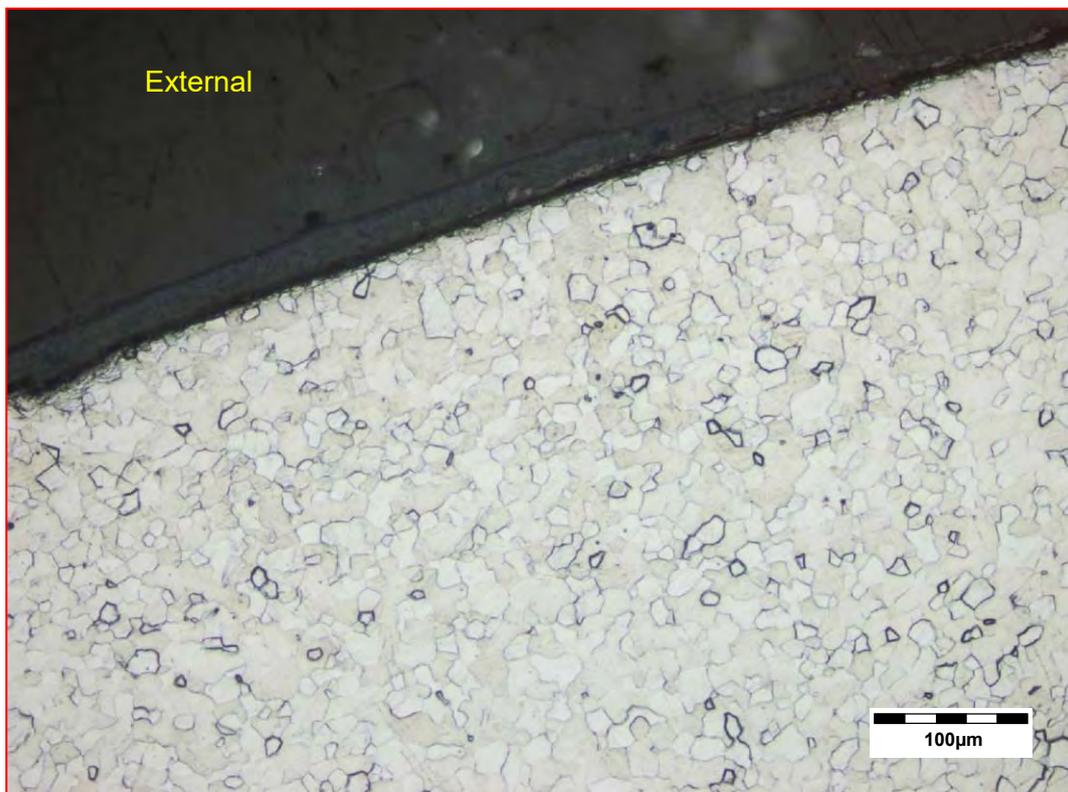
Figure 204: Micrograph of the metal tube at 200X magnification.

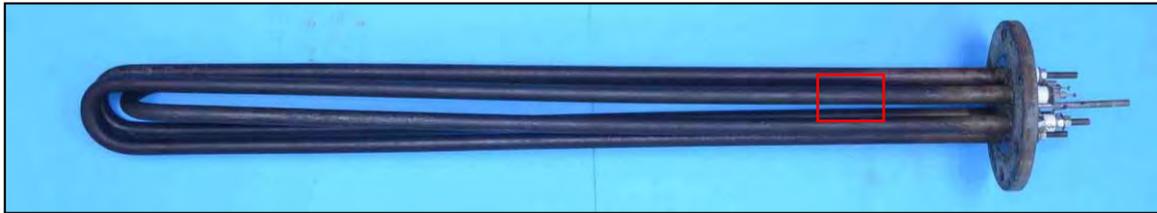
4 Additionally, the heater with blisters was sectioned across one of its blistered metal tubes for examination (Figure 205 to Figure 210).

Figure 205: The used heater with blisters were sectioned across one of the blister.

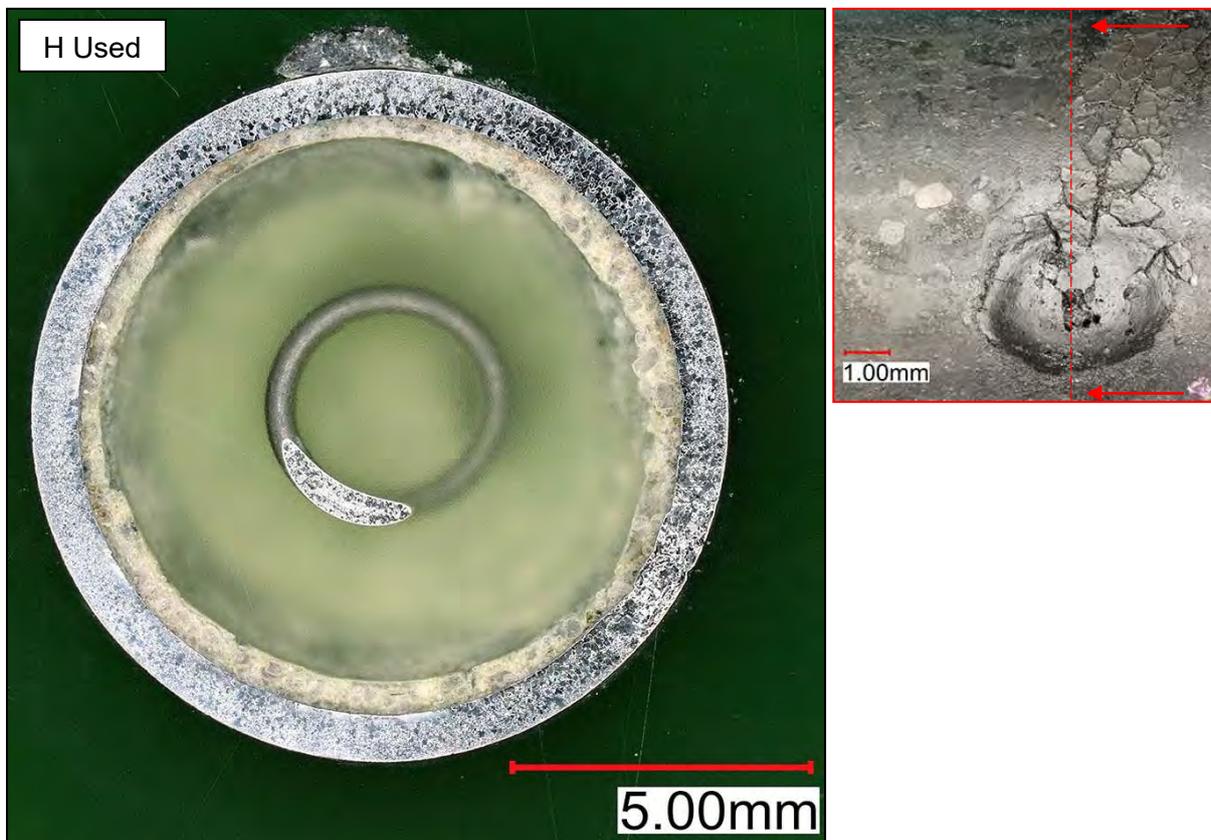
Figure 206: Cross section across the blister, metal tube and resistor wire of the used heater. The insulation powder inside the metal tube was removed for ease of metallographic examination.

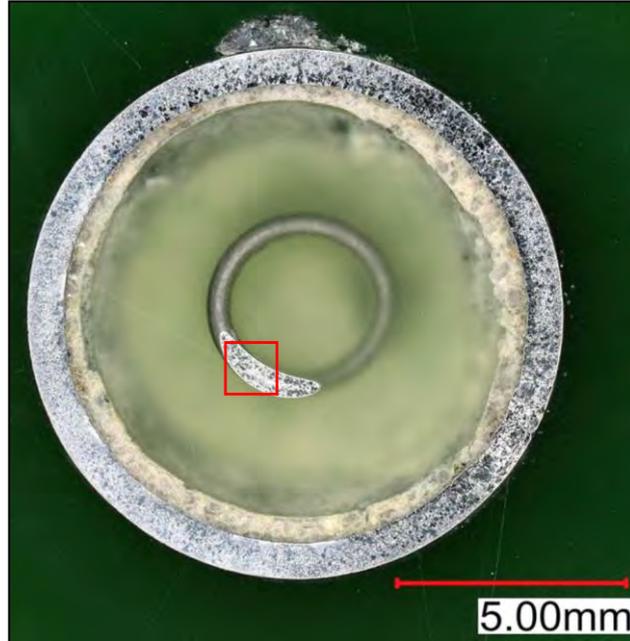
Figure 207: Sectional metallographic examination was conducted across a metal tube with blister of used heater.

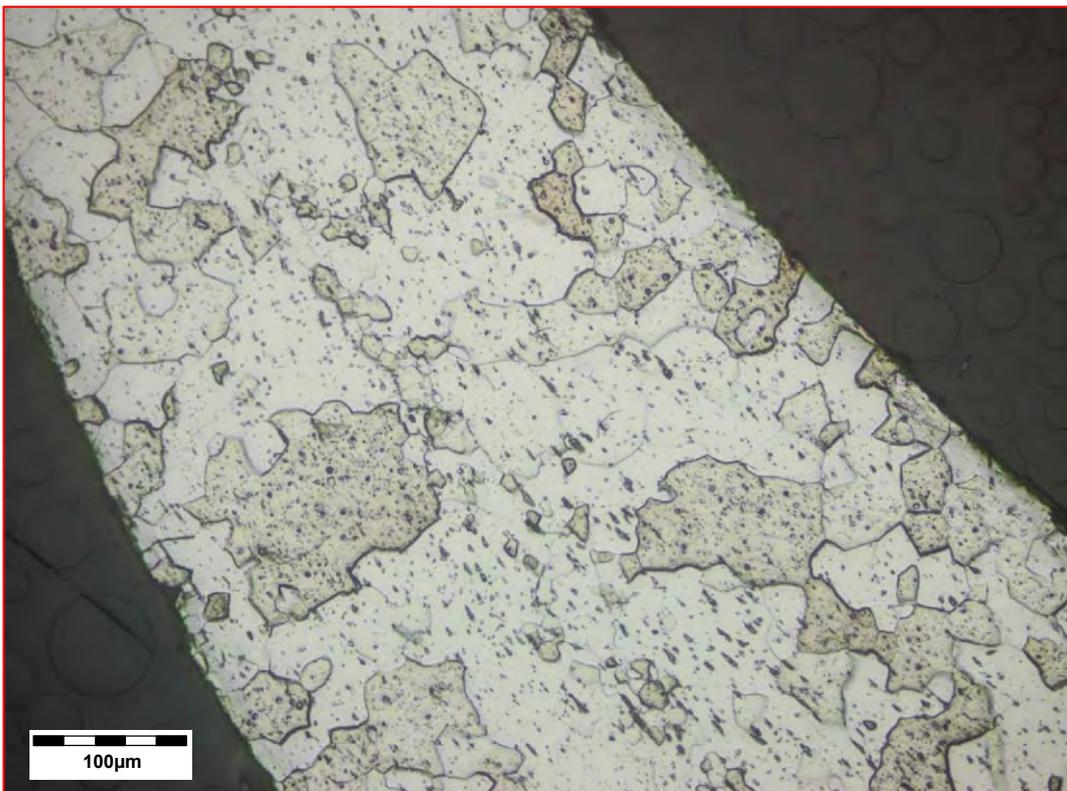
Figure 208: Micrograph of the resistance wire at 200X magnification. The resistance wire had experienced grain growth (compared with H New, Figure 202).

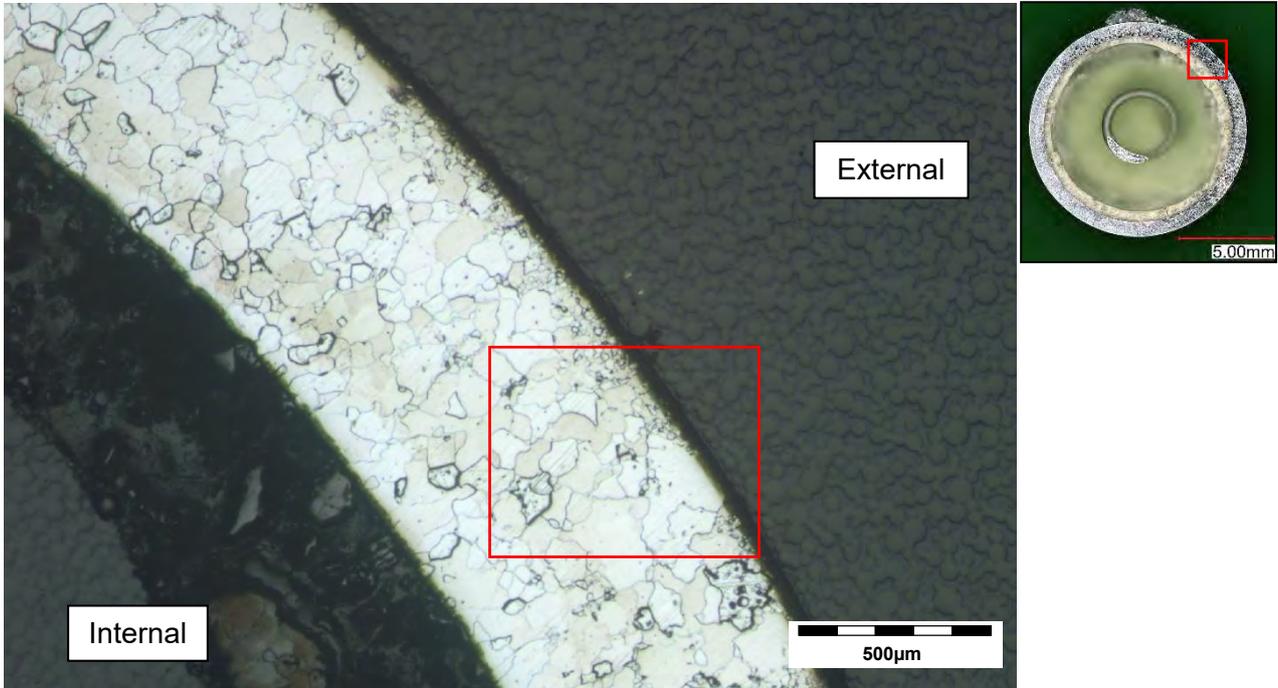
- 6 ➤ The metal tubes had an average grain size of about 106 μm or ASTM number range of 3 – 4, indicating that it had been used and experienced grain growth
8 (Figure 209 and Figure 210).

Figure 209: Micrograph of the metal tube at 50X magnification. All the metal tubes were generally similar in microstructure and had experienced grain growth (compared with H New, Figure 203).

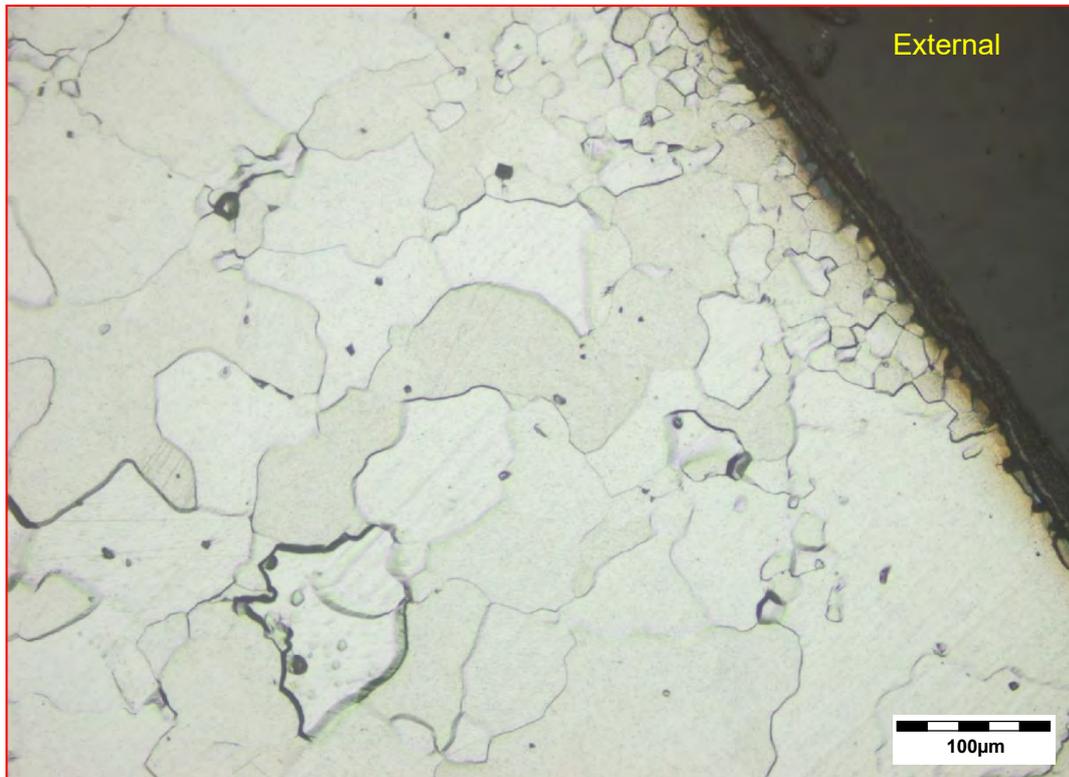
Figure 210: Micrograph of the metal tube at 200X magnification (compared with H New, Figure 204).

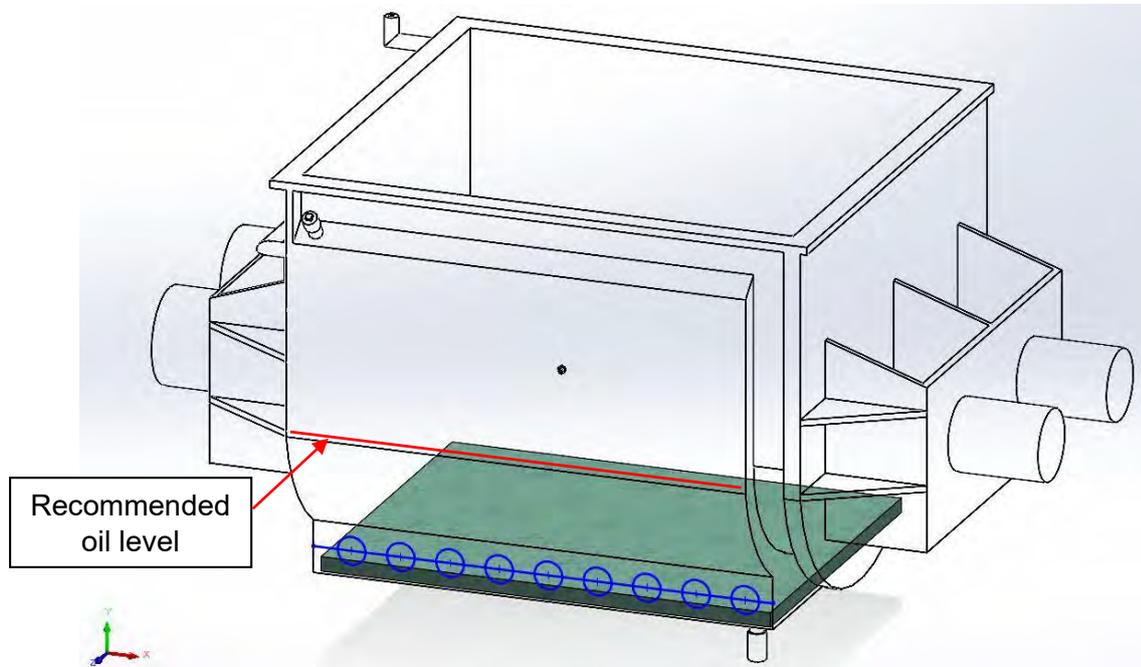
40L oil level

22 The oil level needed to touch the metal tube at the lowest possible location was
24 39.1 mm while the oil level needed to fully cover the metal tube at the highest possible
26 location was 90.3 mm. The following table summarises the oil volumes and the
corresponding estimated fill level inside the oil jacket (Figure 211 to Figure 228).

Figure 211: 3D model showing the oil fill level at 40L. The level is estimated to be below the heaters.

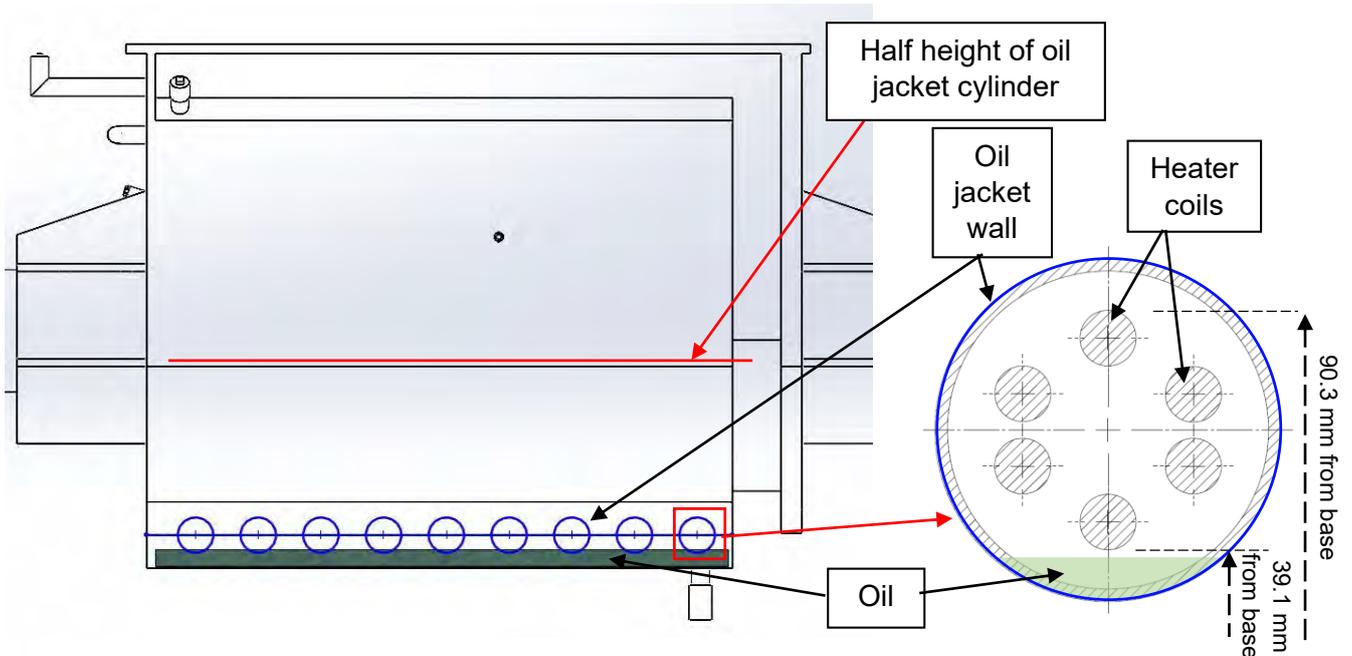
Figure 212: 3D model showing the oil fill level at 40L. The level is estimated to be 27 mm below the centreline of heaters.

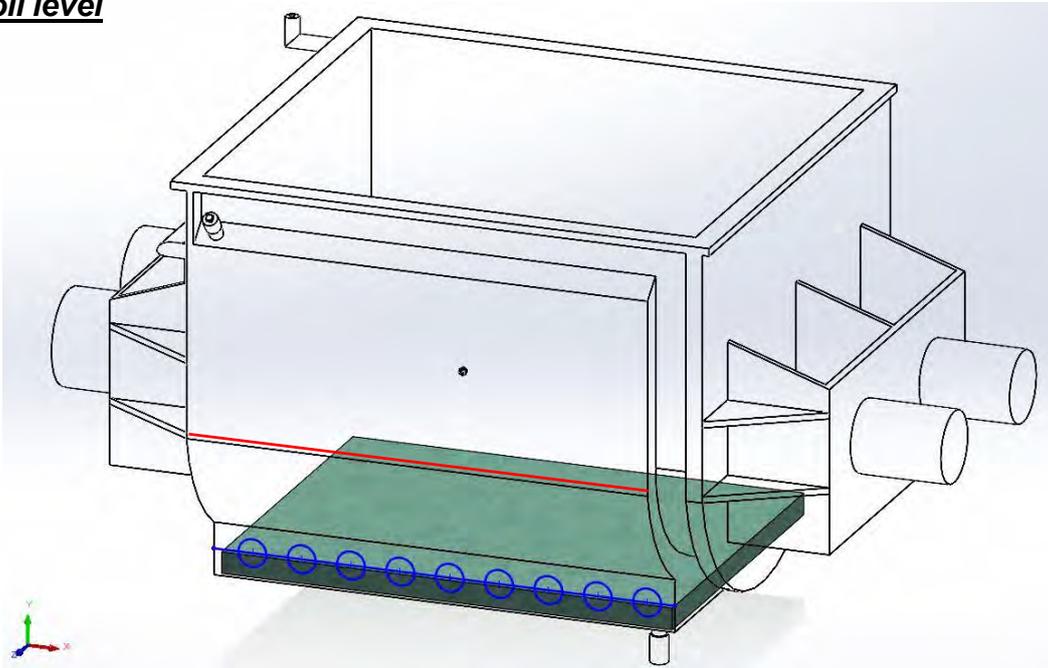
60L oil level

Figure 213: 3D model showing the oil fill level at 60L. The level is estimated to be slightly below the centreline of the heaters.
