**Report of the Inquiry
Committee for the accident
at Stars Engrg Pte Ltd on
24 February 2021
(PART II – ANNEXES)**

TECHNICAL REPORT

| Title of Report: Failure Analysis of a Failed Mixer Machine Retrieved from Unit 32E of Platinum @ Pioneer Building involved in a Fire Explosion Incident | | Date of Last Revision/Revision No: |

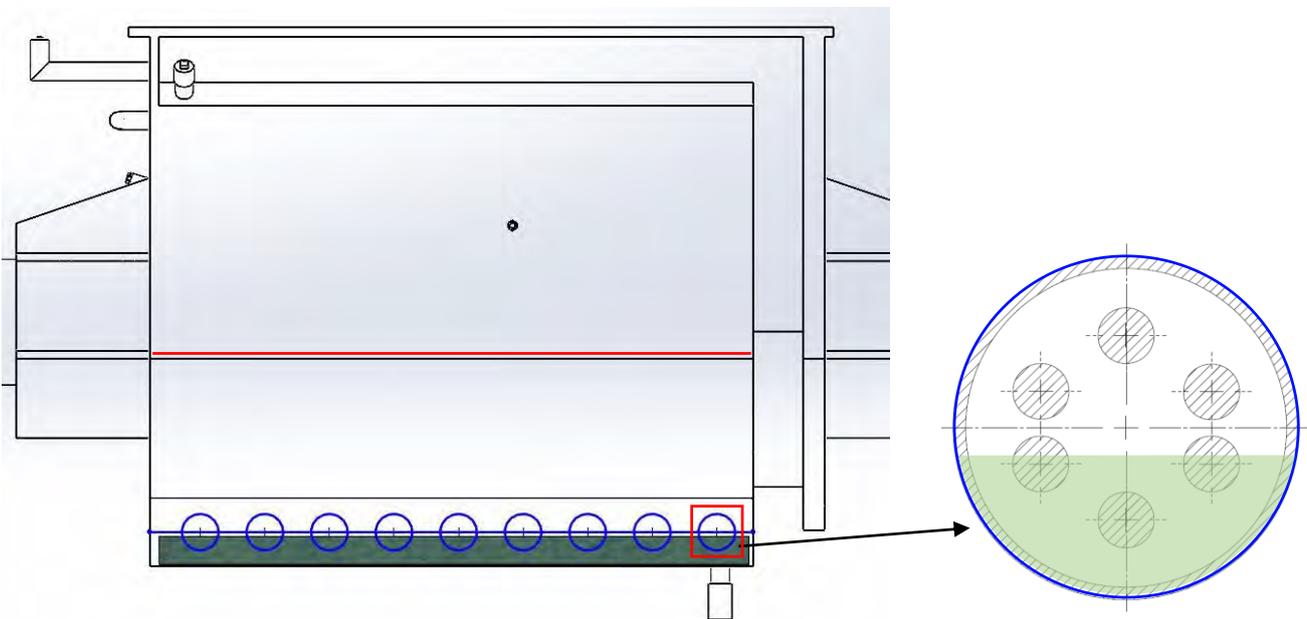
Figure 214: Model showing the oil fill level at 60L. The level is estimated to be 8 mm below the centreline of the heaters.

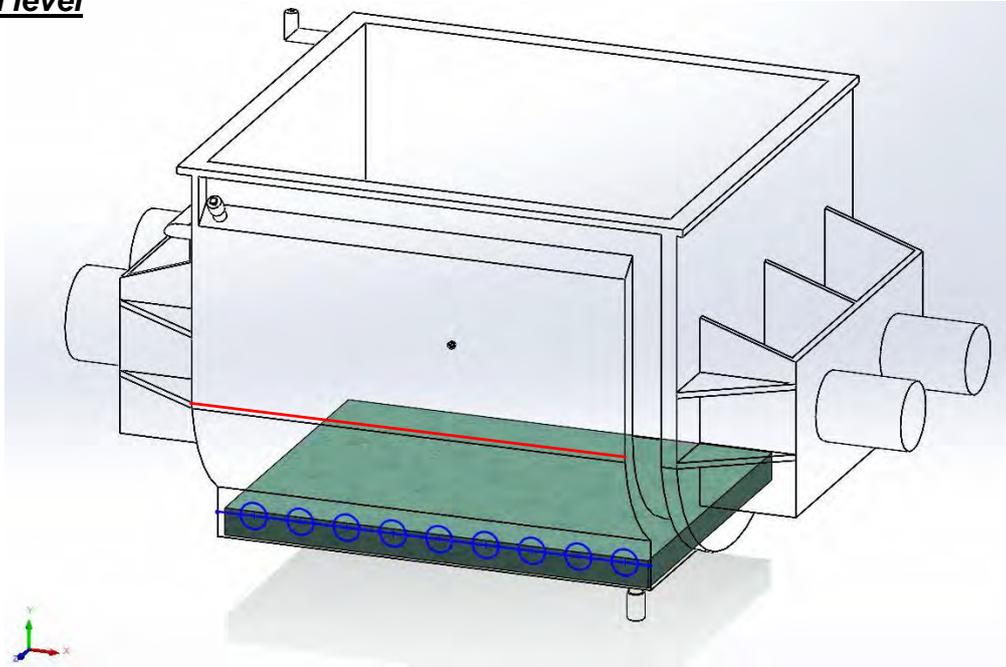
80L oil level

Figure 215: 3D model showing the oil fill level at 80L. The level is estimated to be slightly above the centreline of the heaters.

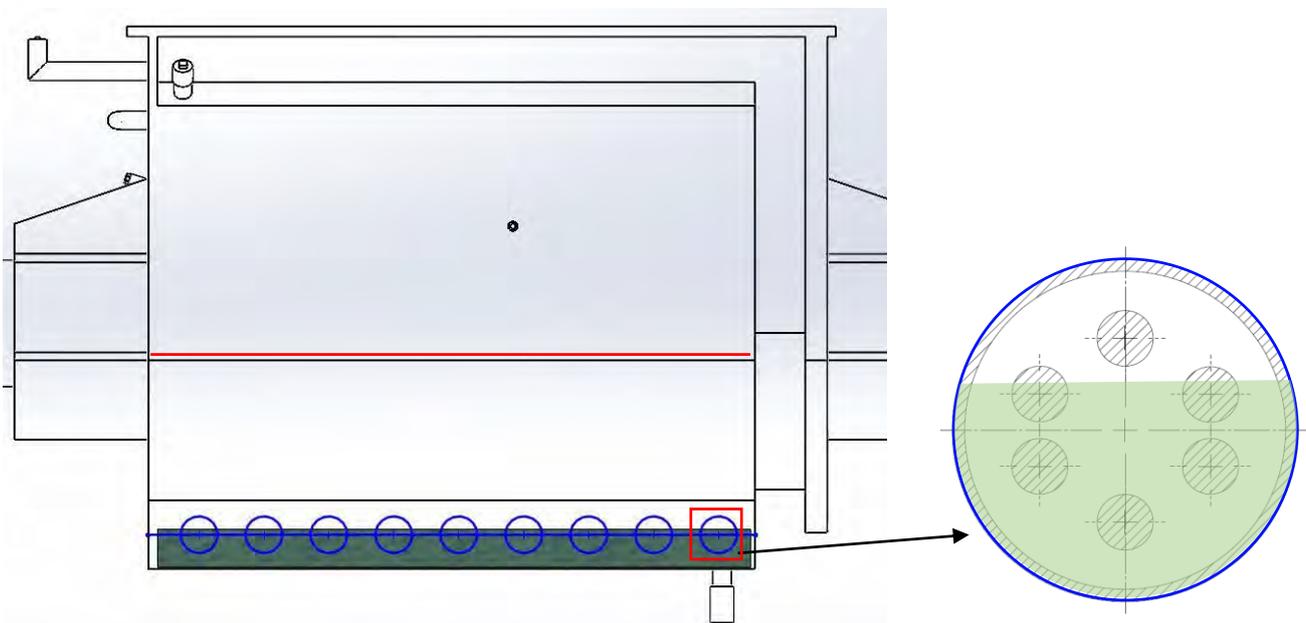
Figure 216: 3D model showing the oil fill level at 80L. The level is estimated to be 10 mm above the centreline of the heaters.

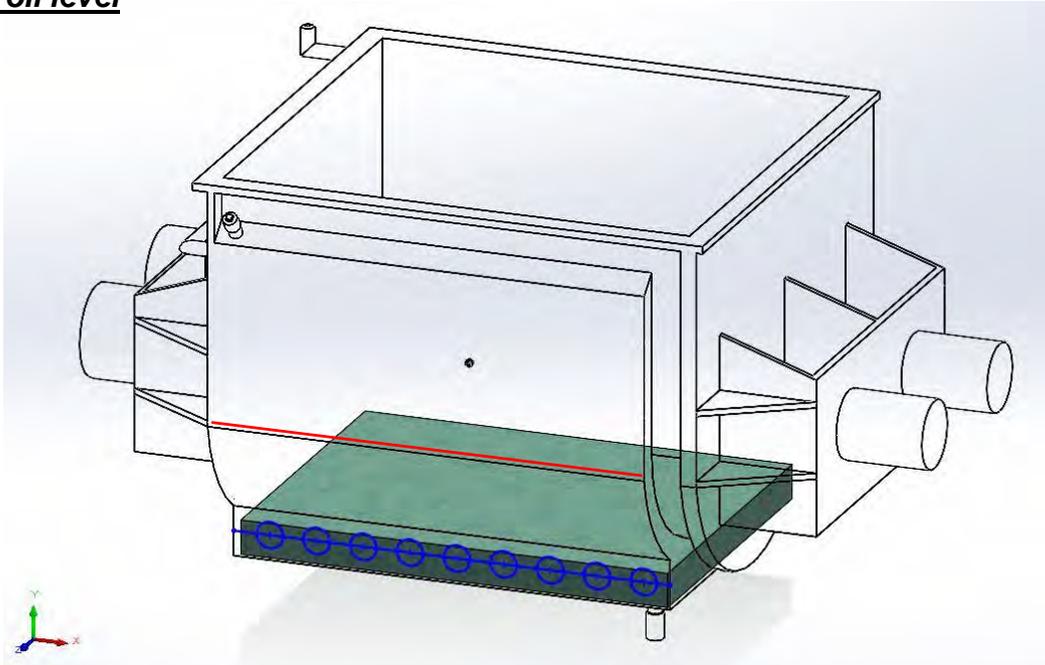
100L oil level

Figure 217: 3D model showing the oil fill level at 100L. The level is estimated to be slightly above the centreline of the heaters.

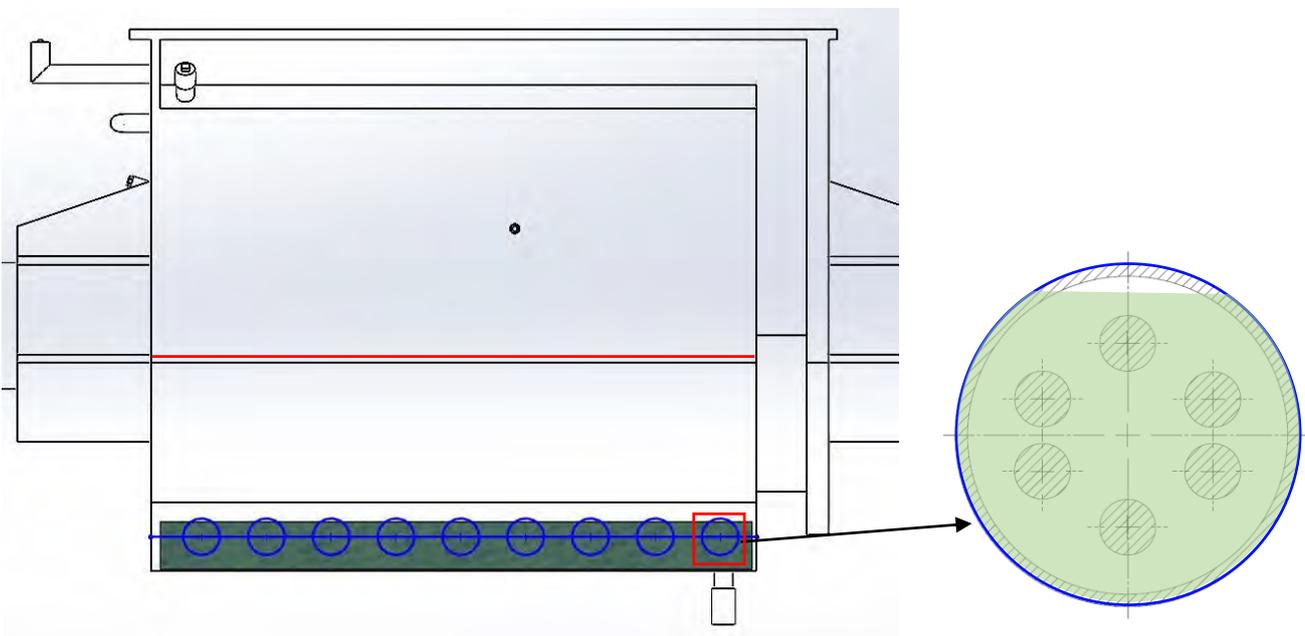
Figure 218: 3D model showing the oil fill level at 100L. The level is estimated to be 30 mm above the centreline of the heaters.

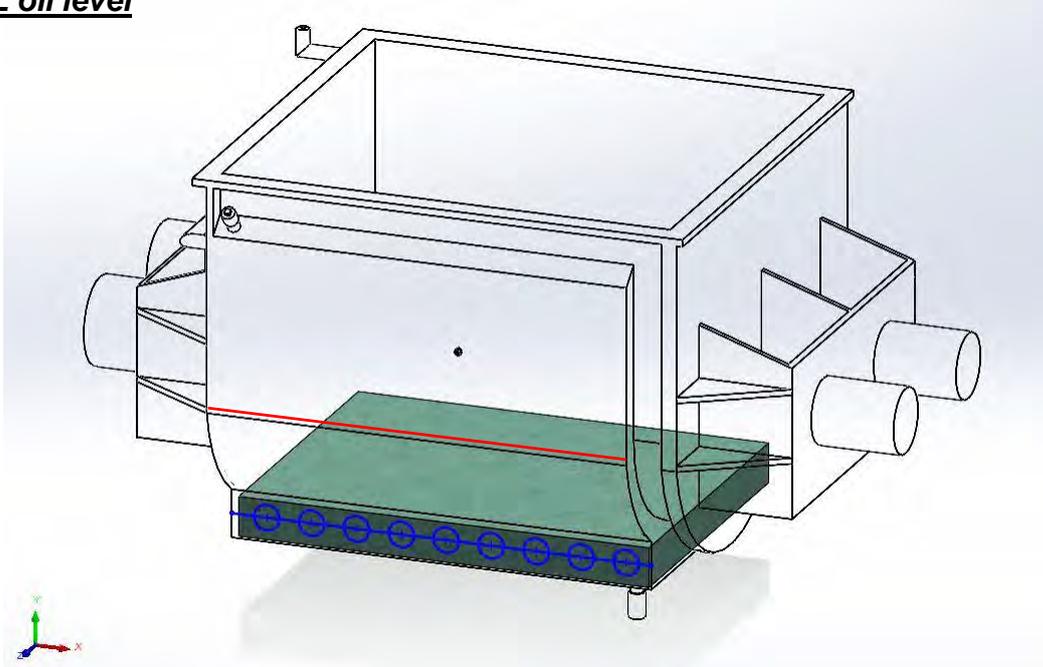
120L oil level

Figure 219: 3D model showing the oil fill level at 120L. The level is estimated to be slightly above the centreline of the heaters.

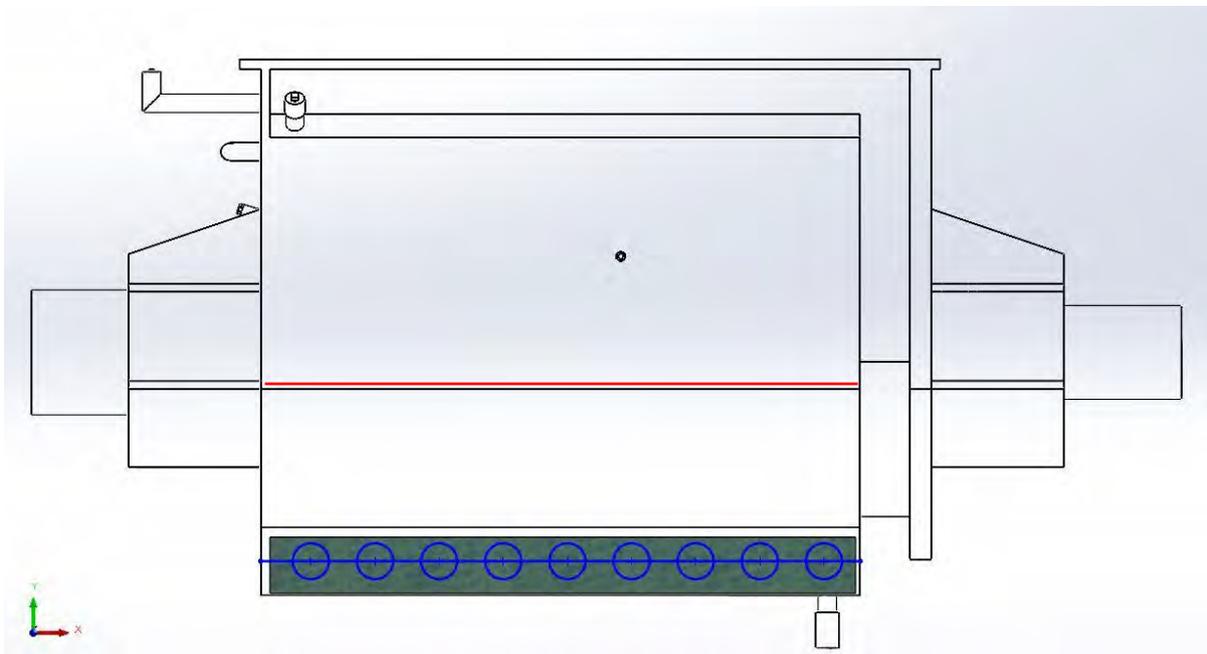
Figure 220: 3D model showing the oil fill level at 120L. The level is estimated to be fully covering the heaters.

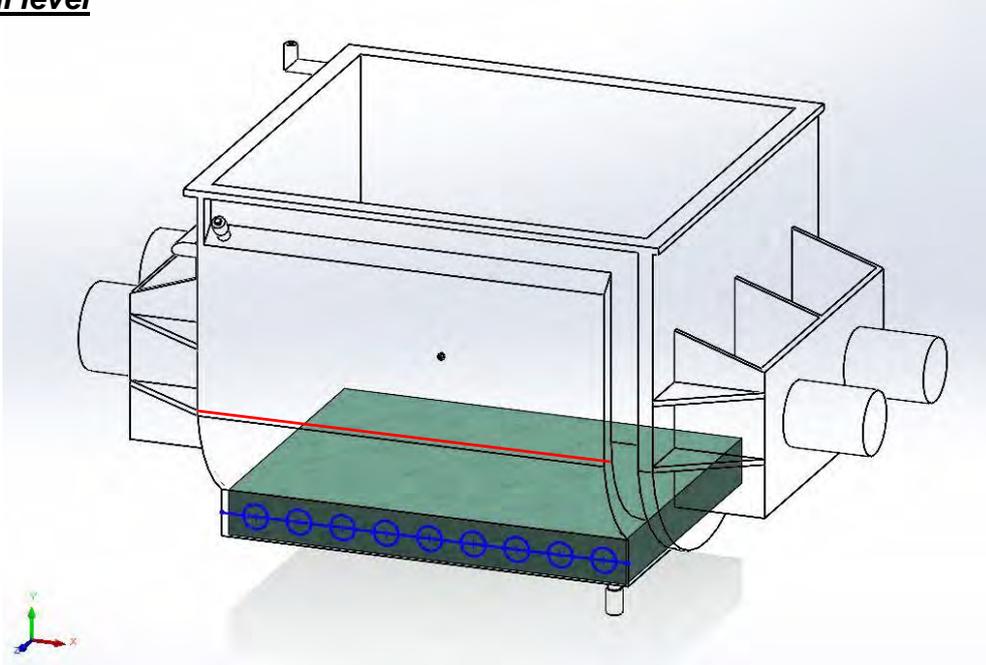
140L oil level

Figure 221: 3D model showing the oil fill level at 140L. The level is estimated to be slightly above the centreline of the heaters.

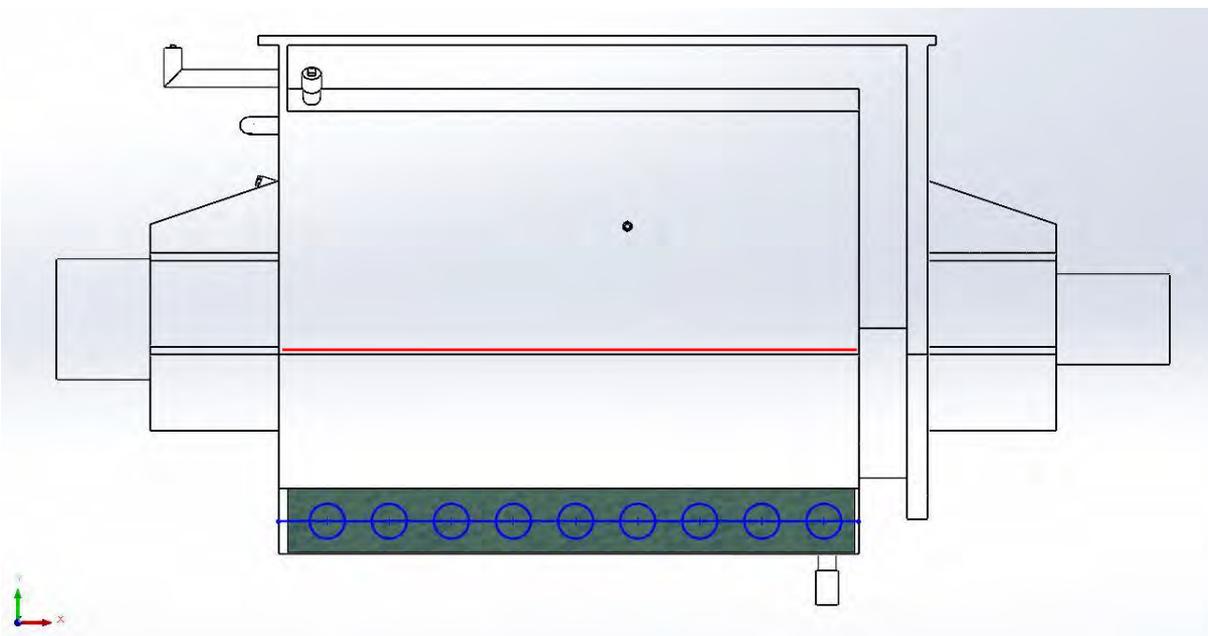
Figure 222: 3D model showing the oil fill level at 140L. The level is estimated to be fully covering the heaters.

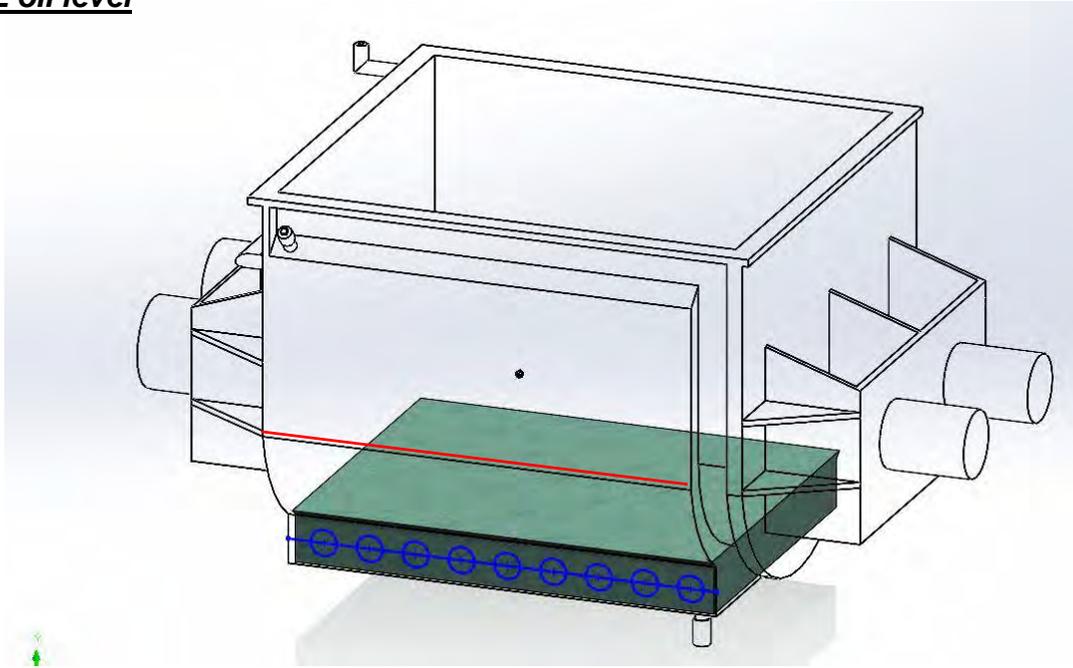
160L oil level

Figure 223: 3D model showing the oil fill level at 160L. The level is estimated to be slightly above the centreline of the heaters.

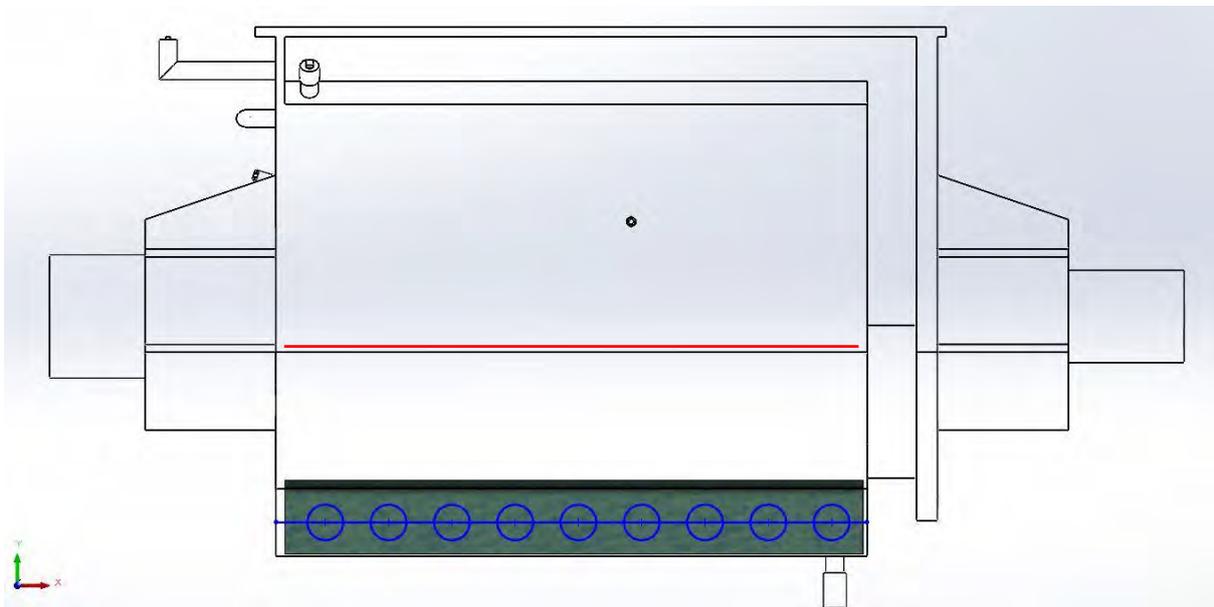
Figure 224: 3D model showing the oil fill level at 160L. The level is estimated to be fully covering the heaters.

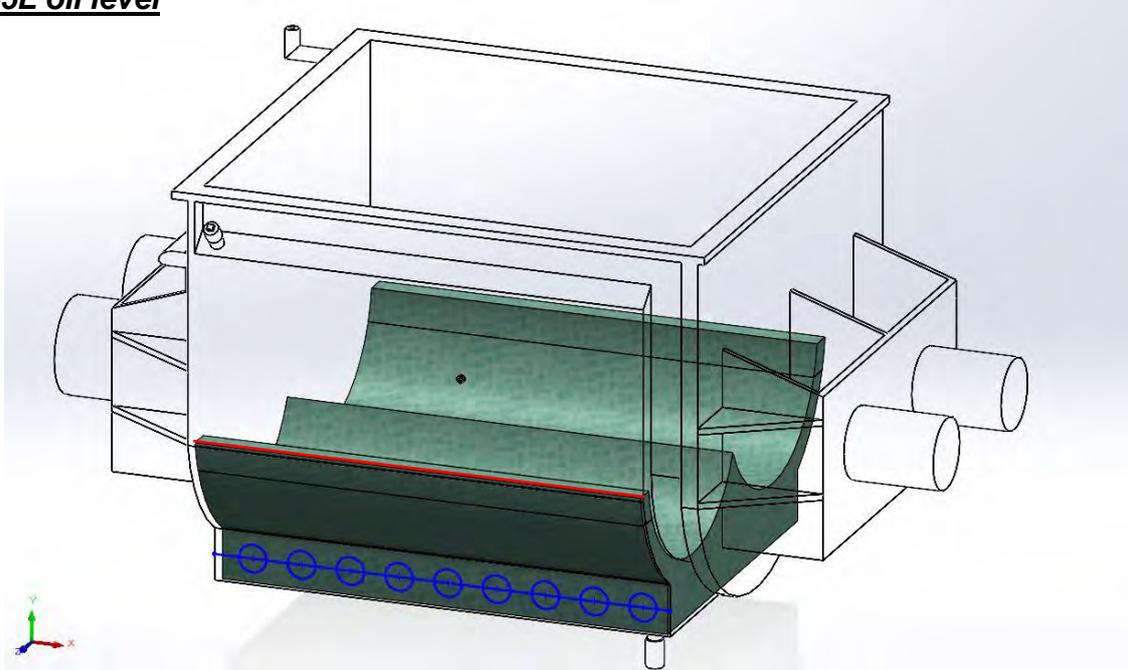
245L oil level

12 Based on the background information provided, the oil jacket did not have sufficient oil inside during its operating life. The User Guide states that heat conduction oil is to be added up to half the height of the cylinder (as stated in Section 3.7). The 3D model shows that the amount of oil needed to fill to the stated level is approximately 245L (Figure 225), much higher than the initial 40L or subsequent 80L.

Figure 225: 3D model showing the oil fill level at 245L. This is the estimated volume needed to filled up to half the mixing cylinder height as per the User Guide.

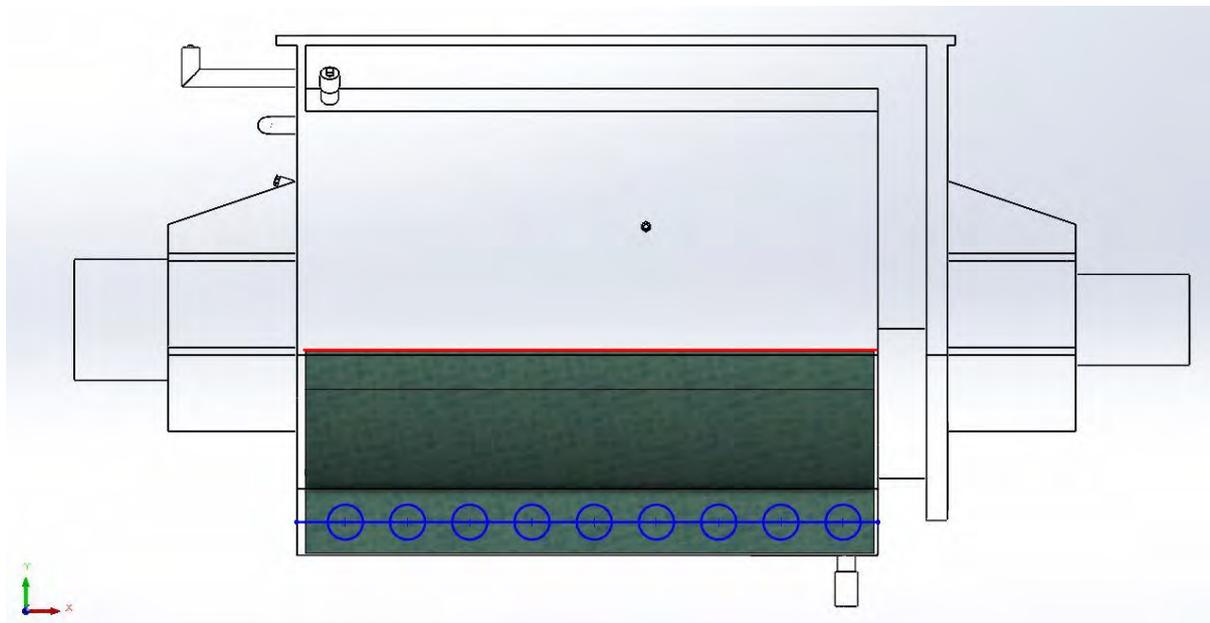
Figure 226: 3D model showing the oil fill level at 245L. This is the estimated volume needed to filled up to half the mixing cylinder height as per the User Guide.

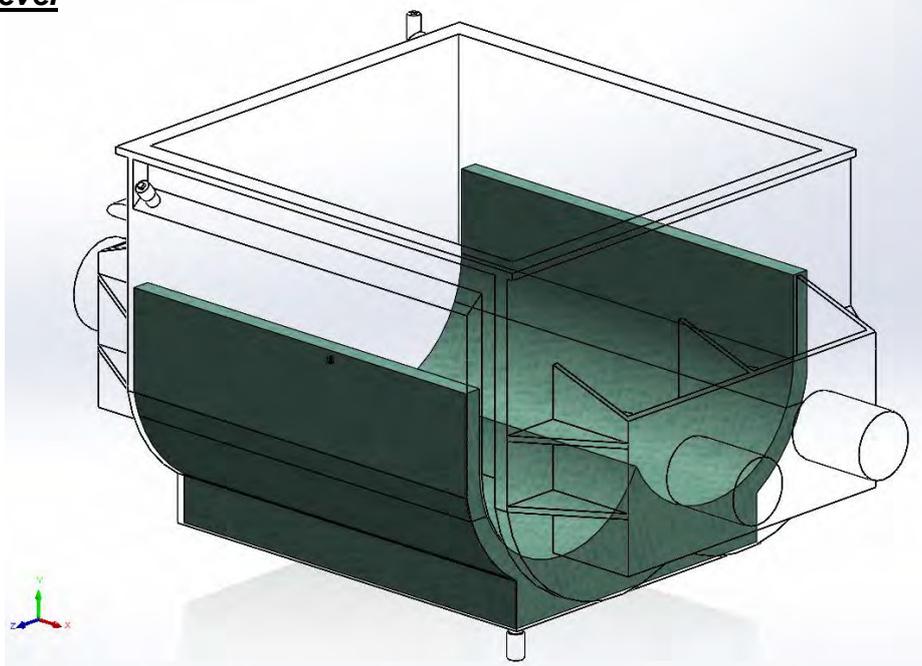
279L oil level

Figure 227: 3D model showing the oil fill level at 279L. This is the estimated volume needed to filled up to half the height of the oil jacket's RTD measure points.

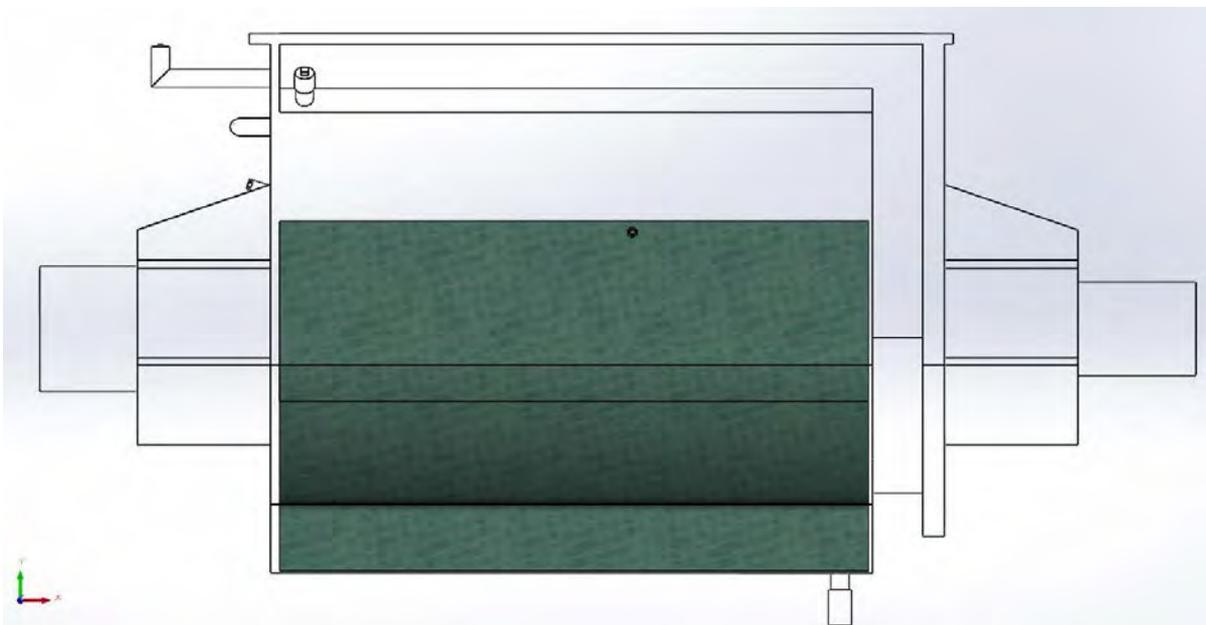
Figure 228: 3D model showing the oil fill level at 279L. This is the estimated volume needed to filled up to half the height of the oil jacket's RTD measure points.

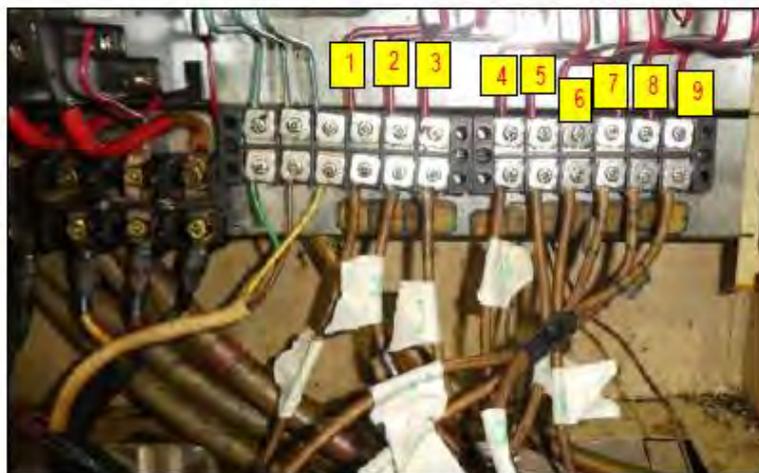
The termination of the heating coil wires

The above figure was furnished by Mr. Ashley Ng from Matcor, showing the termination of the heater wires in the LCP before removal on site. The wires terminated to the contactors are numbered (in yellow box) from left to right. The contactors correspond to the 3 switches at the top of the panel. Each switch controls the group of heaters linked to contactors 1 to 3, 4 to 6, and 7 to 9.

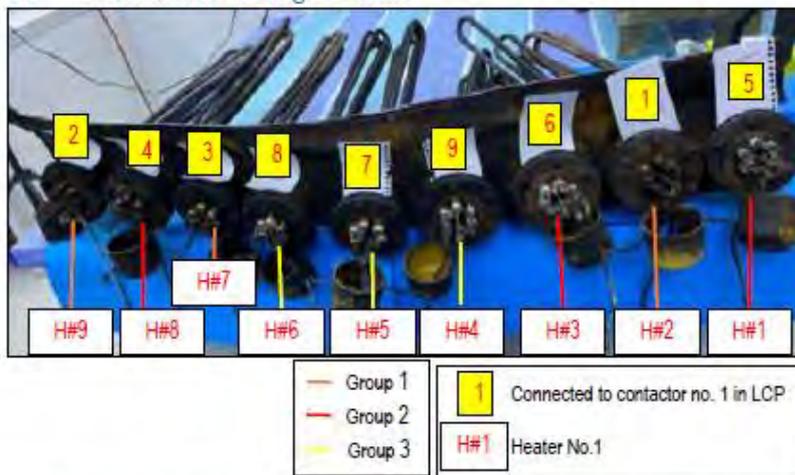
1.2 Connection to heating elements

The figure above shows the 9 heaters and their corresponding wire termination in the LCP contactors.

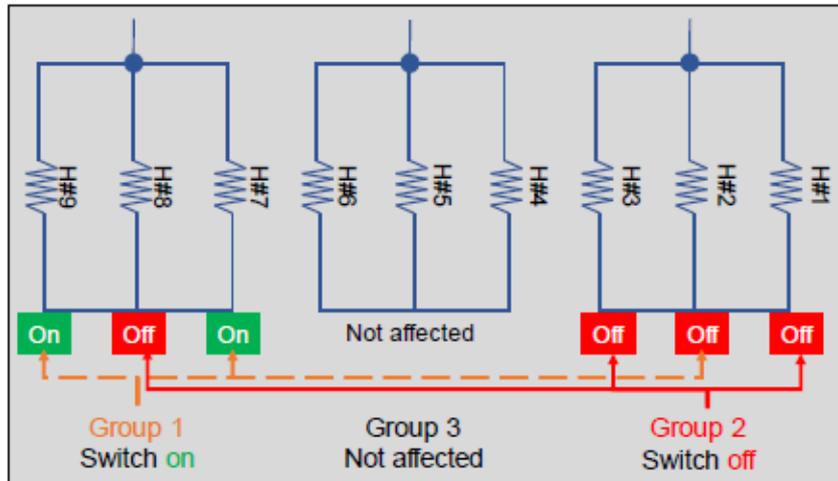
The termination for Group 1 & Group 2 heater switches to the heaters were incorrect. Such termination results in lower heating output if the switch for either group 1 or group 2 is turned off. This is depicted in the following sketch.

Operating state of heating coils when switch for Group 1 is turned on and switch for Group 2 is turned off.

When the switch for Group 1 heaters (consist of H#2, H#7 and H#9) is turned on and switch for Group 2 heaters (consist of H#1, H#3 and H#4) is turned off, only H#7 and H#9 will operate. This result in a 2/3 of heating output instead of the full 3 heaters capacity.

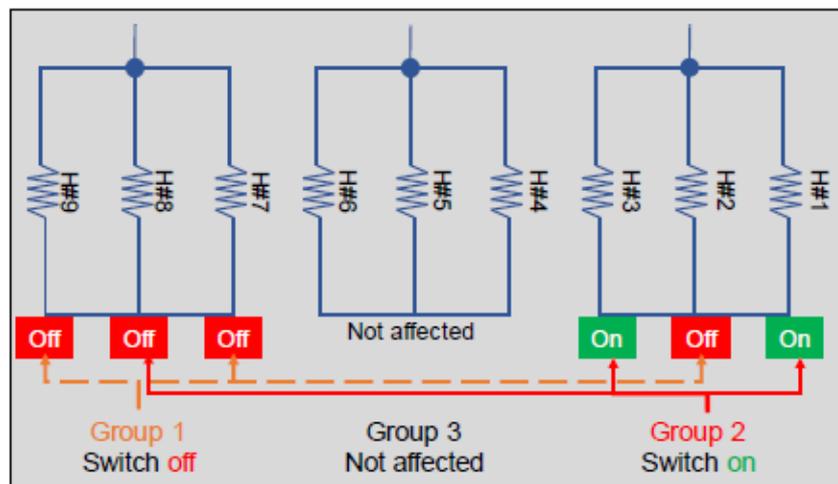
Operating state of heating coils when switch for Group 2 heaters is turned on and switch for Group 1 is turned off.

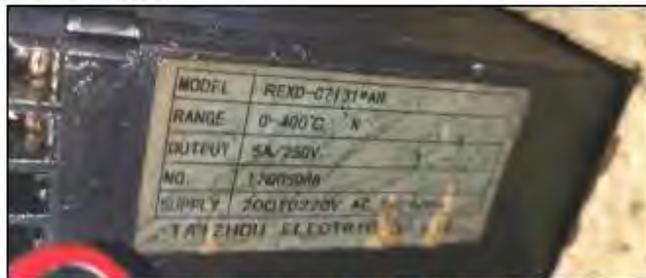
- The 3 groups of heaters' contactors are interlocked with the "Jacket Temperature" thermostat. This means that all the heaters will stop heating when the "Jacket Temperature" thermostat detects a temperature (through RTD sensor) that exceed a pre-set temperature. The thermostat, serial number REXD-C7131*AN, has a detective temperature range of 0 - 400°C (see Annex for specification sheet of thermostat with model "REXD-C7131*AN").

Label with serial number and specification of the thermostat.

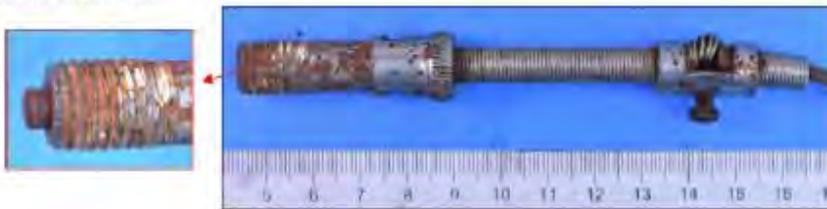
- RTD A resembled a 2-wire Pt100 sensor but cannot be confirmed due to lack of information or serial number.
- RTD A was tested by connecting the RTD terminals to a multimeter and heating the sensor with a lighter. The resistance increases with exposure to heat, confirming it is in working condition.

RTD A with working sensor on left.

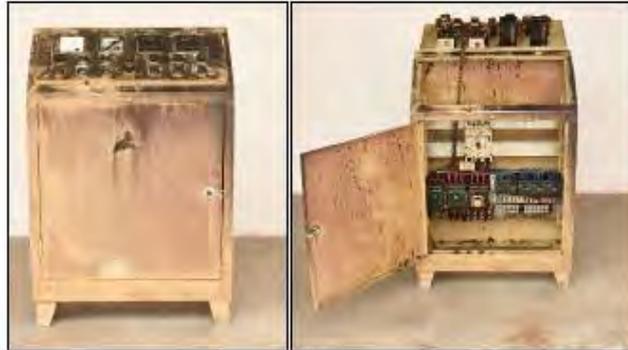
As-received condition of local control panel.

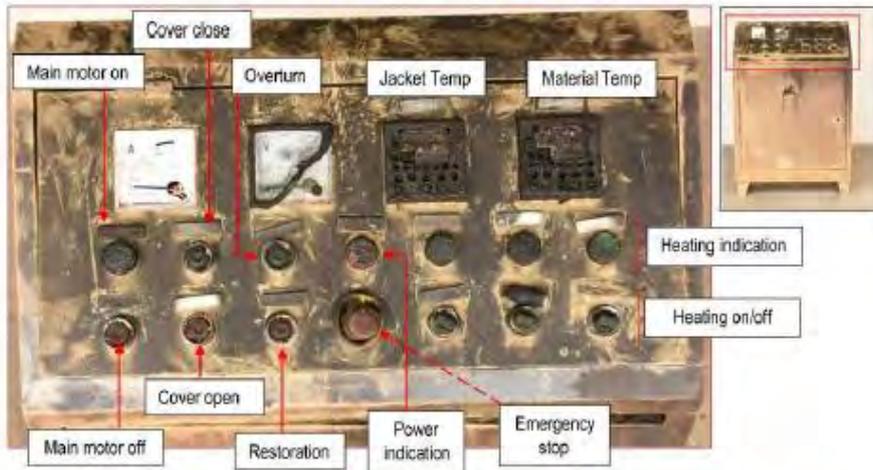
Components including buttons, switches and thermostats of LCP.

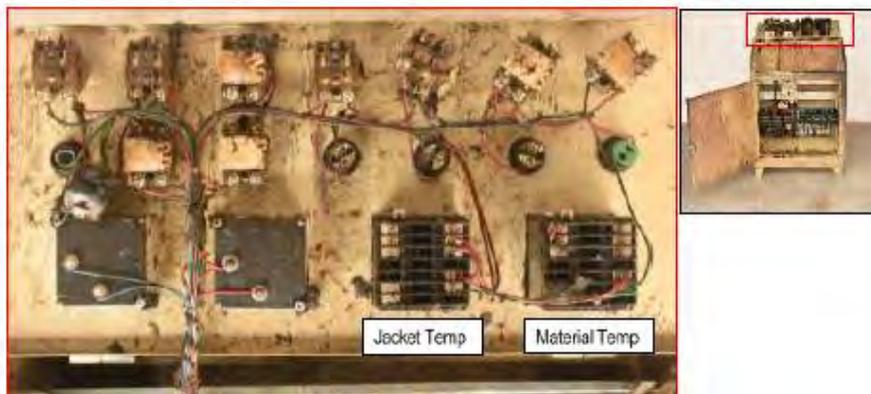
View of components from inside the LCP.

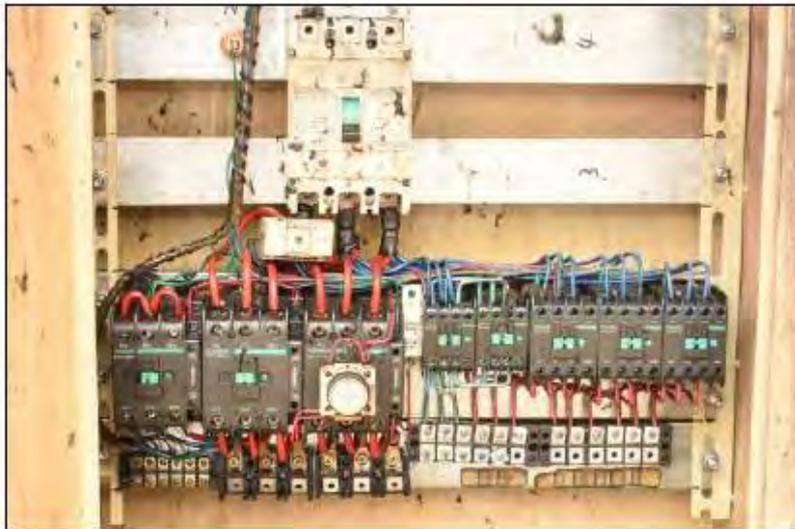
View of components from inside the LCP.
