**Report of the Inquiry
Committee for the accident
at Stars Engrg Pte Ltd on
24 February 2021**

ACCIDENT INVESTIGATION REPORT

FIRE AND EXPLOSION AT STARS ENGRG PTE LTD (32E, TUAS AVENUE 11)

**INVESTIGATION INTO THE CAUSE OF THE EXPLOSION
THAT OCCURRED AT 32 E TUAS AVENUE 11, SINGAPORE ON
24 FEBRUARY 2021**

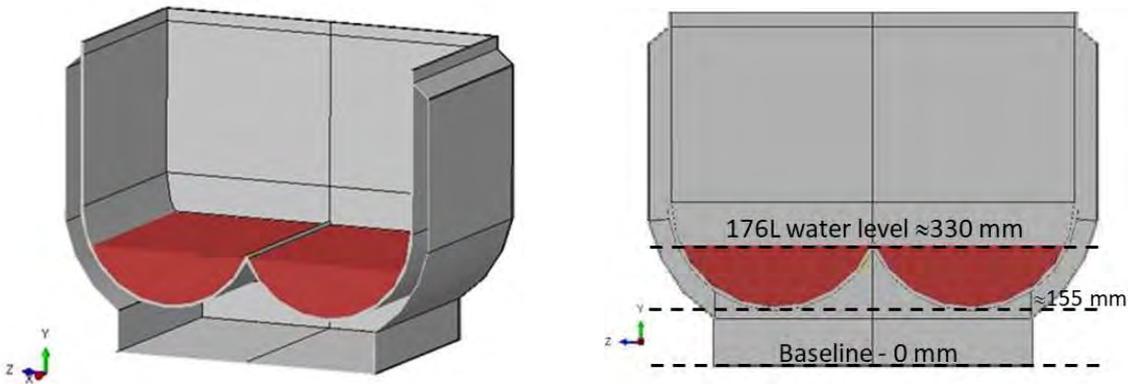
Based on further details provided by MOM, it was indicated that the internal mixing chamber was likely filled with approximately 176 litres of water just prior to the incident (based on the usual production process). This translates to the water level being about 175 mm from the base of the mixing chamber. This volume of water will only partially fill the mixing chamber as shown in **Figure 10** below.

Figure 10. Illustration of mixing chamber with a water fill of 176 litres of water

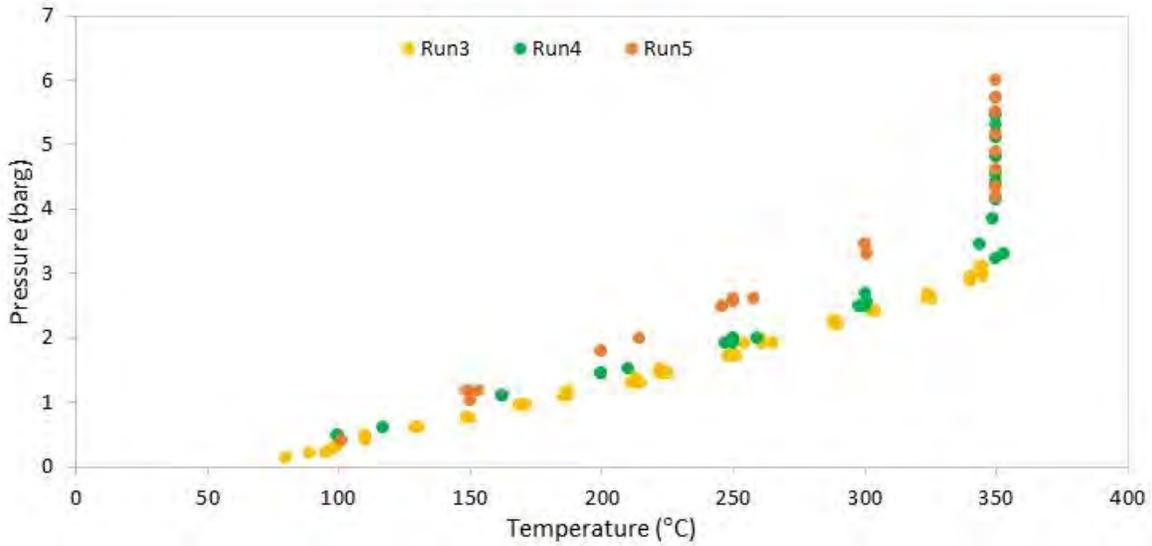
18
19 Based on the results obtained for all five experimental runs, it can be seen that at temperatures
20 below 300 °C, there does not seem to be any significant or abrupt pressure increases that would
21 indicate an exothermic or decomposition reaction happening within the HTF. However, at around
22 350 °C, it was observed that there was a significant pressure increase during experimental Run 4 and
23 Run 5 which was not present in Run 3 which ended at 340 °C. These observations can be seen in the
24 consolidated graphical plots for Runs 3, 4 and 5 as shown in **Figure 11**.

2 **Figure 11.** Consolidated graph of pressure against temperature for experimental Runs 3, 4 and 5

4 From **Figure 11**, the pressure was seen to increase to around 6 barg when the temperature was held
 at 350 °C. However, when the experimental temperature range was extended up to 450 °C for
 6 experimental Run 1 and Run 2, a larger pressure increase of up to 103 barg was observed. The
 experimental runs were terminated and the system was cooled once the system pressure was seen
 8 to exceed 100 barg due to safety reasons. The consolidated graphical plots of pressure against
 temperature for Runs 1 and 2 are shown in **Figure 12**.

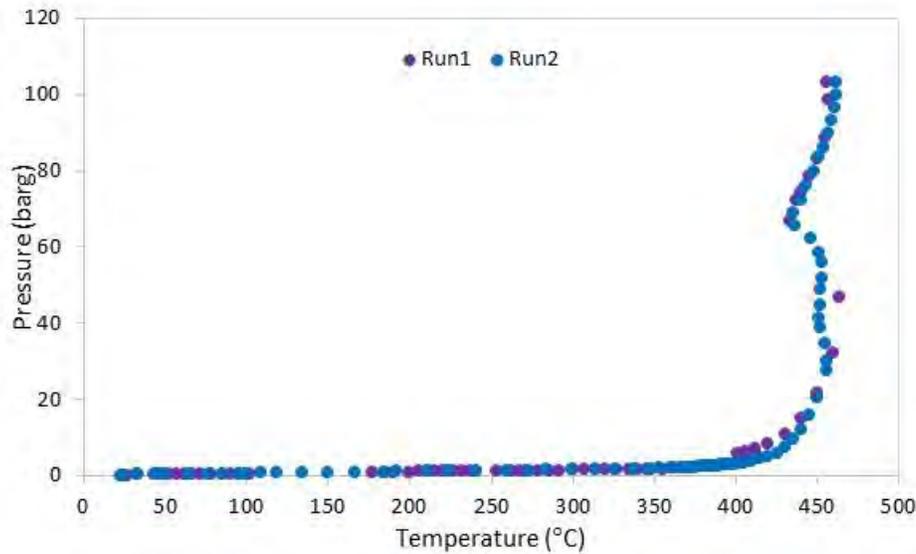
2 **Figure 12.** Consolidated graph of pressure against temperature for experimental Runs 1 and 2

4 As shown by the consolidated graphical plots in **Figure 11** and **Figure 12**, prior to the sharp pressure
 increases at 350 °C and 450 °C, the pressures were seen to be increasing gradually. It is likely that in
 6 the initial stage of the experiments at temperatures less than 340 °C, the pressure increases were
 due to vapourisation of the HTF along with the thermal expansion of the gas in the headspace above
 8 the liquid. Under a vapour pressure dominated regime, a graphical plot of the pressure logarithm
 against the reciprocal of temperature would generate a straight line as the system tends towards
 10 ideal/real gas behaviour. In addition, when the system behaviour deviates from this straight line, it
 would also indicate a transition into a gas generating, thermal decomposition regime.

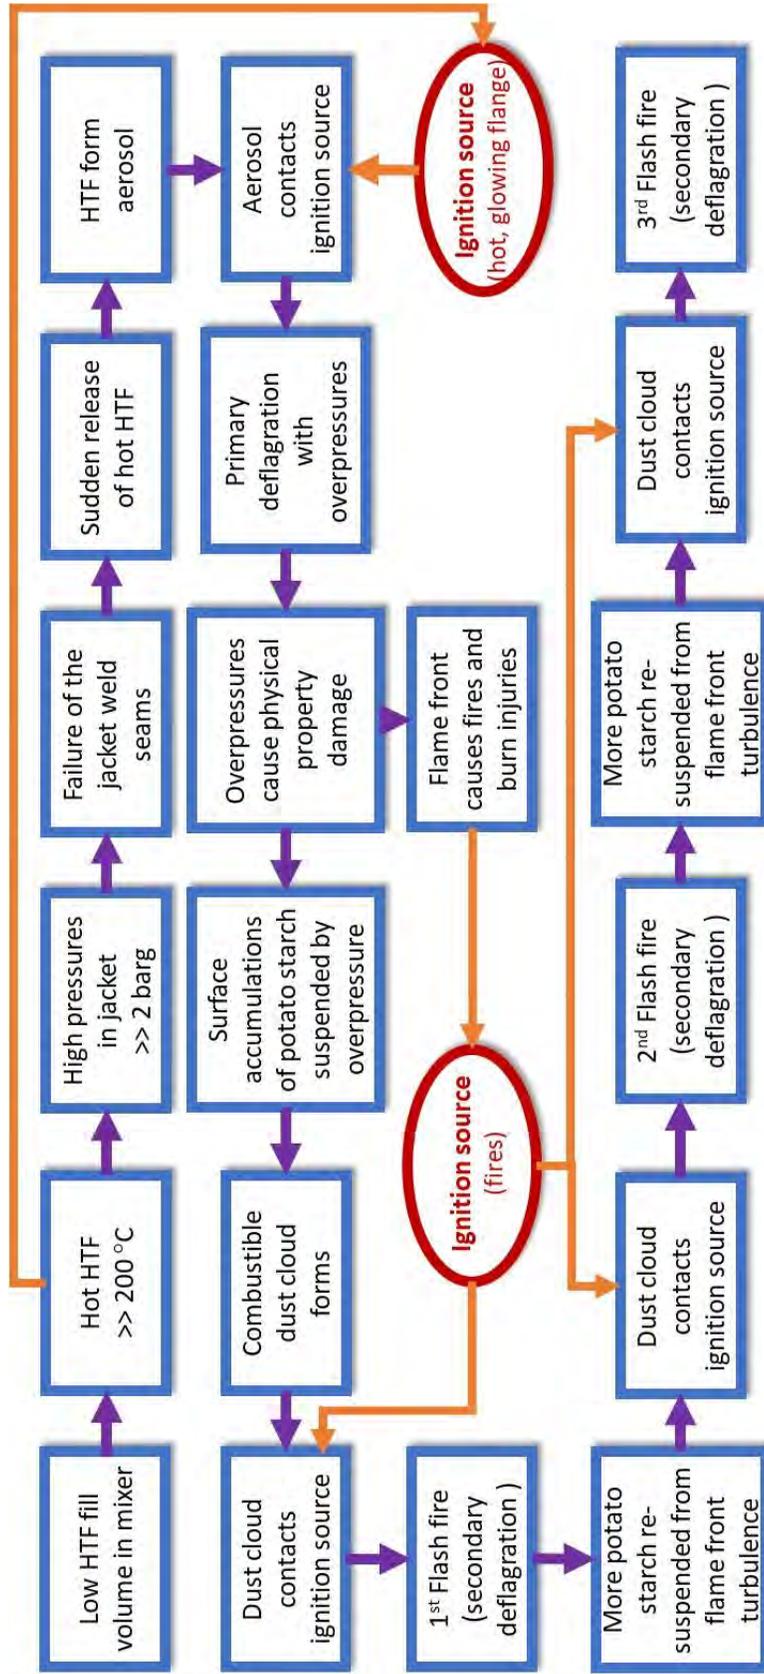
- various surfaces. The suspended potato starch dust could then be ignited by the fires that were
- 2 initiated by the primary deflagration event which then resulted in a secondary deflagration/flash fire.
- This process of dust suspension could be repeated a number of times after each deflagration/flash
- 4 fire, thus resulting in the three flash fires that occurred.
- 6 The overall flow diagram showing the likely sequence of events is shown in **Figure 27**.

Figure 27. Overview of the likely sequence of events that resulted in the primary and secondary deflagrations at Stars Engr.

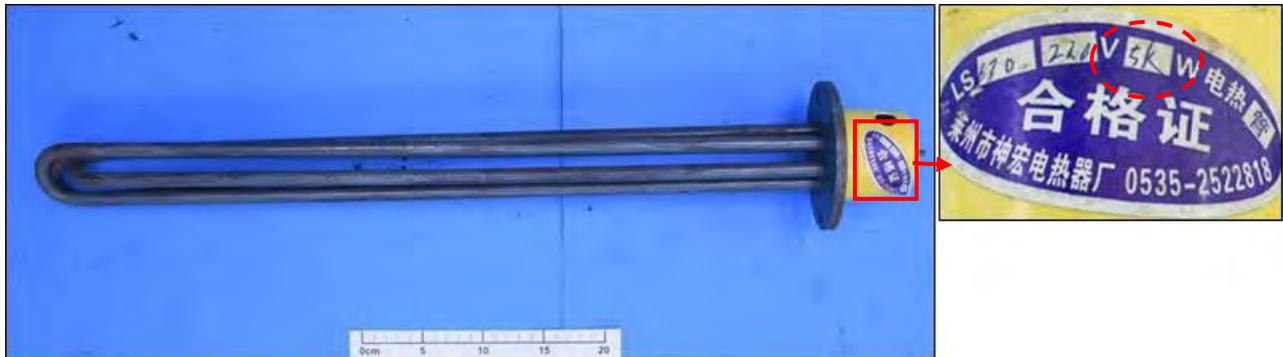
2 Subsequently, investigations revealed that each heating element unit had a power rating of 5 kW
as shown in **Figure B.3** below. Hence, FEA simulations were also conducted to study the effects
4 of a higher heat load on the mixer system.

6 **Figure B.3.** Photograph of heating element of the NH Sigma Kneader taken by Matcor

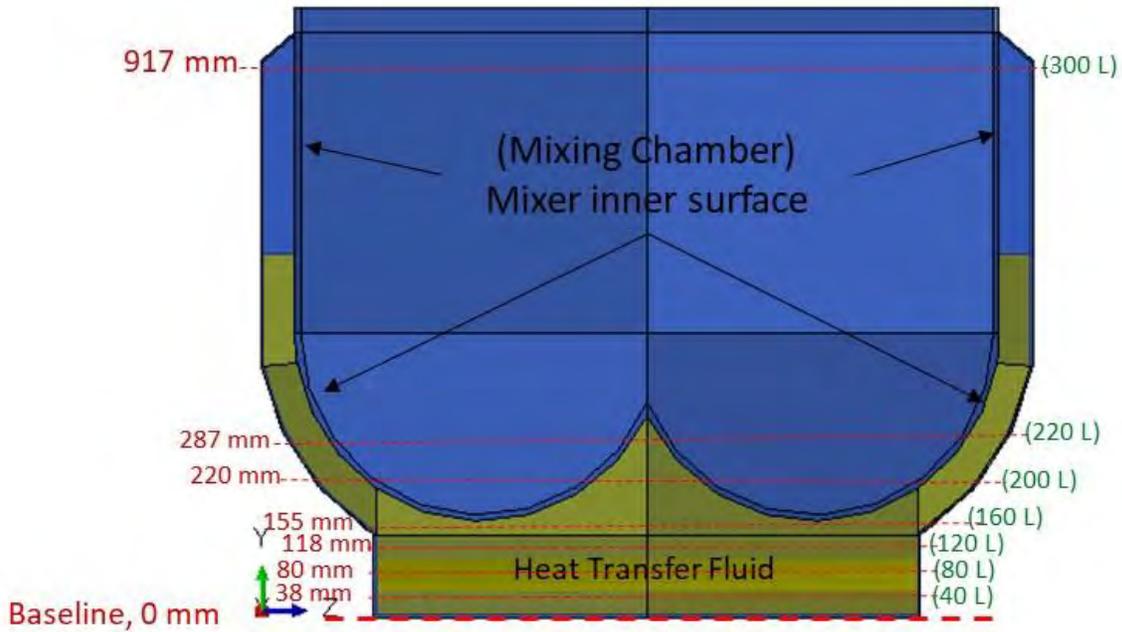
4 Apart from these levels, based on information provided by MOM, the amount of heat transfer
 6 fluid added into the jacket by the workers from Stars Engrg could range from 40 litres to 160
 8 litres. A fill volume of 160 litres would result in a fluid level of 155 mm as illustrated **Figure B.6**
 below. Meanwhile, a fill volume of just 40 litres (32 kg of heat transfer fluid) would result in a
 fluid level that is only 38 mm above the base of the mixer's heating jacket as illustrated in **Figure**
B.6 below.

2 **Figure B.6.** Low heat transfer fluid volumes within the mixer’s jacket

4 At fill volumes of about 220 to 40 litres, the heat transfer fluid will not be fully in contact with the
 6 mixer’s inner surface. This would result in low heat transfer to the mixing chamber. In such a
 8 situation, the temperature of the heat transfer fluid will be expected to be very high and would
 likely result in phase changes with vapours accumulating in the void space above the HTF level.
 Since phase change and latent heat models have not been included in the current FEA modelling,
 HTF volumes less than 222 litres were therefore not simulated.

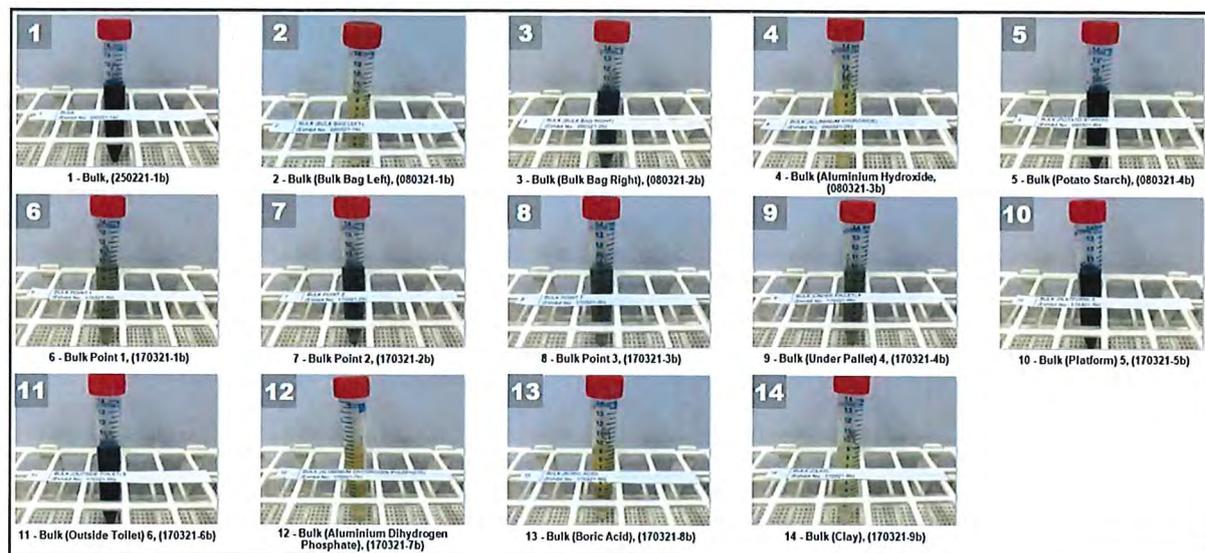
1. The sample images obtained after I₂-KI solution introduction are presented as Figure 1 and Table 1.

Figure 1 – Summary image of samples after I₂-KI solution introduction

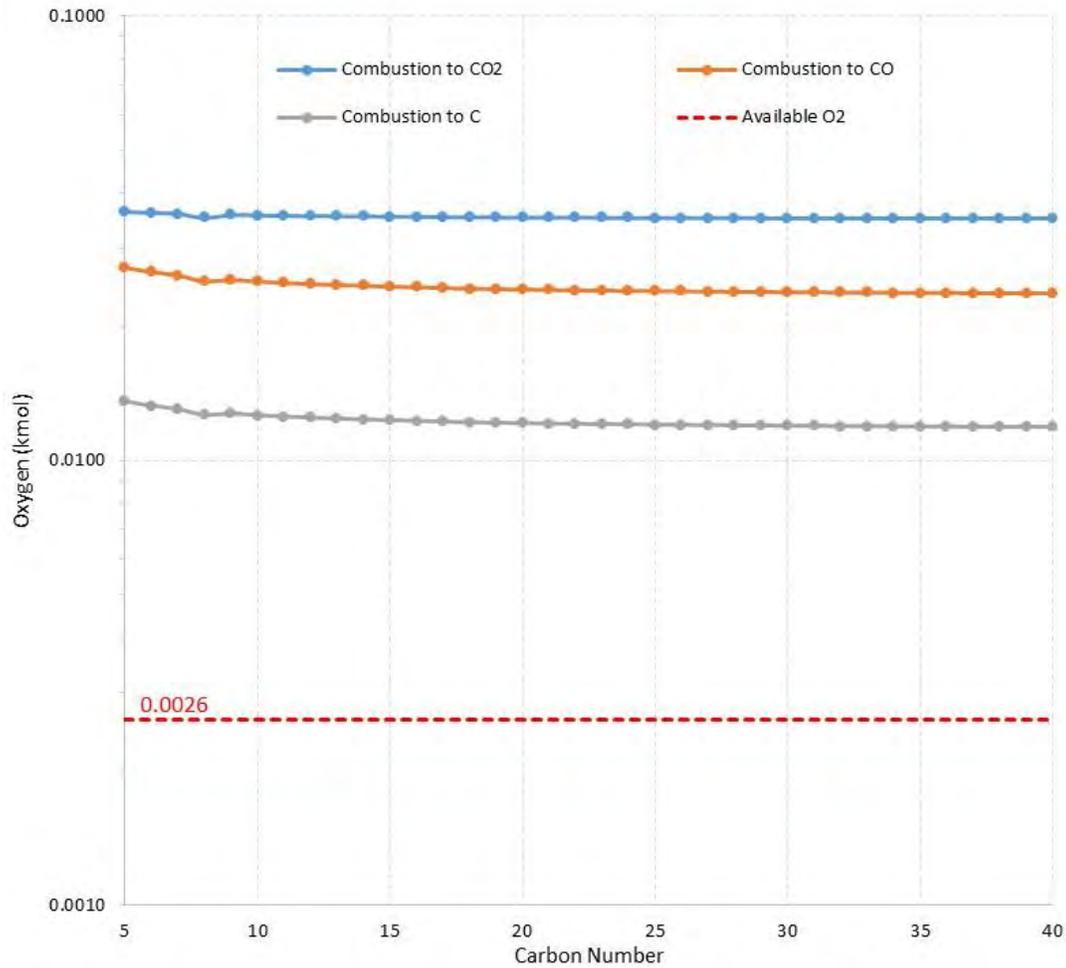
Figure 1. Plots of oxygen required for the complete and incomplete combustion of C5 to C40 alkanes based on the TNT equivalent approach.

From **Figure 1**, we can see that at all carbon numbers (i.e. C5 to C40), the amount of O₂ required for either complete or incomplete combustion exceeds that available in the heating jacket (i.e. 0.0026 kmol O₂). The lowest level of oxygen required is for the incomplete combustion of C40 (tetracontane) to carbon which needs 0.0119 kmol of O₂. Since it is practically impossible for the HTF to consist solely of C40 hydrocarbons (melting point 84 °C) and would actually consist of hydrocarbons with lower carbon numbers, such a mixture of alkanes would require more than 0.0119 kmol of O₂ for combustion.

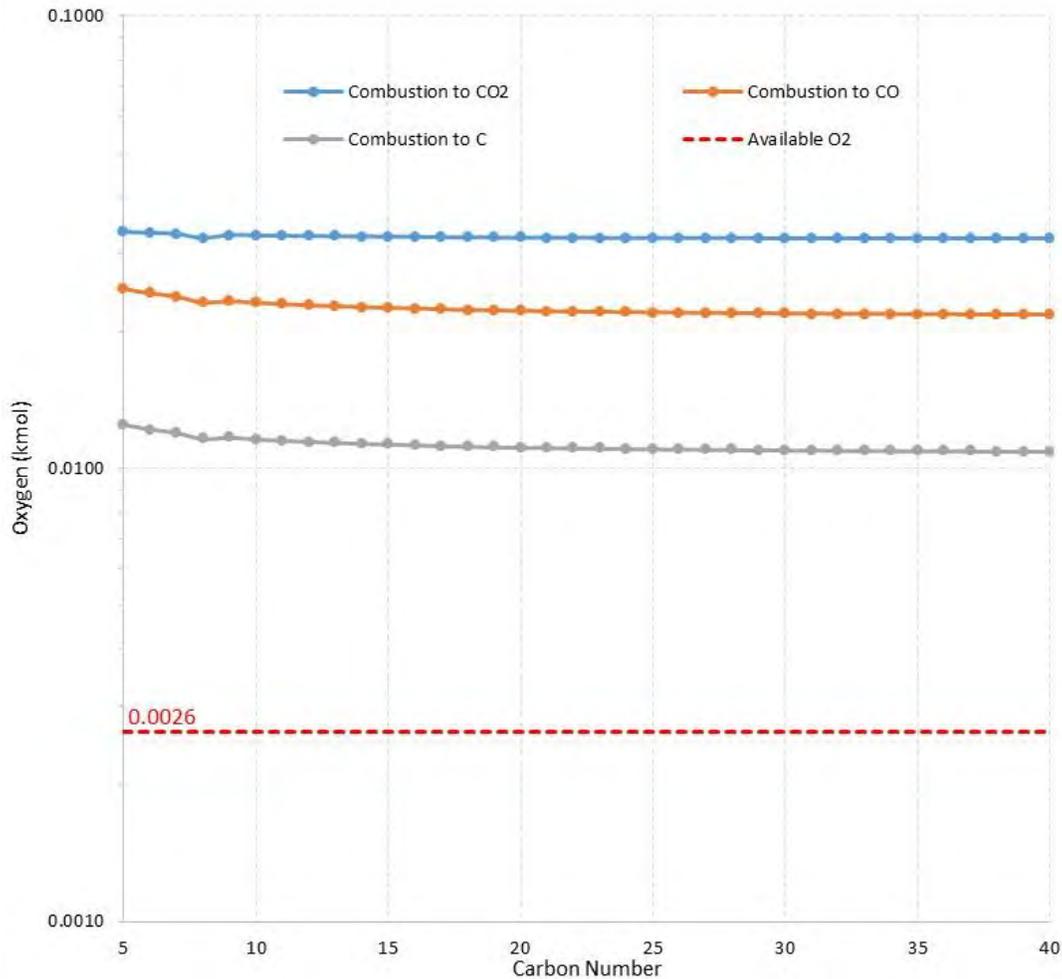
1 **Figure 2.** Plots of oxygen required for the complete and incomplete combustion of C5 to C40
 2 alkanes based on the oil mist concentration approach

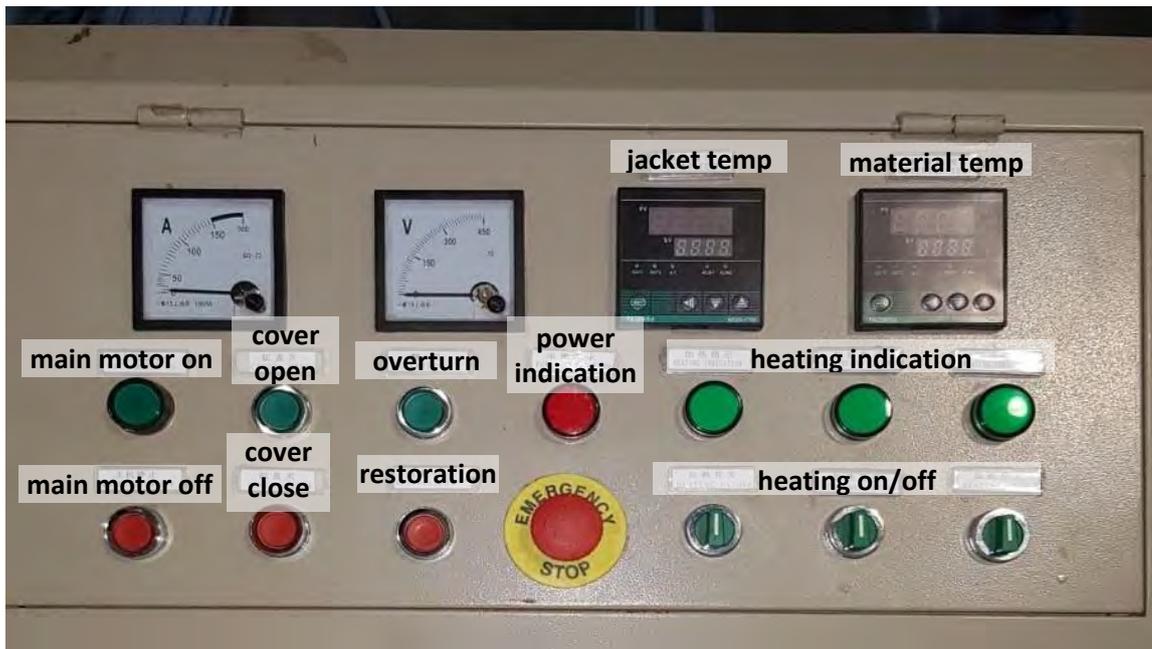
heaters rated at 5kW of power each at the bottom of the heating jacket. The heaters are connected to the electrical control panel and controlled by power switches (green knobs) at the bottom right hand corner of the electrical control panel (see Fig. 3).

2.1.4 The Mixer Machine's design temperature is 200°C, and the operating temperature range is 70°C to 160°C. The heating jacket temperature is measured by a resistance temperature detector/sensor (RTD A) mounted either on the front or the rear of the heating jacket. RTD A is connected to an electrical control panel as shown in Fig. 3 where the jacket temperature can be set. Based on the 'Electrical Report on Local Electric Panel' dated 25 July 2021, prepared by Yong Chun Hao, a licenced electrical worker with Yogo Engineering, and Vincent Char Poh Fang, a Switchboard Manufacturer of One Electric Pte Ltd (annexed to Matcor's Report), RTD A operates on an interlock system where, once the jacket temperature exceeds the value preset at the control panel, the interlock system will switch off power supply to the electrical heaters for safety.

Fig. 3: Photograph of the control panel, with labels added (obtained from MOM)

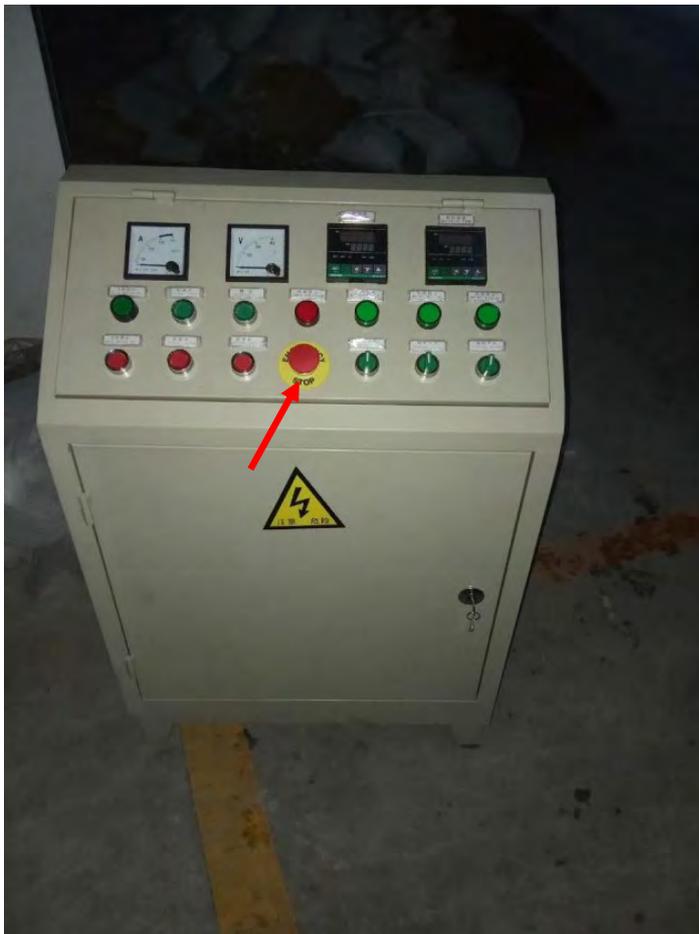
Photograph 5:
The control panel of the machine incorporated an emergency stop button (arrowed).

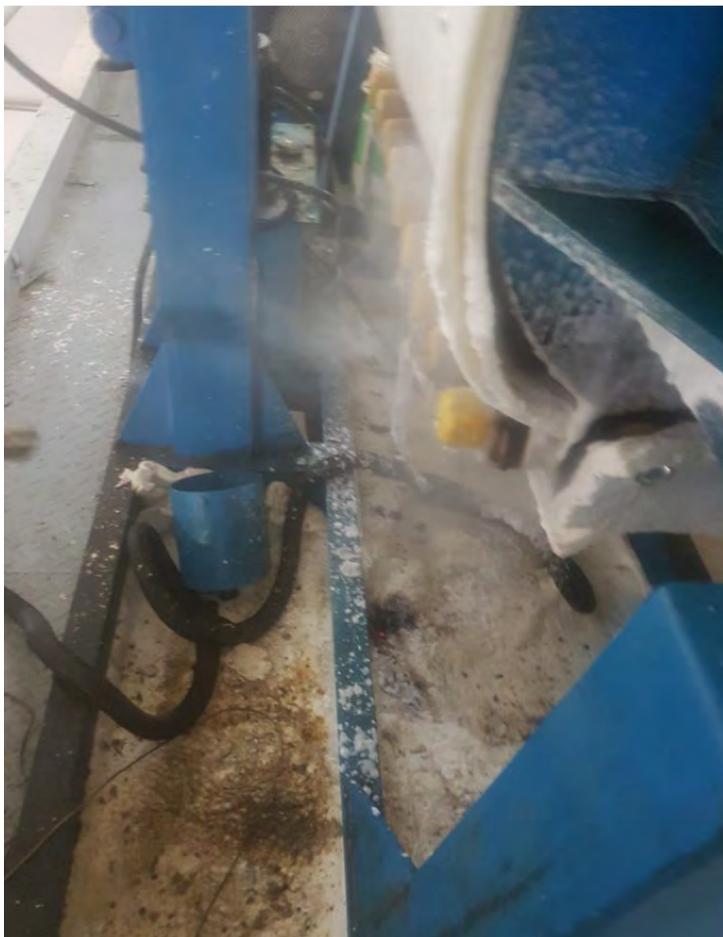
Photograph 10:

Taken after the fire had been extinguished. Smoke is still visible and (white) foam fire-fighting medium is apparent.

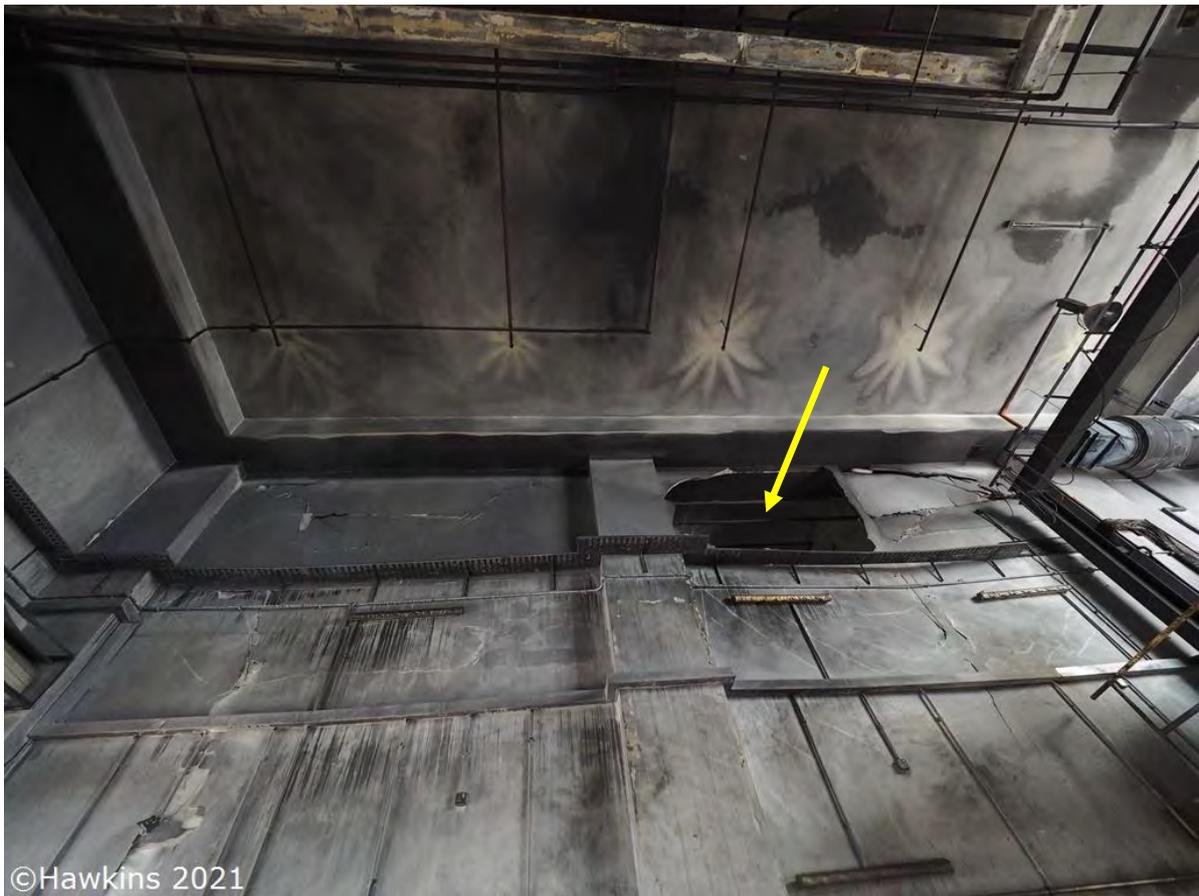
- 4.3.2 The stock, packaging materials, equipment, and items such as the plastic diffusers fitted to fluorescent light fittings inside the unit were burnt slightly or melted by heat. I saw nothing to indicate that a significant sustained fire had burnt inside the premises despite the sprinklers having operated (**Photographs 16 to 19**).

Photograph 19: Soot wash marks showing that the sprinklers had activated. Note the hole in the party wall between units 32E and 32F.

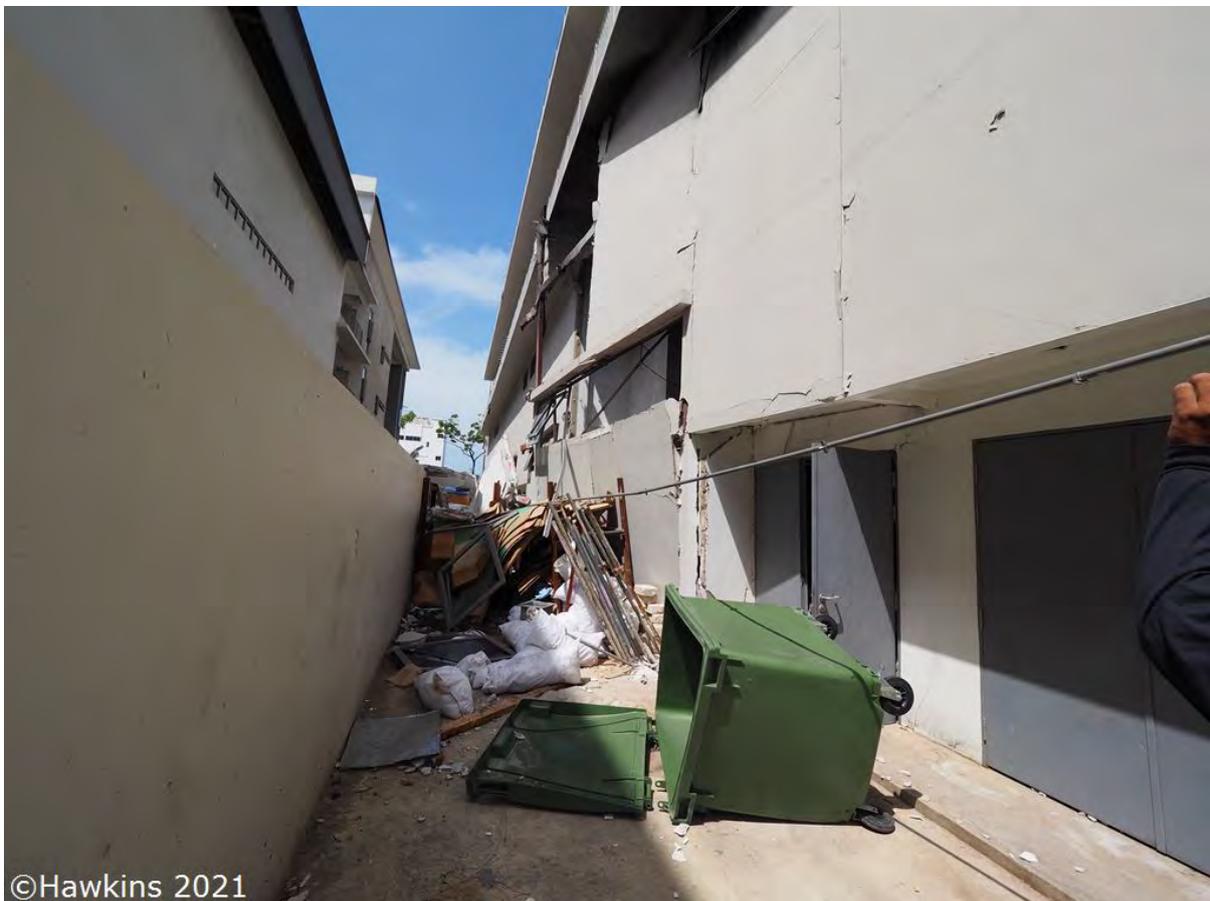
- 4.3.4 The rear wall and windows had been displaced outwards into the alleyway (**Photographs 20 and 21**) and the fire escape door pushed outwards. The contents at the rear of Unit 32E had sustained more severe damage than those at the front; however, none was fire damaged significantly.

Photograph 20: The rear wall of 32E, as viewed from the alleyway.

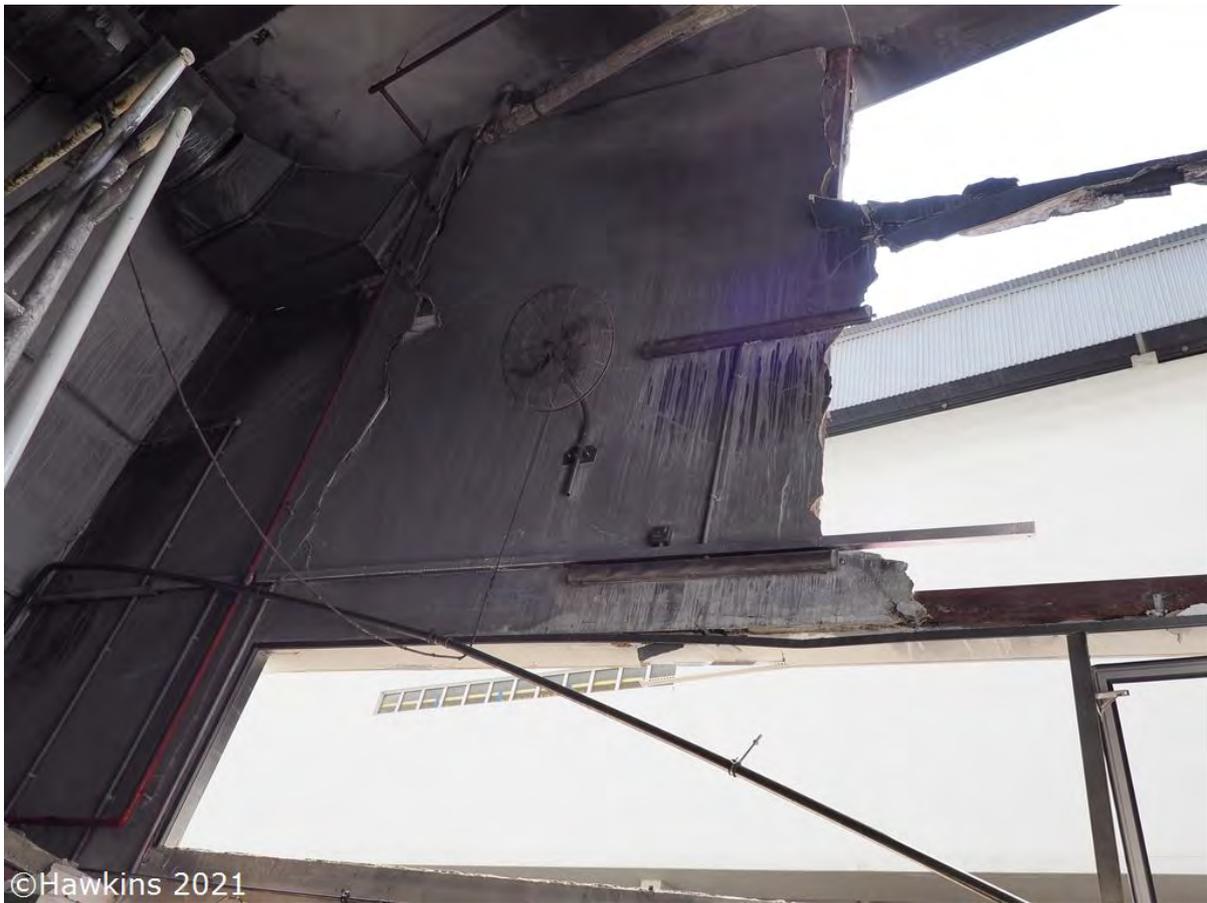
Photograph 21: The rear wall of the unit as viewed from the mezzanine.

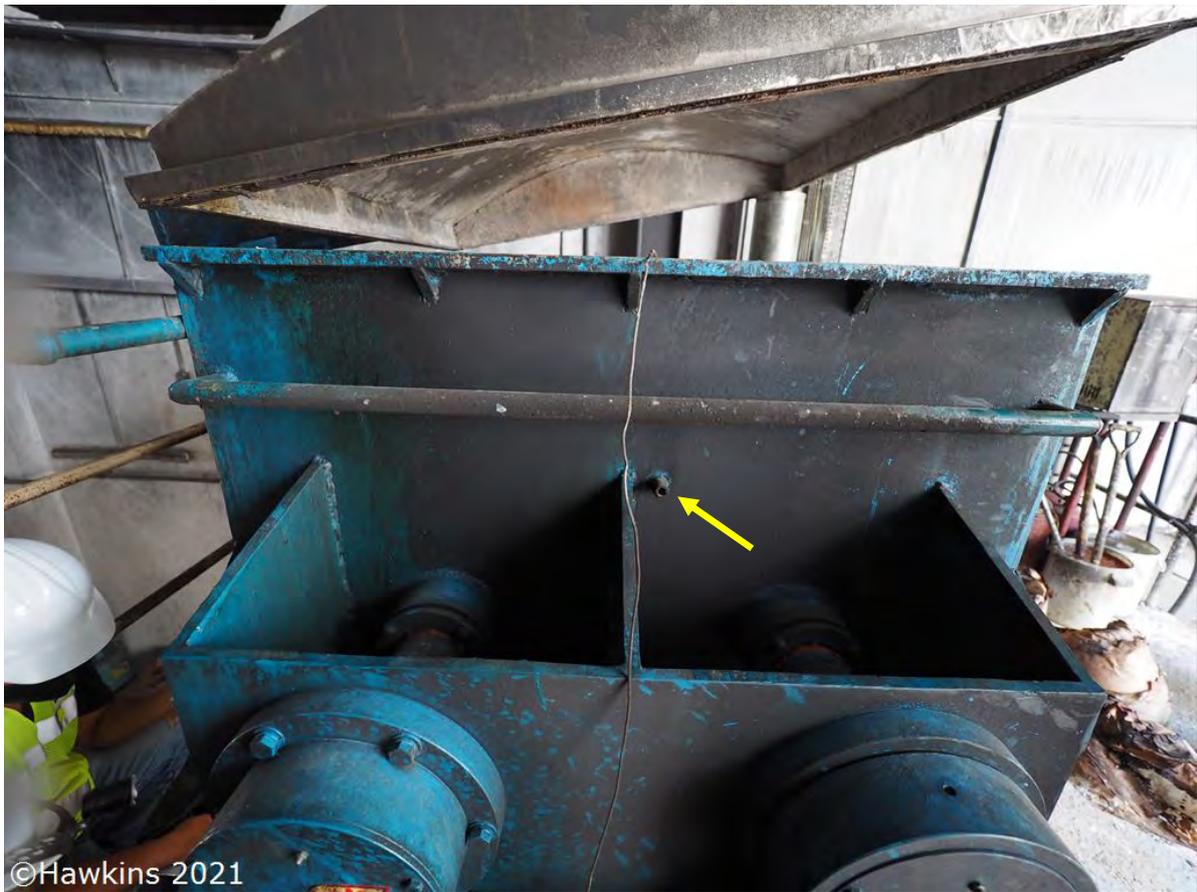
Photograph 28: The mixing chamber of the machine. The thermocouple wire is highlighted.

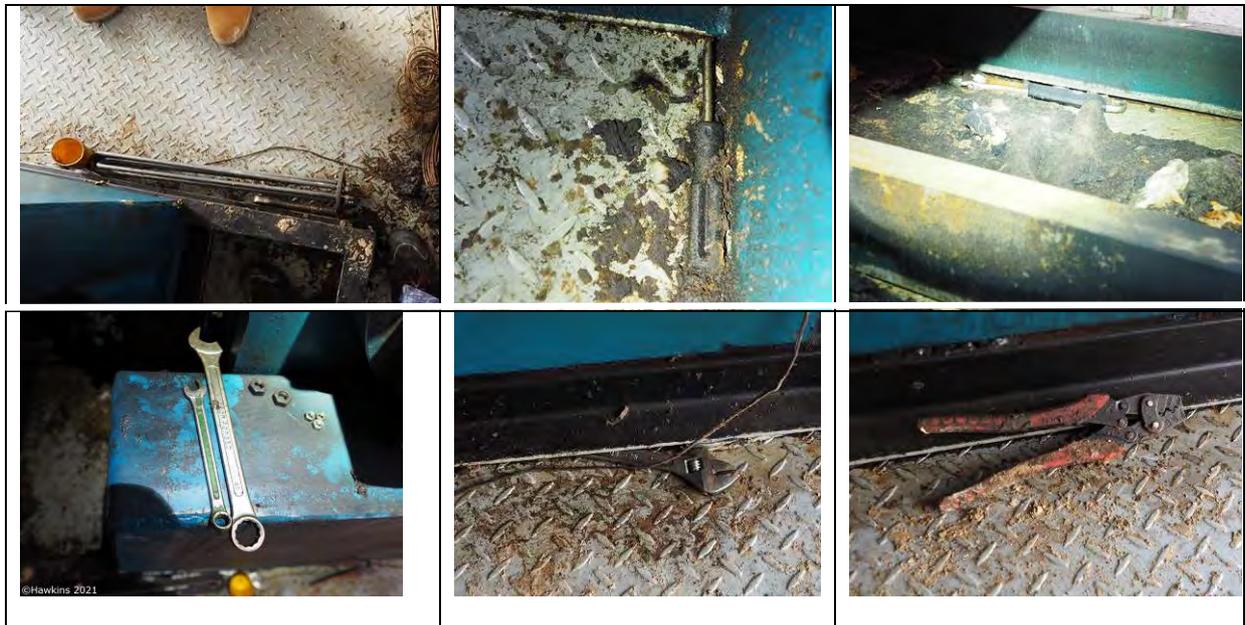
Photograph 29: What appeared to be a port for a second thermocouple. No thermocouple was in-situ.

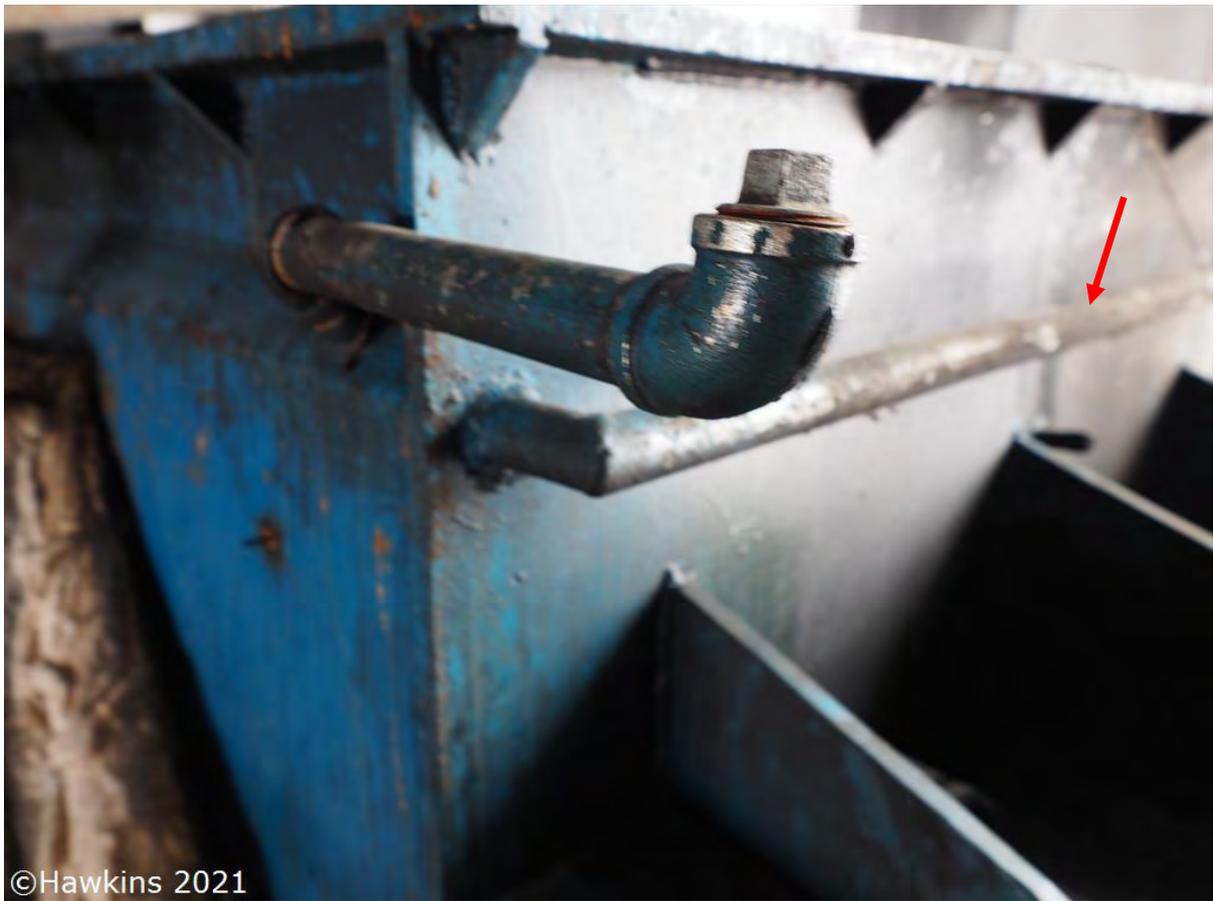
4.3.12 A spare heating element lay on the mezzanine next to the machine. There were also some tools on the mezzanine and on horizontal surfaces of the machine. These included a spanner, a screwdriver, cable crimps, a socket and ratchet (**Photograph 30**).

Photograph 30: Montage of the spare heater with a socket and ratchet (top left) and the selection of tools left on the machine and mezzanine. They included spanners, a screwdriver and cable crimps. Note the two nuts on the machine next to the spanners (bottom left image).

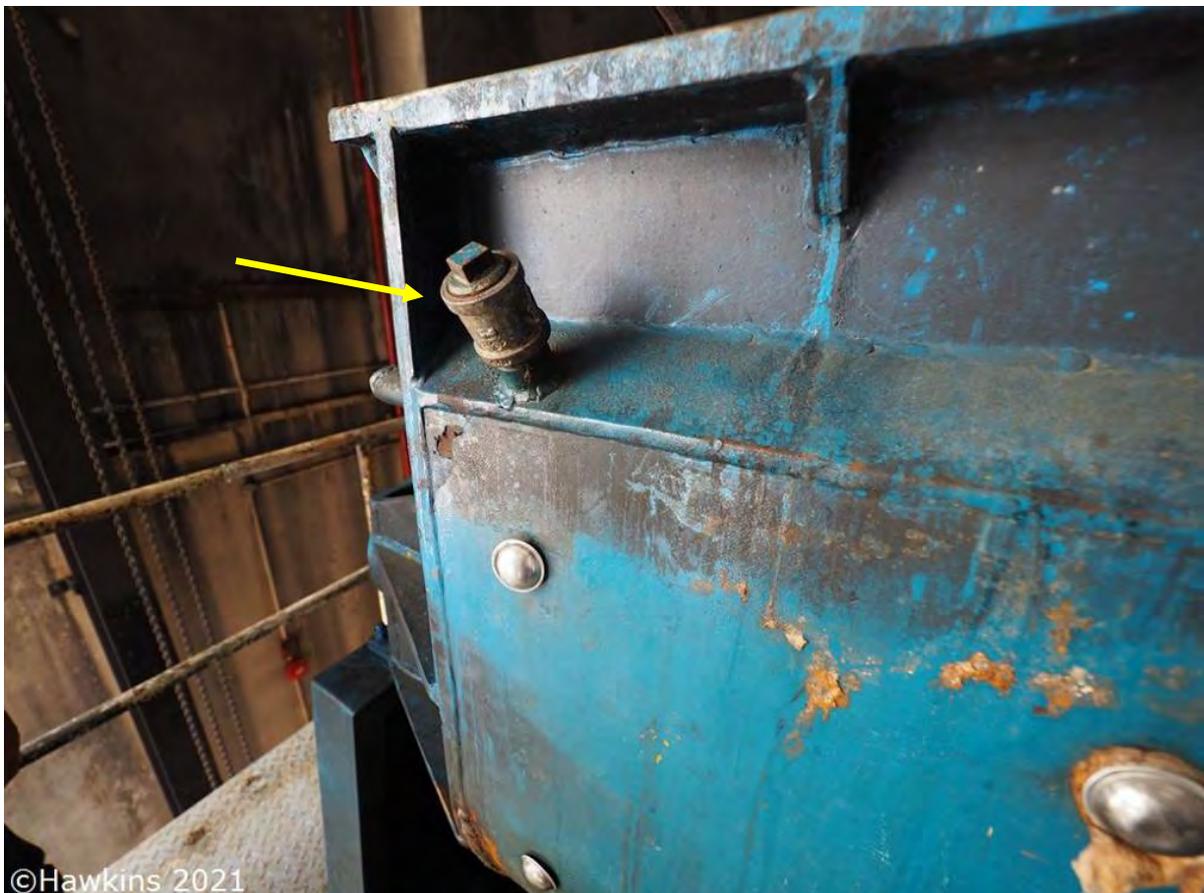
4.3.13 The oil reservoir of the machine had what appeared to be two filling points, one at each side of the hopper, connected by a pipe routed between them around the outside of the machine (to equalise the pressure as the top of the reservoir was a nominal 'W' shape when viewed in cross section). The two filling points, which are shown in **Photographs 31** and **32**, had been capped off. I saw no sign of a pressure relief system, nor a dip stick or a sight glass to determine the oil level.

Photograph 31: One of the oil reservoir filling points. Note that it is capped. The pipe connecting the two halves of the reservoir is highlighted by the arrow.

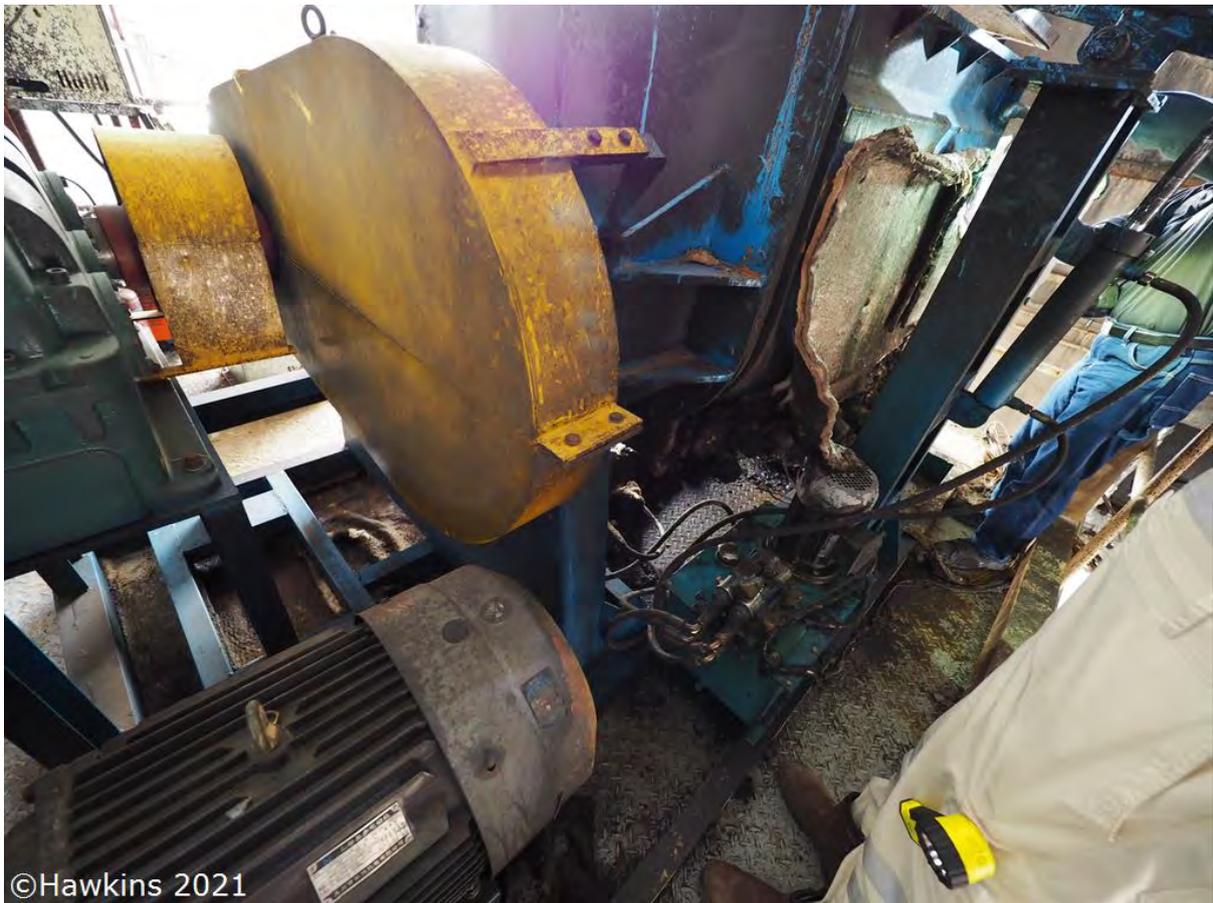
Photograph 32: One of the oil reservoir filling points. Note that it is capped.

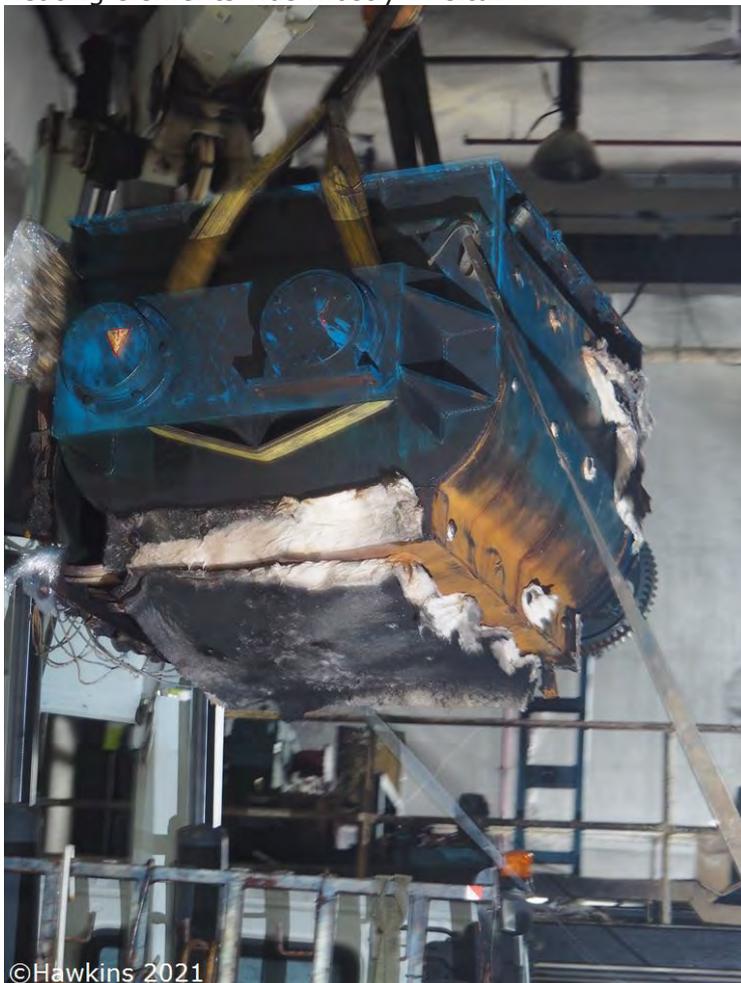
4.3.14 The lower half of the external surfaces of the machine had been covered in an insulation material. It was mostly missing from the side facing the rear of the unit (Photograph 26); whereas that covering the side fitted with the heating elements was mostly still in-situ (**Photograph 33**). The underside and some of the end mineral wool insulation material was still fitted as can be seen in **Photograph 34**.

Photograph 33: The thermal insulation on the side of the machine fitted with the heating elements was mostly in-situ.

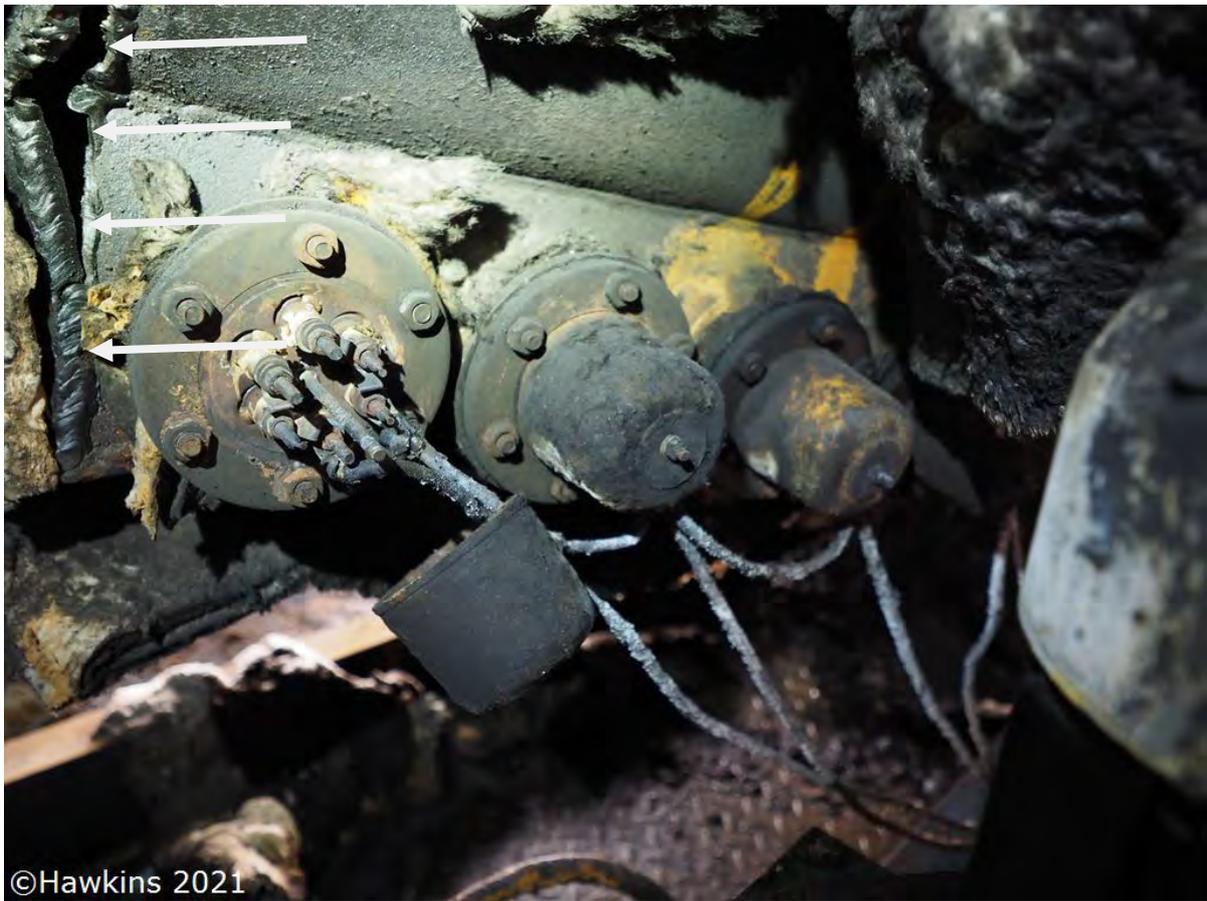
4.3.15 The exposed steel of the machine's oil reservoir was blackened on the side fitted with the heating elements, but it was rusty on the opposite side (**Photograph 35**). The weld repairs to the casing on this side of the machine can be seen clearly. The damage to the steel appeared to be greatest at low level, consistent with a fire burning below the machine, although the thermal insulation was mostly undamaged (Photograph 33). By contrast, the frame on which the machine stood was only fire damaged on the upper surface of the cross member below the failed joint of the oil reservoir (**Photograph 36**).

Photograph 36: The localised fire damage to the frame that supported the machine. The opposite side of the steel frame was hardly affected.
