**Report of the Inquiry
Committee for the accident
at Stars Engrg Pte Ltd on
24 February 2021**

ACCIDENT INVESTIGATION REPORT

FIRE AND EXPLOSION AT STARS ENGRG PTE LTD (32E, TUAS AVENUE 11)

**INVESTIGATION INTO THE CAUSE OF THE EXPLOSION
THAT OCCURRED AT 32 E TUAS AVENUE 11, SINGAPORE ON
24 FEBRUARY 2021**

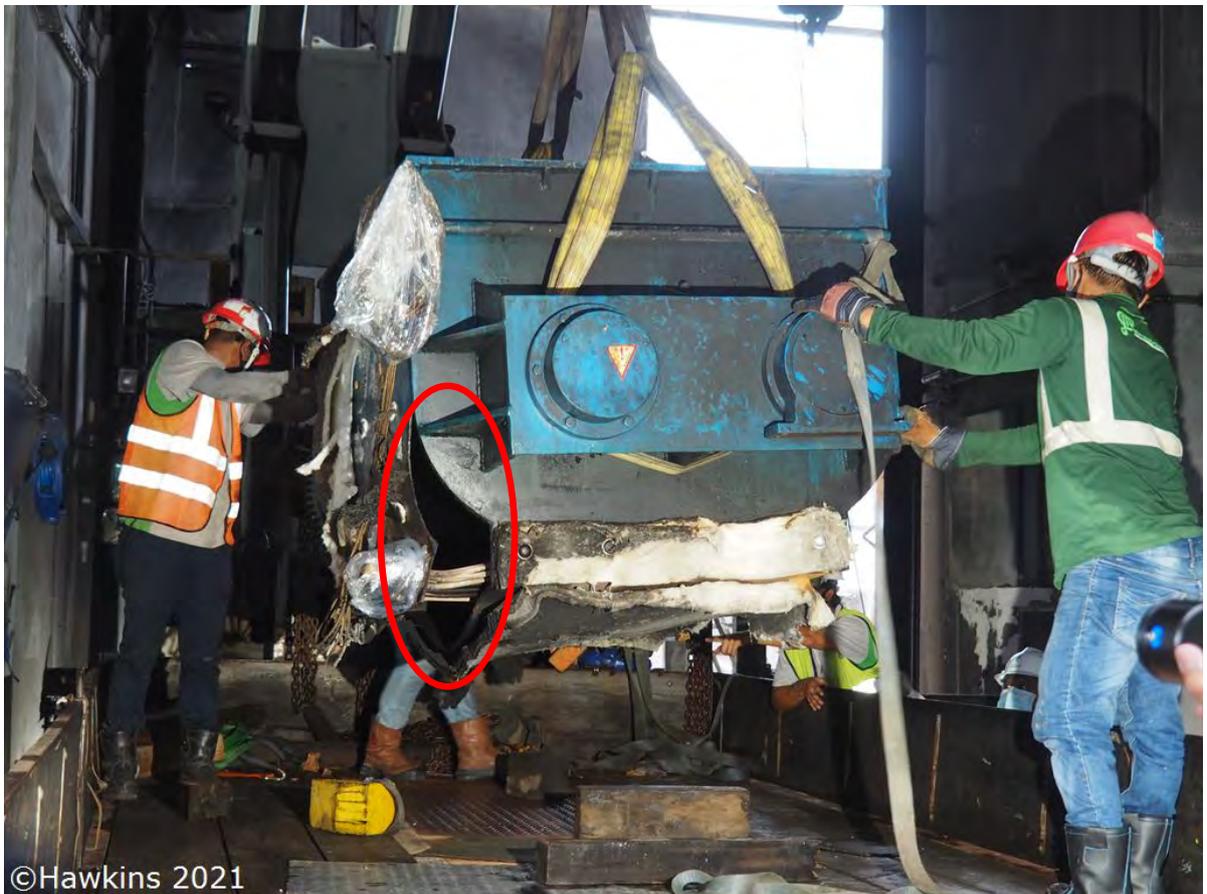
4.3.16 The front corner of the oil reservoir at the end of the machine closest to the drive motors was torn open slightly along a weld (**Photograph 37**). The opposite end,

Photograph 37: The tear in the oil reservoir casing relative to the heating elements.

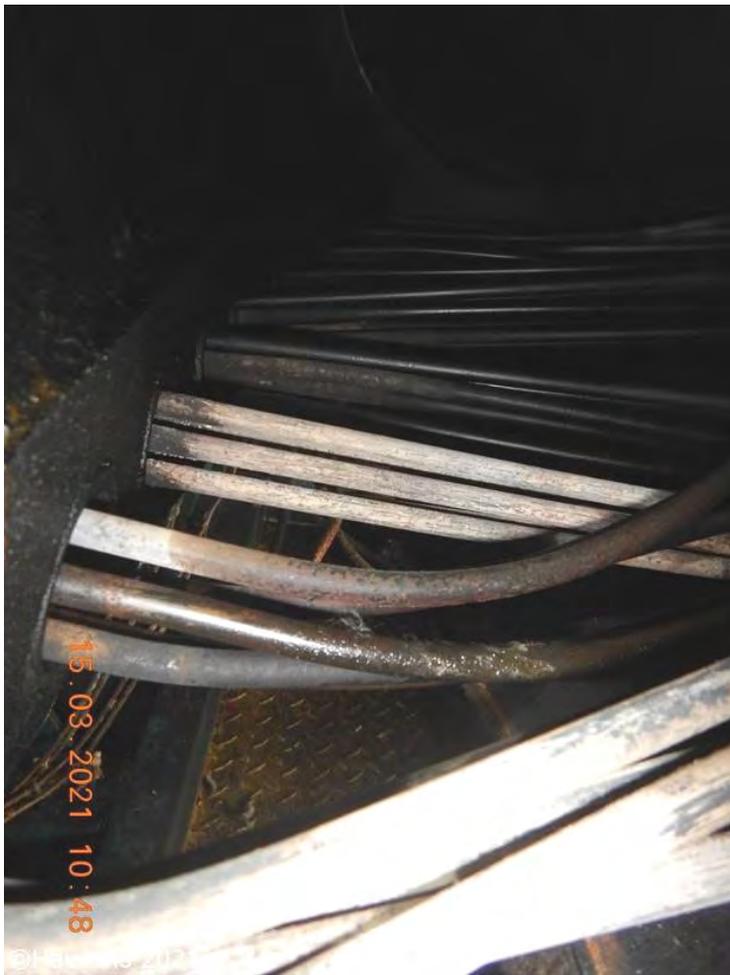
closest to the control panel, was also torn open along a weld line, but to a much greater extent (**Photograph 38**). The opening exposed the nine heating elements inside the oil reservoir (**Photographs 39** and **40**); the elements closest to the control panel were distorted and some appeared to be discoloured.

Photograph 38: The end of the machine that had been closest to the control panel. Note the insulation material is still in-situ and the tear in the oil reservoir casing by the heaters.

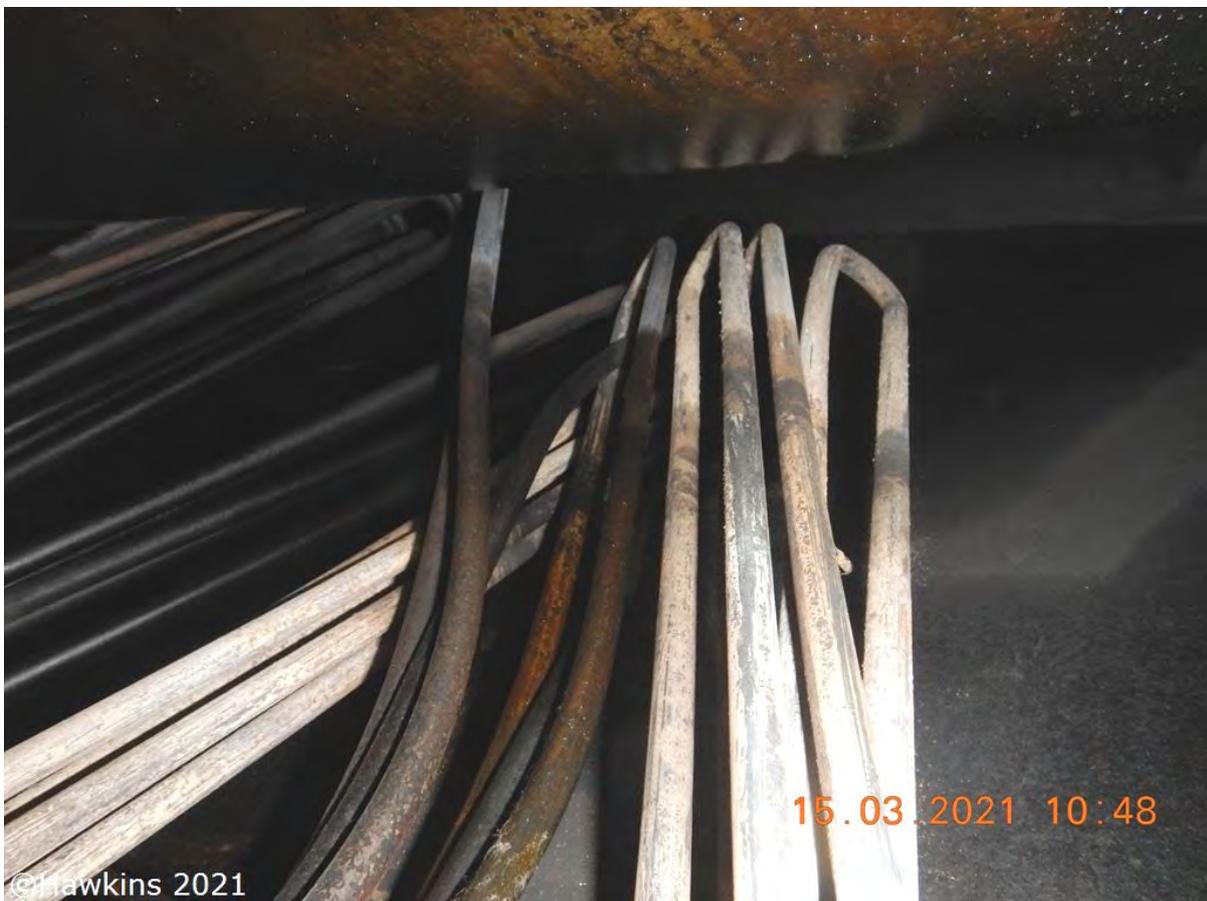
Photograph 39:

Looking past the tear into the oil reservoir. The row of nine heating elements can be seen.

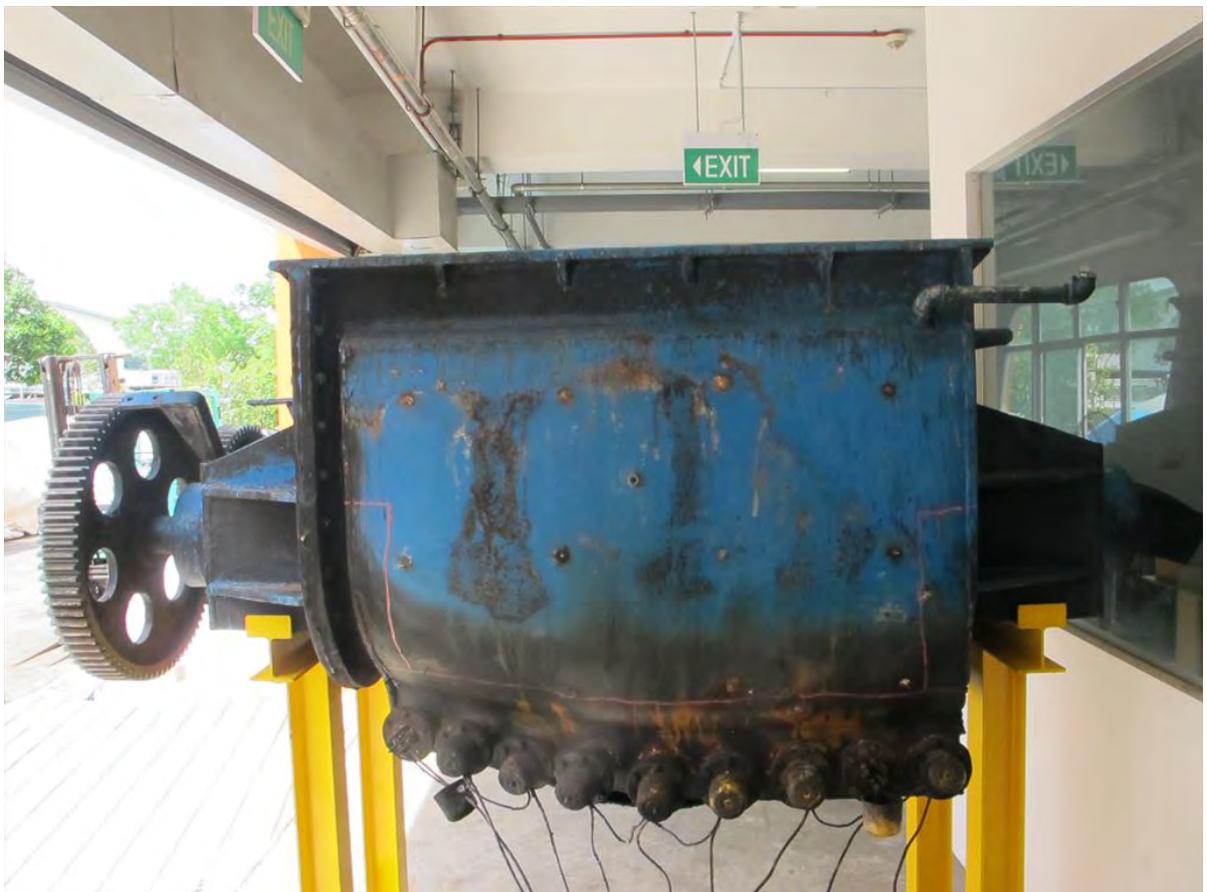
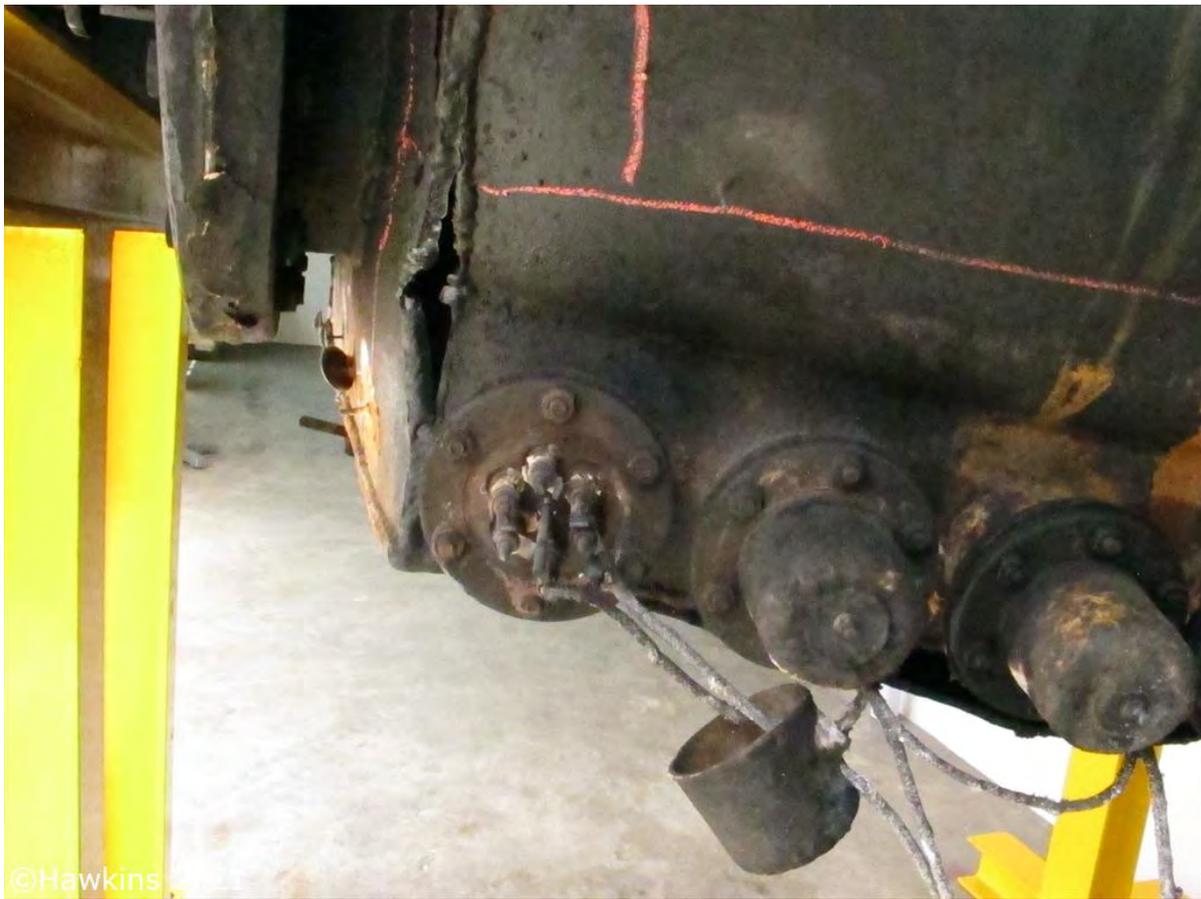
- 5.1 The inspection on 31 March 2021 was to observe where Matcor intended to cut-out the fracture surfaces of the oil reservoir (**Photographs 43** and **44**). At this time, Mr Cooper was able to make a close inspection of the welds used to construct the machine and the subsequent repairs.

Photograph 43: The machine as seen at Matcor. Note the orange chalk marks indicate the intended cut-lines.

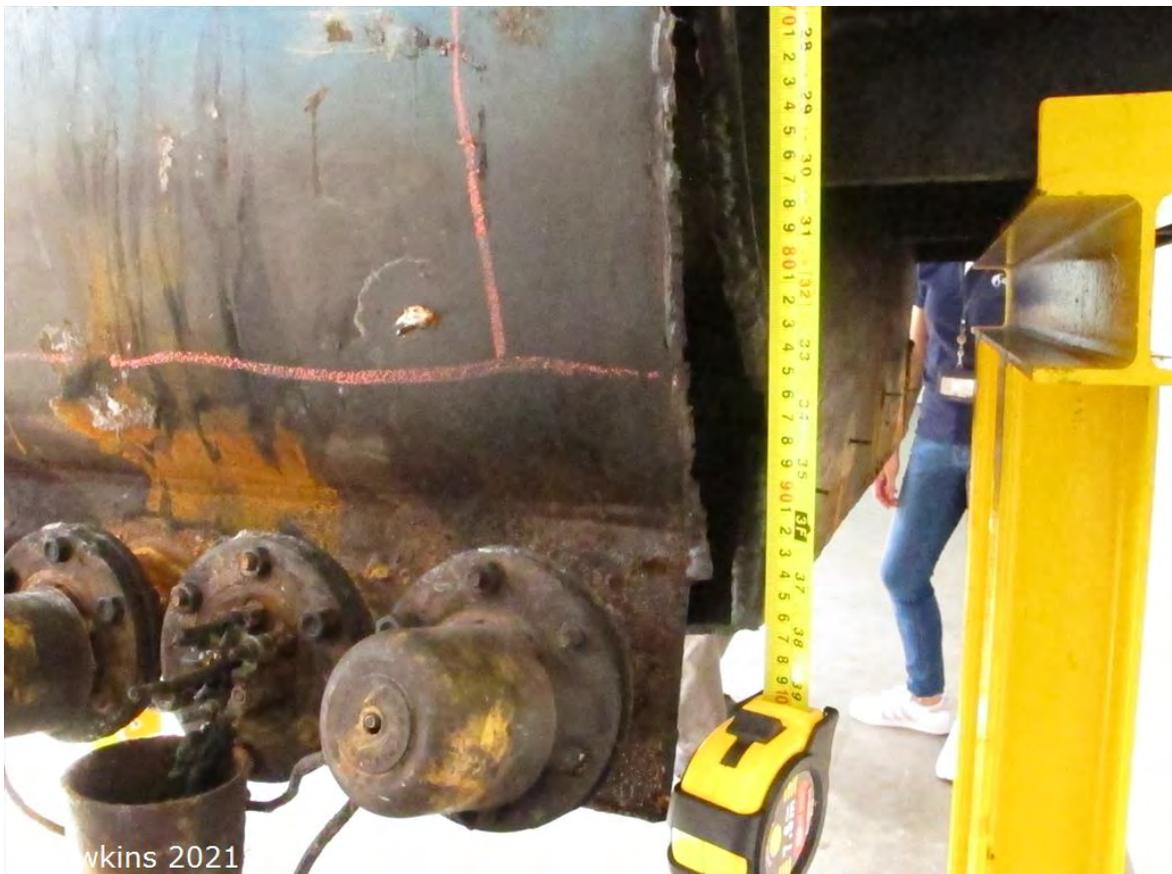
- 5.3 **Photograph 45** shows the tear along the weld between the end of the oil reservoir at the drive-motor end and the side wall where the heaters had been fitted, whereas **Photograph 46** shows the end closest to the control panel. The two ends had not been repaired by the application of a patch; however, the bottom of the reservoir, which had been fitted with a patch, was also distorted outwards (**Photograph 47**).

Photograph 45: A closer view of the tear at the drive-motor end. Note how the end wall of the oil reservoir had distorted outwards.

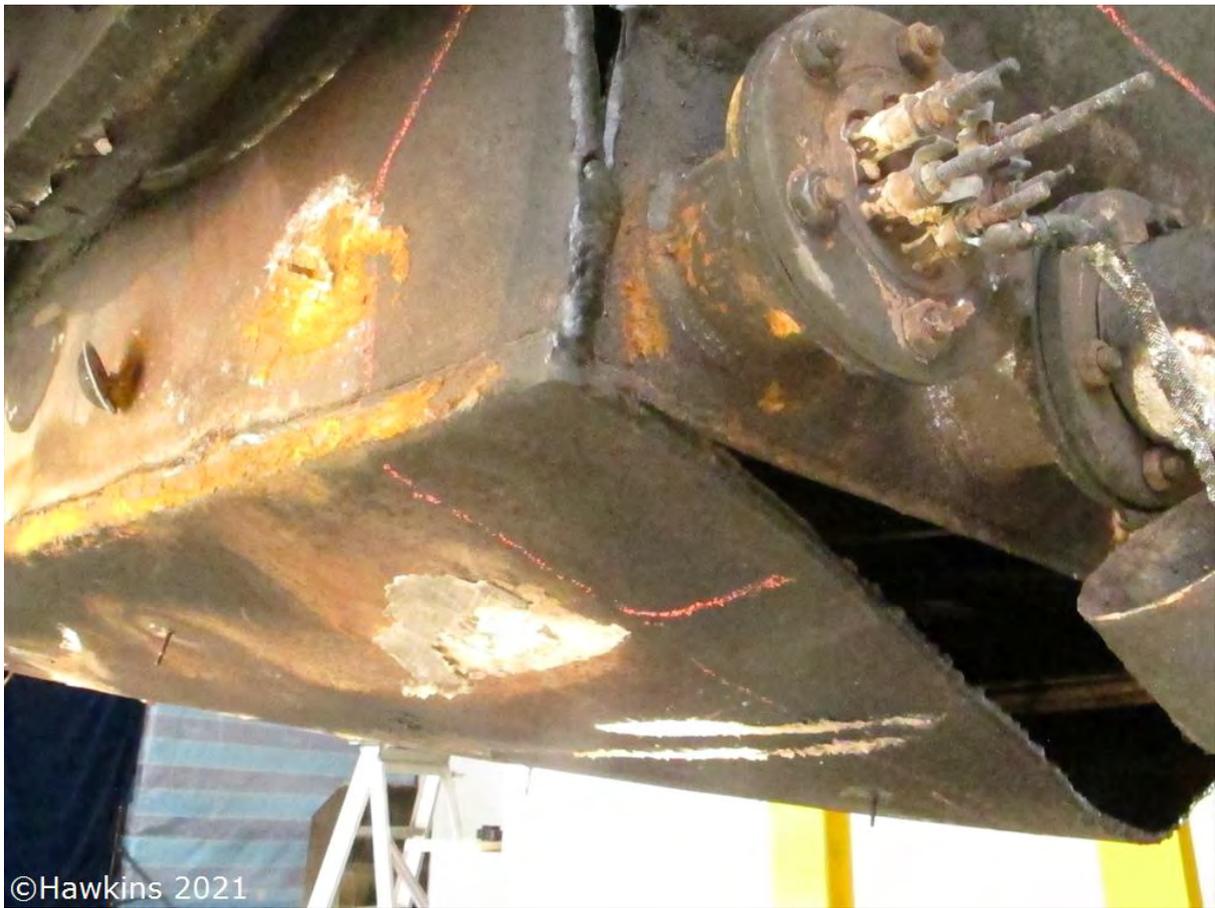
Photograph 46: A closer view of the tear at the end adjacent to the control panel. Note how the side wall of the oil reservoir had distorted outwards.

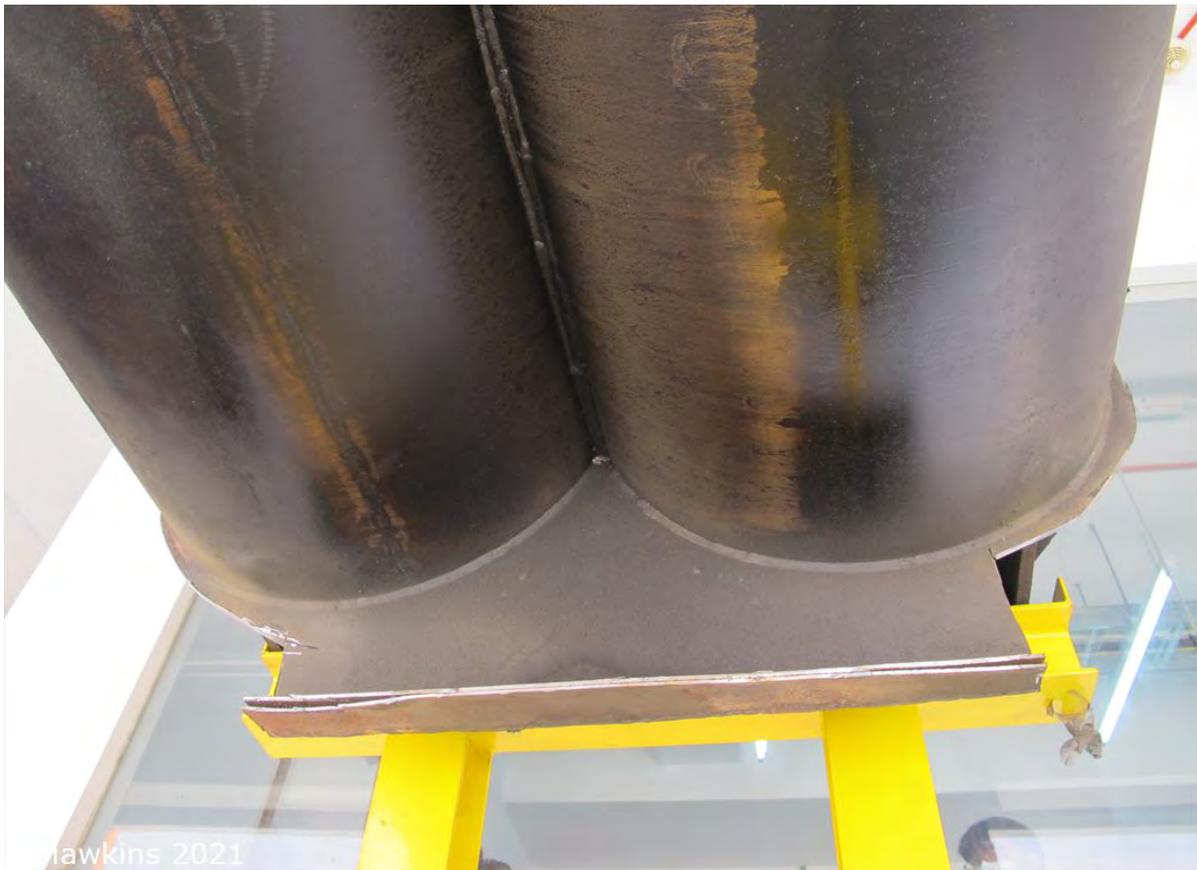
- 5.5 During Mr Cooper's second attendance at the Matcor facility on 12 April 2021, he was able to see the inside of the oil reservoir clearly and found that it was free of wet residues of oil. The internal surfaces appeared to be covered in a fine covering of soot (**Photographs 48 to 52**), with no evidence of a tide mark to indicate the oil level in the reservoir at the time of the explosion. He saw that the interior of the oil jacket appeared to be intact and saw no evidence of a leak from the mixing chamber into the oil reservoir.

Photograph 48: The inside of the oil reservoir looking upwards to the underside of the reaction vessel at the location of the corner closest to the control panel. The soot deposits and the 'double skin' repair can be seen.

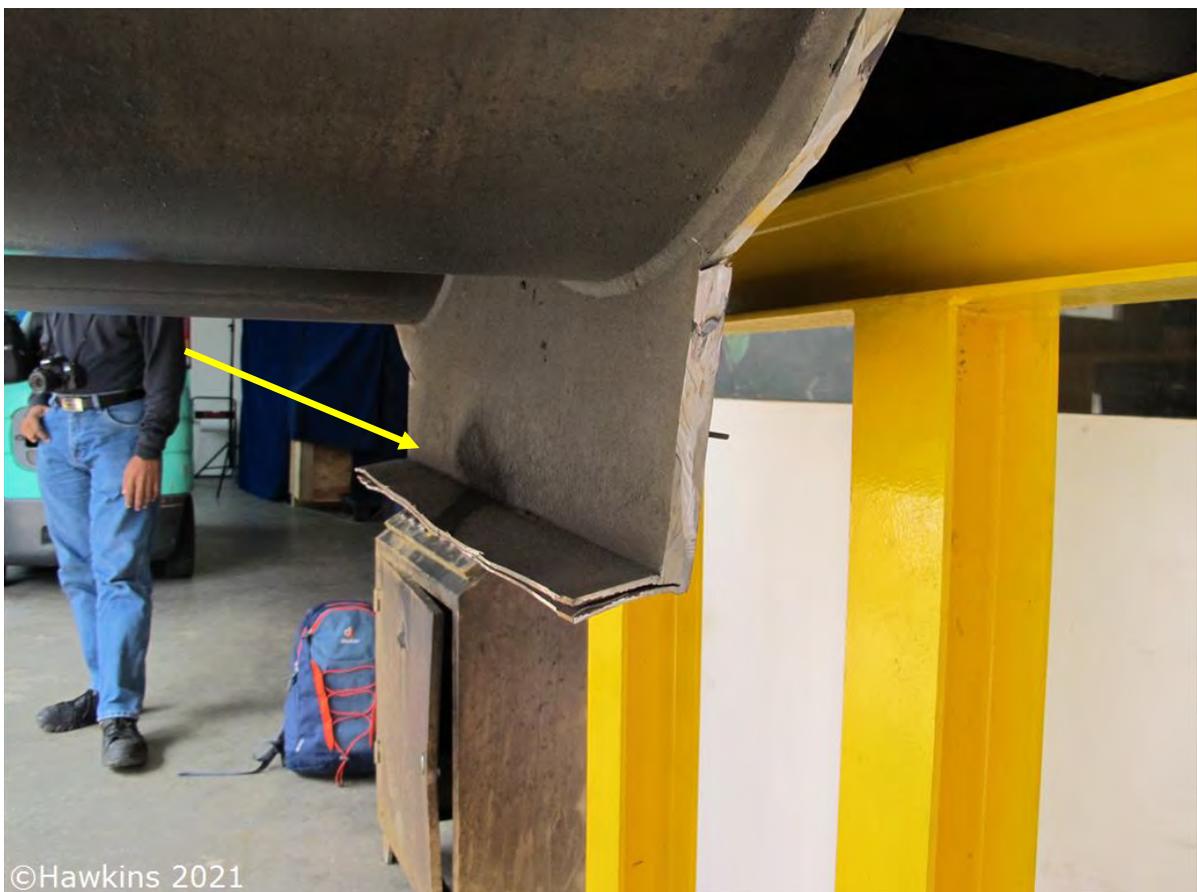
Photograph 49: Photograph 48 in context. Note there is no evidence of a tidemark on the end wall of the reservoir to indicate the oil level before the explosion.

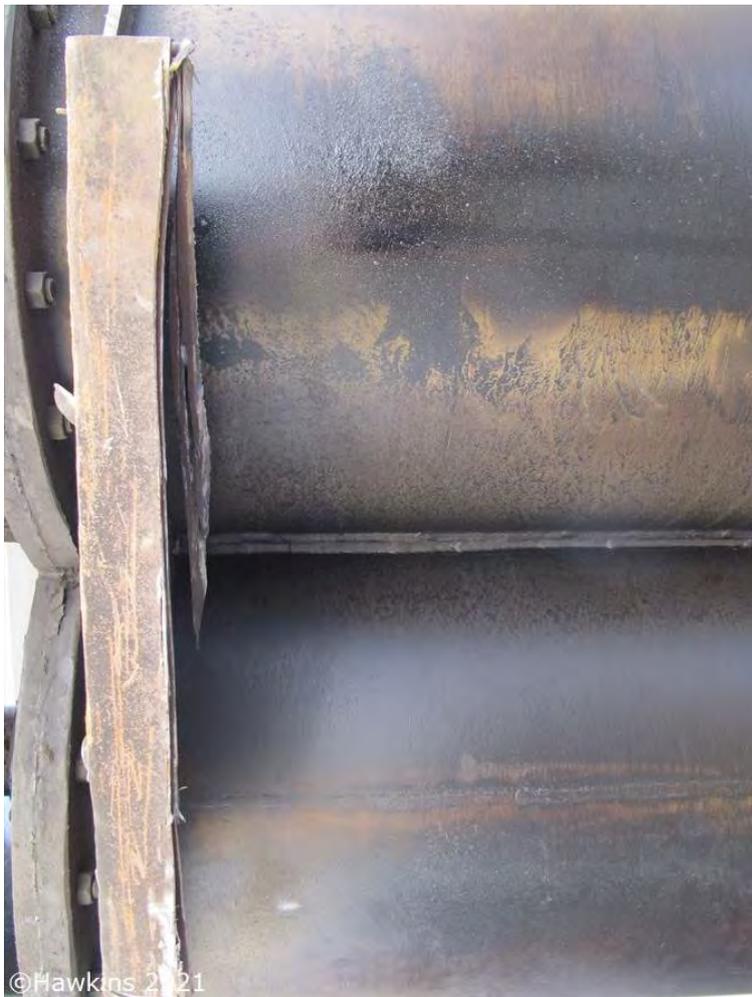
Photograph 50: The inside of the oil reservoir looking across the underside of the reaction vessel from the location of the corner closest to the control panel. What appears to be a 'spray' mark is apparent.

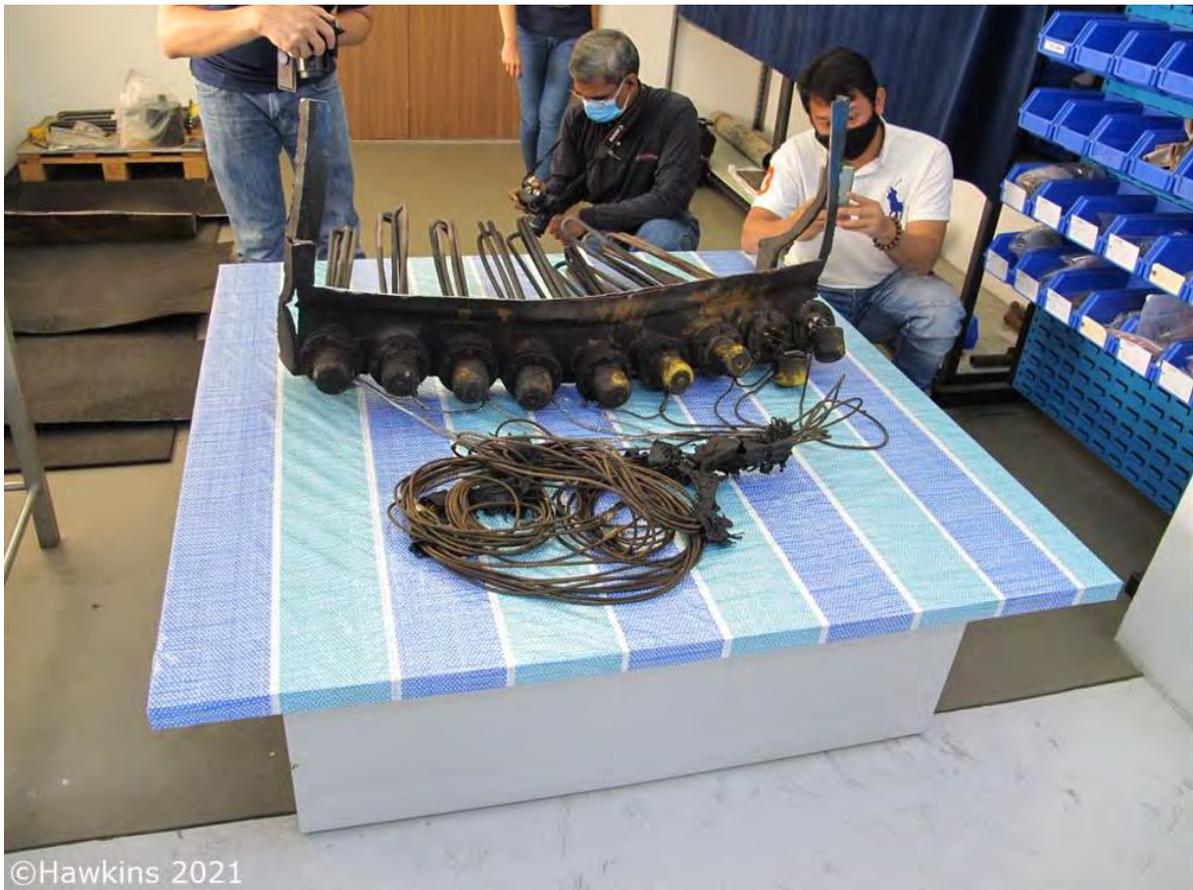
Photograph 52: The bottom and one side of the oil reservoir. Note the soot marks.

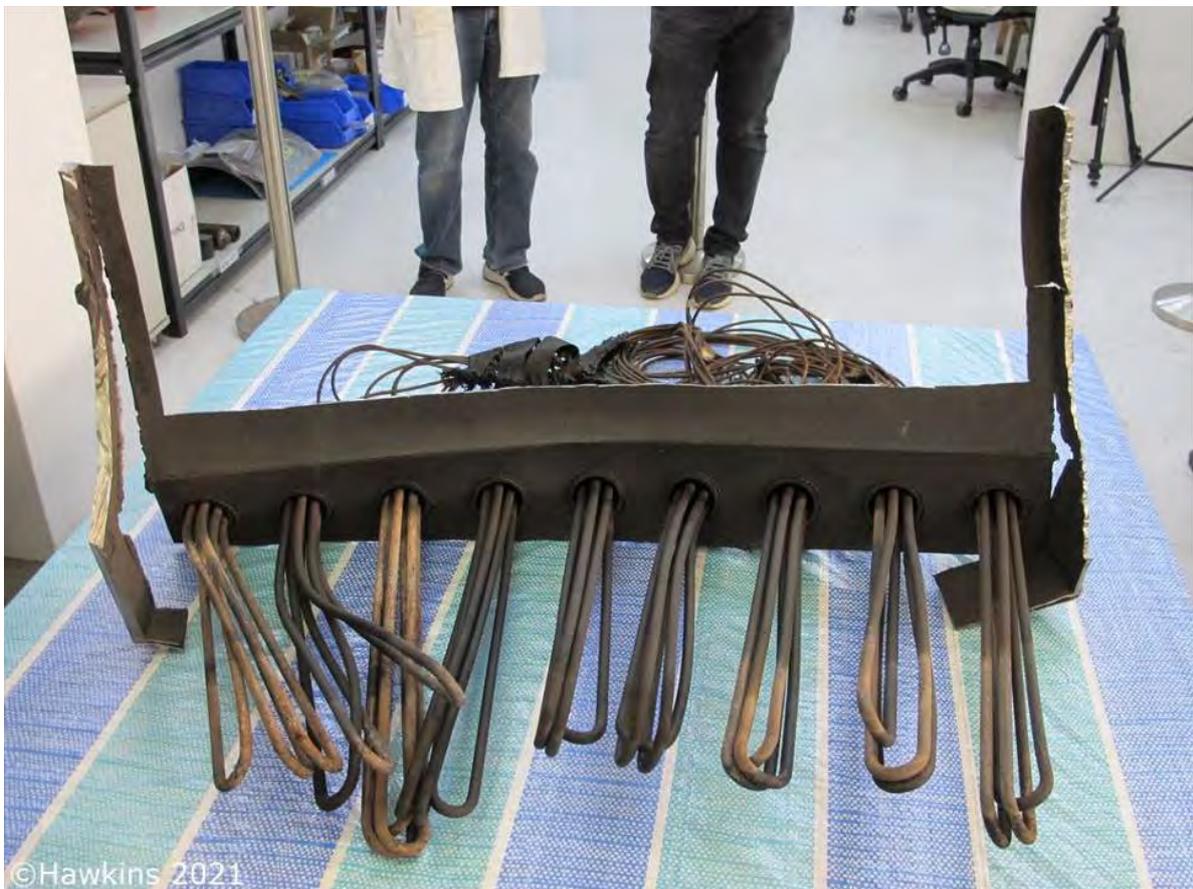
- 5.6 The three heating elements at the end closest to the control panel were bent in towards the centre of the oil reservoir (**Photographs 53 and 54**). Mr Cooper saw no sign of arcing damage to the element sheaths; however, he was not able to touch them, so as to turn them over and inspect their underside.

Photograph 53: The oil reservoir heating elements.
